# **A Retrospective Evaluation of Cured-in-Place Pipe (CIPP) Used in Municipal Gravity Sewers**

**Contract No. EP-C-05-057  
Task Order No. 58**

**U.S. Environmental Protection Agency  
Urban Watershed Branch  
National Risk Management Research Laboratory  
Water Supply and Water Resources Division  
2890 Woodbridge Avenue (MS-104)  
Edison, NJ 08837**

**September 2011**

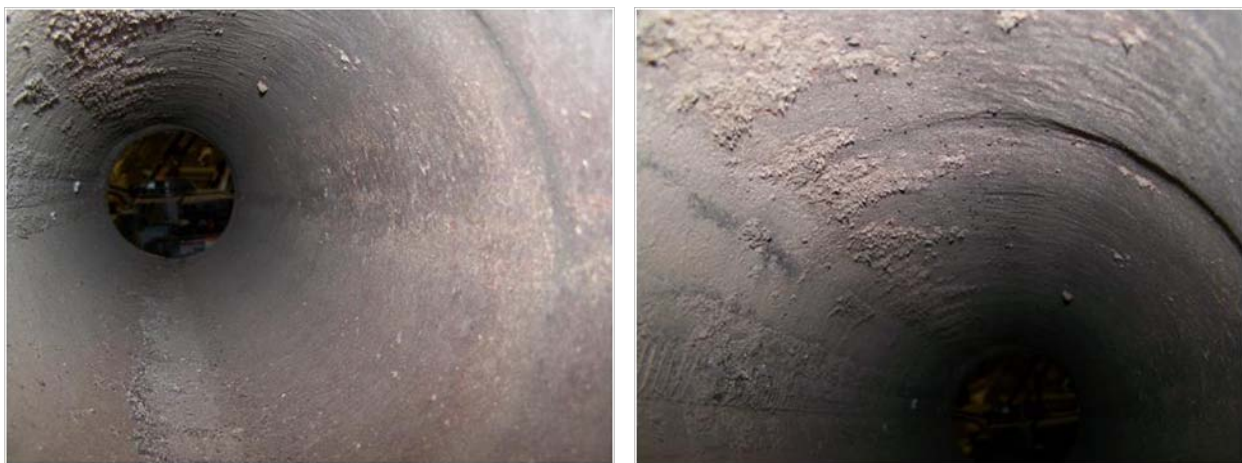
**Figure 4-2. Images of the Inner Surface of the 25-year Old, 6-ft Long CIPP Liner Section**

**4.2.3 Visual Inspection of the Liner.** Overall the liner appeared to be in good shape. The polyurethane coating seemed to be eroded away at the invert of the pipe. Upon discussion with the vendor (Insituform), it was established that the polyurethane laminate coating was intended to serve as a sacrificial layer and act as a barrier for preventing resin from entering the interior of the tube. It was expected that this coating would hydrolyze over time (a chemical reaction causing the breakdown of certain polymers). The vendor was surprised to find out that most of the polyurethane layer remained intact (modern CIPP liners typically utilize a PE or a more durable polyurethane coating, which is considered to be a permanent layer). In locations where the polyurethane coating hydrolyzed, the fibers into which the polyurethane coating dissolved were exposed and somewhat loose. However, the resin-impregnated felt beneath it was solid and intact. The stitched seam holding together the CIPP tube was found to be in good condition. Signs of wear were restricted to the bottom third of the tube. A deposit made up of silt and what appeared to be residue of an organic matter was found at the invert of the CIPP liner (Figure 4-2).

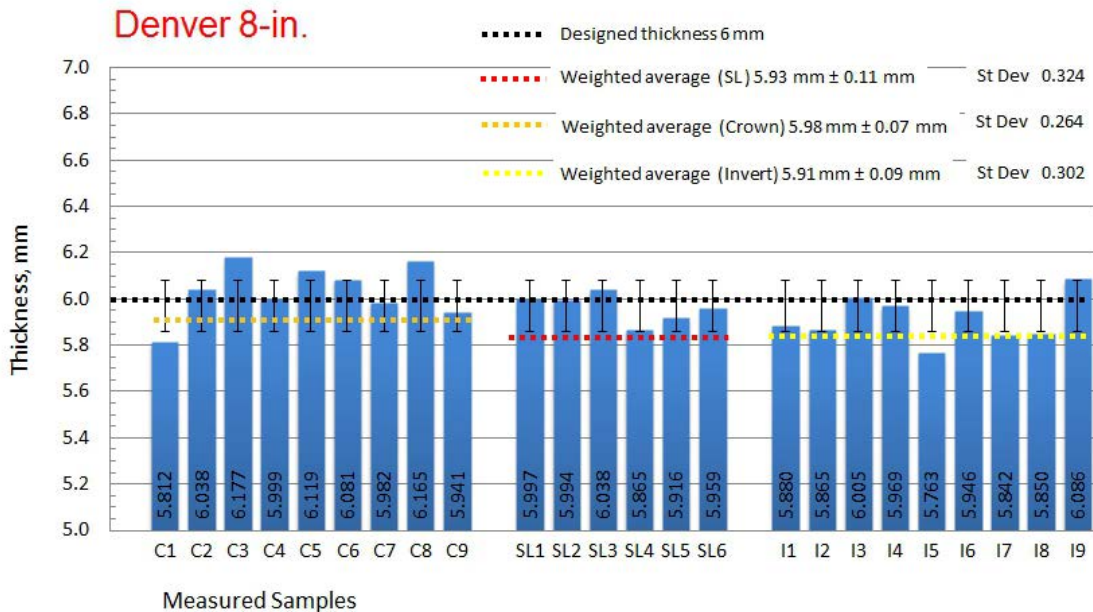
**Figure 4-6. Average Thickness at Different Locations on the Liner**

**4.2.8 Liner Thickness.** A total of 72 readings were taken to measure the thickness at different locations around the pipe circumference. These readings were taken using a caliper with a resolution of  $\pm 0.0001$  in. The average thickness of the liner is shown in Figure 4-6. The thickness of the liner was found to vary slightly around the circumference of the liner with the maximum thickness at the crown (5.98 mm  $\pm$  0.07 mm) and slightly lower values at the spring line (5.93 mm  $\pm$  0.11 mm) and the invert (5.91 mm  $\pm$  0.09 mm). This was attributed mostly to the erosion of the polyurethane coating layer (approximately 0.38 mm thick), originally placed on the internal surface of the liner, at the invert zone. The average measured thicknesses after 25 years in service were all slightly lower than the designed thickness of the liner (6 mm) although some individual readings were higher. No ultrasonic field measurements of liner thickness were possible in the field and when attempted in the laboratory the measurements were not successful. A discussion of this issue is provided in Section 6.

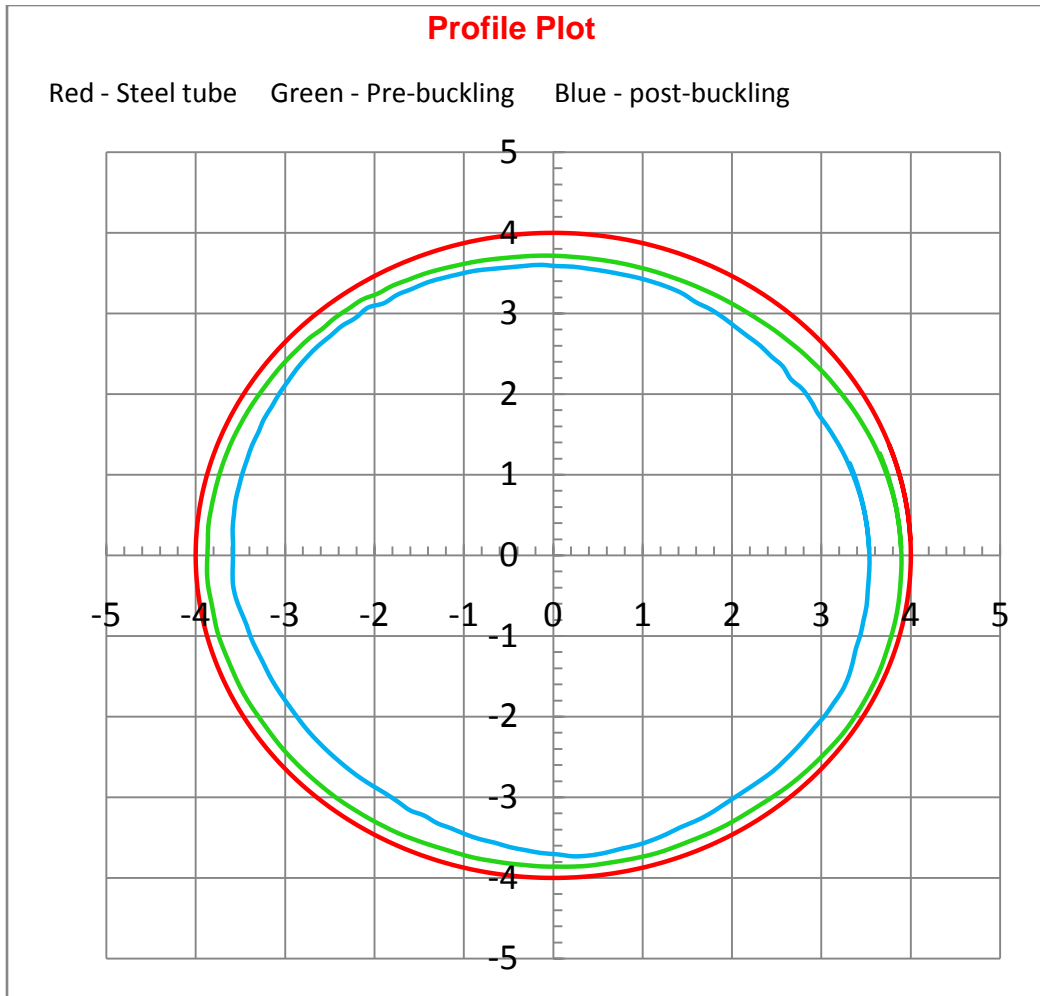
**Figure 4-8. Ovality of the Denver 8-in. Liner (Average of Three Cross-Sections Spaced 1 in. Apart)**

The liner was placed inside a circular polyvinyl chloride (PVC) tube, as if it was inside a host pipe, and careful measurements were taken to ensure that the liner center was aligned with the measuring device. Next, the profile plotter was aligned with the center of the CIPP liner tube. Continuous readings were taken around the circumference of three cross-sections spaced 1 in. apart and averaged. The liner was found to be approximately circular with reference to its center (green line in Figure 4-8). On the spring line to spring line plane, the liner had a slightly larger diameter than on the crown-invert plane, most likely due to geometrical imperfections in the original host pipe. The percent ovality based on the ovality definition in ASTM F1216 is 5.07%. The red and blue lines are shown in connection with the liner buckling test that was carried out on this liner and which is described in Section 4.2.12. When a host and/or liner are oval in shape, the larger radius of curvature in the flatter section of the oval liner reduces the ability of the liner to resist external buckling pressures. This is taken into account in the design equations for the liner in ASTM F1216. When pipe ovality exceeds 5%, the structural impact on liner strength becomes more significant.

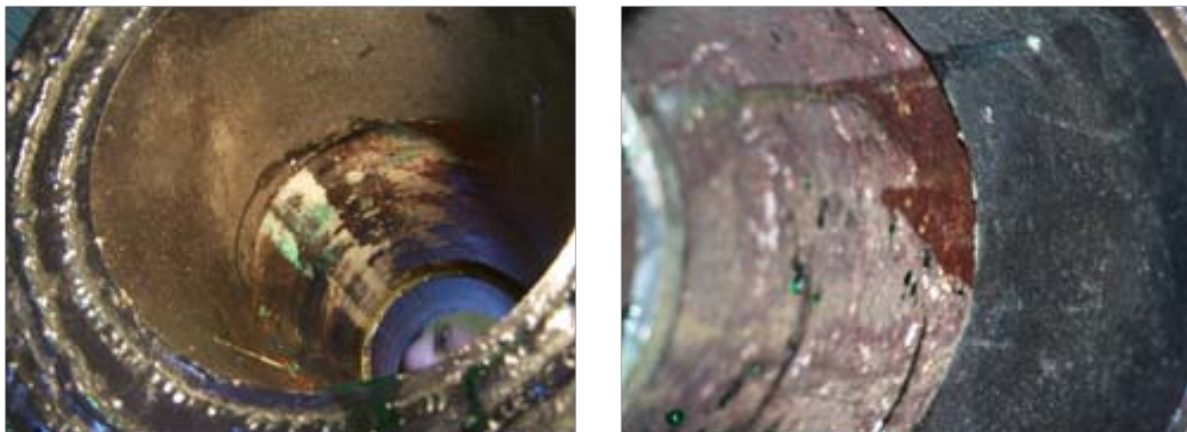
**Figure 4-22. Localized Leak on the Liner – Green Spots Due to Green Food Color**

Even with the brief peak at 200 psi pressure, visible evidence did not show a buckling failure of the liner although there was evidence of water leaks through the liner that indicated some localized failures (Figure 4-22).

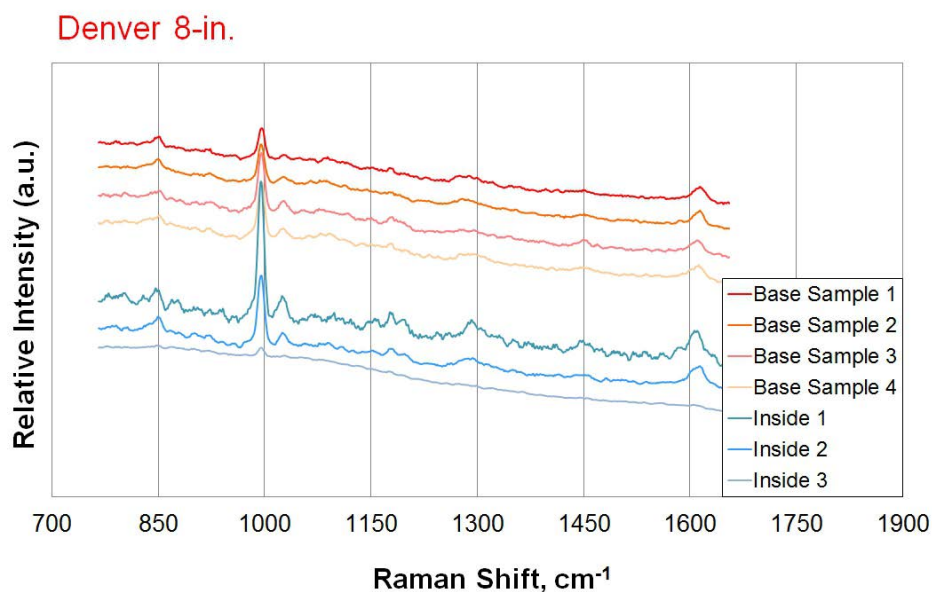
**Figure 4-25. Raman Spectra (Denver 8-in. Liner)**

The plots are nearly identical for the base resin and liner used for 25 years, with no significant change in the intensity of the peaks or region shift, indicating high chemical stability. Additional tests were carried out on the exterior surface of the liner, but no significant changes from the spectra shown in Figure 4-25 were detected.

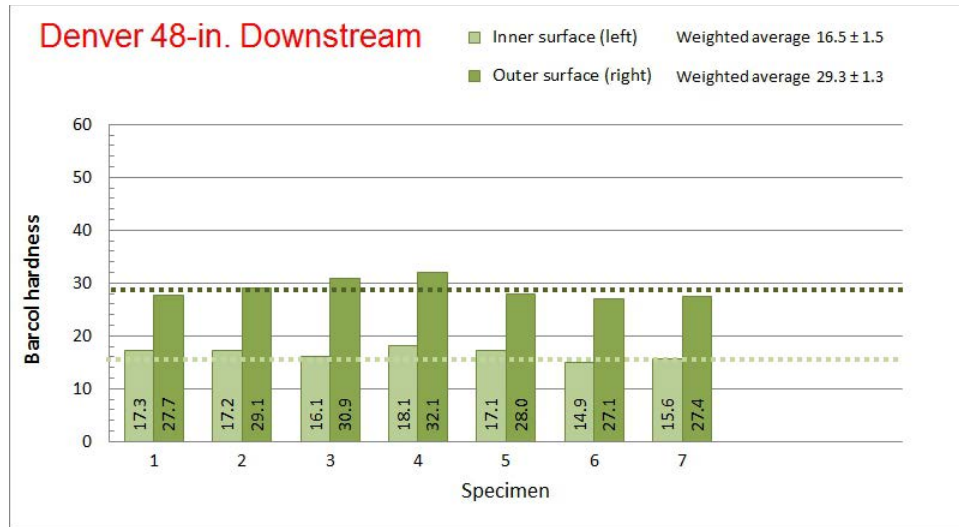
**Figure 4-46. Barcol Hardness of Denver 48-in. Downstream Sample**

The average calculated values and their standard deviations are shown in Figure 4-46. The weighted average of Barcol hardness for the sample inner surface was calculated to be 16.5 and the weighted error  $\pm 1.5$ , and for the outer surface  $29.3 \pm 1.3$ .

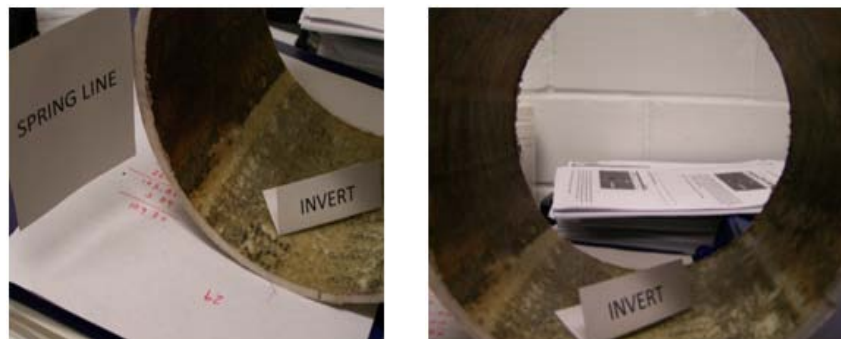
**Figure 5-2. Images of the Inner Surface of the 5-year Old Columbus 8-in. Liner**

**5.2.3 Visual Inspection of Liner.** The visual inspection in the field was documented by Ed Kampbell of Jason Consultants. The liner appeared to be in good shape overall (see Figure 5-2). The polymeric film on the CIPP appeared to be intact with no evidence of hydrolysis. In-situ measurements indicated that the CIPP was at least 6.0 mm thick around the circumference, with the greatest thickness observed being approximately 6.5 mm. The annular space was very small, including that at the branch connection. A large amount of resin was formed around the circumference of the liner at each branch connection location. There was no evidence of external hydrostatic loading (no visible signs of a seasonal water table). The resin-impregnated felt was solid and intact. The stitch holding together the CIPP tube was found to be in good condition. Signs of wear were restricted to the bottom third of the tube. The liner varied significantly in external diameter as it accommodated the short pipe segments between the four branches.

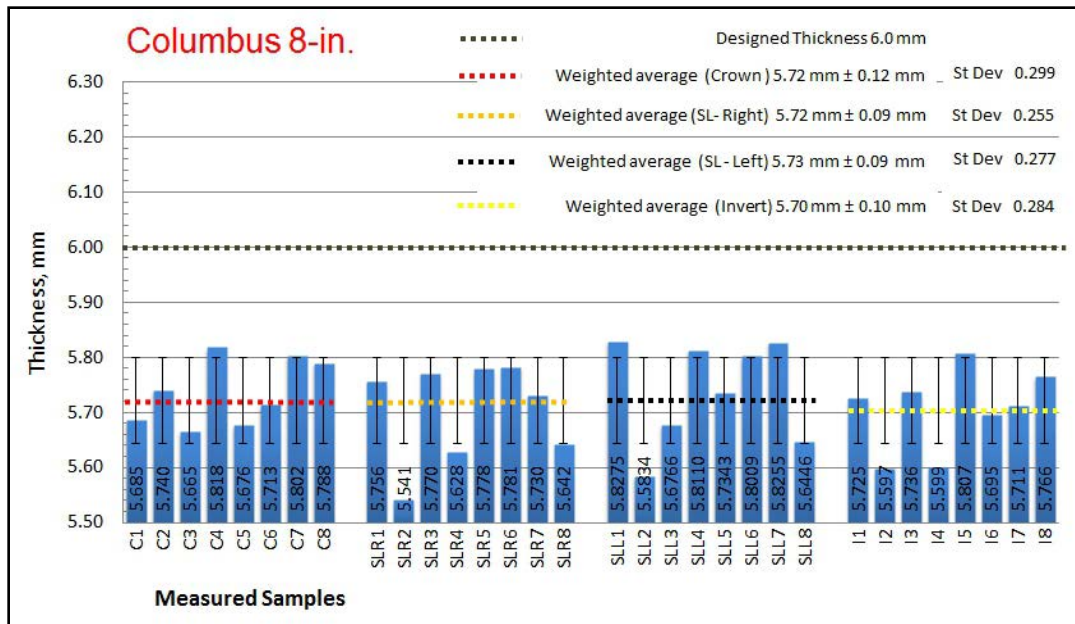
**Figure 5-8. Average Thickness at Different Locations (Columbus 8-in. Liner)**

The average thickness of the liner at different locations is shown in Figure 5-8. The thickness at the crown (5.7 mm) was found to be similar in thickness to the other locations (invert and spring line) around the circumference of the liner. The average liner thickness for each location is slightly less than the as-specified liner thickness of 6.0 mm. Additional discussion of the data measured at the time of installation with the current data is given in Section 5.2.14.

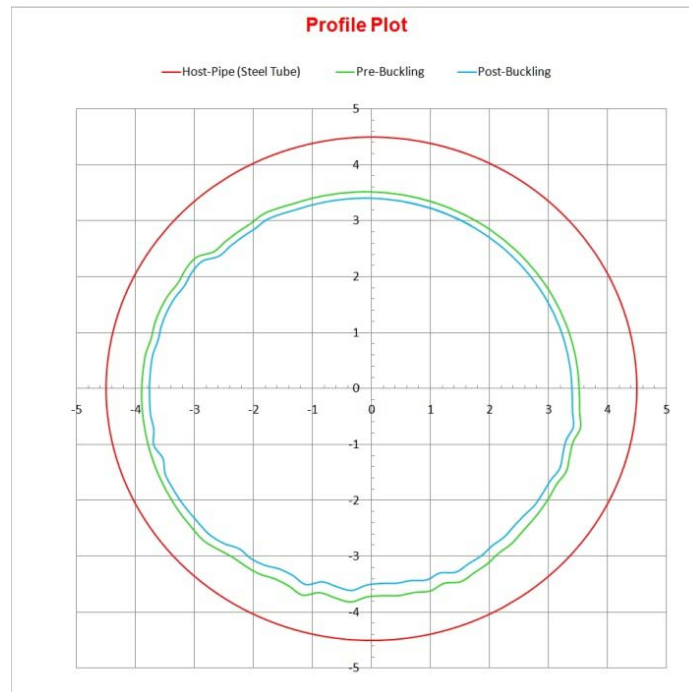
**Figure 5-11. Profile Plot of Steel Host Pipe and Liner Before and After the Buckling Test (Columbus 8-in. Liner)**

Figure 5-11 compares the pre-buckling and post-buckling profile plots. From the pre-buckling profile plot, it can be seen that the liner did not follow a perfect circular shape. The liner had several irregularities that probably matched irregularities in the original host pipe with the largest excursion (nearly a quarter inch outwards) from a circular shape occurring at the invert of the liner. The ovality of the liner calculated in accordance with ASTM F1216 was 7.4%. It should be noted that for the buckling test (described in Section 5.1.15), the liner was inserted and sealed within a circular steel pipe.

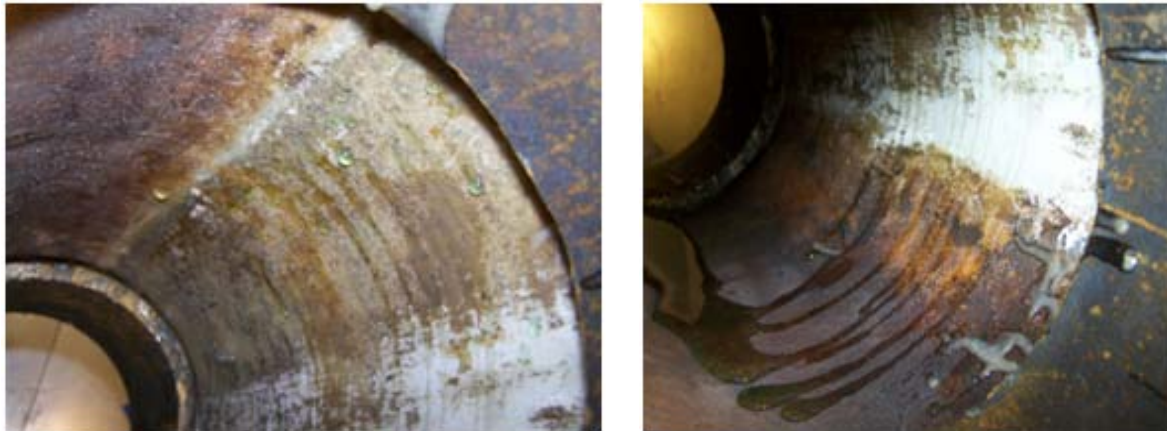
**Figure 5-24. Localized Leak on the Liner – Green Spots Due to Green Food Color**

Once the setup was completed, the buckling test commenced (Figure 5-22). The liner held a pressure of over 50 psi (corresponding to around 115 ft depth of immersion in water) for nearly 15 minutes (Figure 5-23). Leakage of water was observed through the liner material on the inner wall of the CIPP liner. These leaks suggest the presence of some migration paths through the resin matrix (Figure 5-24) at this elevated pressure. The cross-sectional profile of the liner before and after buckling is shown in Figure 5-11.

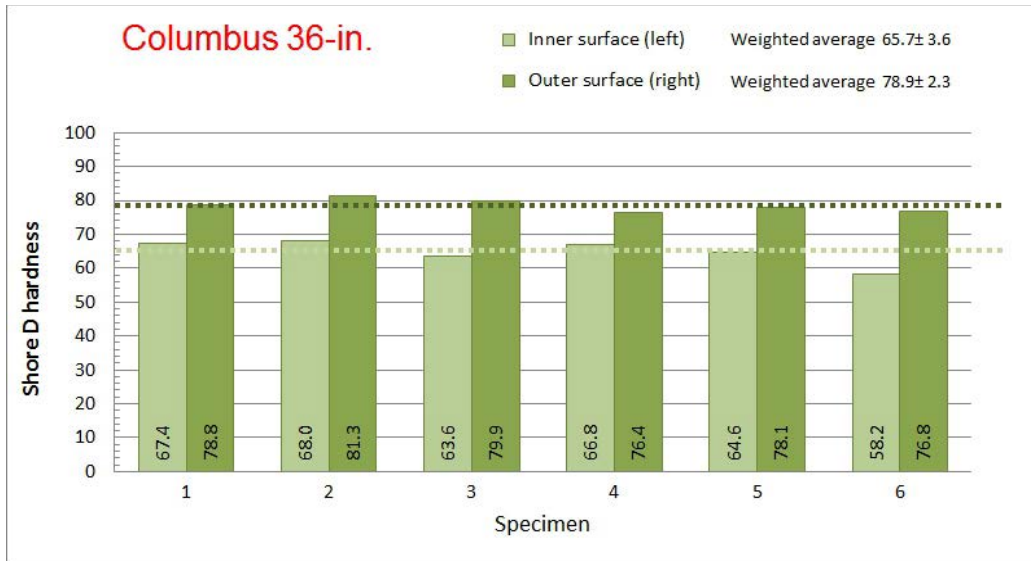
**Figure 5-38. Shore D Hardness of Columbus 36-in. Liner Sample**

**5.3.10 Shore D Hardness.** A total of six specimens measuring approximately 1 in. × 1 in. were prepared and tested using the Shore D hardness test. A total of 36 tests were conducted on each sample: 18 tests on the inner surfaces and 18 tests on the outer surfaces. The average calculated values and their standard deviations are shown in Figure 5-38. The weighted average of Shore D hardness for the sample inner surface was calculated to be 66±4, and for the outer surface 79±2.

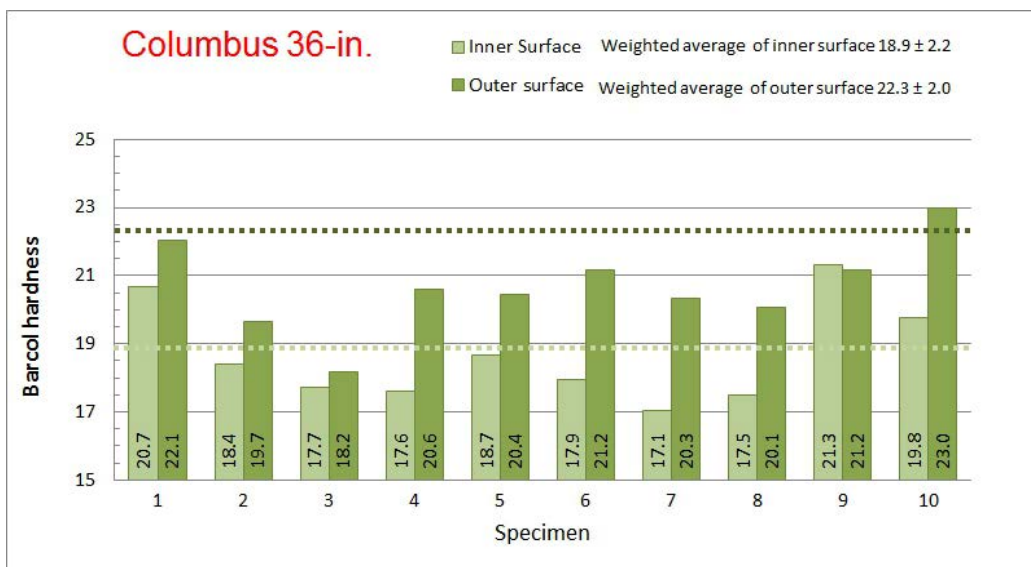
**Figure 5-39. Barcol Hardness Readings on Inner and Outer Surfaces (Columbus 36-in. Liner)**

**5.3.11 Barcol Hardness.** For each of 10 specimens, a total of 36 readings of Barcol hardness were taken: 18 on the outer surface and 18 on the inner surface. The average calculated values and their standard deviations are shown in Figure 5-39. The weighted average of Barcol hardness for the sample inner surface was calculated to be  $18.9 \pm 2.2$  and for the outer surface  $22.3 \pm 2.0$ . As for most of the liners tested, the outer surface hardness is higher than for the inner surface. For the Barcol test on this sample, the inner surface has an average hardness approximately 15% less than the outer surface.
