Field Demonstration of Innovative Condition Assessment Technologies for Water Mains: Acoustic Pipe Wall Assessment, Internal Inspection, and External Inspection

**FIELD DEMONSTRATION OF INNOVATIVE CONDITION ASSESSMENT TECHNOLOGIES
FOR WATER MAINS: ACOUSTIC PIPE WALL ASSESSMENT, INTERNAL INSPECTION,
AND EXTERNAL INSPECTION**

VOLUME 1: TECHNICAL REPORT

September 2013

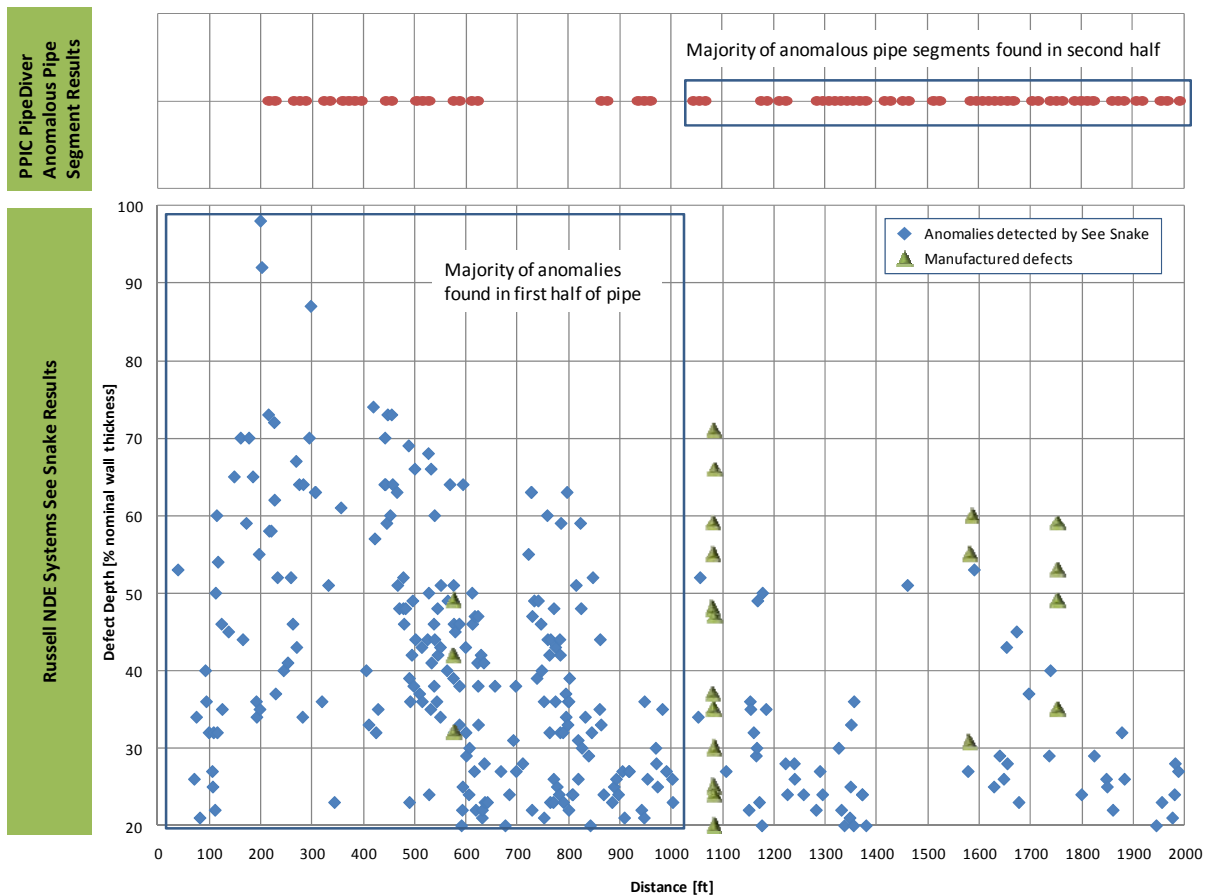
Figure 2-2. Defect Scatter Graph for See Snake[®] vs. Anomalous Pipe Locations for PipeDiver[®]

From this comparison, it is evident that See Snake[®] found a much larger number of defects in the first half of the test pipe with some locations corresponding to anomalous pipe found by PipeDiver[®]. On the other hand, PipeDiver[®] found a greater number of anomalous pipe segments in the second half of the test pipe, while See Snake[®] found far fewer and less severe anomalies. Verification of anomalies in specific pipe samples using wall thickness measurements by EPA’s contractor for selected pipe segments showed some pitting, but generally the pipe was in good condition. See Snake[®] provided the most detailed inspection results for the entire pipe length and the condition reported by See Snake[®] was found to correlate with the post-demonstration assessment of the 12 exhumed pipe segments by EPA’s contractor. The bell and spigot joints could be seen in the raw data, but not characterized in detail. Eight joints were identified as anomalous. Due to magnetic permeability noise, See Snake[®] was not able to characterize any of the machined calibration or test defects. The vendor identified four potential causes of the interference arising from either the installation process for the artificial defects or the previous operation of other electromagnetic inspection devices in the vicinity.

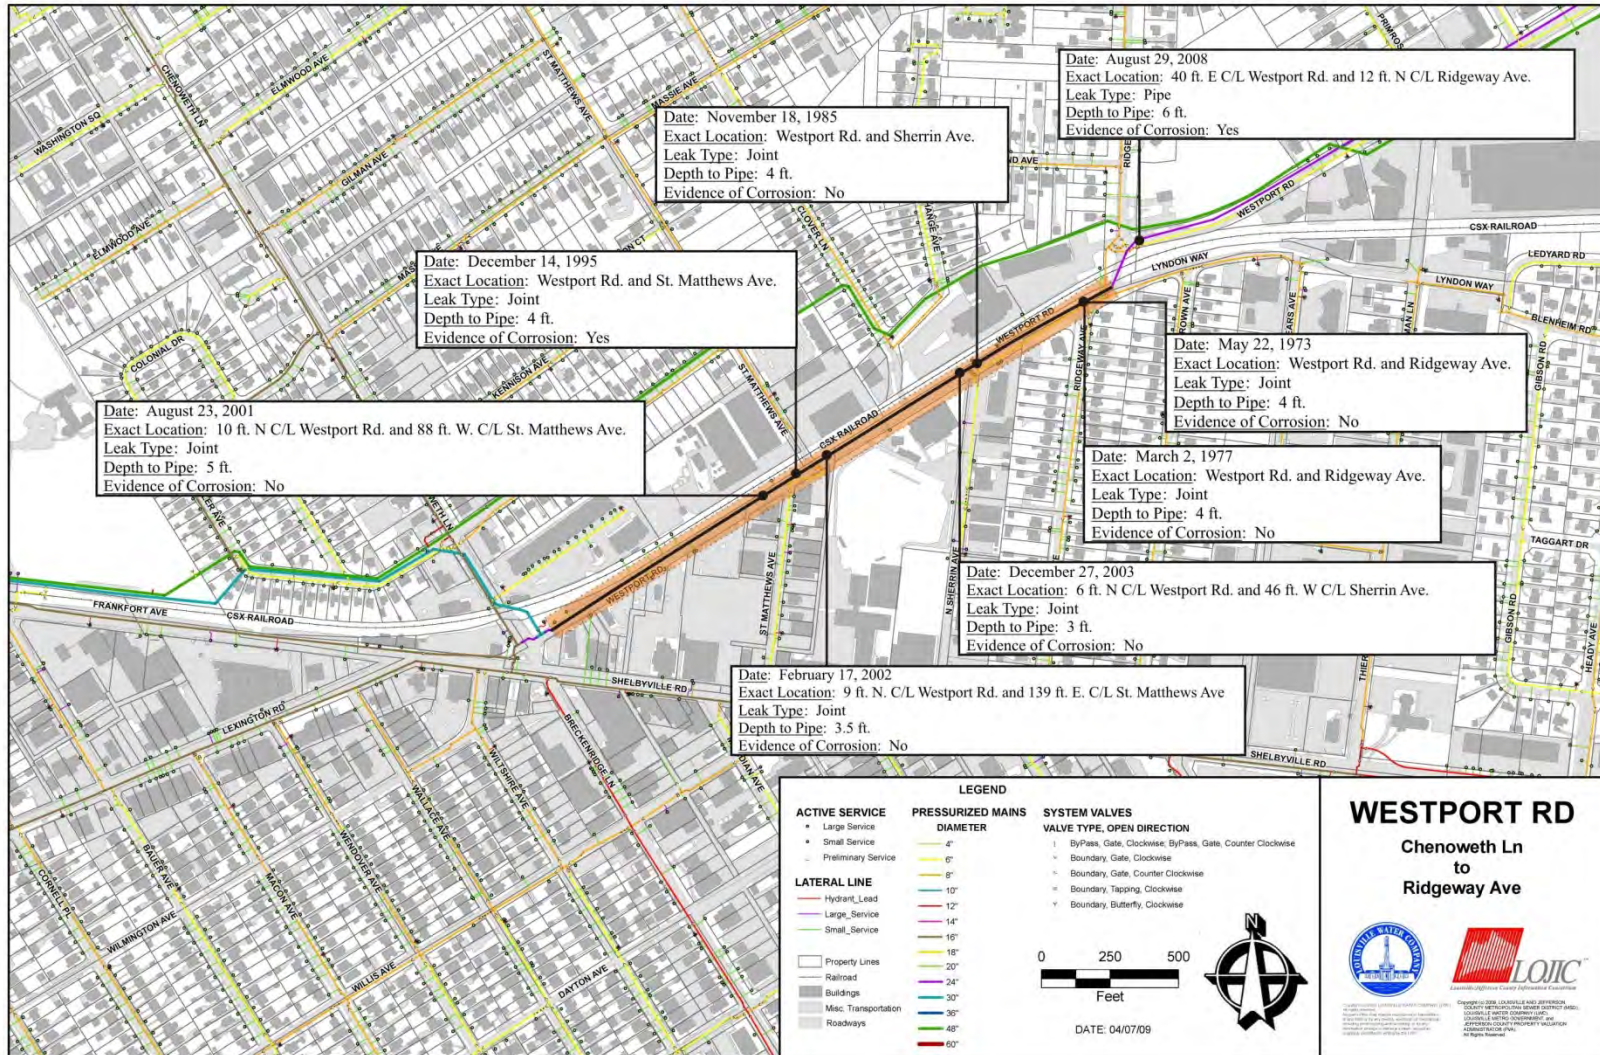
Figure 3-2. Locations and Details of Pipe and Joint Breaks and Leaks

Since no evidence of wall loss was noted at the time of the repairs, most of these joint leaks are assumed to have been induced by settling/consolidation of underlying fill material or natural soils or as a result of the freeze/thaw cycle causing differential movement of pipe segments attached to the common joint. The exception to this was the December 14, 1995 joint leak at the intersection of St. Matthews Avenue and Westport Road in which evidence of corrosion was observed.

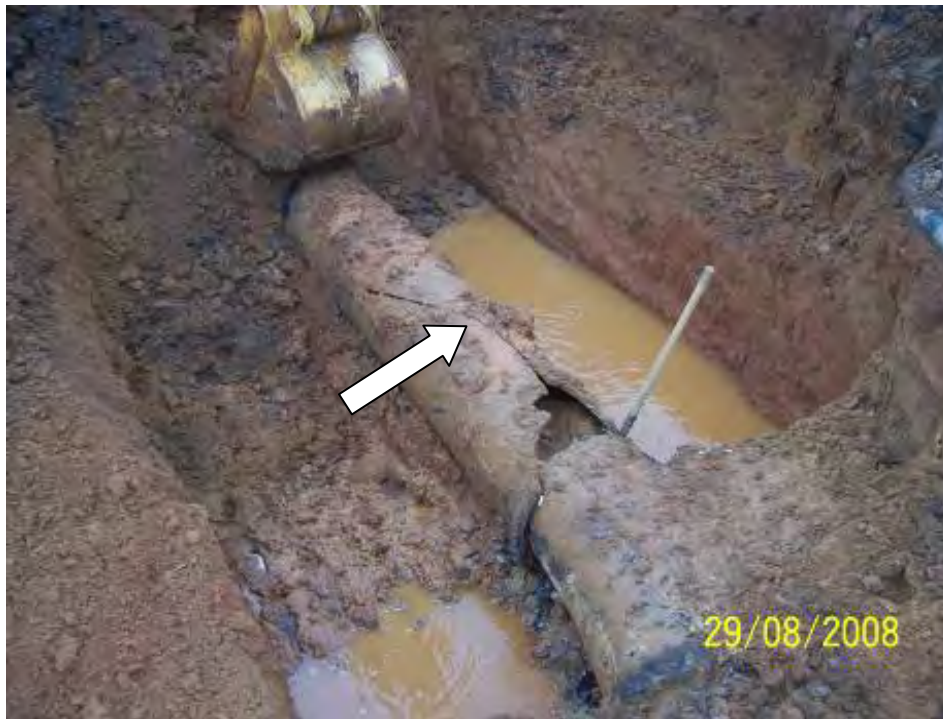
The only recorded pipe break occurred on August 29, 2008, approximately 12 ft north of the centerline of Ridgeway Avenue and 40 ft east of the centerline of Westport Road. The break appears to have occurred near a joint and propagated longitudinally along the pipe (see Figure 3-3), resulting in complete failure. The pipe break was caused by an attempt to operate the line at its full capacity, which indicated that the pipe might have lost part of its original structural integrity due to aging. It should be noted that the location of the pipe break is outside the test area (that is, not strictly part of the test pipe). However, it is noteworthy because of the nature of the break and because it occurred just a few days before the EPA Forum, which prompted LWC to offer the pipe for this demonstration.

Note arrow pointing to longitudinal propagation of crack

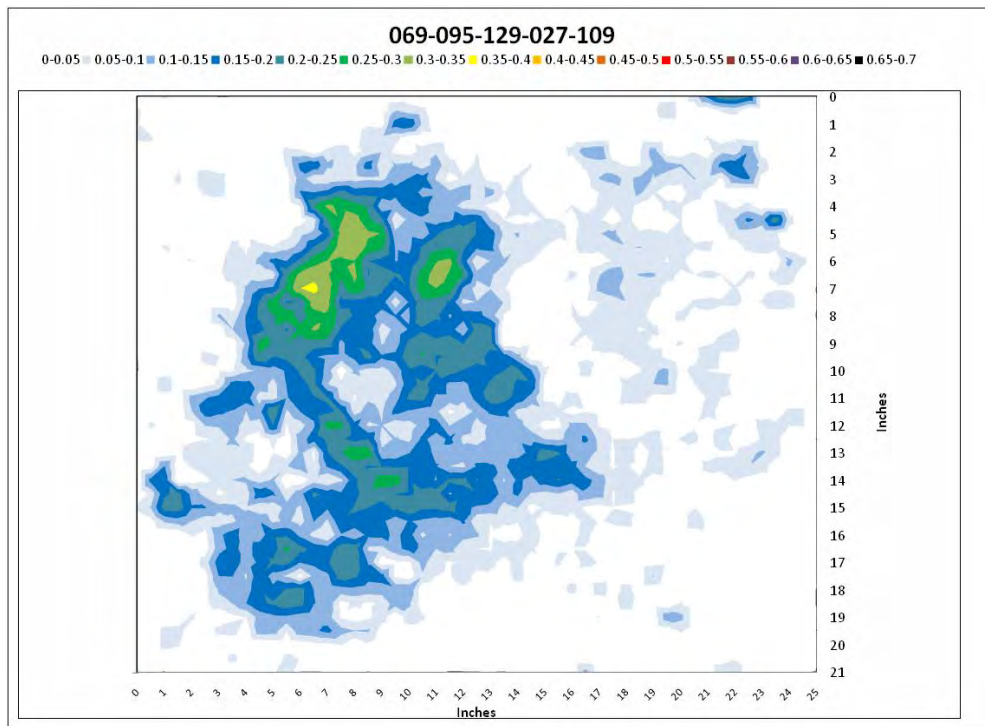
Figure 4-5. Map of Corrosion Area on Pipe 69: 95-in. from the spigot, 129-degrees from the top of the pipe, 27-in. in axial extent and 109-degrees in circumferential extent

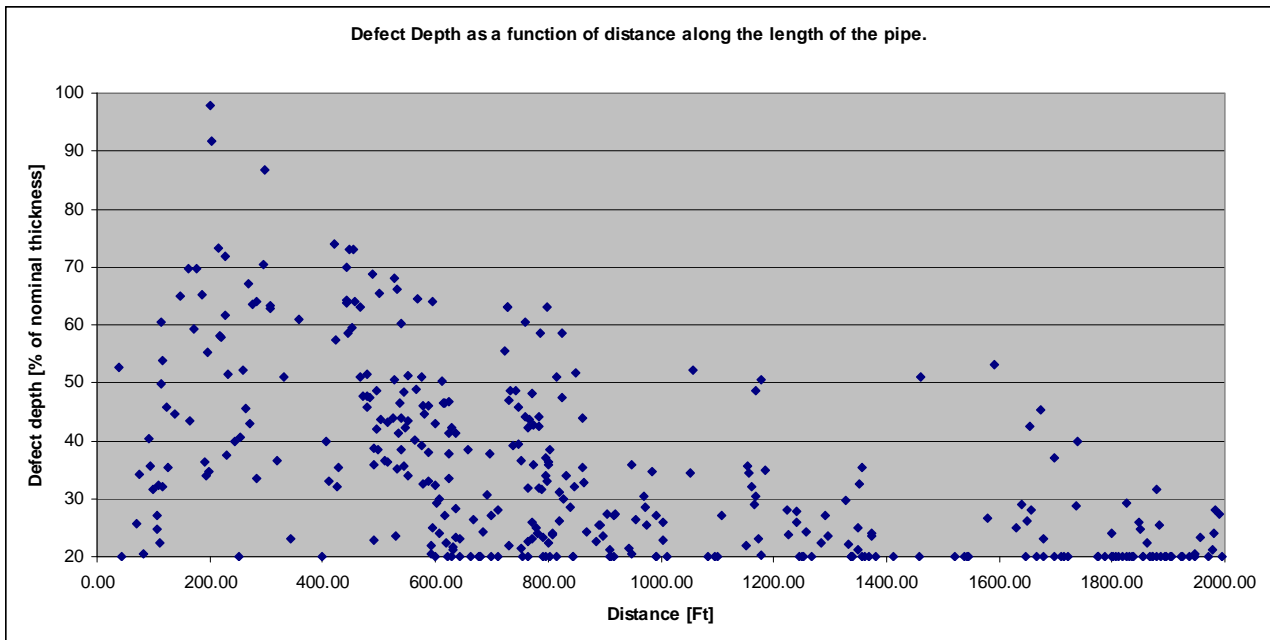
Discussion. Of all of the condition assessment technologies demonstrated, See Snake[®] provided the most detailed results for the entire pipe length and correlated the best with the post-demonstration assessment of the exhumed pipe segments. The total number of corrosion pits, as well as corrosion pit location with respect to the pipe joint and clock position, were clearly reported and correlate well. This was the initial use of this tool and the last technology demonstrated. Since replacement of the line was scheduled to begin immediately following the demonstration, there was not time for additional tests or slips in the schedule. There was trouble controlling the winch that caused velocity excursions, jerking and surging. On the final day, all equipment worked well and an acceptable data set was acquired. The implementation was intrusive for the demonstration as the pipe had to be drained and cut, and a pull cable had to be threaded for this inspection. The potential for magnetic interference and its potential effects on See Snake[®] performance should be considered during future testing and/or application of the technology.

(Courtesy of vendor report)
Figure 5-14. See Snake[®] Defect Scatter Graph

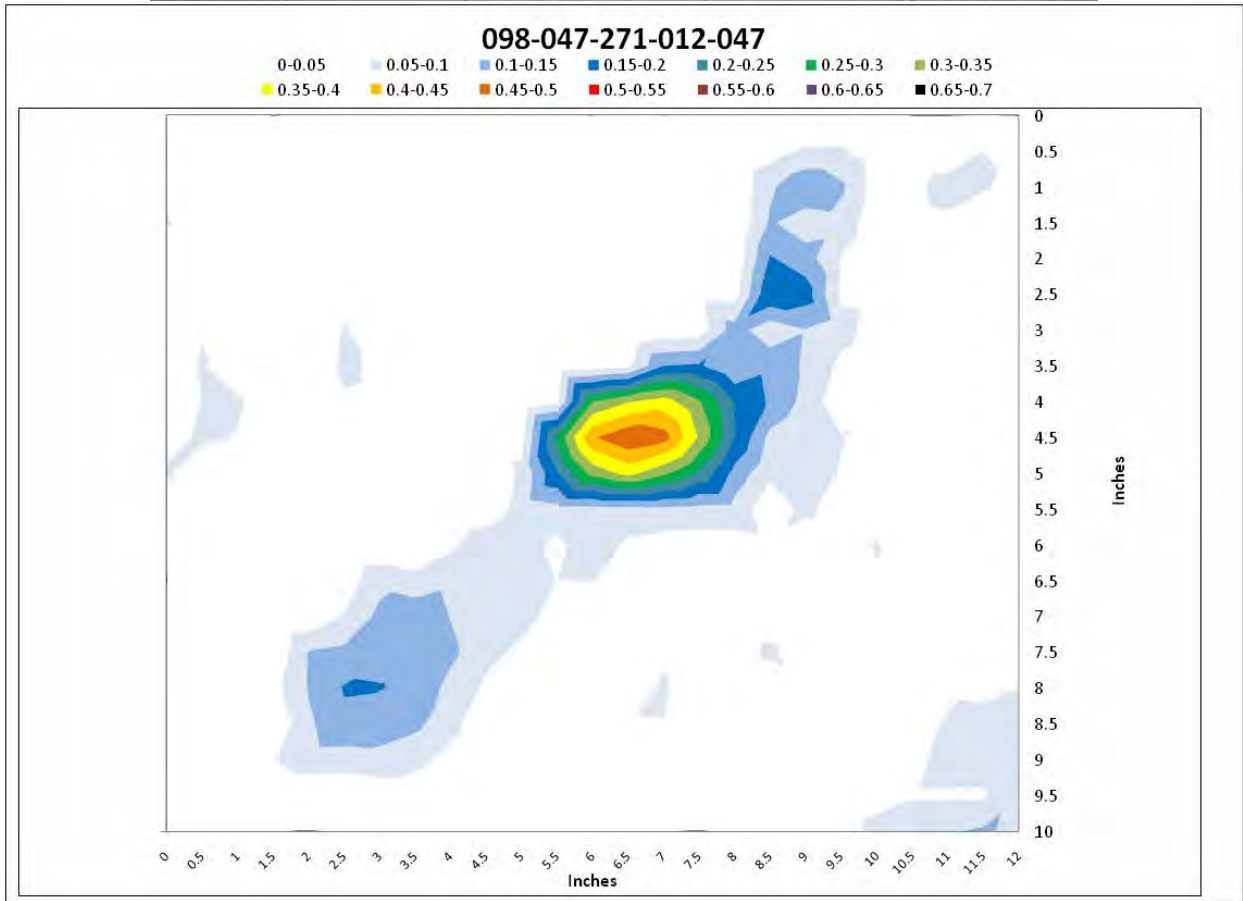
Figure A-98(1). Pipe 98, area 098-047-271-012-047

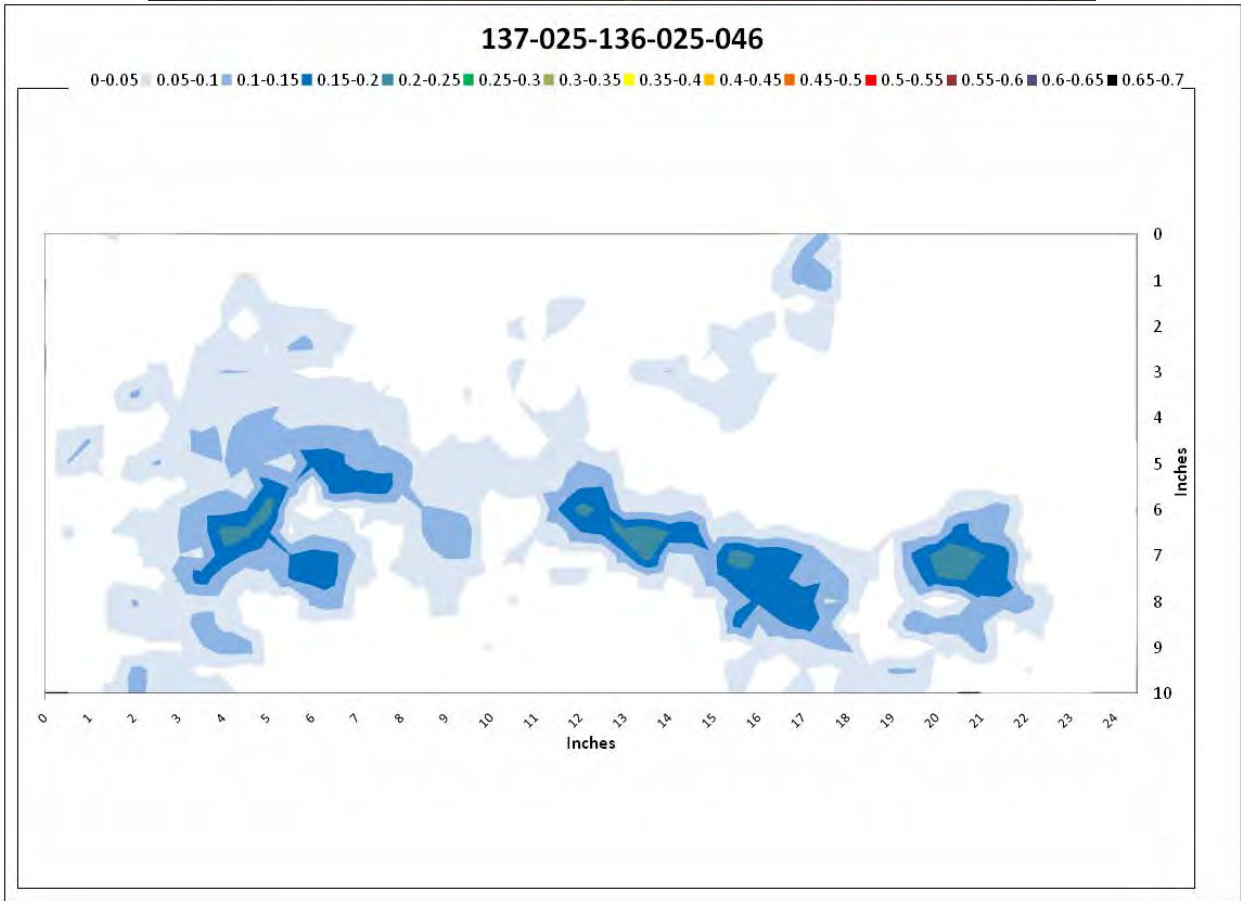
Figure A-137(1). Pipe 137, area 137-025-136-025-046

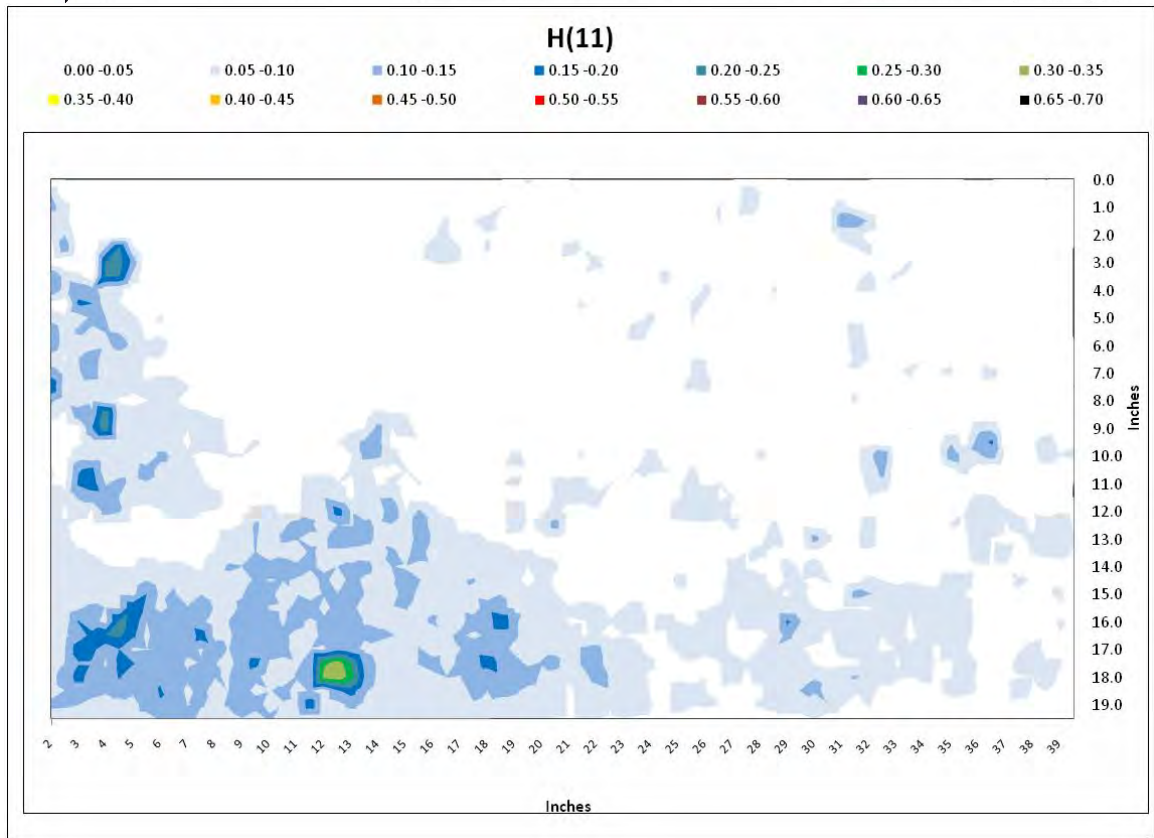
Figure A-145(1). Pipe 145, 0-3 feet and 0-90 degrees

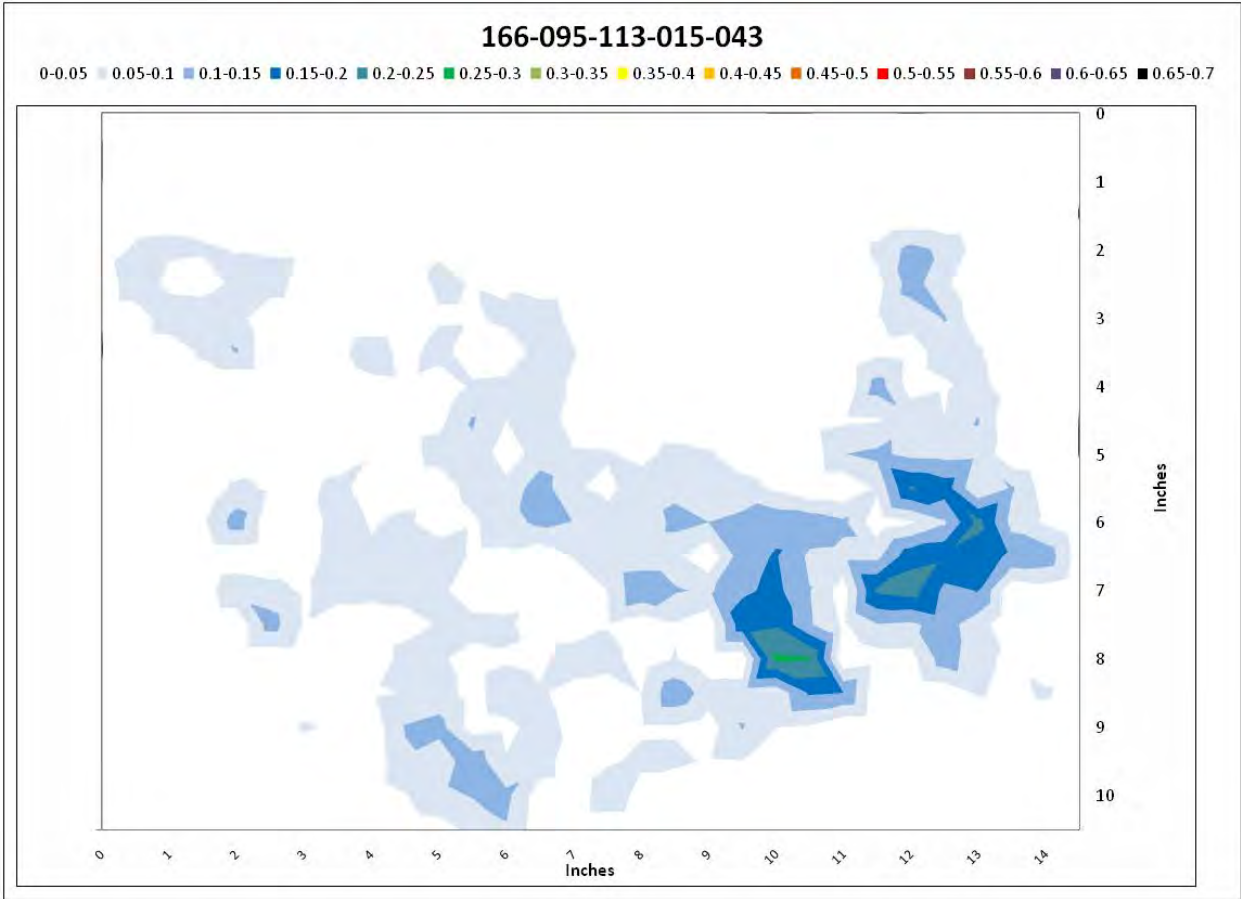
Figure A-166(1). Pipe 166, area 166-095-113-015-043
