Demonstration of Innovative Sewer System Inspection Technology SewerBatt™

Srinivas Panguluri
Shaw Environmental & Infrastructure, Inc.
Cincinnati, OH

Contract No. EP-C-11-006

Daniel Murray
Water Supply and Water Resources Division
U.S. Environmental Protection Agency
Cincinnati, OH 45268

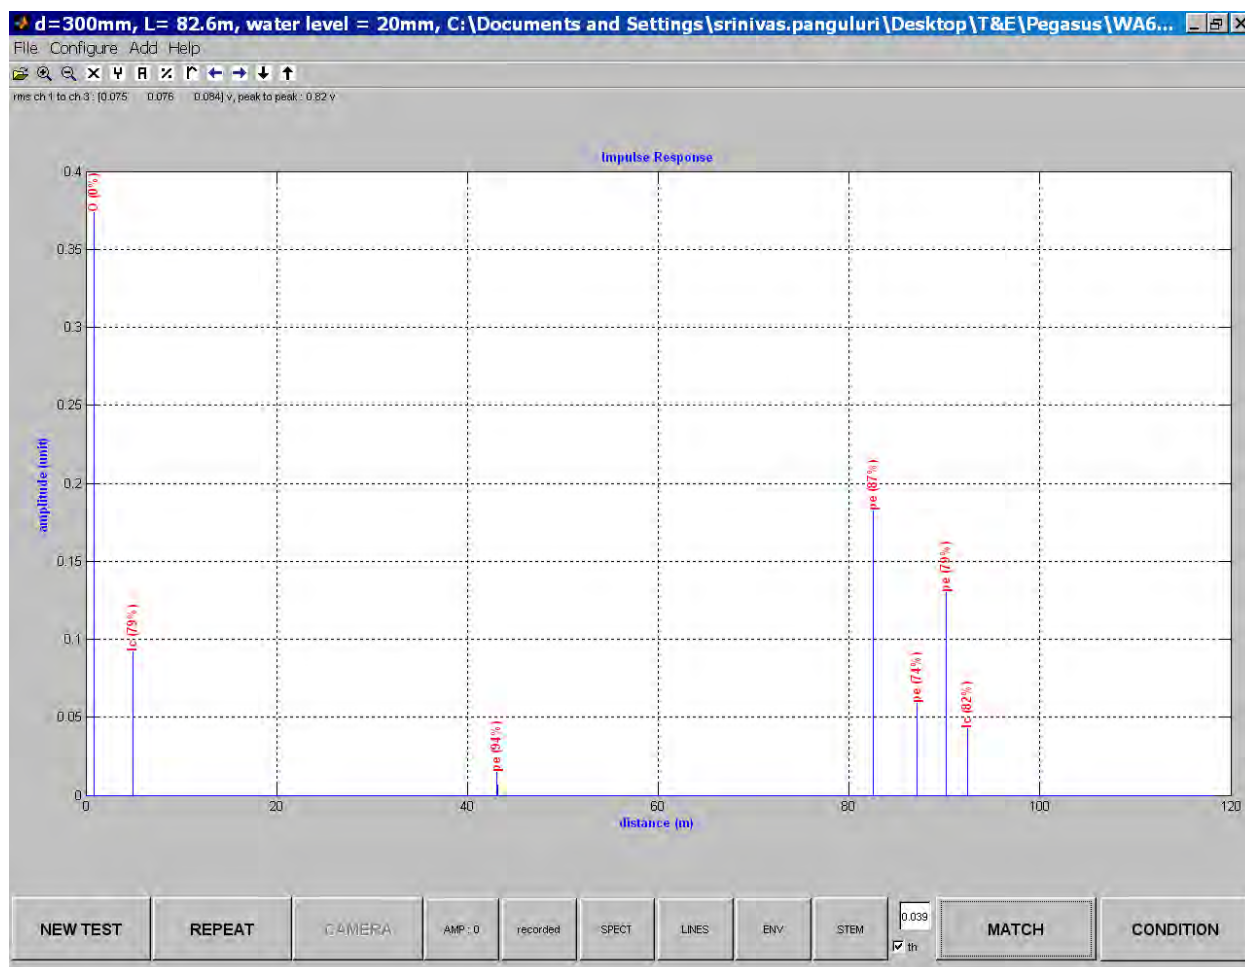
Figure 1-8. SewerBatt Acoustic Response Match Plot

The “Match” plot indicates that the response at the initial 4.93m obstruction is likely a lateral connection (lc), and the later responses at the 43.12m and 82.51m locations are likely pipe ends (pe). Although the SewerBatt system is designed to identify such discrete features/defects along the sewer pipe, additional effort and time will be necessary to build a substantial acoustic signal response signature library. Therefore, for the purposes of this technology demonstration project, ASTL developed a rapid assessment feature. A more detailed overview of the SewerBatt’s discrete defect identification capability is available in Romanova et al., 2013.

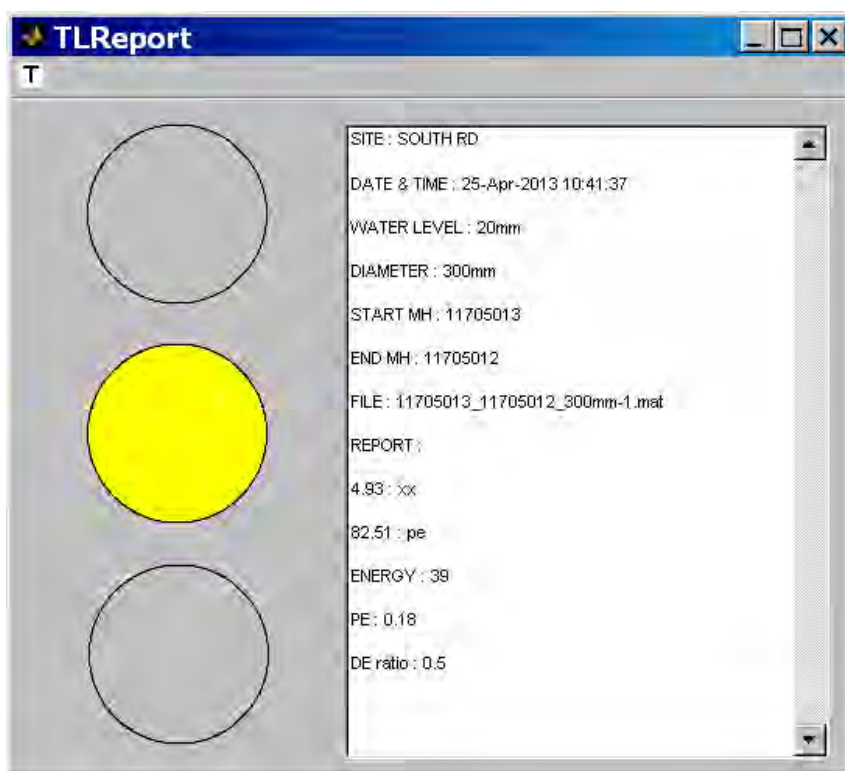
Figure 1-9. SewerBatt Condition Assessment (RAG) Response

This assessment was performed by clicking the “condition” button, which asked the user to confirm the pipe end location and if the acoustic responses at the 4.93m and 43.12m locations were related to pipe ends or lateral connections. Because the current signature library was limited, the decision was made to reject those identified assessments. Although the energy level was in the green range, the RAG algorithm comes up with a summary assessment of an elevated value or amber because of the DE ratio 0.5 (0.09/0.18) for blockage response at 4.93m (as shown in Figure 1-9). A more detailed discussion of this pipe segment is presented in Section 3.0, where the CCTV findings indicate the presence of 15% medium roots at 4.93m (~16 feet) and 30% medium roots at about 44m (~147 feet). Appendix A contains a more detailed report from ASTL that provides additional details on the SewerBatt

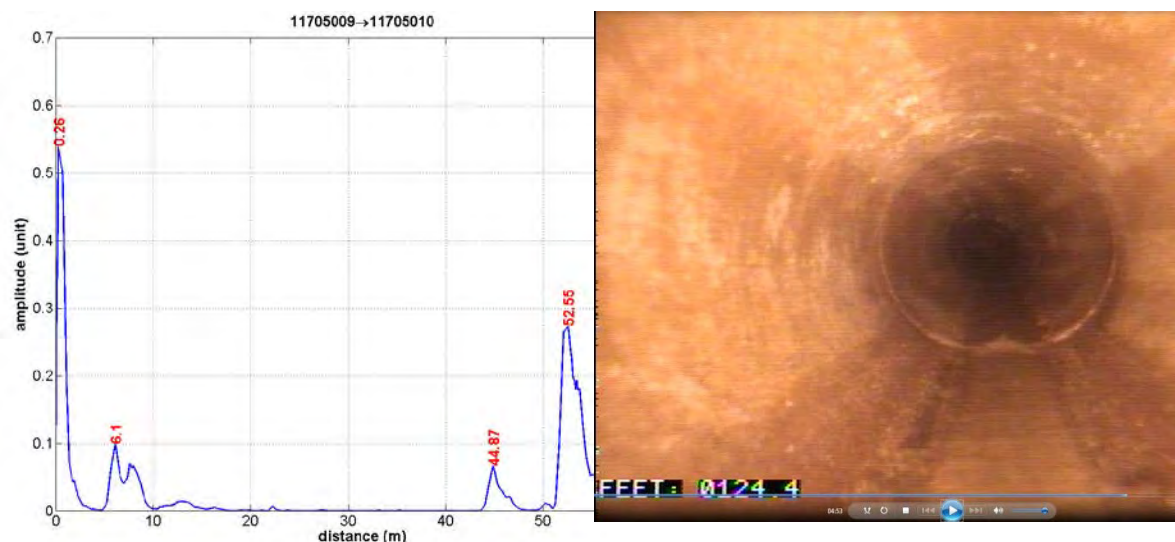
Figure 3-1. SewerBatt/CCTV Response Comparison (Segment ID 11705010-11705009)

The first selected pipe-segment (11705010-11705009) was assessed from the downstream manhole (i.e., from manhole ID 11705009) and showed a SewerBatt response at 6.1m. This location is equivalent to 127 feet (distance compensated for reverse setup of the SewerBatt vs. the CCTV) on the CCTV inspection. The pipe-end response is correctly indicated at 44.87 m (~147 feet), and no major defects were found; however, a noticeable hydraulic jump was seen at the 127 feet joint on the CCTV footage. Figure 3-1 shows the CCTV response image for the exact location where a SewerBatt response (6.1 m) was noted for this segment.

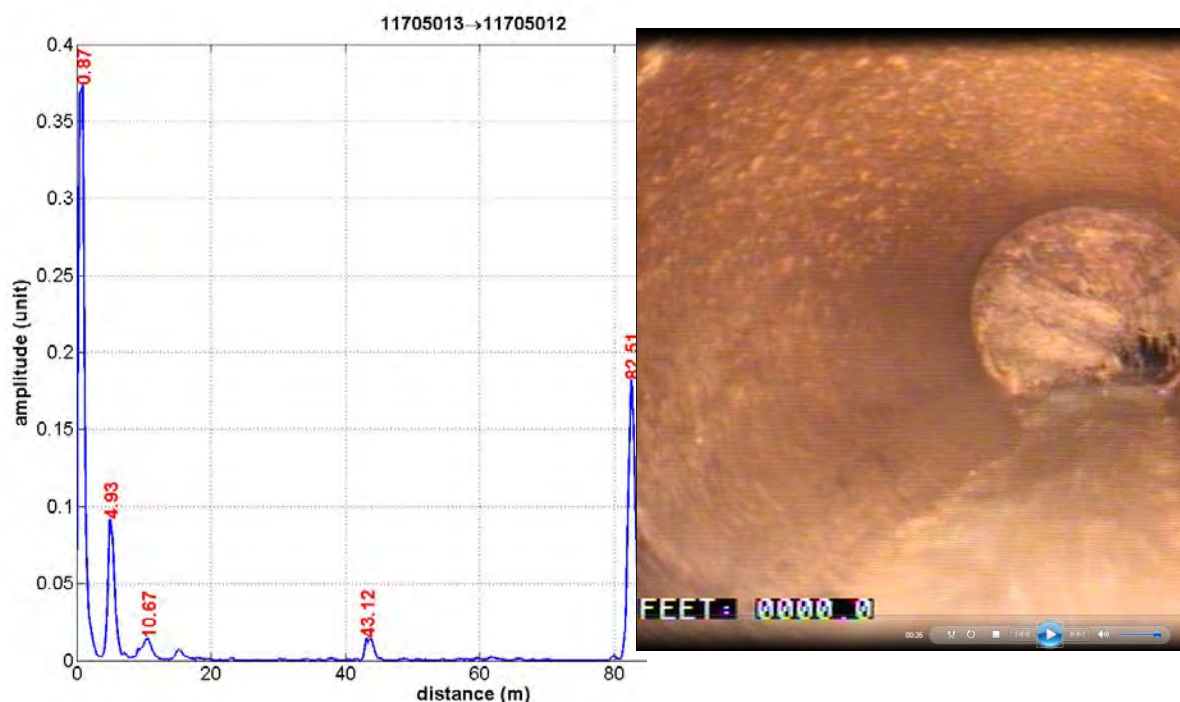
Figure 3-2. SewerBatt/CCTV Response Comparison (Segment ID 11705013-11705012)

For segment 1705013–1705012, the SewerBatt identified responses, seen in Figure 3-2, at 4.93m (16') and at about 44m (147') which were consistent with roots seen with CCTV. A downgrade to amber is considered appropriate.

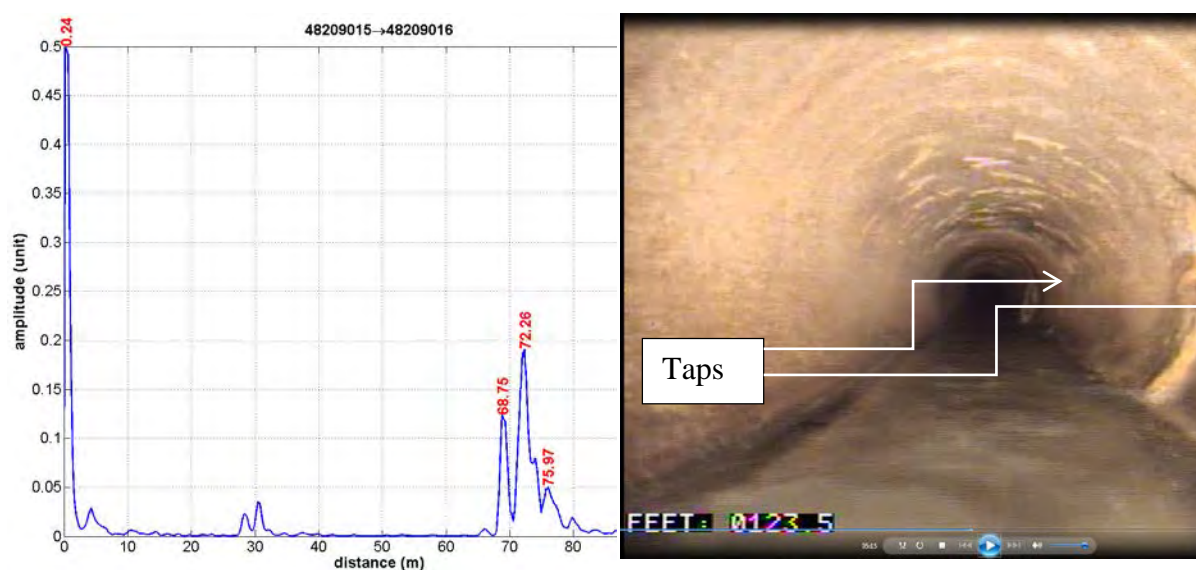
Figure 3-4. SewerBatt/CCTV Response Comparison (Segment ID 48209015-48209016)

At the second segment 48209015-48209016, SewerBatt responded in the vicinity of two (2) break-in taps identified by CCTV at about 30 meters (See Figure 3-4). No other issues were found with this pipe; therefore the green rating was appropriate.

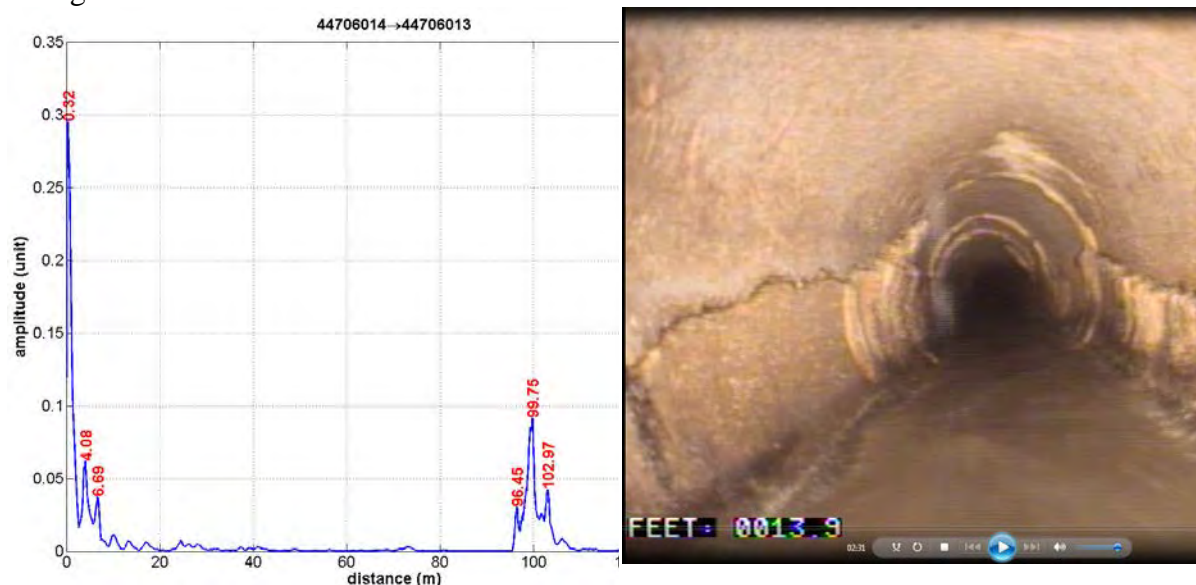
Figure 3-5. SewerBatt/CCTV Response Comparison (Segment ID 44706014-44706013)

One of the few pipes with noticeable structural issues, 44706014-44706013, also received a red grade. There was significant horizontal cracking ~14 feet from the deployment manhole. The SewerBatt responded in the area of this defect (at 4.08m – See Figure 3-5). Additionally, deposits were identified beyond this area which may have further affected the response from the target manhole.

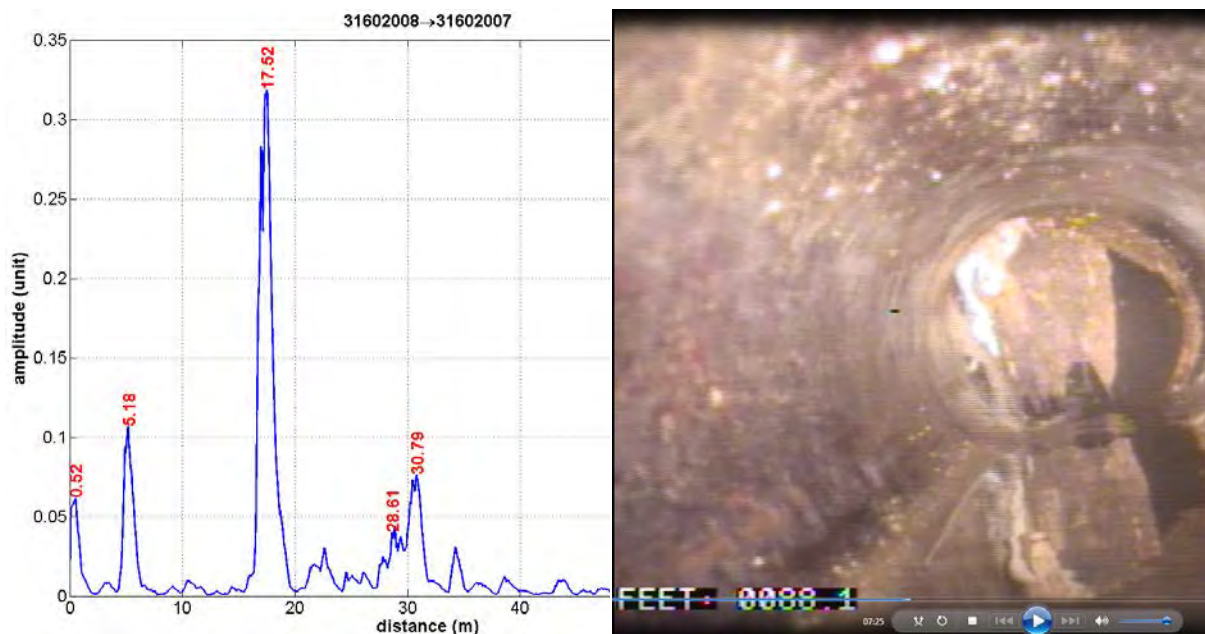
Figure 3-7. SewerBatt/CCTV Response Comparison (Segment ID 31602008-31602007)

In two (2) of the three (3) pipe segments supported with CCTV data, SewerBatt responded at locations where CCTV identified roots in the pipe. Figure 3-7 shows the SewerBatt and CCTV response comparison for segment 31602008-31602007 (note roots at tap ~91' on the CCTV and strong SewerBatt response at 17.52m). It should be noted that the CCTV and SewerBatt assessments for this segment were initiated from opposite manholes.

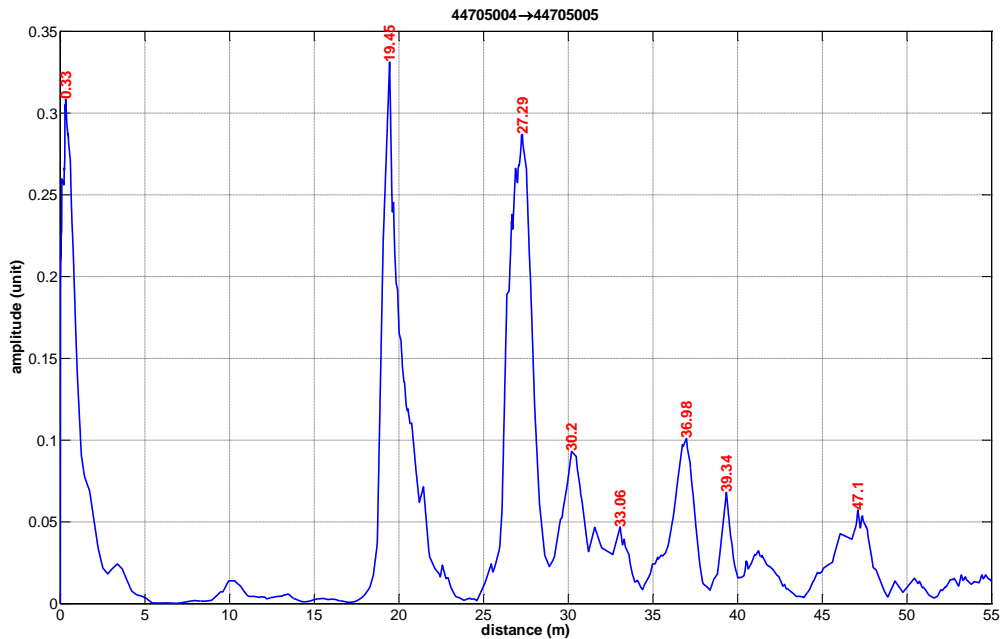
AUTO CONDITION GRADE – Red by manual assessment.

COMMENT – GIS length = 53m. Condition assessment performed manually this case. CCTV is recommended on account of the many strong responses recorded and the heavily attenuated response from the target manhole.

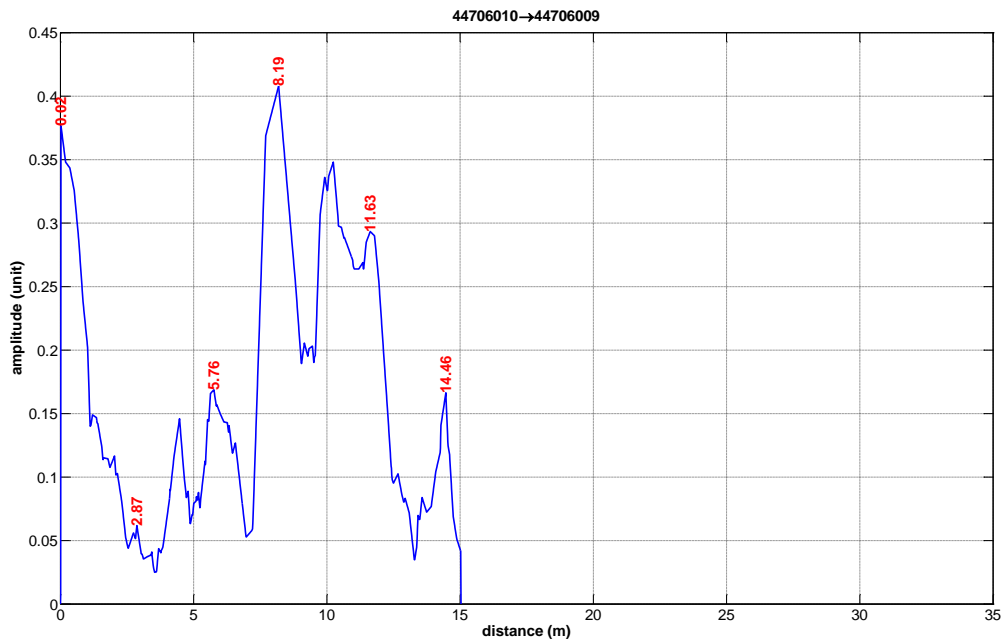
AUTO CONDITION GRADE – Red by manual assessment.

COMMENT – GIS pipe length = 31.6m. The SewerBatt output data provided includes three tests of this pipe. All of them provide results similar to the above, where the record is truncated some distance short of the target manhole. Given the many responses recorded in the data that is available then CCTV is recommended.

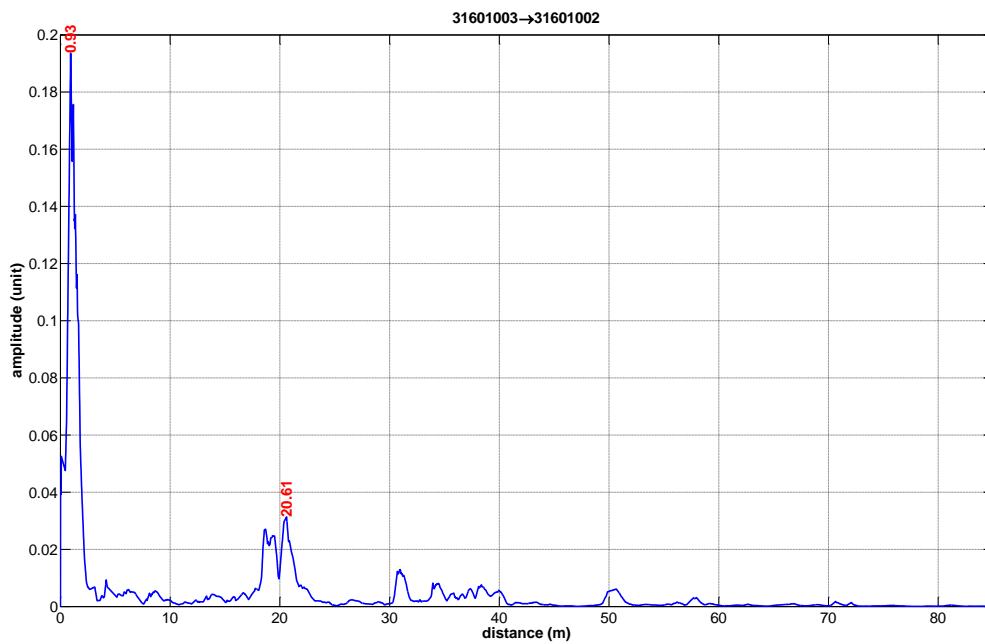
AUTO CONDITION GRADE – Red by manual assessment.

COMMENT – GIS pipe length = 81m. CCTV is recommended.

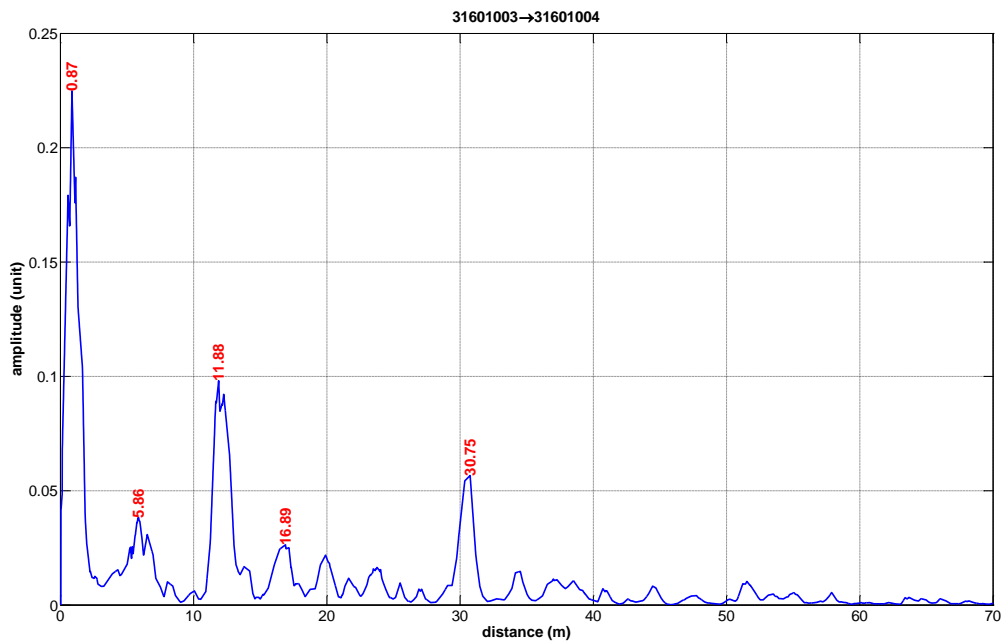
AUTO CONDITION GRADE – Red by manual assessment.

COMMENT – GIS pipe length = 64m. CCTV is recommended.

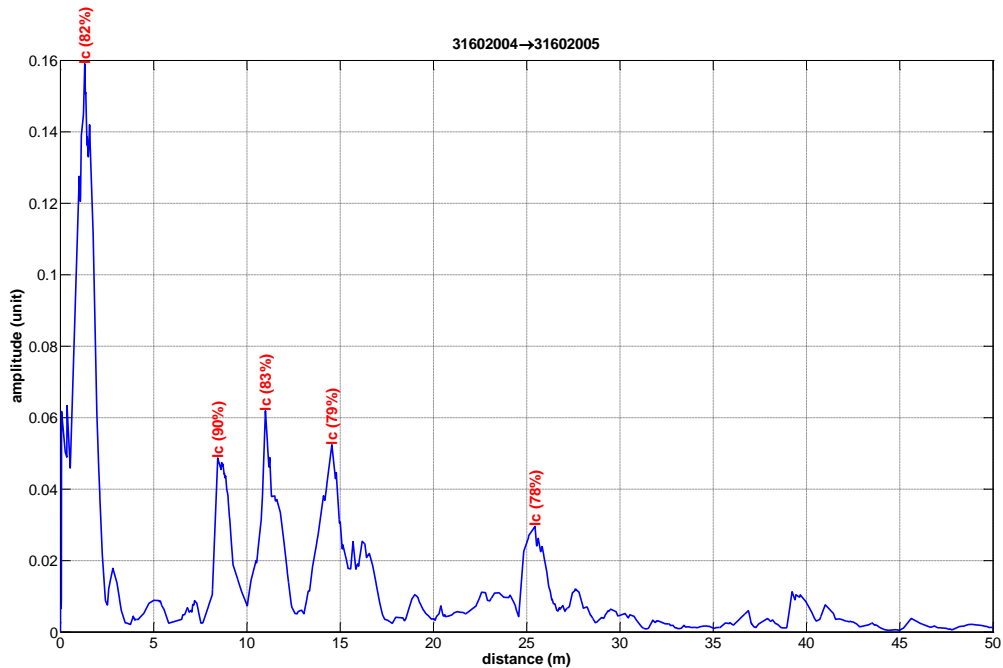
AUTO CONDITION GRADE – Amber by manual assessment.

COMMENT – GIS pipe length = 45m. The pipe between the laterals appears to be in reasonable condition. Log for resurvey after an appropriate interval..

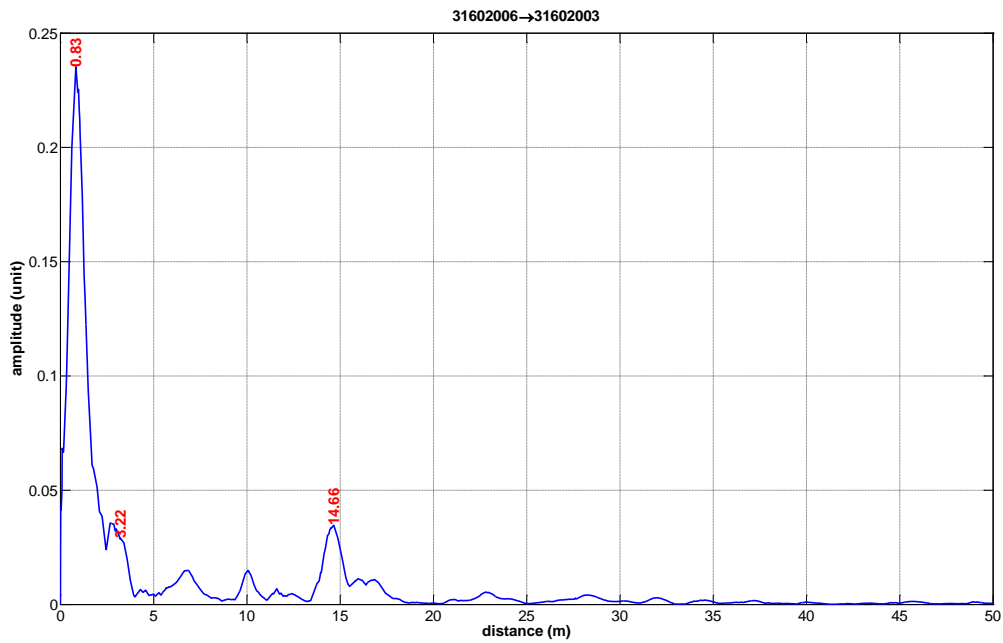
AUTO CONDITION GRADE – Red by manual assessment.

COMMENT – GIS pipe length = 44m. CCTV is recommended.

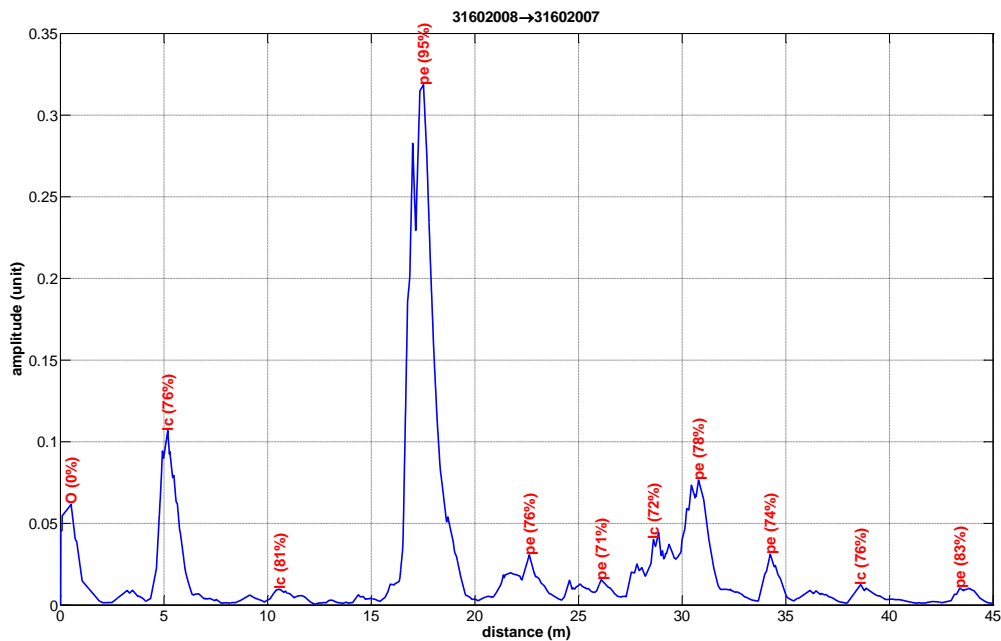
5.18 : lc (crack, infiltration)

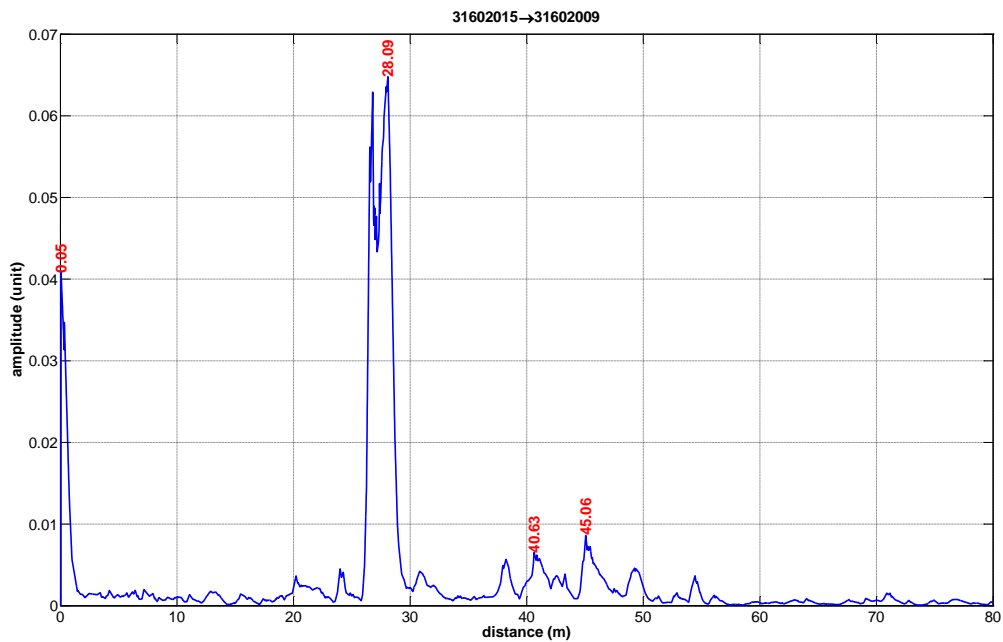
AUTO CONDITION GRADE – Red by manual assessment.

COMMENT – GIS pipe length = 79.5m. CCTV is recommended.

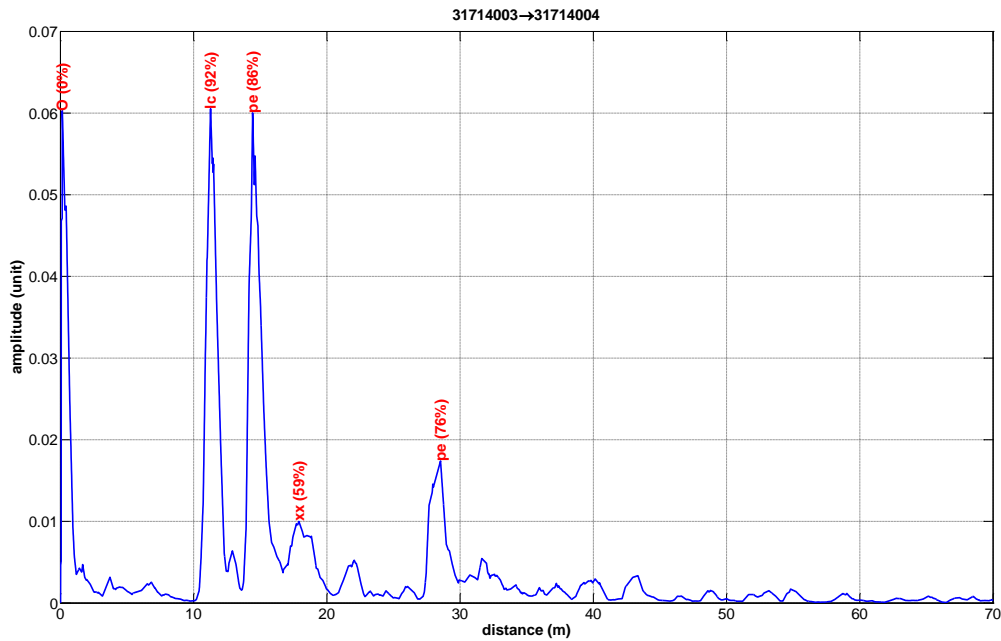
AUTO CONDITION GRADE – Red by manual assessment.

COMMENT – GIS pipe length = 69.5m. CCTV is recommended.

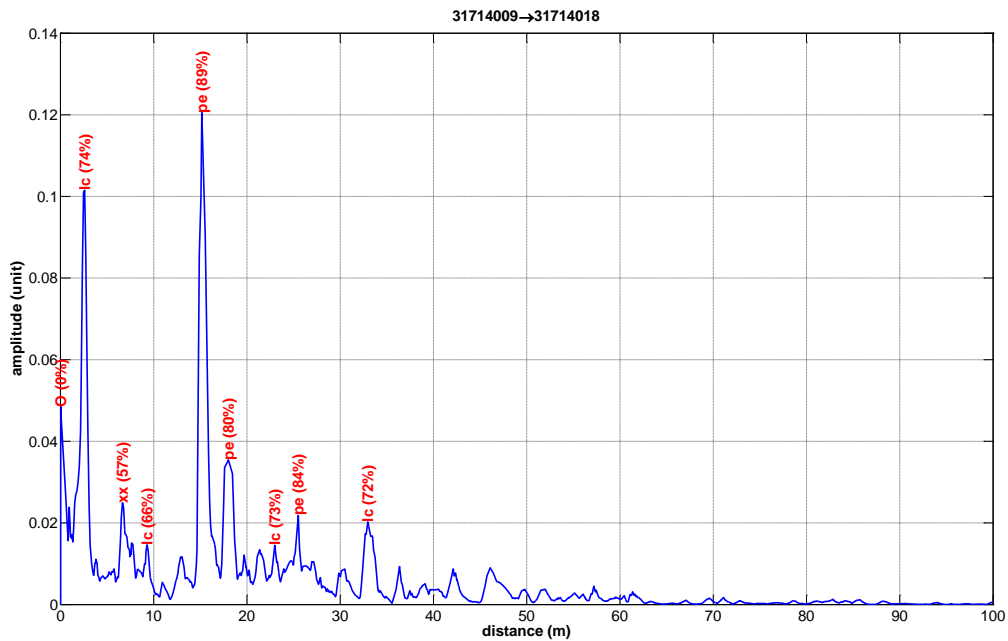
AUTO CONDITION GRADE – Red by manual assessment. Not previously graded

COMMENT – GIS pipe length = 91m. Persistent noise in the response along the pipe indicates a general low level of continuous defects such as roots, debris and displaced joints. CCTV is recommended.

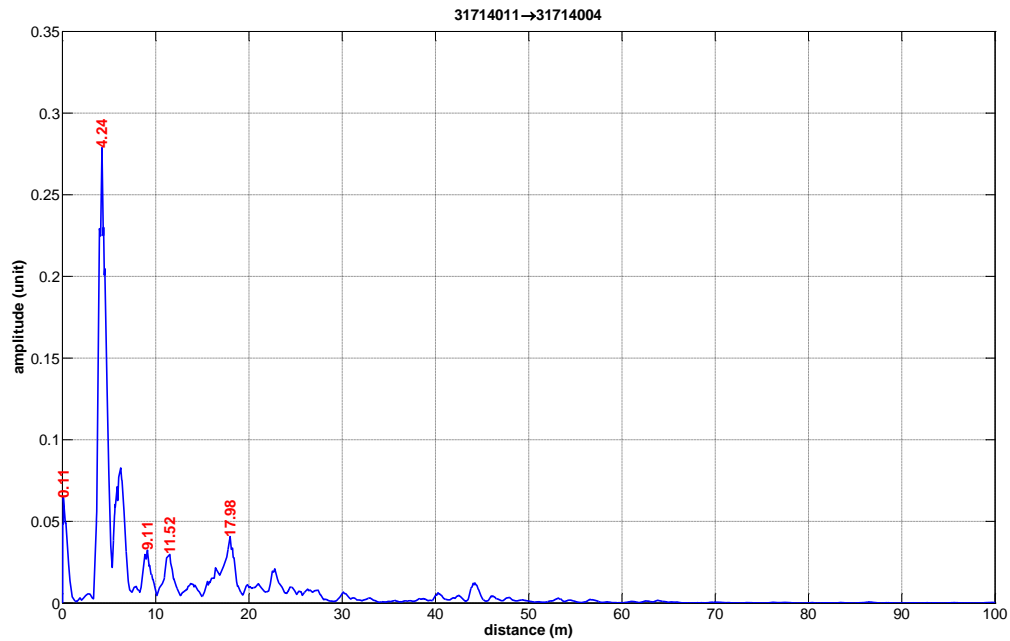
AUTO CONDITION GRADE – Red by manual assessment.

COMMENT – GIS pipe length = 92m. CCTV is recommended.
