# **EPA CHEMICAL ACCIDENT INVESTIGATION REPORT**

**Accra Pac Group, Inc.  
North Plant  
Elkhart, Indiana**

## **The EPA Chemical Accident Investigation Program**

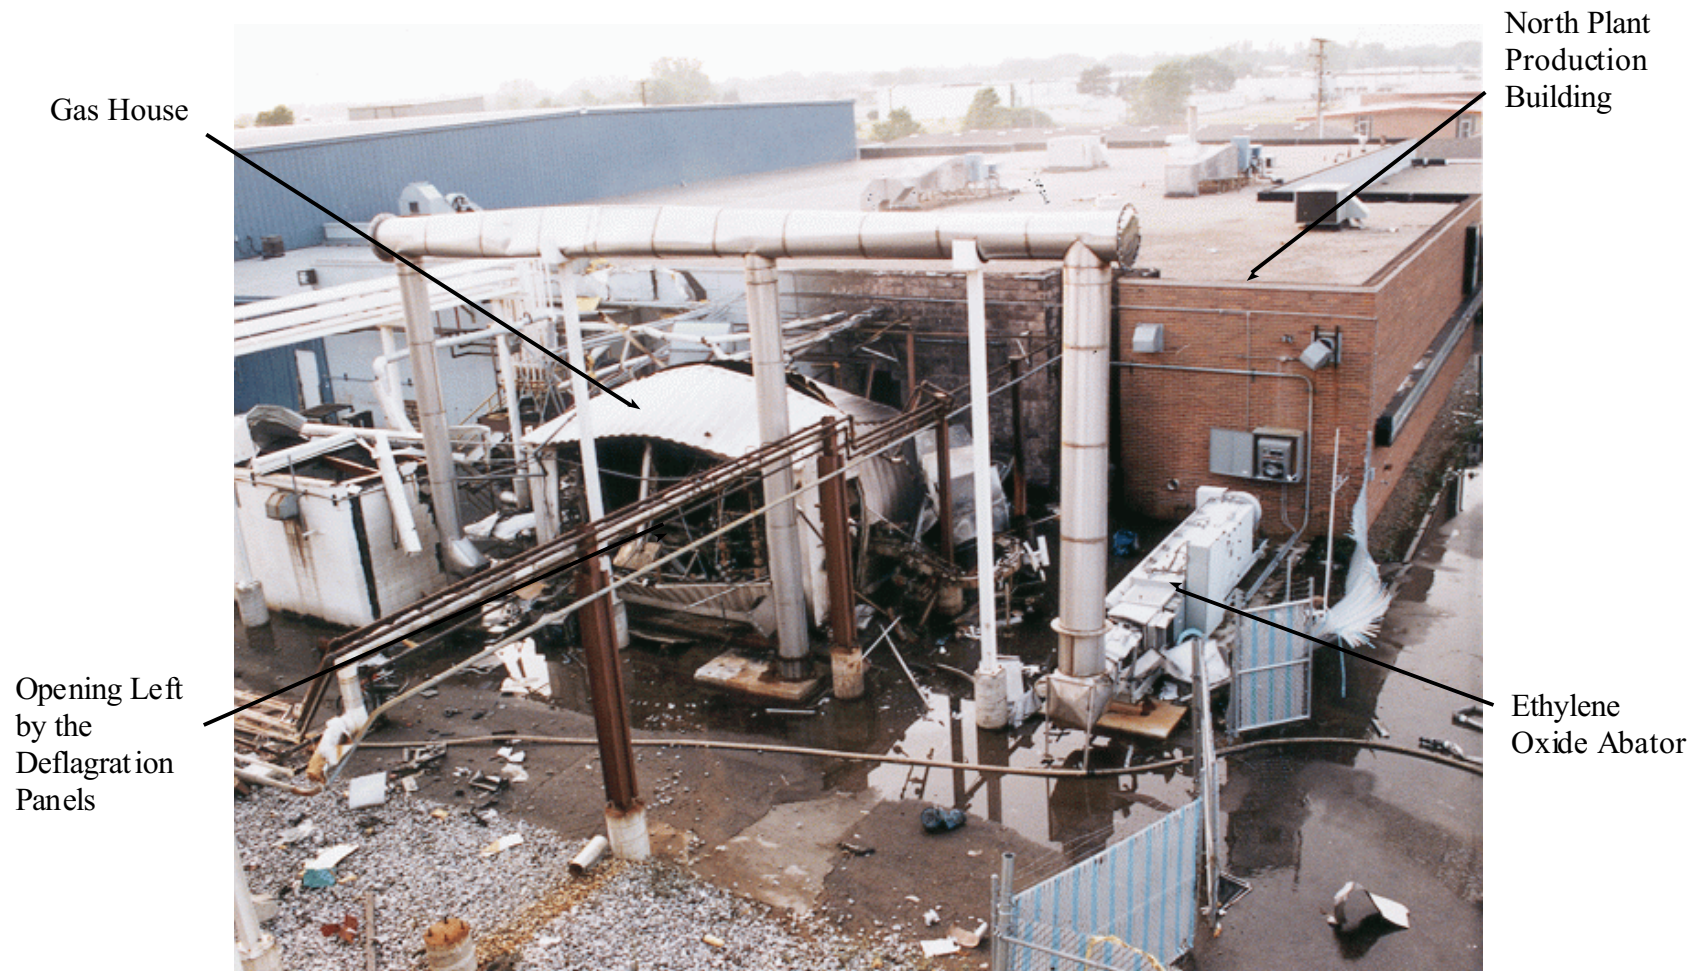
An Accra Pac employee working in the Production Building across from the Gas House was killed as a result of the explosion. When the Gas House doors were blown off, the door facing the Production Building impacted the Production Building door and caused that door and its frame to be dislodged and blown into the Production Building where it struck and killed the employee.

**A-1: The Gas House and the Production Building after the explosion and fire.**

- **Properly locate and provide sufficient barriers between units that have a potential for explosion from other processes in accordance with NFPA 30, 5-3.2.2.** Units that are recognized as hazardous with a potential for explosion should be sufficiently spaced away or provided with blast walls between units such that if an explosion occurs, employees in other locations are not harmed.

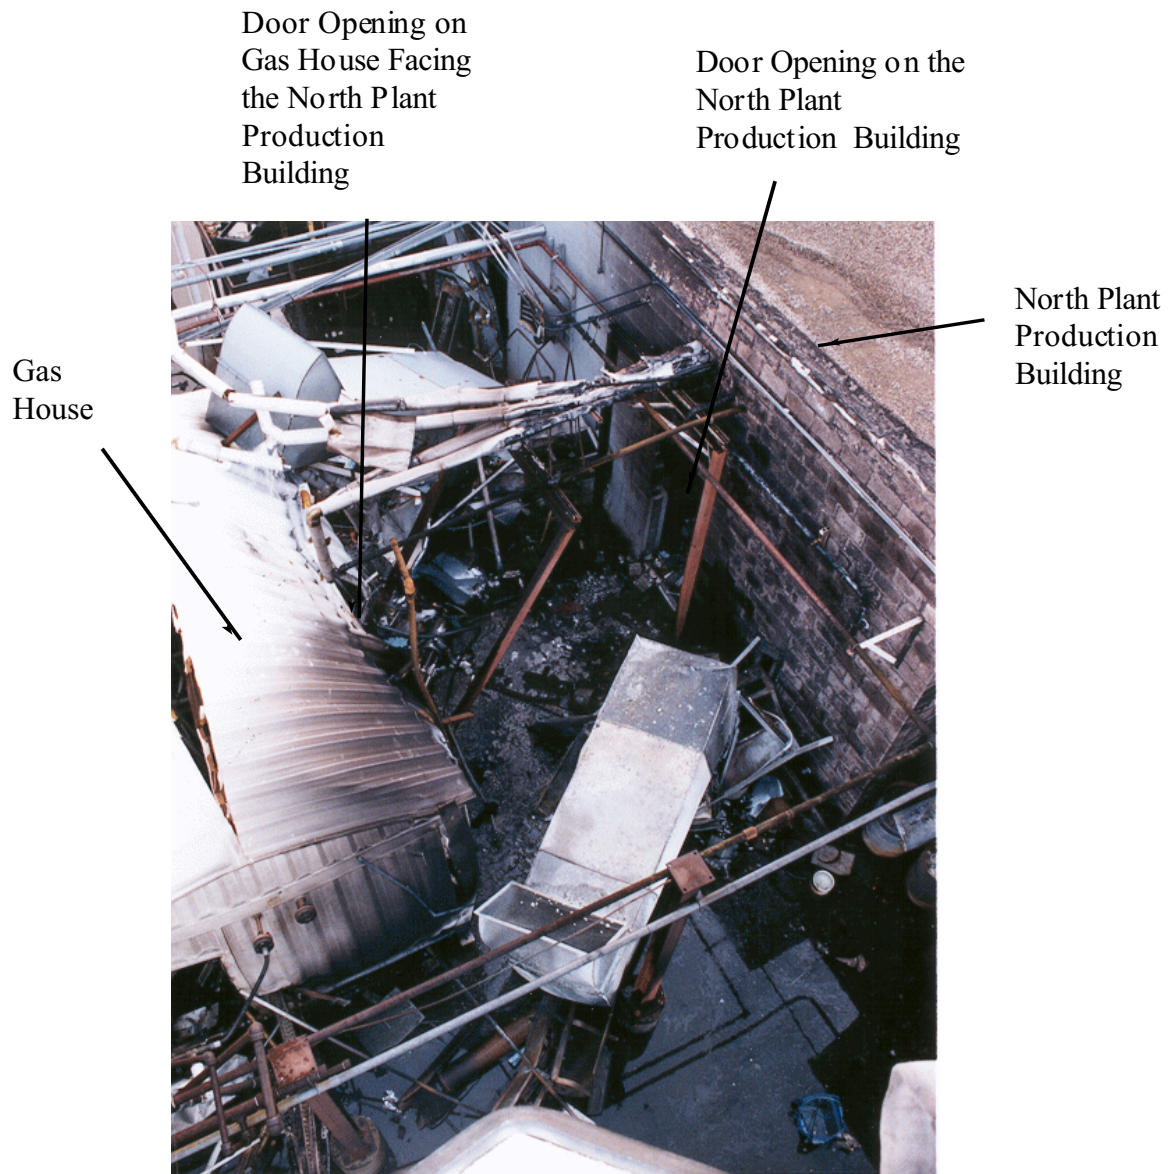
**A-2: Top View of the separation between the Gas House and the Production Building after the explosion and fire.**

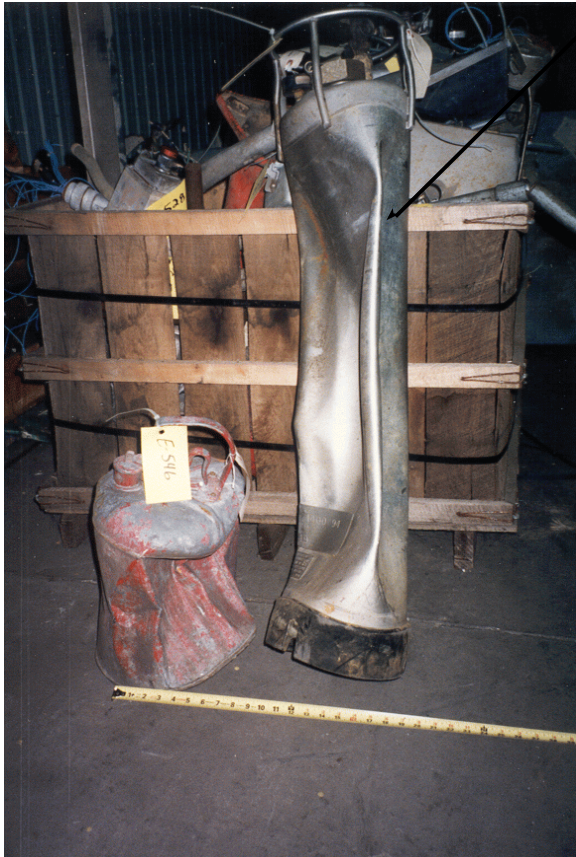
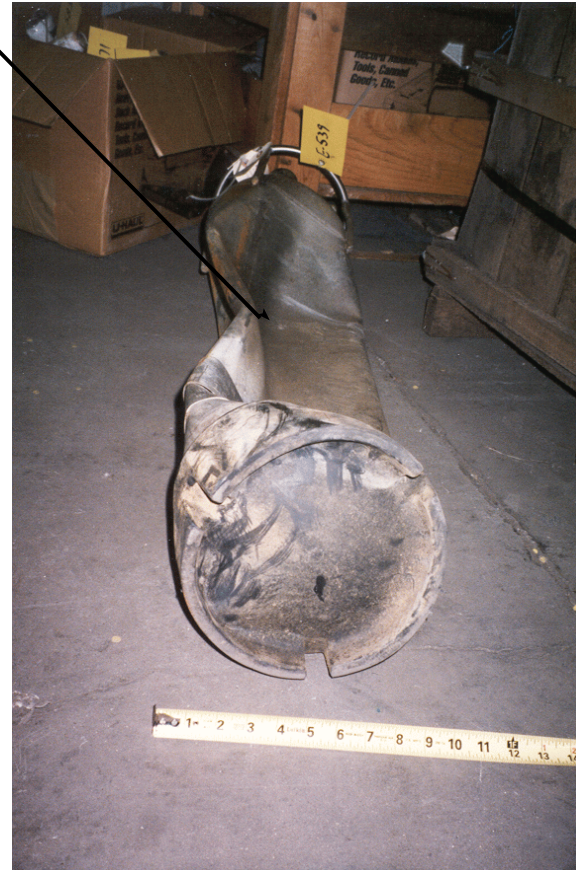
Ethylene Oxide Reclamation Tank

- The ethylene oxide reclamation tank in the Gas House was found to have been crushed by the force of the explosion. (See Appendix A-3) The tank collapsed from three sides leaving almost no void volume. Had the reclamation tank been substantially full of liquid, which is not compressible, the reclamation tank would not have become crushed in the explosion. The reclamation tank showed no signs of puncture or rupture. Thus, any release of ethylene oxide would have had to have occurred in the connectors, valves, or tubing associated with the reclamation tank.

**A-3: Side and bottom view of the ethylene oxide reclamation tank after the explosion and fire.**

- **Relocate the reclamation tank to a location outside the Gas House to reduce the amount of hazardous material inside the occupied building.** In the event of a tank leak, this would reduce the likelihood of injury to the occupant of the Gas House. Also, **develop a way to monitor the quantity of material in the reclamation tank.** This capability is necessary to avoid overfilling which can lead to an accidental release. Finally, **install a non-return check valve on the reclamation tank.** This would minimize any release should the feed line or any connectors leading to the reclamation tank fail.
