Envirotech/ Chemico Pushing Emissions Control System Analysis

Final Report

**GCA CORPORATION
GCA/TECHNOLOGY DIVISION
Bedford, Massachusetts**

April 1983

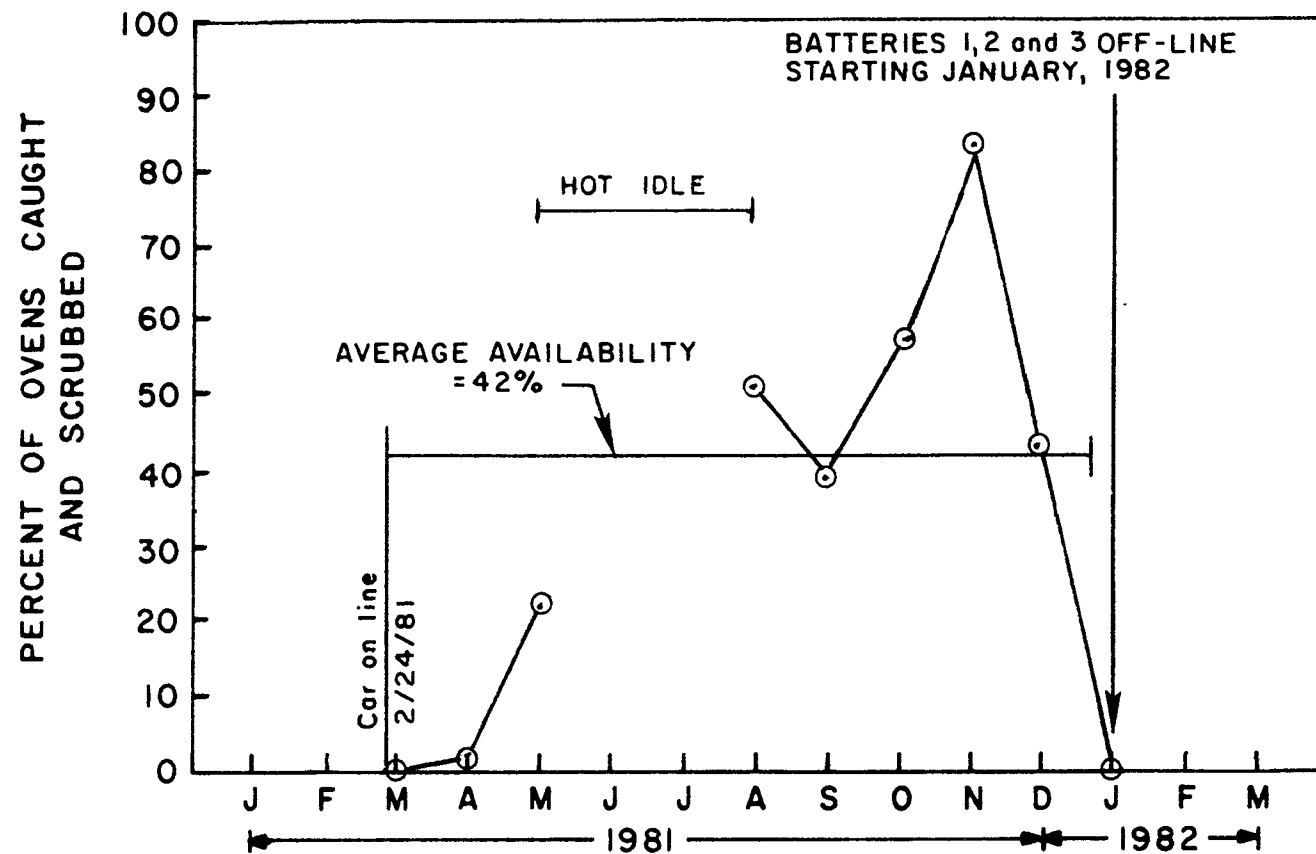
Figure 1. Availability data for H-III serving Batteries 1, 2 and 3 at U.S. Steel/Clairton. Average shown for 7 months operation, March 1981 through December 1981, excluding hot idle downtime.

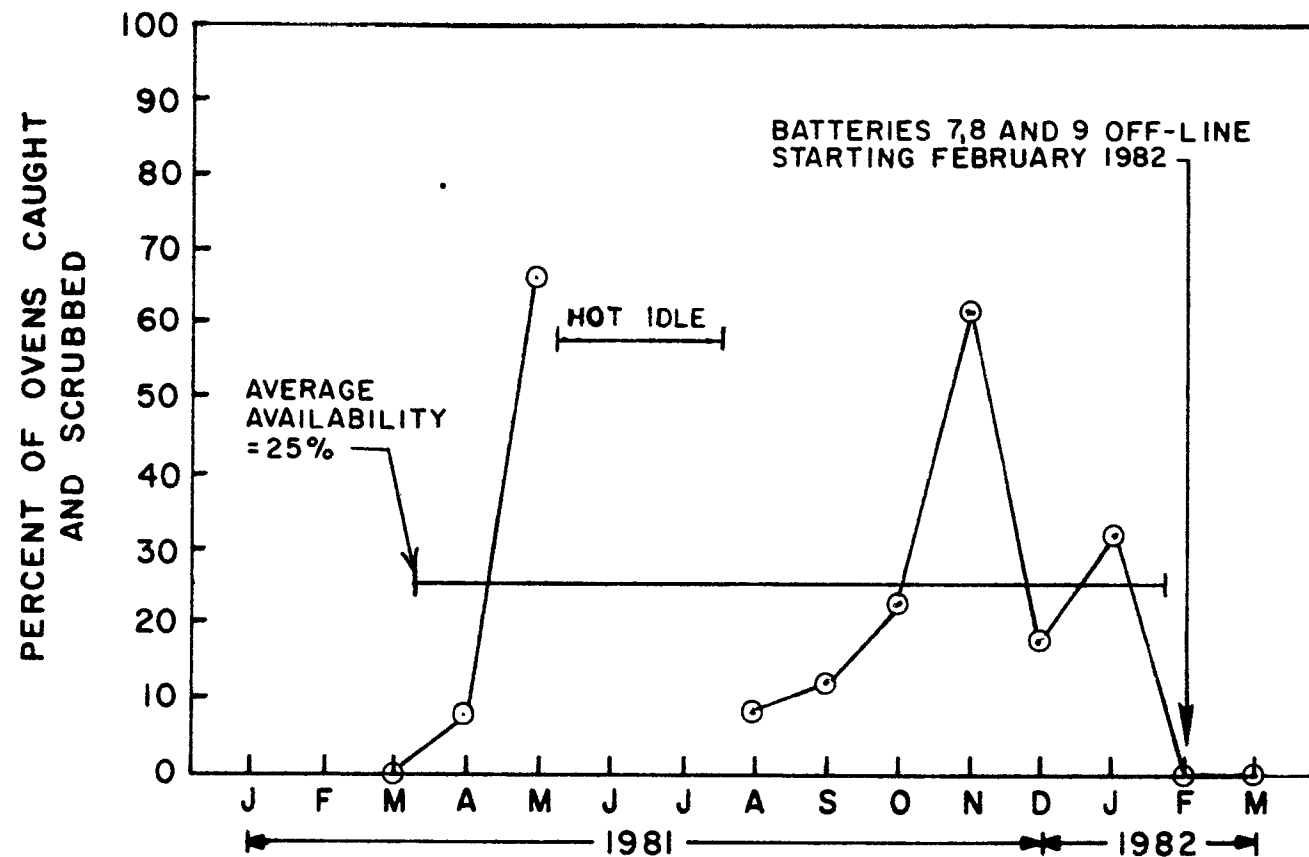
Figure 2. Availability data for H-III serving Batteries 7, 8 and 9 at U.S. Steel/Clairton.

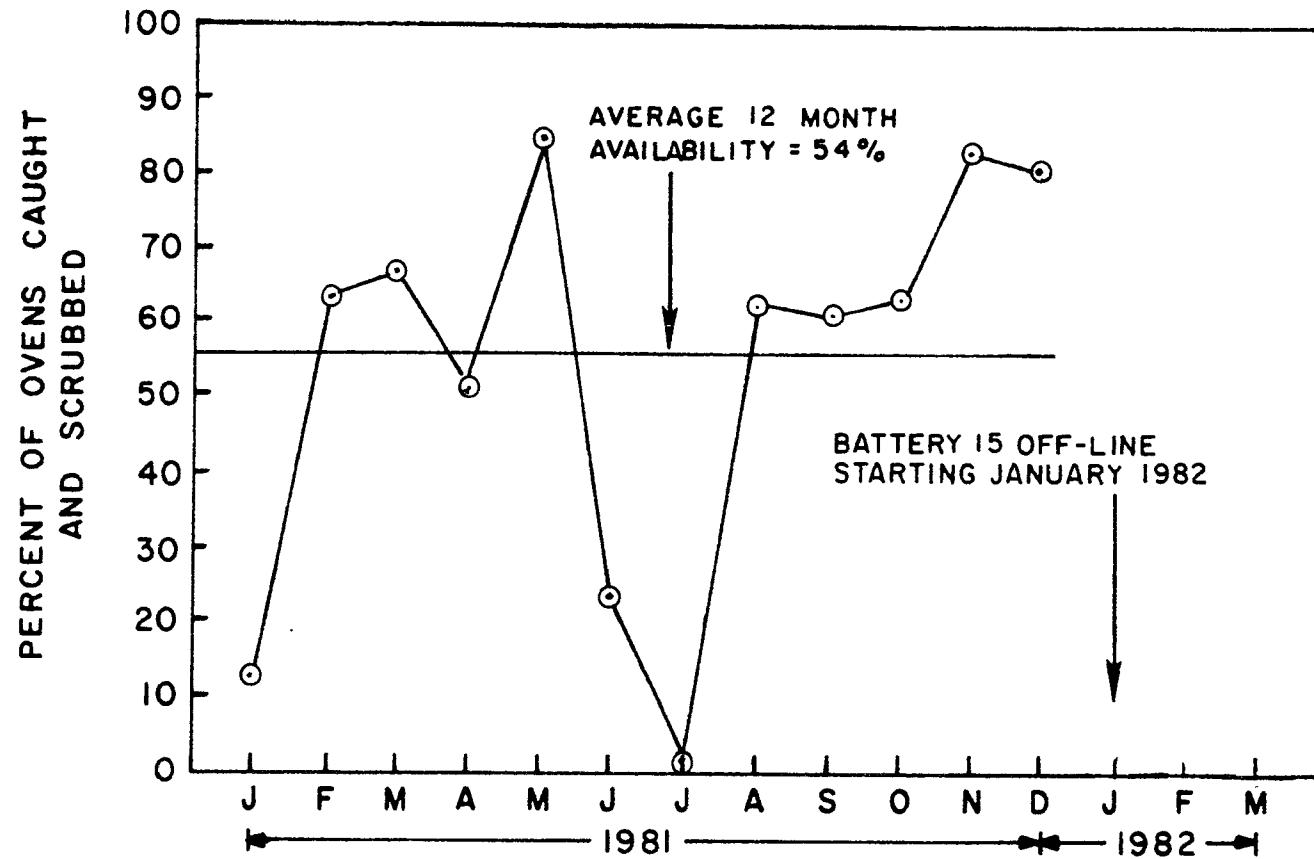
Figure 3. Availability data for H-III serving Battery 15 at U.S. Steel/Clairton.

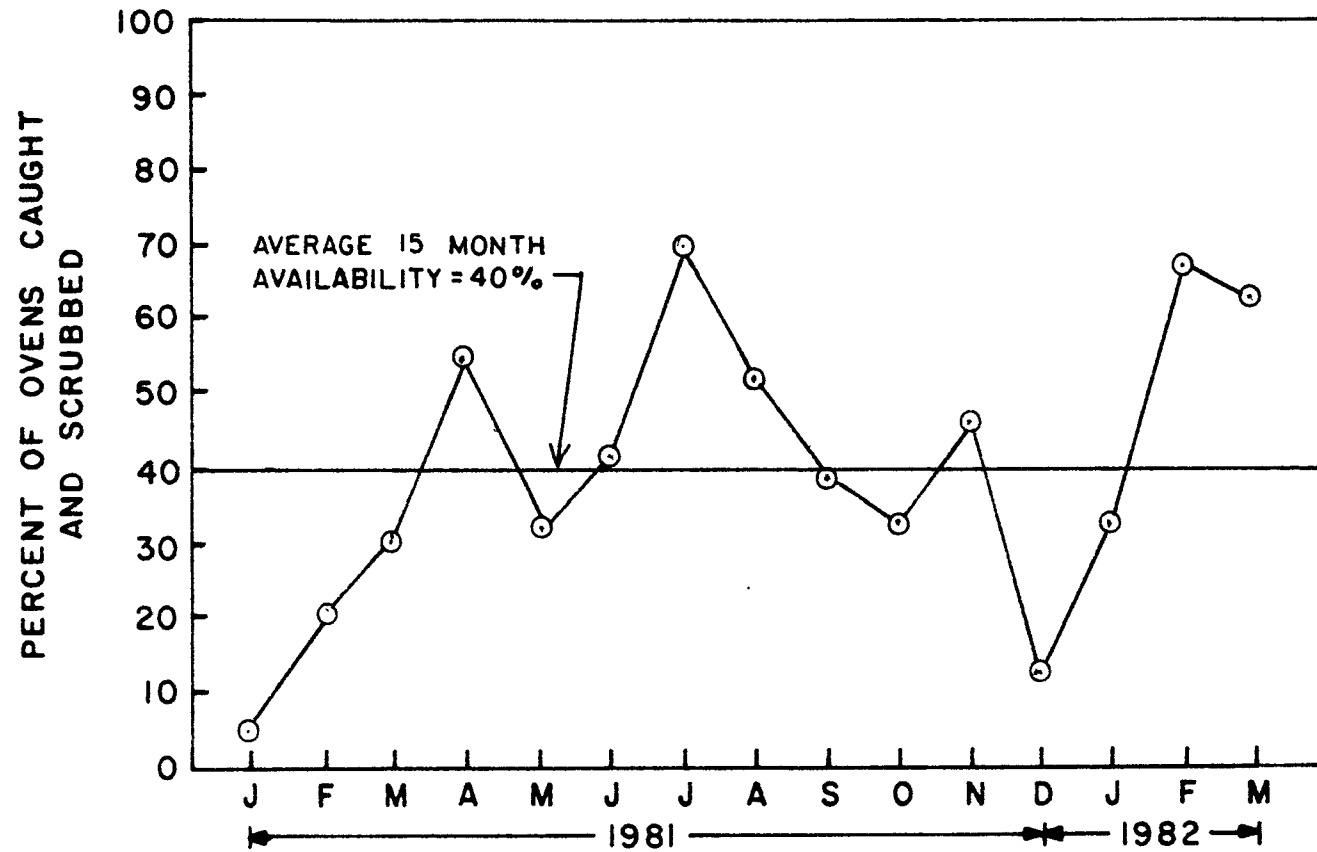
Figure 4. Availability data for H-III serving Batteries 19 and 20 at U.S. Steel/Clairton.

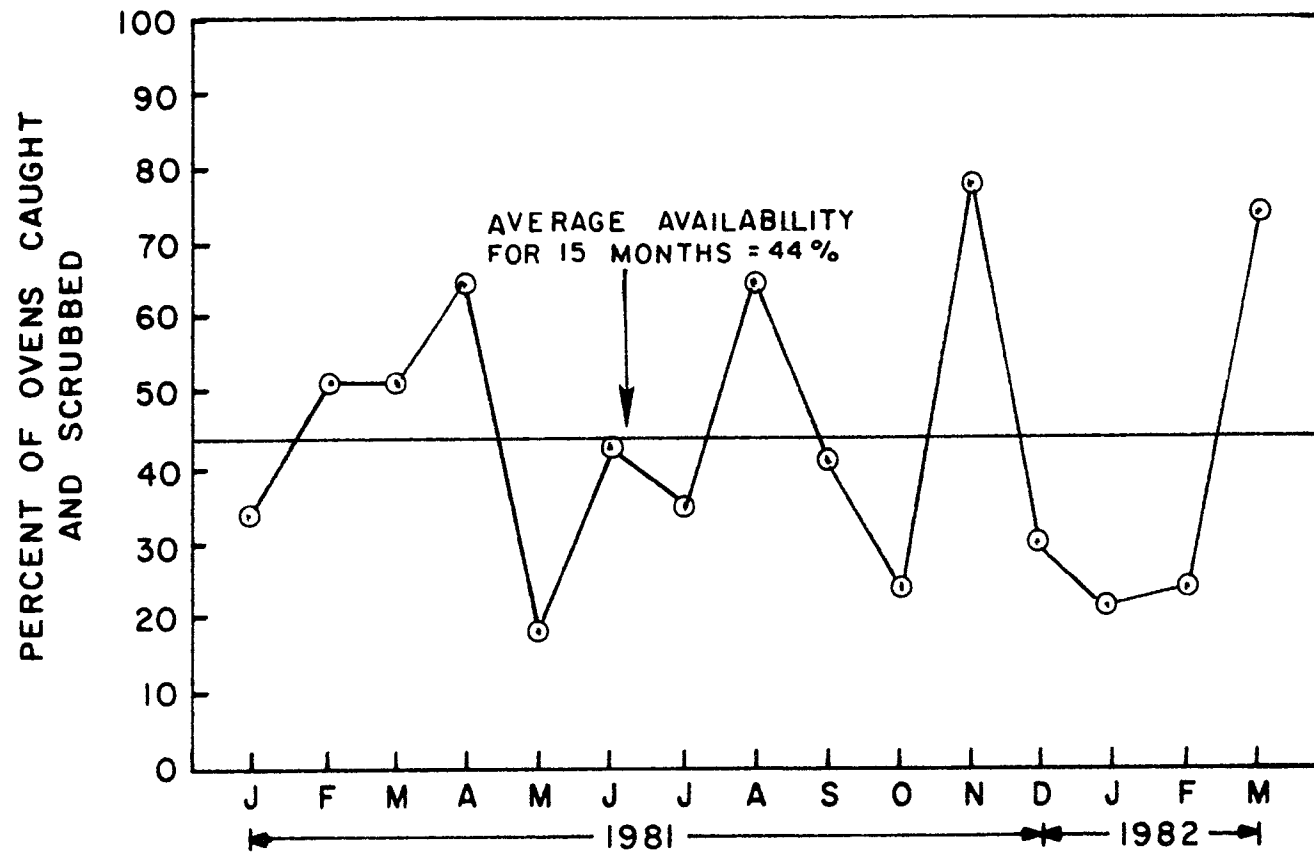
Figure 5. Availability data for H-III serving Batteries 21 and 22 at U.S. Steel/Clairton.

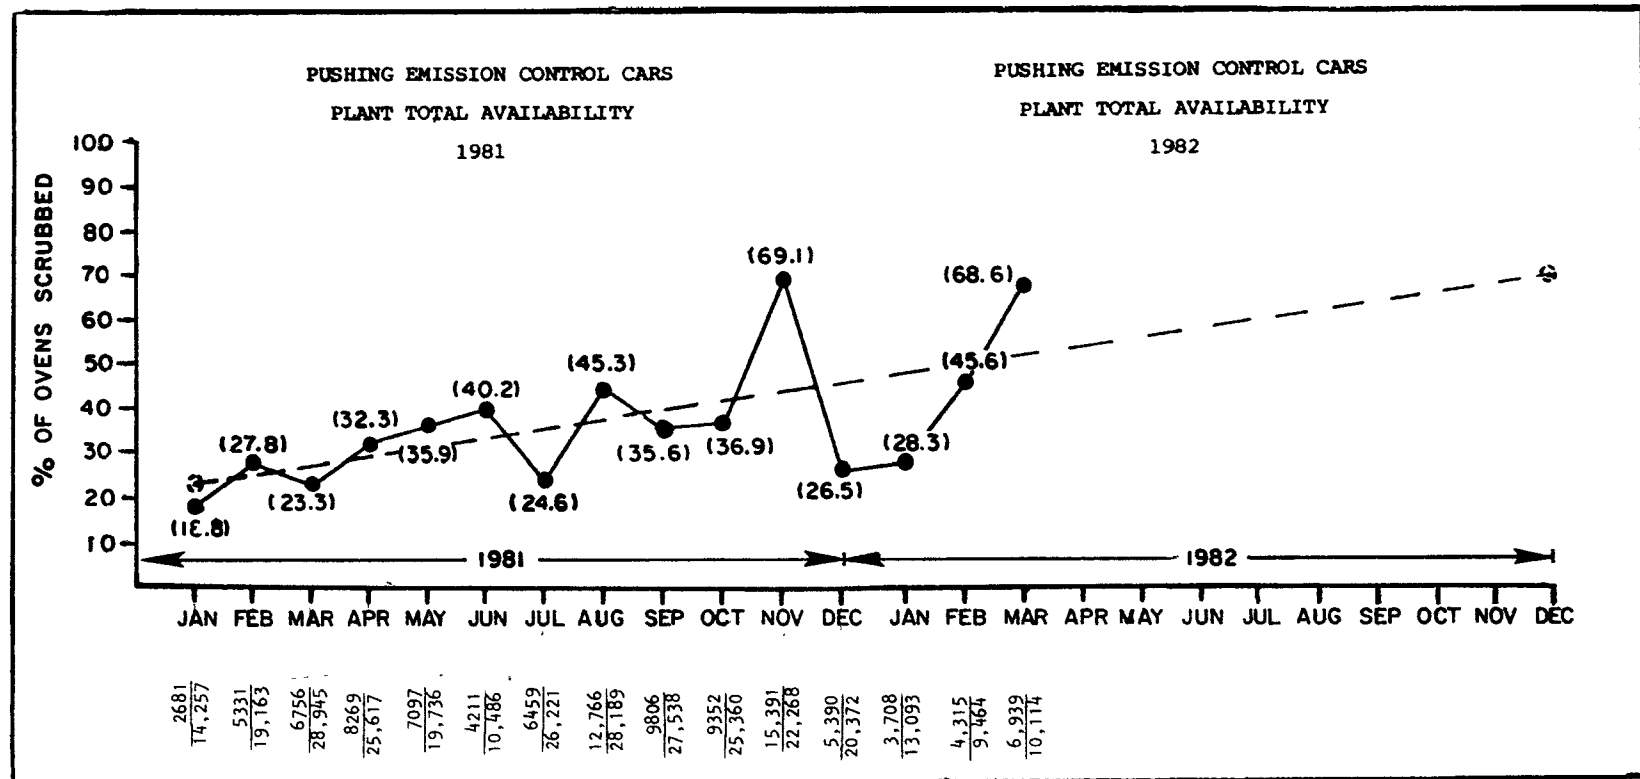
Figure 6. Availability of all operating H-III systems (combined) at U.S. Steel/Clairton (supplied by U.S. Steel).

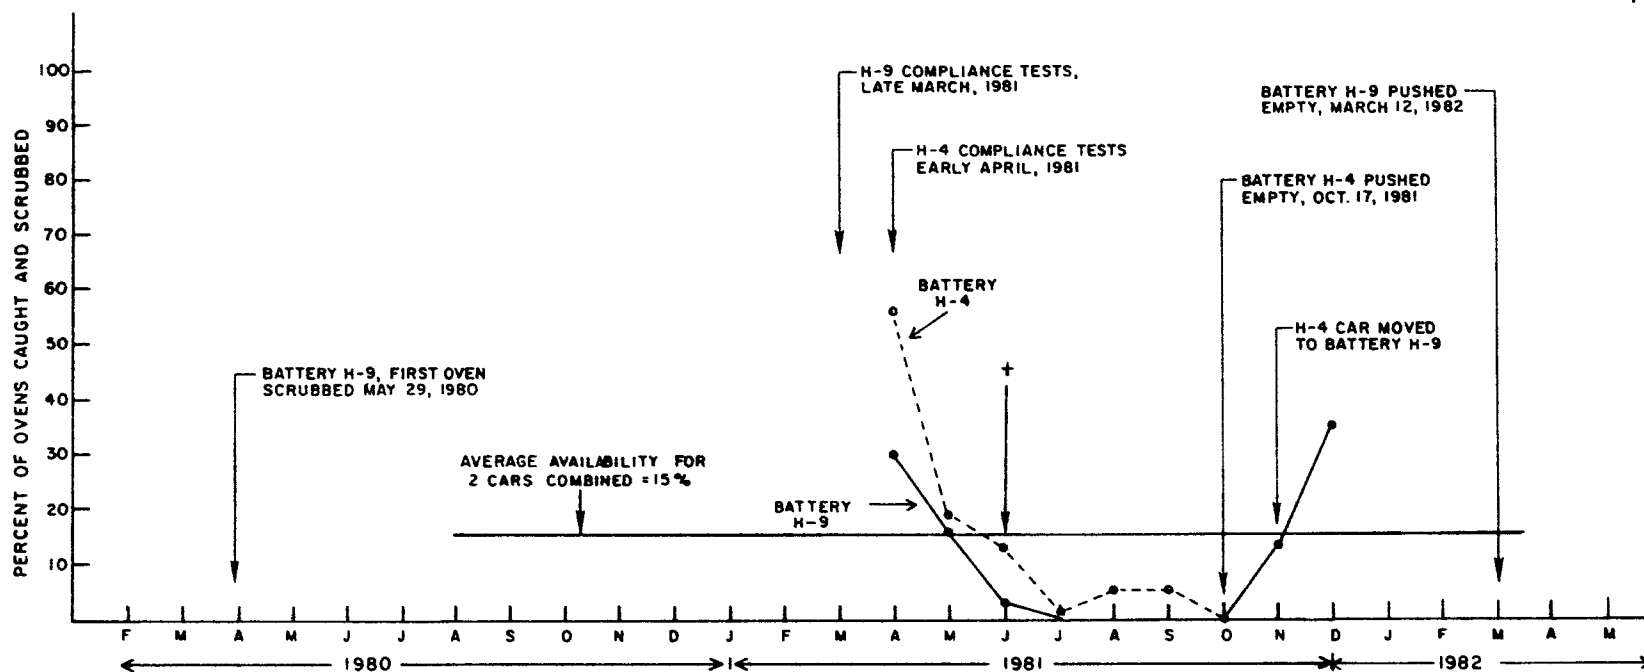
Figure 8. Availability data for H-III at J&L/Indiana Harbor Works (two cars, two batteries). Additional data not available from EPA or J&L.

⁺Accidents at both batteries occurred in June 1981 due to operator error, according to J&L, placing both cars out of service.

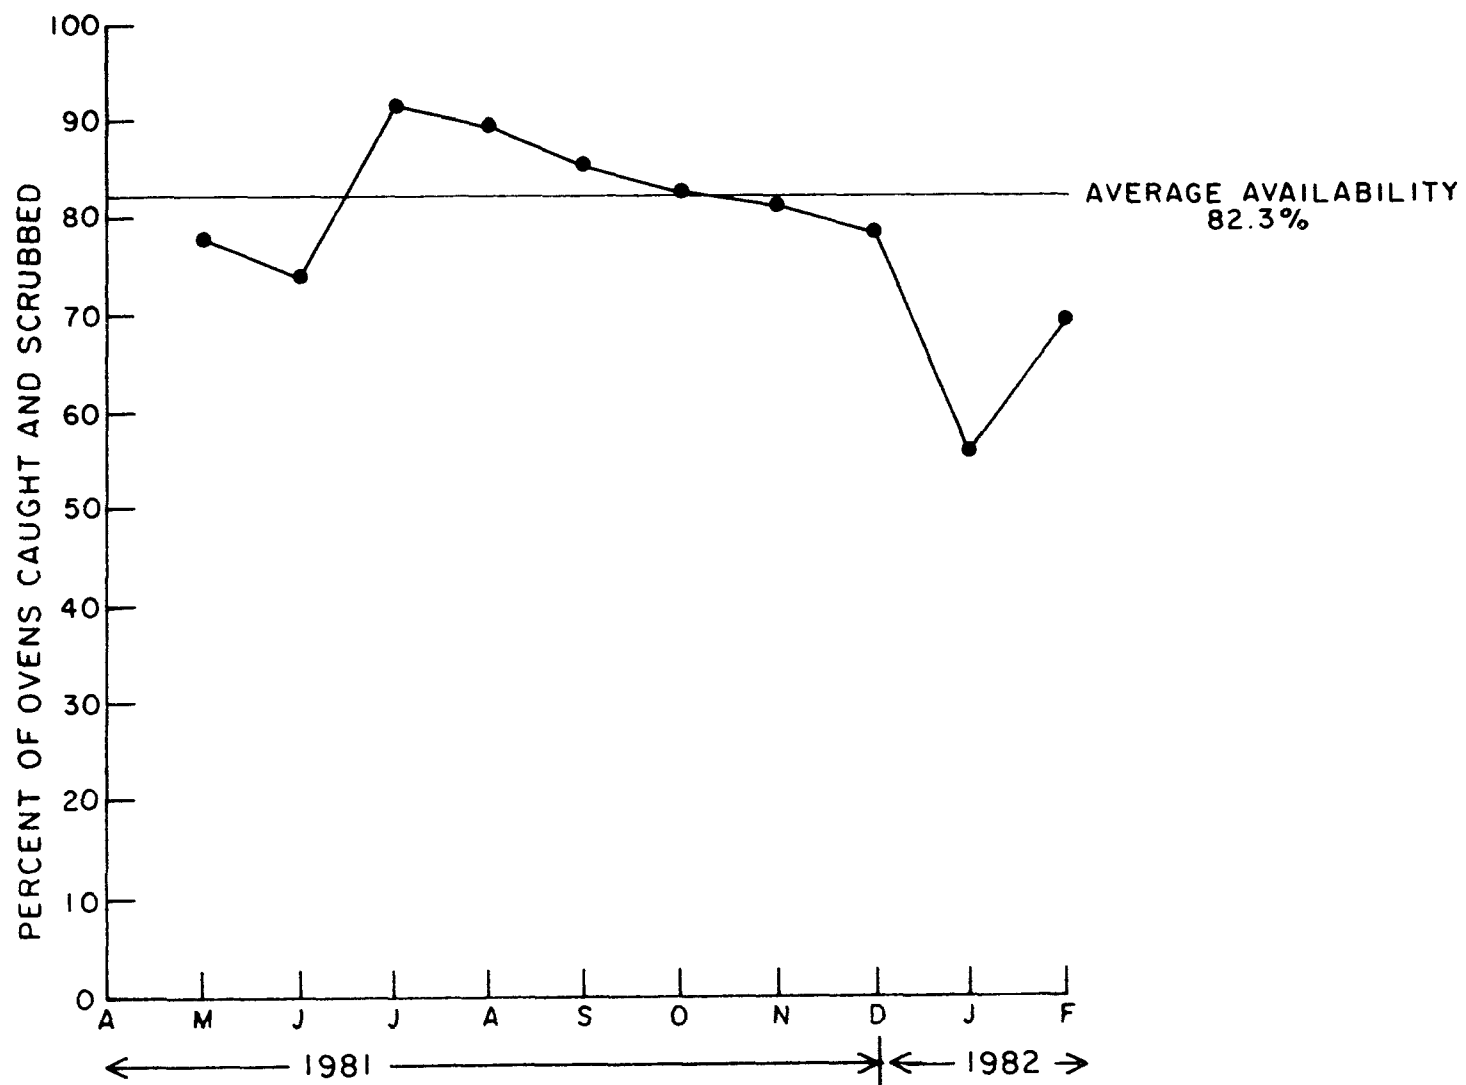
Figure 9. Availability data for H-III at Republic/Warren (two cars serve one battery).

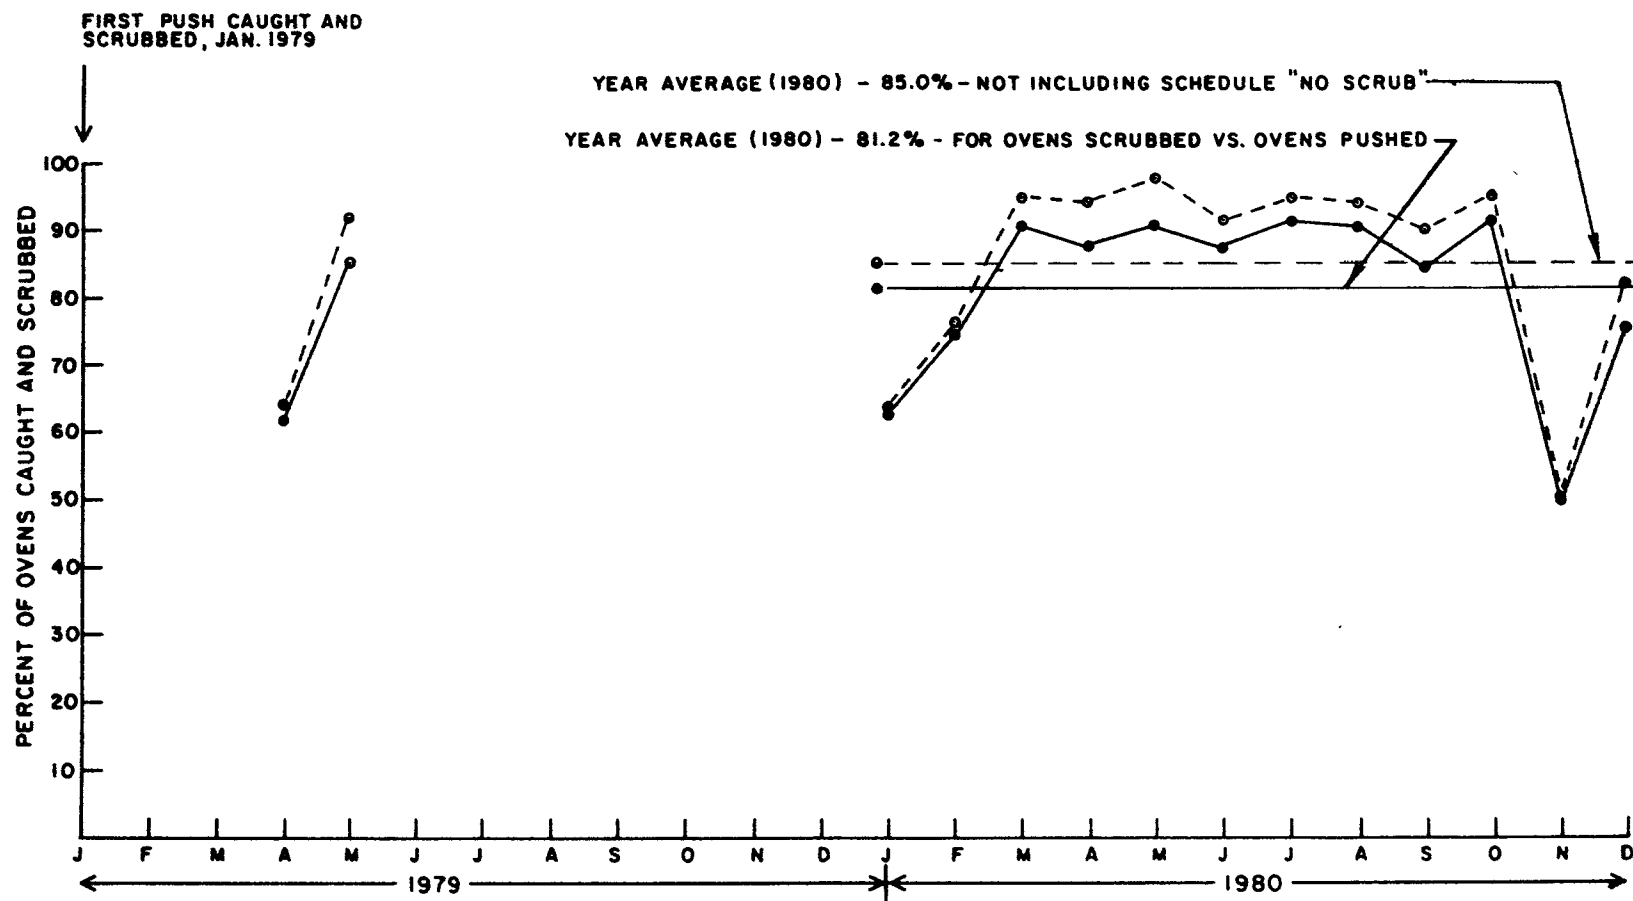
Figure 10. Availability data for H-II at Bethlehem Battery No. 5 at Bethlehem (one car, one battery).

The Bethlehem data were compiled from daily plant records supplied to EPA by the company. Some entries in the Bethlehem data package were illegible. However, it was possible to fairly accurately compile a list of ovens not caught and scrubbed, and the causes as shown in Tables 15 and 16 for 1979 and 1980, respectively. In addition, Table 17, supplied by Bethlehem Steel, provides more car availability details for 1980.

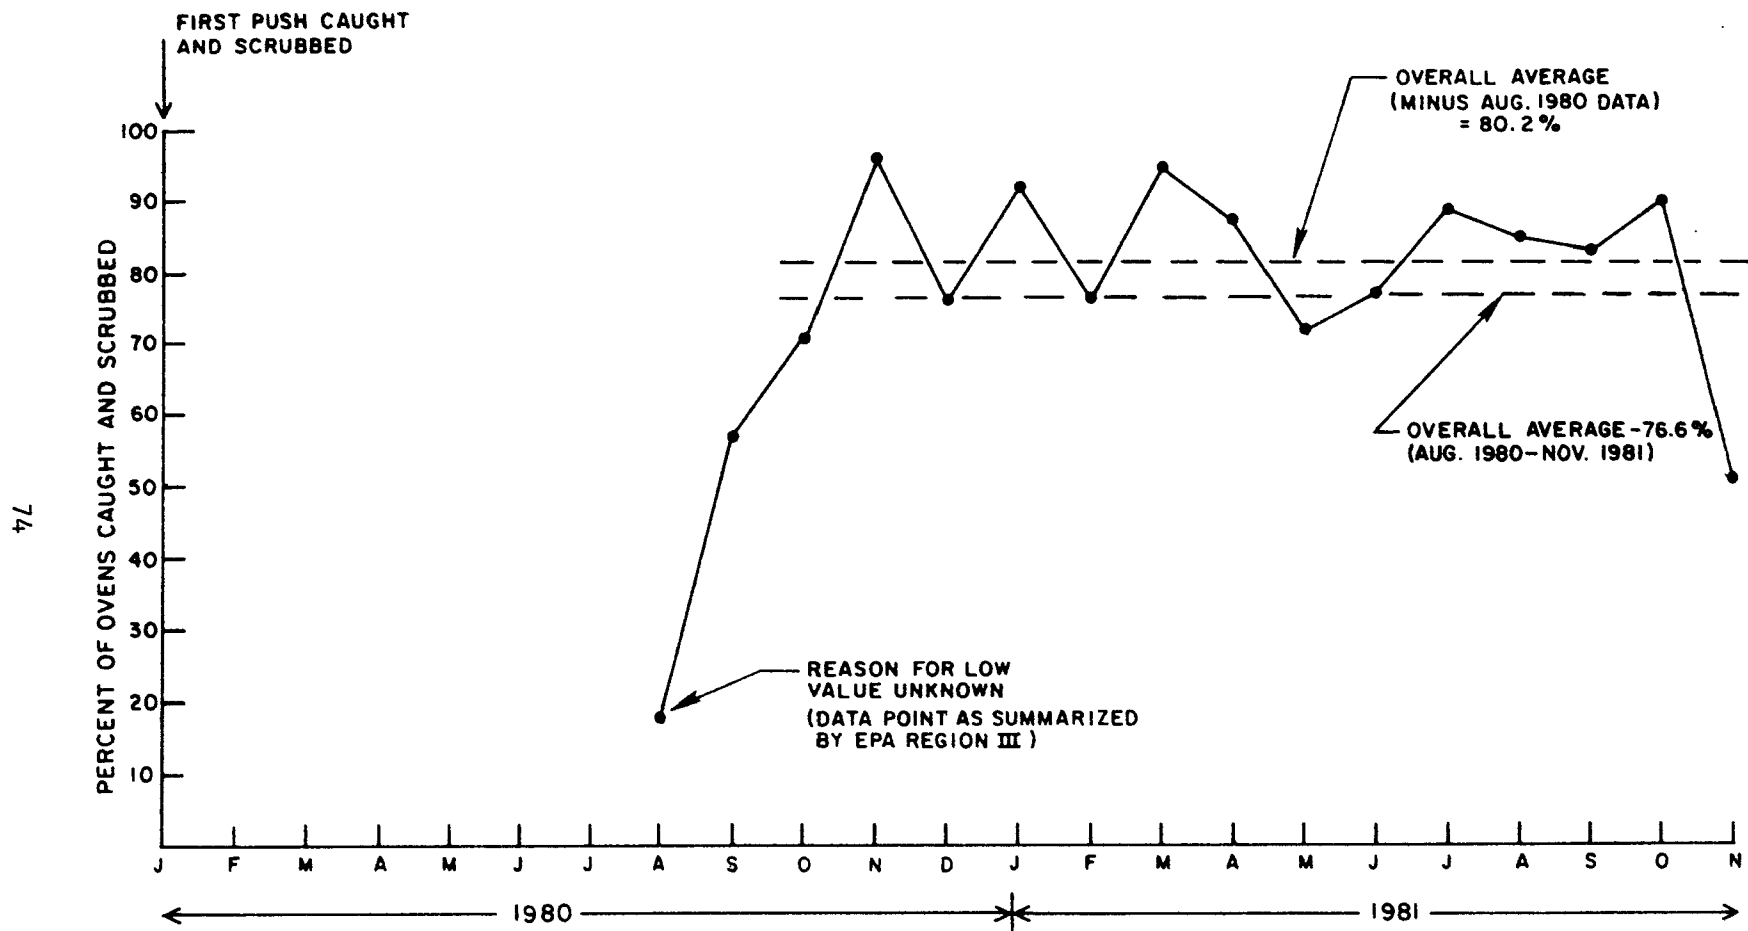
Figure 11. Availability data for H-II at Shenango (one car, two batteries).

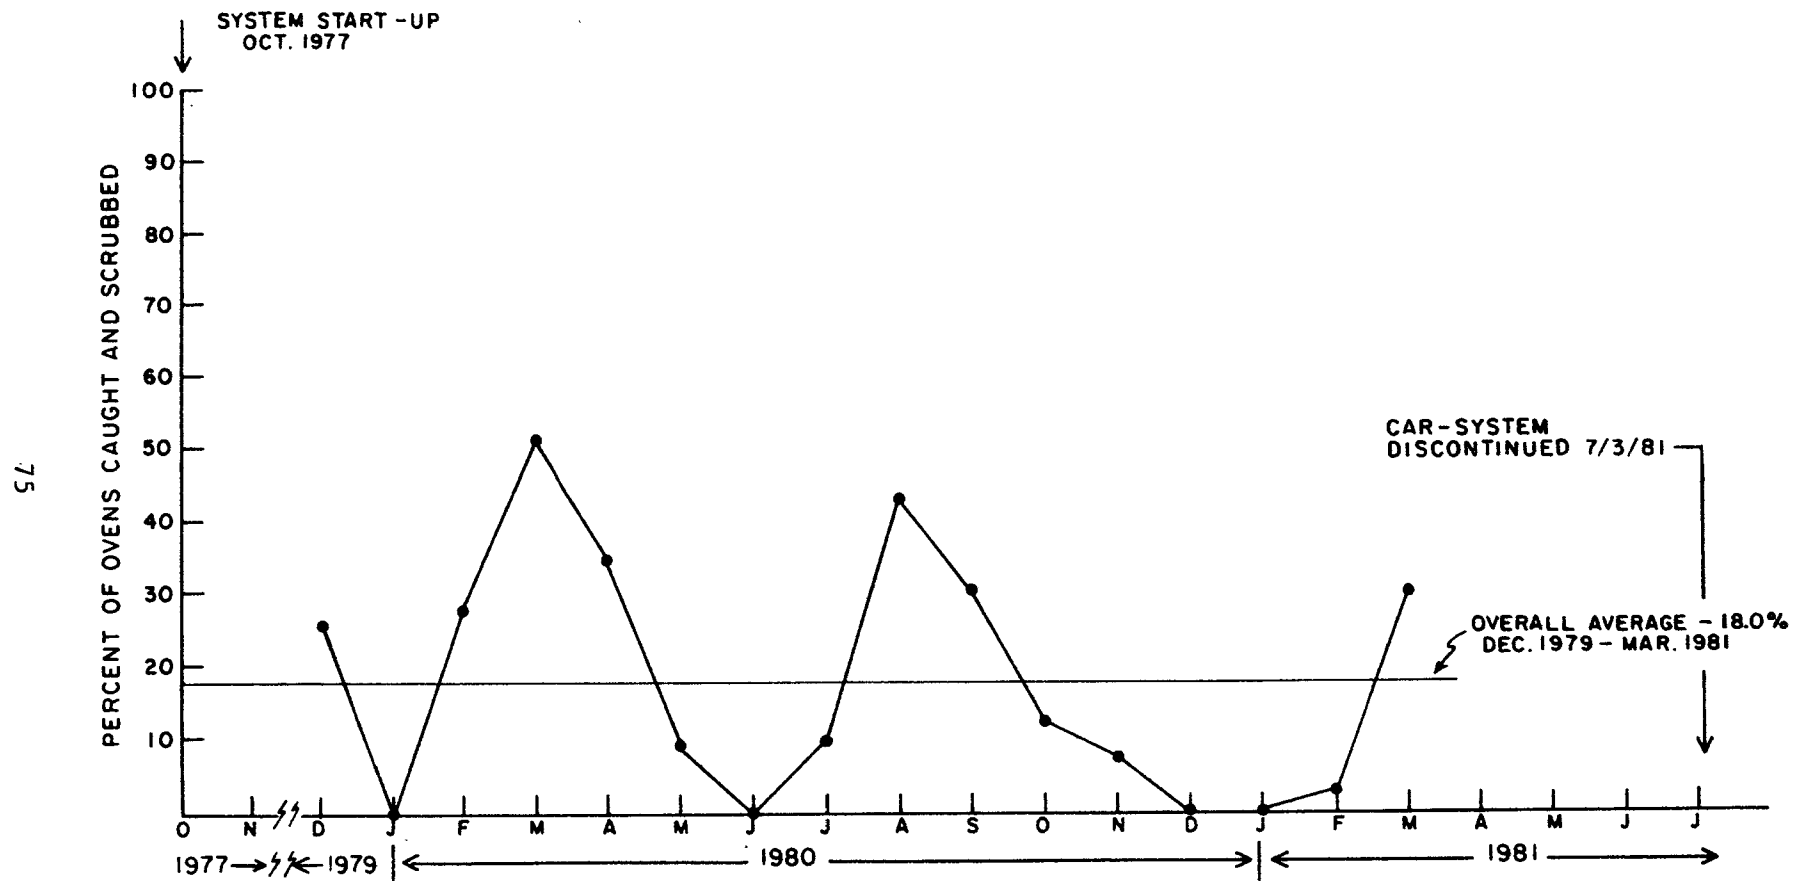
Figure 12. Availability data for H-II at J&L/Pittsburgh Battery P-4
(one car, one battery).
