United States  
Environmental Protection  
Agency

EPA-340/1-83-011  
January 1983

# **A Compilation of Opacity Monitor Performance Audit Results**

Steve Plaisance  
Entropy Environmentalists, Inc.  
Research Triangle Park, North Carolina

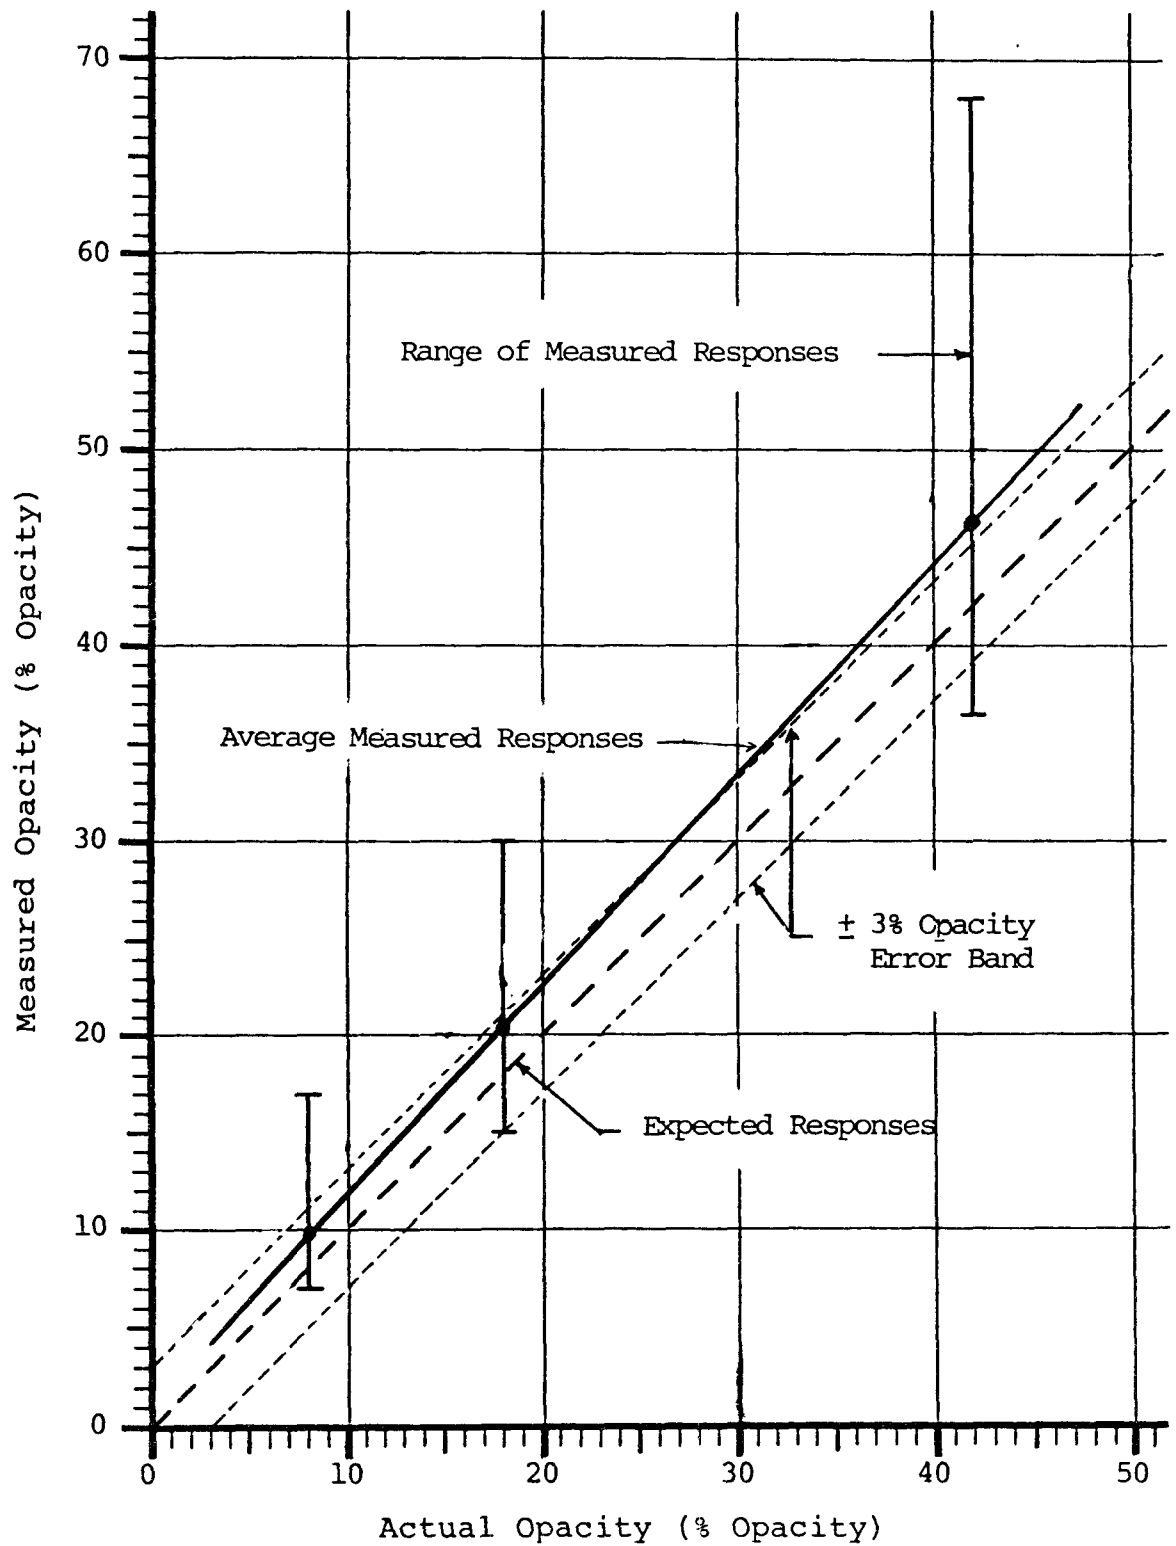
Figure 1. Observed Opacity Responses for All Audited Monitors: 89 Monitors

For all four types of monitors evaluated, the high range calibration error was the most prevalent with 25 percent of the monitors having opacity readings in excess of the specifications. Furthermore, the mid and low range error analyses indicated corresponding reductions in calibration error, with these values being determined as 17 percent and 11 percent, respectively. Thus, a linear relationship between the magnitude of the opacity and that of the calibration error was indicated wherein monitors with lower range errors would not only have high range errors, but these errors would be of a greater magnitude (see Figure 1). In general, the monitors audited with calibration errors in excess of 3 percent opacity were biased high. Poorly performing monitors tended to give falsely high opacity readings, and, therefore, it is in the source's best interest to calibrate and maintain opacity monitors properly.

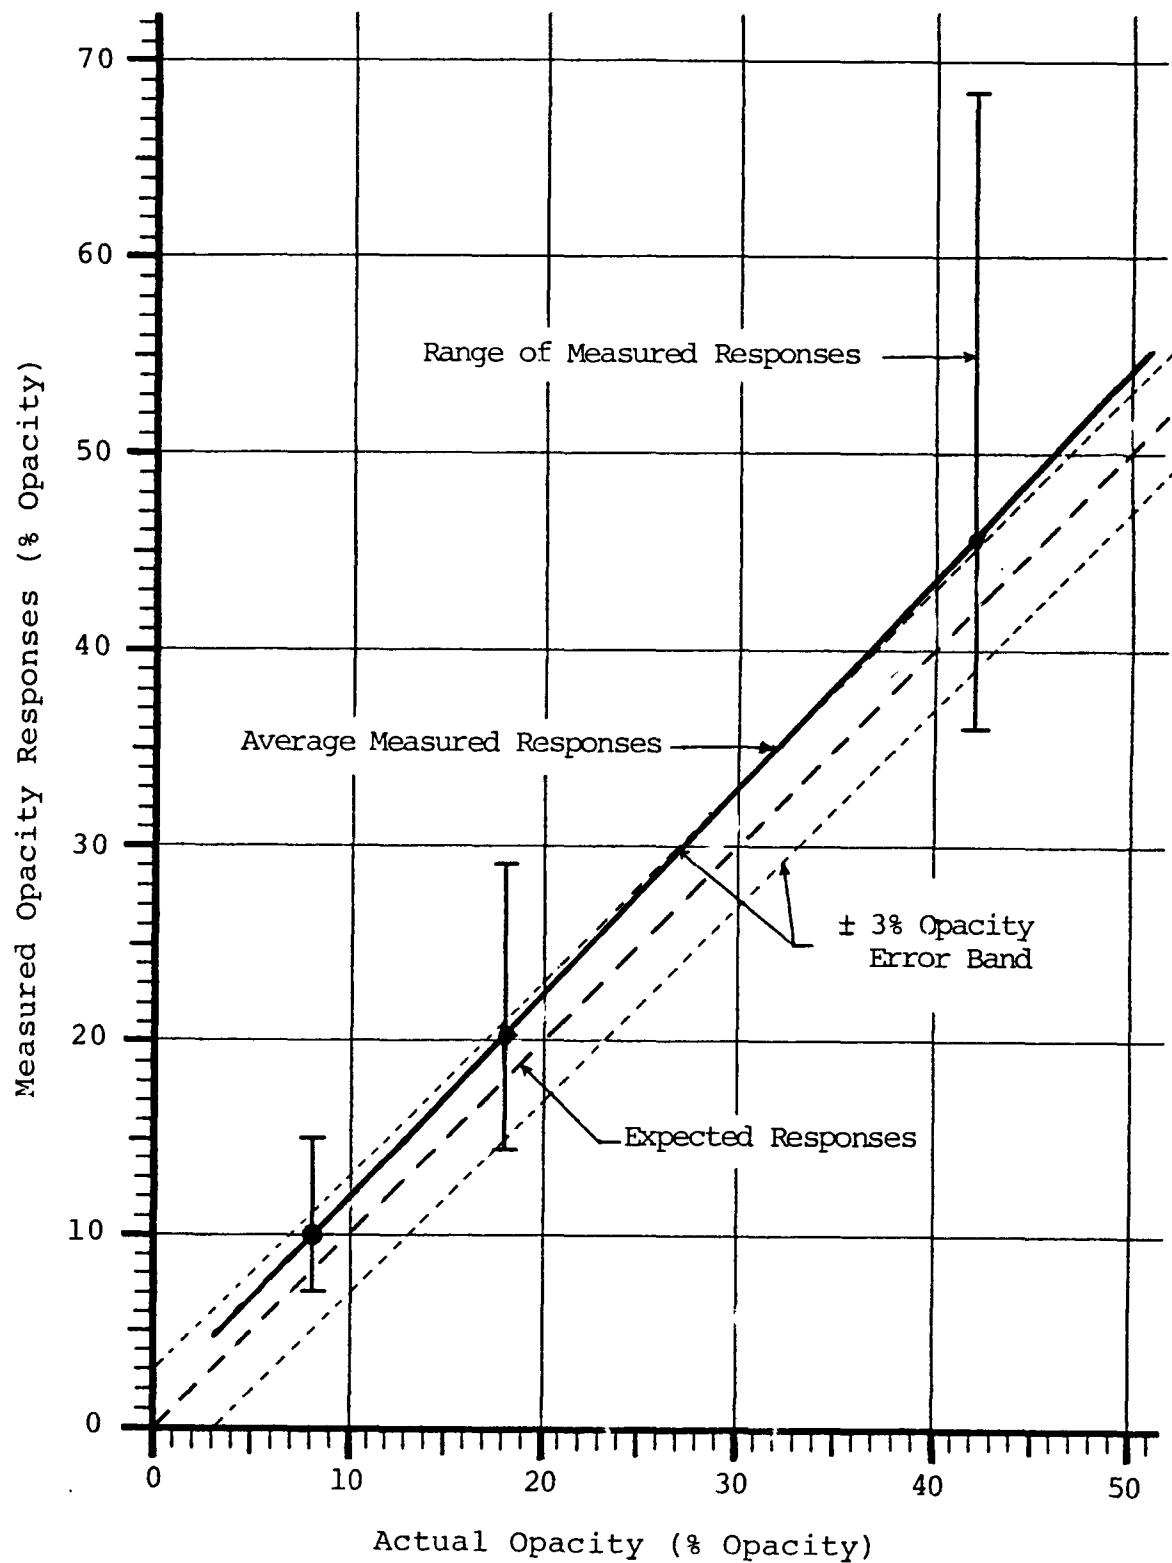
Figure 2. Observed Opacity Responses for 58 Lear Siegler Monitors

Monitor calibration was found to be generally accurate and linear, with the greatest number of "out of specification" monitors resulting from the high range calibration error analysis (9 monitors, or 16 percent of the total). As Figure 2 illustrates, the Lear Siegler monitors tended to give elevated opacity measurements, but typically not in excess of the 3 percent

opacity error band based on average measured responses. However, the range of measured opacities increased disproportionately with increases in the actual opacity, thereby indicating that monitor accuracy deteriorated with higher actual opacity.

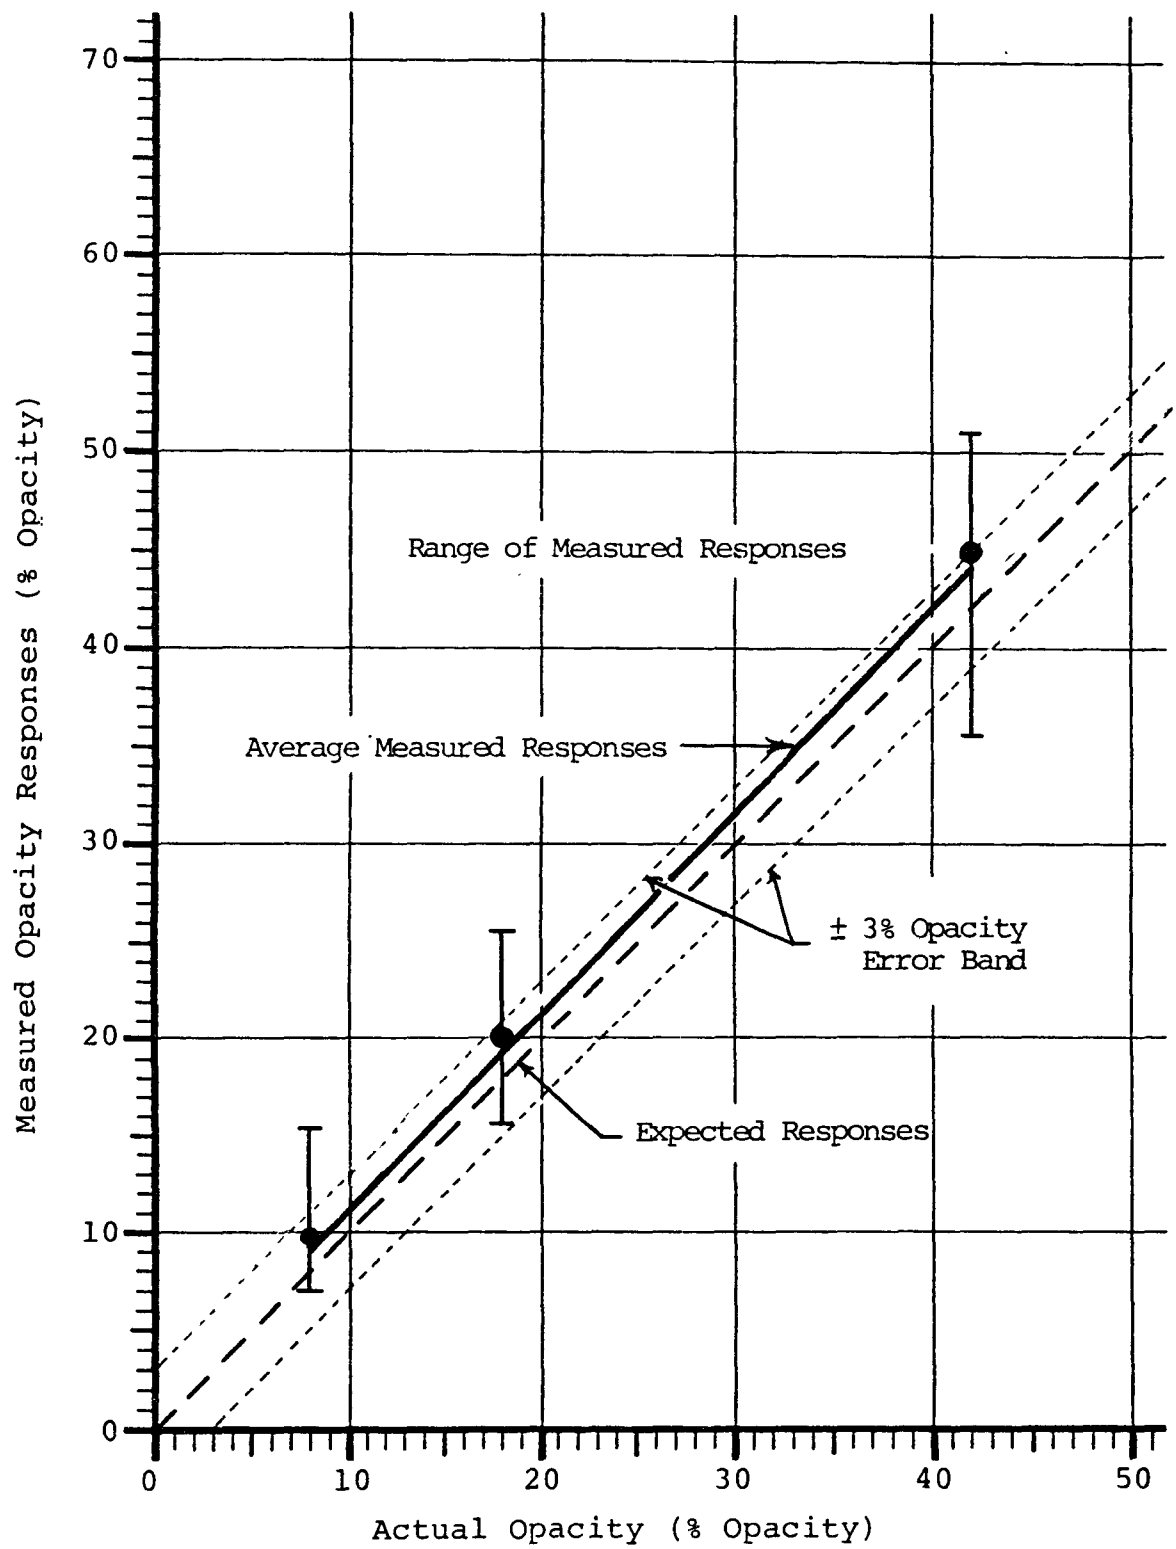
Figure 3. Observed Opacity Responses for 27 Contraves Goerz Monitors

Contraves Goerz. An analysis of the performance of 27 Contraves Goerz monitors indicated that panel meter and internal span errors occurred in about 20 percent of the monitors audited. Monitor maintenance, as indicated by the optical dust accumulation, was generally satisfactory, with only 3 units (about 12 percent of the total) having excessive dust accumulations. Monitor calibration, as illustrated in Figure 3, was adequate, with average low, medium, and high opacity values falling within the  $\pm 3$  percent opacity error band. Contraves Goerz monitor opacity measurements were typically higher than actual opacity values, and this bias increased with higher actual opacity values.

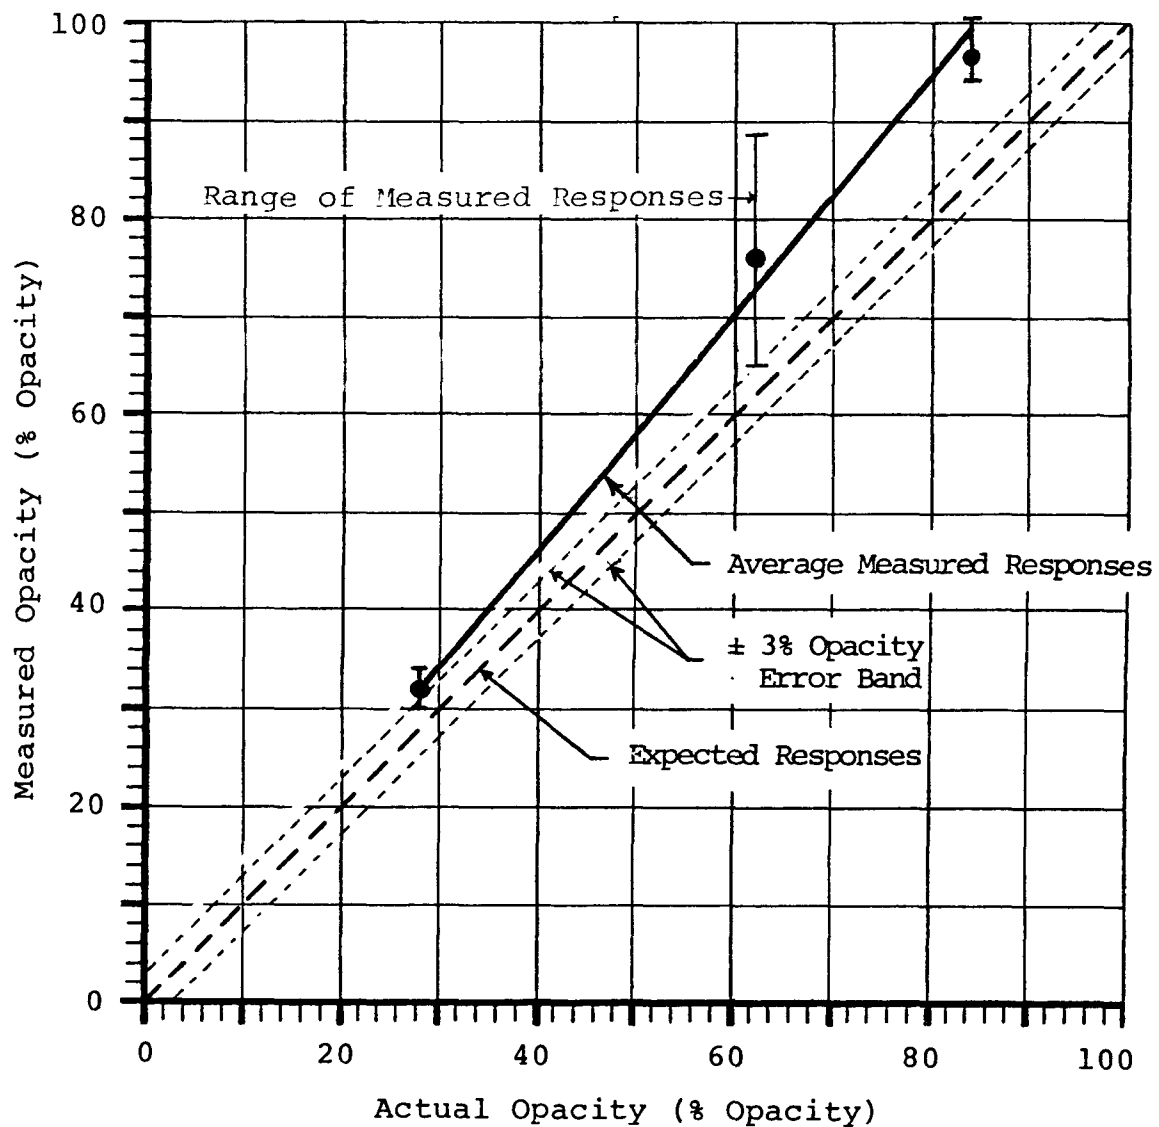
Figure 4. Observed Opacity Responses for 5 Dynatron Monitors

Maintenance of Dynatron monitors, as indicated by dust accumulation on monitor optics, was satisfactory, with only one monitor having excessive dust on system optics. Figure 4 illustrates the very high bias found in the calibration analysis, indicating severe inaccuracies in measured opacity, particularly in the higher range of actual opacity values. In fact, only 25 percent of the Dynatron units were found to be within the acceptable range of accuracy for low and mid-range opacity values. Moreover, monitor linearity was found to be deficient, with average mid-range opacity values having less accuracy than either low or high range opacity values.

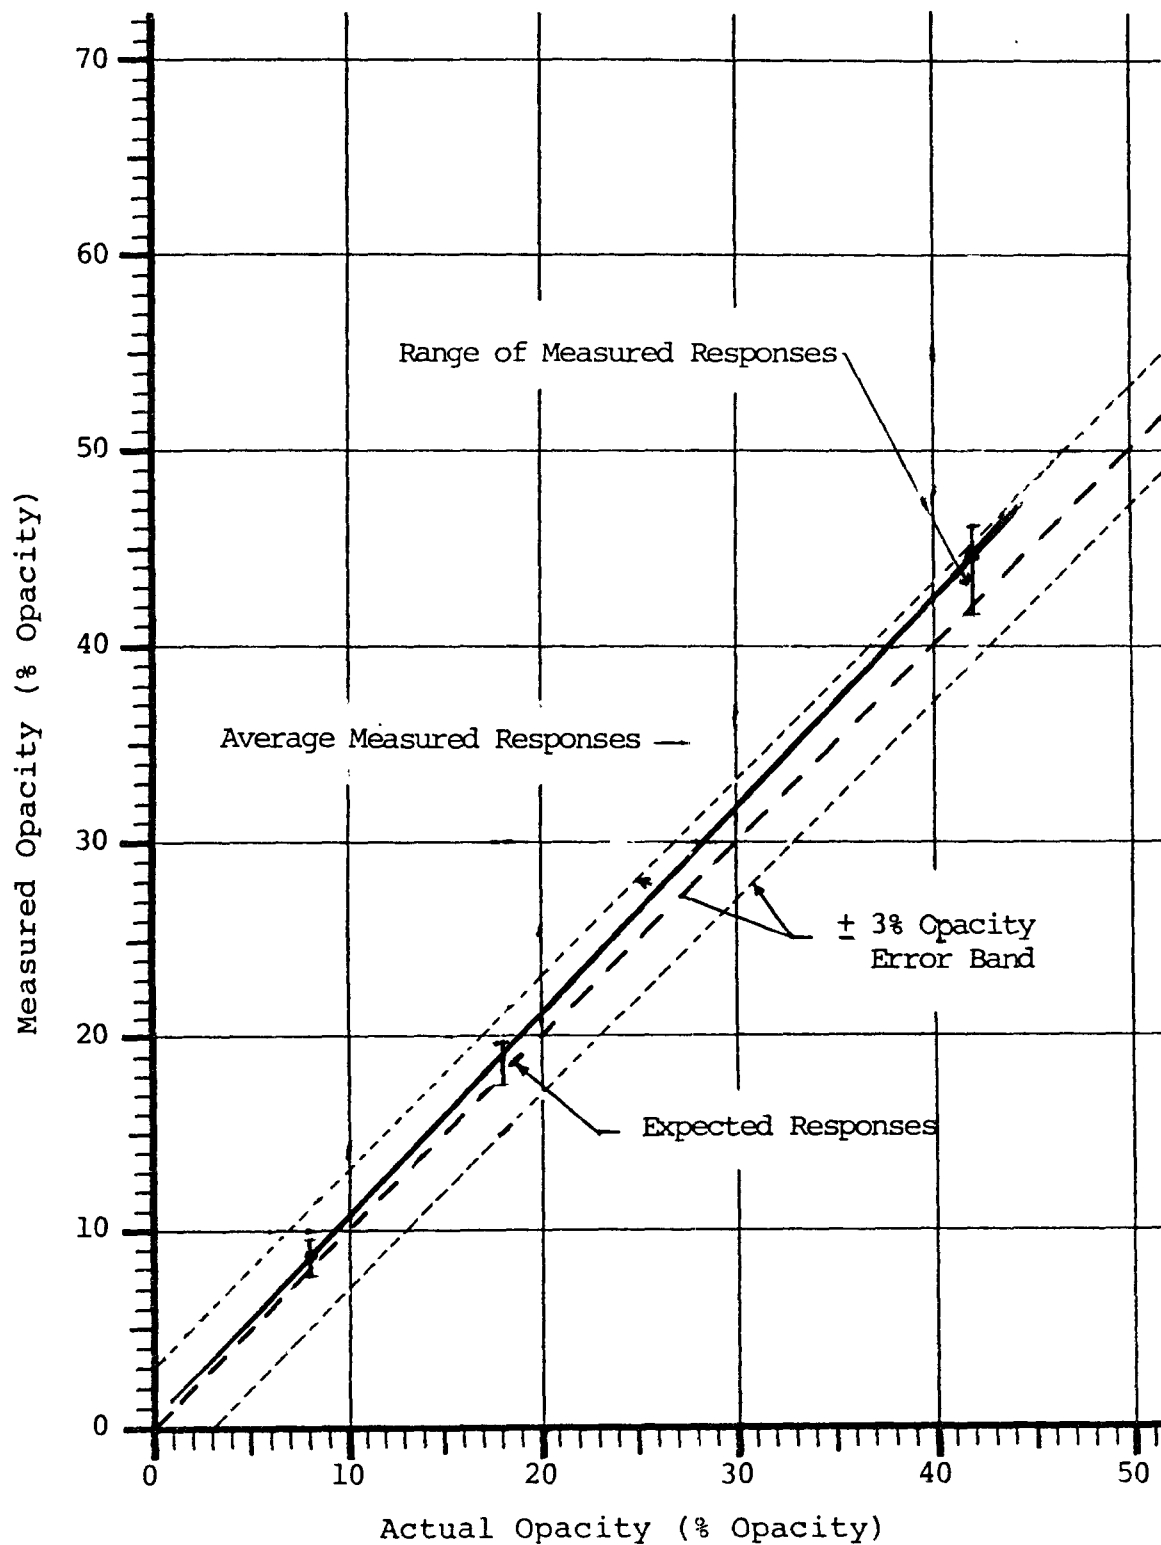
Figure 5. Observed Opacity Responses for 3 Esterline Angu Monitors

Esterline Angus. Of 3 Esterline Angus monitors audited, one unit had problems with monitor alignment and panel meter errors. Optical dust accumulations were found to be minimal, thereby indicating adequate monitor maintenance. Furthermore, only one unit was found to have excessive calibration error (high range). Monitor accuracy and linearity, as illustrated in Figure 5, were satisfactory, with both low and mid-range calibration errors falling well within the  $\pm 3$  percent error band.
