## Project Summary

# Field Verification of Liners from Sanitary Landfills

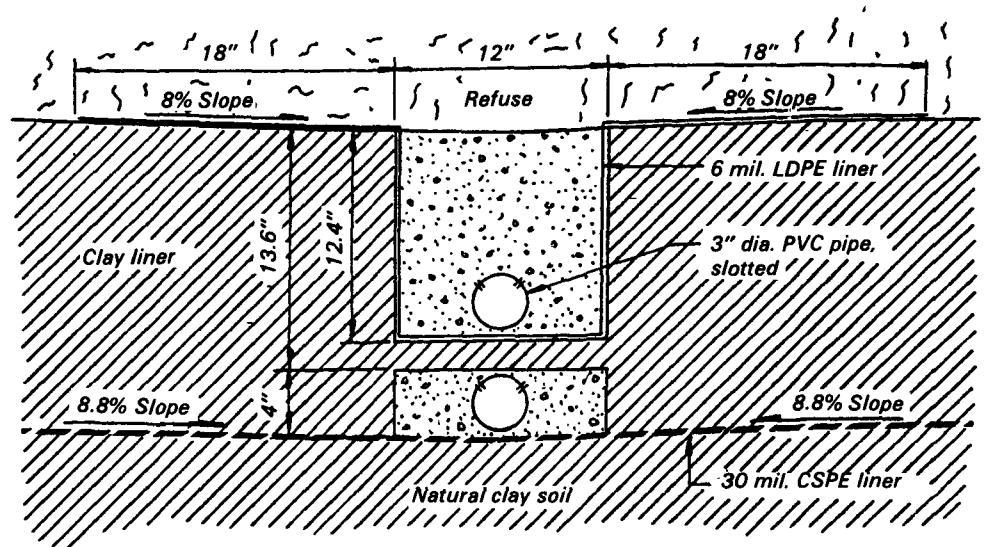
Figure 1. Cross section of TC-1 at Observation Bulkhead.

From TC-1, samples were taken of a clay liner, a chlorosulfonated polyethylene liner (CSPE), and a low-density polyethylene liner (LDPE). Figure 1 shows the relative positions of these liners in the test cell.

The clay liner was composed of a slightly sandy moderately plastic clay containing limestone rock fragments up to 26 cm (10 in.) long. Liner thickness varied from 44 to 62 cm (17 to 24 in.). The clay was classified as a CL by the Unified Soil Classification System, with an average liquid limit of 42 and a plasticity index of 20. Rock fragments lay parallel to the liner surface. Average in-place dry density was 99 pcf, and average moisture content was 25 percent. Permeability ranged from 4 to 5 x 10<sup>-7</sup> cm/sec for in-place tests; in laboratory tests, it was 2 x 10<sup>-8</sup> cm/sec. The liner was light brown-gray to a depth of 31 to 36 cm (12 to 14 in.), where it abruptly changed to a more natural orange-tan for the remainder of its thickness. No visual signs of cracking, channeling, or unusual changes in texture or consistency were noted in any of the excavations.

Chemical analyses of the clay liner in TC-1 indicated that it provided effective leachate containment. Some leachate had collected below the clay liner, but this leakage resulted from a small perforation in the clay surface during cell preparation.

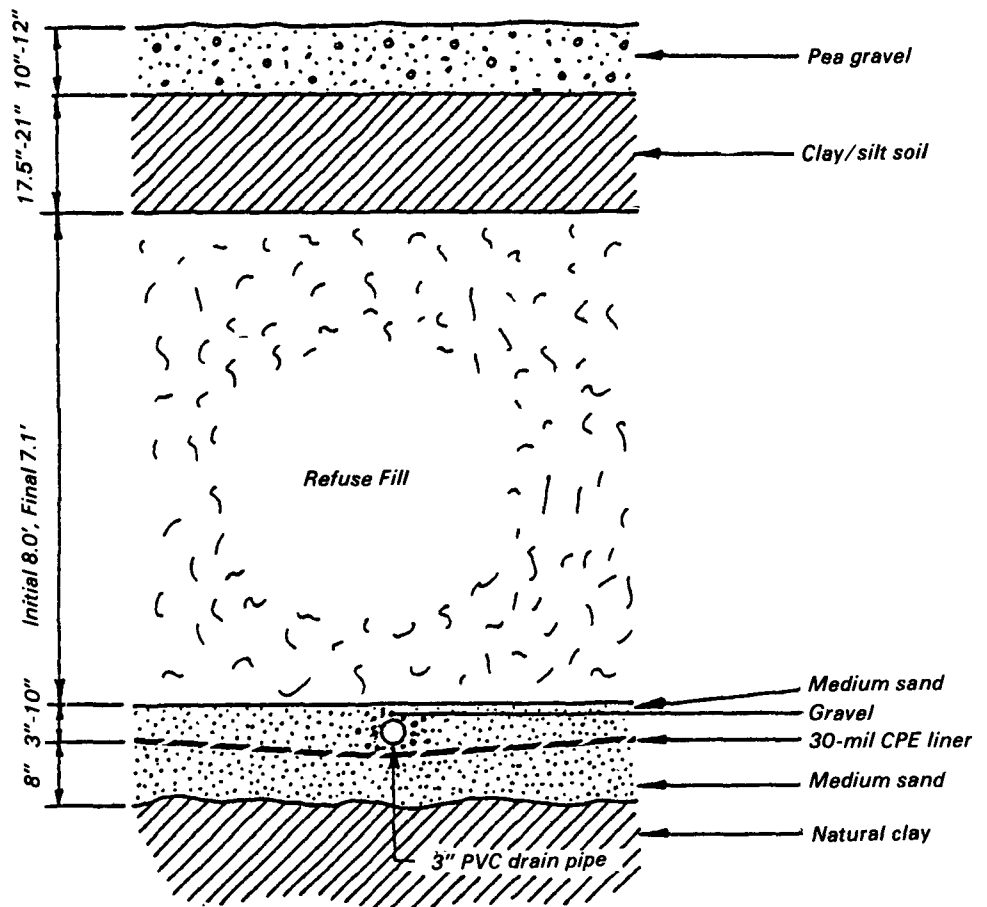
Figure 2. Test cell construction details for TC-2D.

From TC-2D, six samples were taken of a 30-mil, unreinforced, chlorinated polyethylene (CPE) liner. Four of the samples were taken from the bottom of the cell, and two were collected above ground at the top of the cell (and had thus been exposed to the weather). Figure 2 shows the position of the CPE liner in relation to the other construction details of TC-2D.

The four leachate-exposed CPE samples from the bottom of TC-2D had been exposed to all the unattenuated leachate generated within the cell during the 9 years of operation. Chemical analyses of the layers of sand above and below the CPE liner indicated that it has contained the leachate within the cell. Samples were stiff and leathery. Though they showed significant absorption of leachate, their properties were relatively good. Volatile contents ranged from 16.7 to 18.8 percent. The latter value is equal to an increase of 23 percent by weight (based on the original), or a 31.7-percent increase by volume.

An investigation of the subsoils in TC-2D revealed that the CPE liner was under an upward hydrostatic pressure from fluids in the underlying sand. Analyses showed, however, that the fluid did not contain leachate. The sand immediately below the CPE liner was a light tan except for a 1.3- to 1.9-cm ( $\frac{1}{2}$  to  $\frac{3}{4}$ -in.) gray zone at the point of contact with the liner. The thick, natural clay section below the sand was a mottled gray-green in the upper 2.5 to 5.1 cm (1 to 2 in.). The remainder was a natural orange-tan.
