Technical Note
ORP/TAD-79-2

On Board Corrosion Analysis of a Recovered Nuclear Waste Container

Stephen C. Dexter
Assistant Professor
of Ocean Engineering
and Materials Science
College of Marine Studies
University of Delaware

August 1979

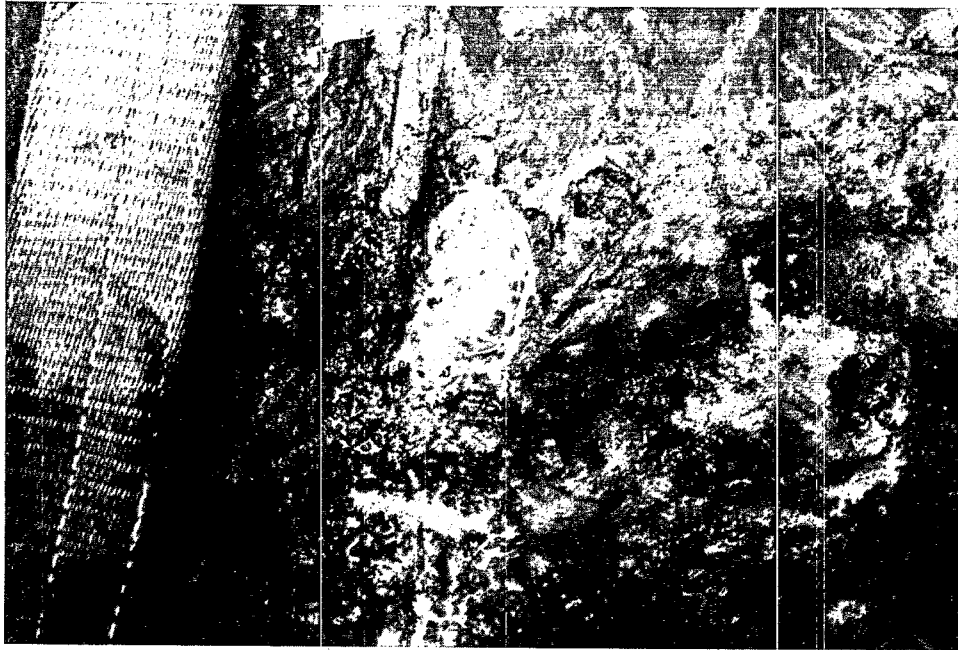
When the container first arrived at the surface, it was apparent that there was a perforation in the metal drum as a stream of seawater was observed coming out as if under pressure. The stream can be seen just below the letter "B" in both Figures 3a and 3b. The area from which the stream came was below the mud line and is shown close up in Figure 7. By the time this photograph was taken, the pressure had nearly equalized and the remaining liquid was seeping out as shown. Some of this liquid was collected by the EPA Project Officer for subsequent laboratory analysis. Upon further examination with a probe, it became apparent that the perforation was not due to corrosion but was a recent puncture. It is suspected that this occurred as the drum was being dragged along the bottom as related above.

found to be between 6 and 8. There was one notable exception. The pH of the water bubbling from the puncture described in connection with Figures 3 and 7 was between 13.0 and 13.5.

Figure 7. Water oozing out of perforation on cylindrical surface of container. Location of the perforation is just below the letter "B" in Figure 3(a) and (b).
