RADIOLOGICAL SURVEY AT THE INACTIVE URANIUM MILL SITE NEAR RIVERTON, WYOMING

**U.S. ENVIRONMENTAL PROTECTION AGENCY
OFFICE OF RADIATION PROGRAMS
LAS VEGAS FACILITY
LAS VEGAS, NEVADA 89114**

Richard L. Douglas

June 1977

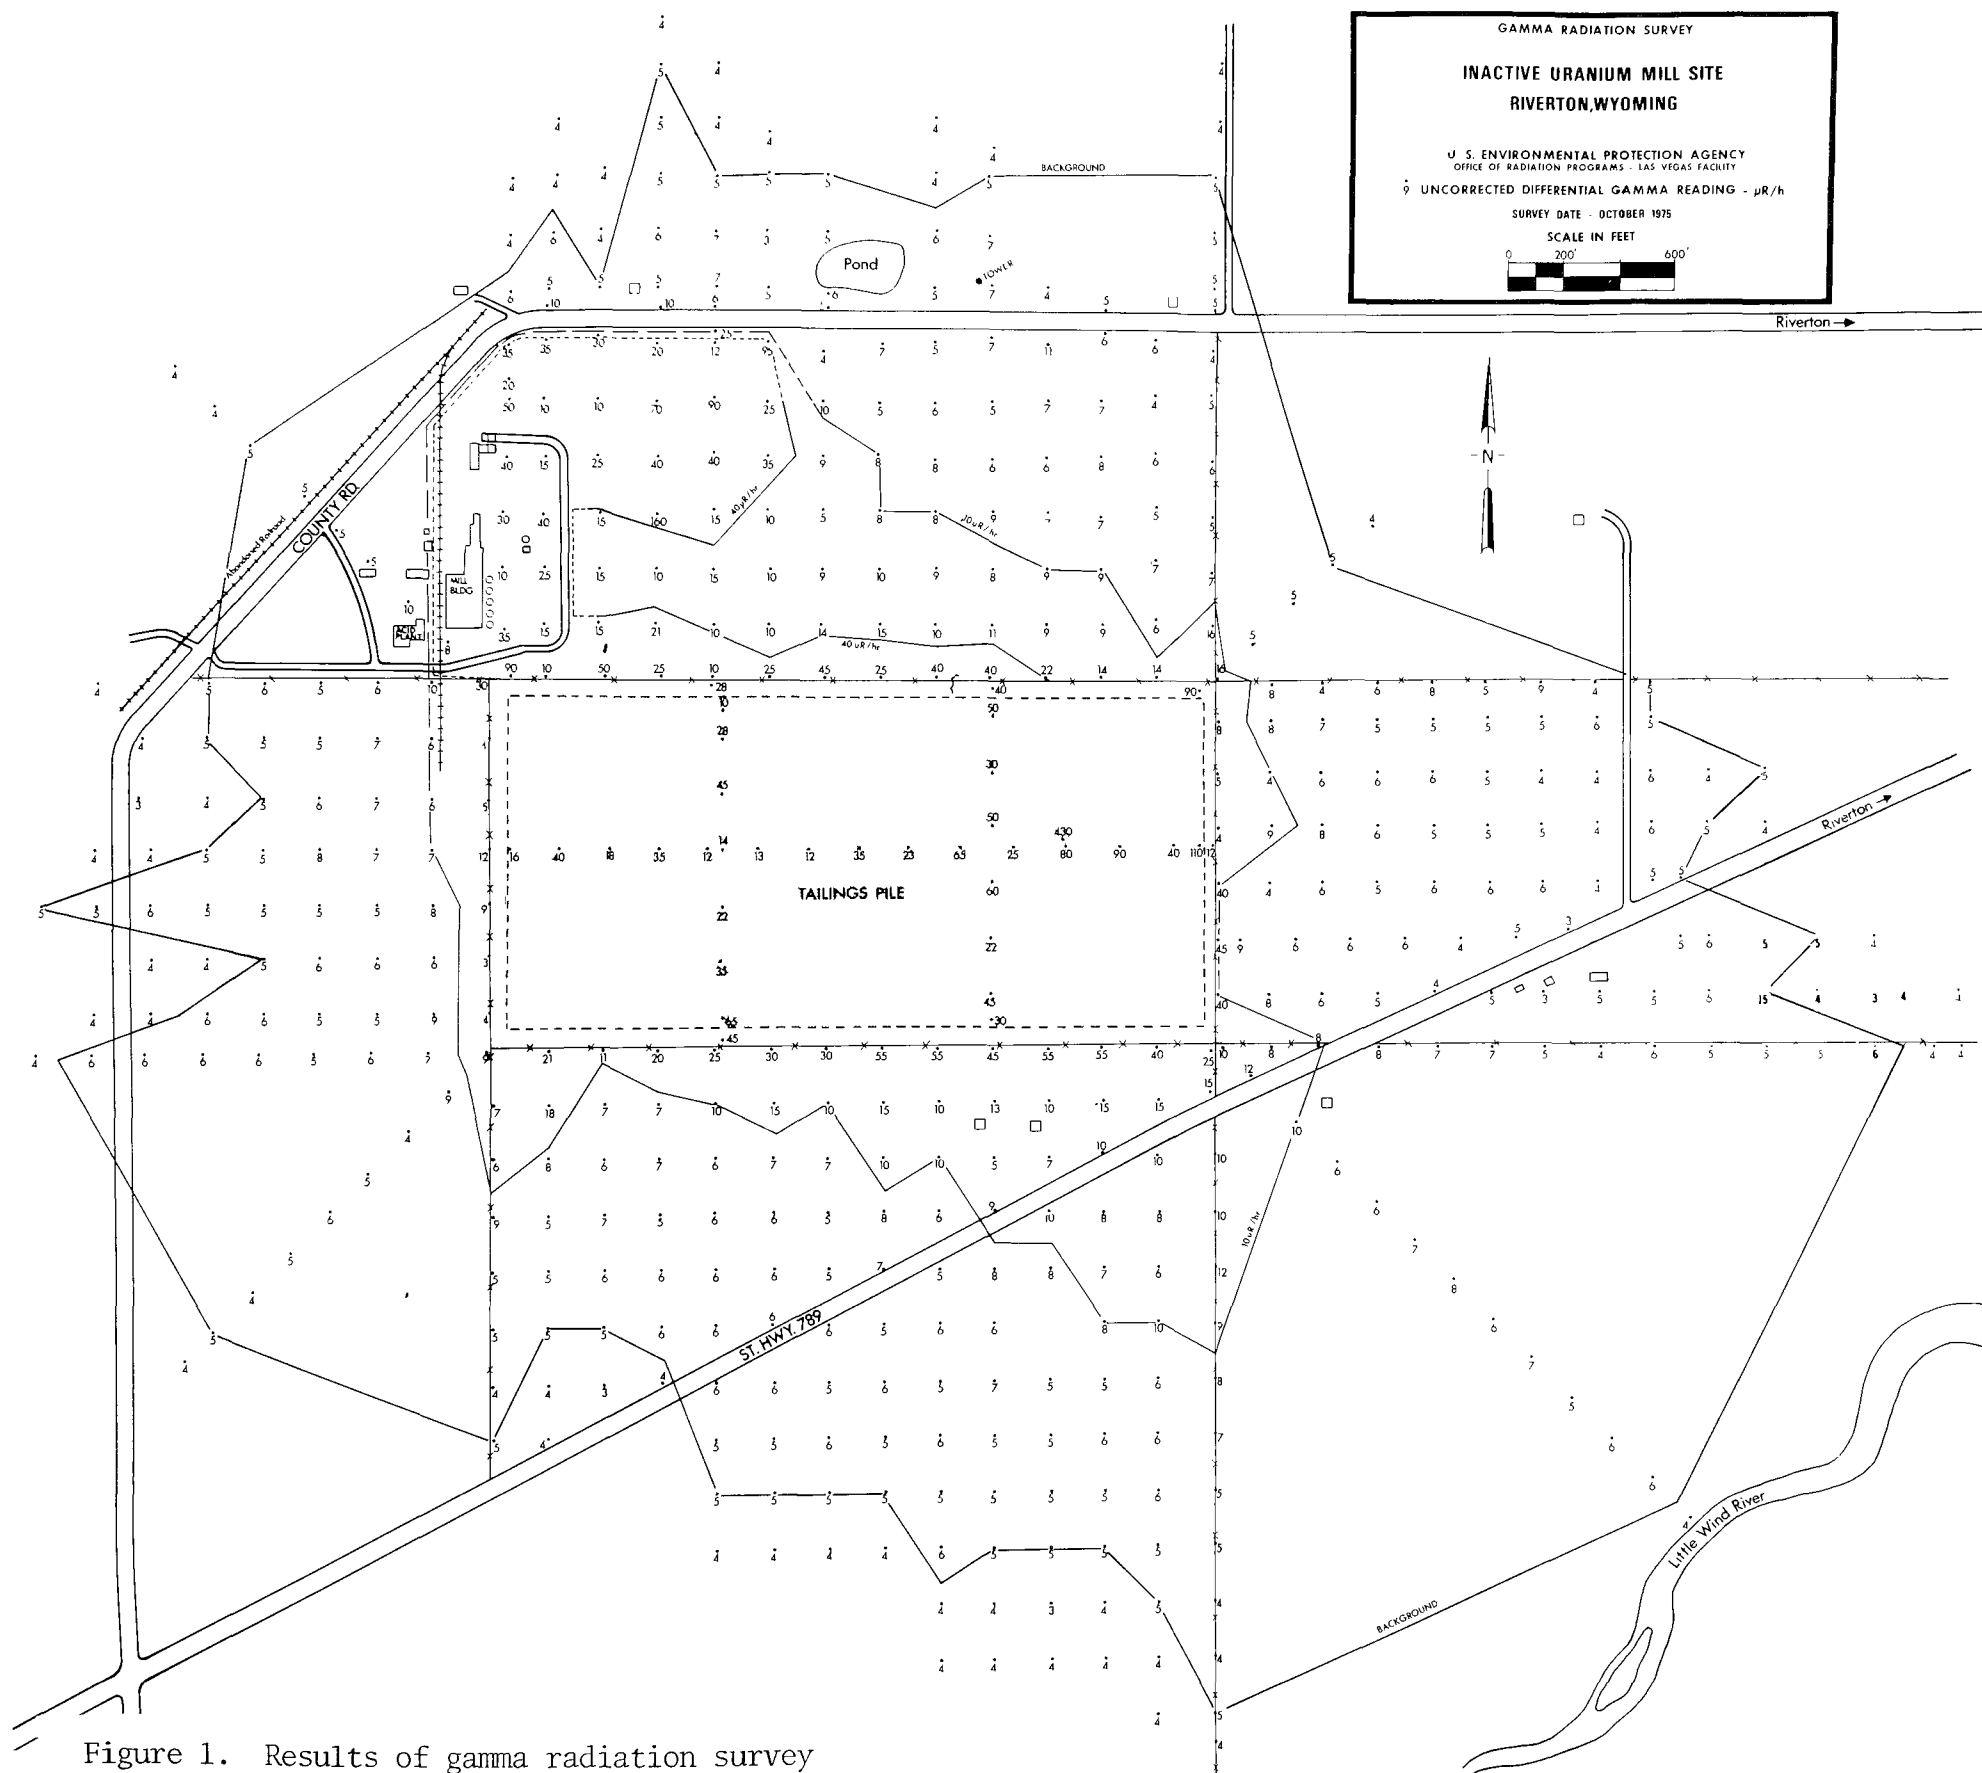
Figure 1. Results of gamma radiation survey

The results of the gamma survey are shown in Figure 1. The delta value is shown at each measurement point. Iso-exposure rate lines were constructed on the basis of these delta values by the method of Douglas and Hans (1975). In keeping with current Environmental Protection Agency guidance (EPA, 1974) iso-lines corresponding to residual gamma exposure rates of 40 μ R/hr, 10 μ R/hr, and background were located. The significance of these lines is as follows (Douglas and Hans, 1975):

As can be seen in Figure 1, the most extensive area of contamination lies in a sector southeast of the pile. The maximum distance from the pile fence to the background line was about 2500 feet east of the southeast corner of the pile. The land in this sector is mostly undisturbed range land. The land immediately east and northeast of the pile is cultivated. This cultivation quite likely has reduced the level of surface contamination (as measured by the delta method) by mixing windblown tailings material into the soil. Therefore, more tailings have probably been deposited on the east and northeast sectors than the results of this survey indicate.

In view of these results, the location of the 10 μ R/hr line in the field east of the pile, and of both the 10 μ R/hr and background lines in the field northeast of pile, should be considered only approximate, since they only represent current levels of surface contamination.

The 40 $\mu\text{R/hr}$ line encompasses an area of about 30 acres, exclusive of the tailings pile. This includes a strip averaging about 200 feet in width along most of the north side of the pile, and former ore storage area northeast of the mill yard. The mill yard itself was arbitrarily included within the 40 $\mu\text{R/hr}$ line, as indicated by the dashed line. The delta readings in the mill yard were too erratic to allow construction of the 40 $\mu\text{R/hr}$ line, due to the spotty nature of contamination in the yard. However, it is apparent that the entire mill yard is sufficiently contaminated to warrant decontamination.

The 10 $\mu\text{R/hr}$ line encompasses about 99 acres, exclusive of the tailings pile. As discussed above, the mill yard was included within this line. The dashed portion of this line along the west side of the mill yard and along the county road north of the mill indicate that the delta readings were not sufficiently uniform in these areas to allow the theoretical construction of the line. Therefore, the location of this portion of the line is somewhat subjective, and is based on adjacent readings and practical considerations for decontamination. Two houses south of the pile are within the 10 $\mu\text{R/hr}$ line.

The background line encompasses about 460 acres, exclusive of the tailings pile. Except for the two cultivated fields discussed above, this is largely range or pasture land. About six houses are within the background line.

The contaminated areas were delineated by making a series of differential gamma exposure rate measurements at the ground surface. A total of about 460 acres, exclusive of the tailings pile, was found to be contaminated above background levels. An area of 30 acres would have to be decontaminated to reduce the maximum residual exposure rate to 40 $\mu\text{R/hr}$, and 99 acres would have to be decontaminated to reduce the maximum residual exposure rate to 10 $\mu\text{R/hr}$.

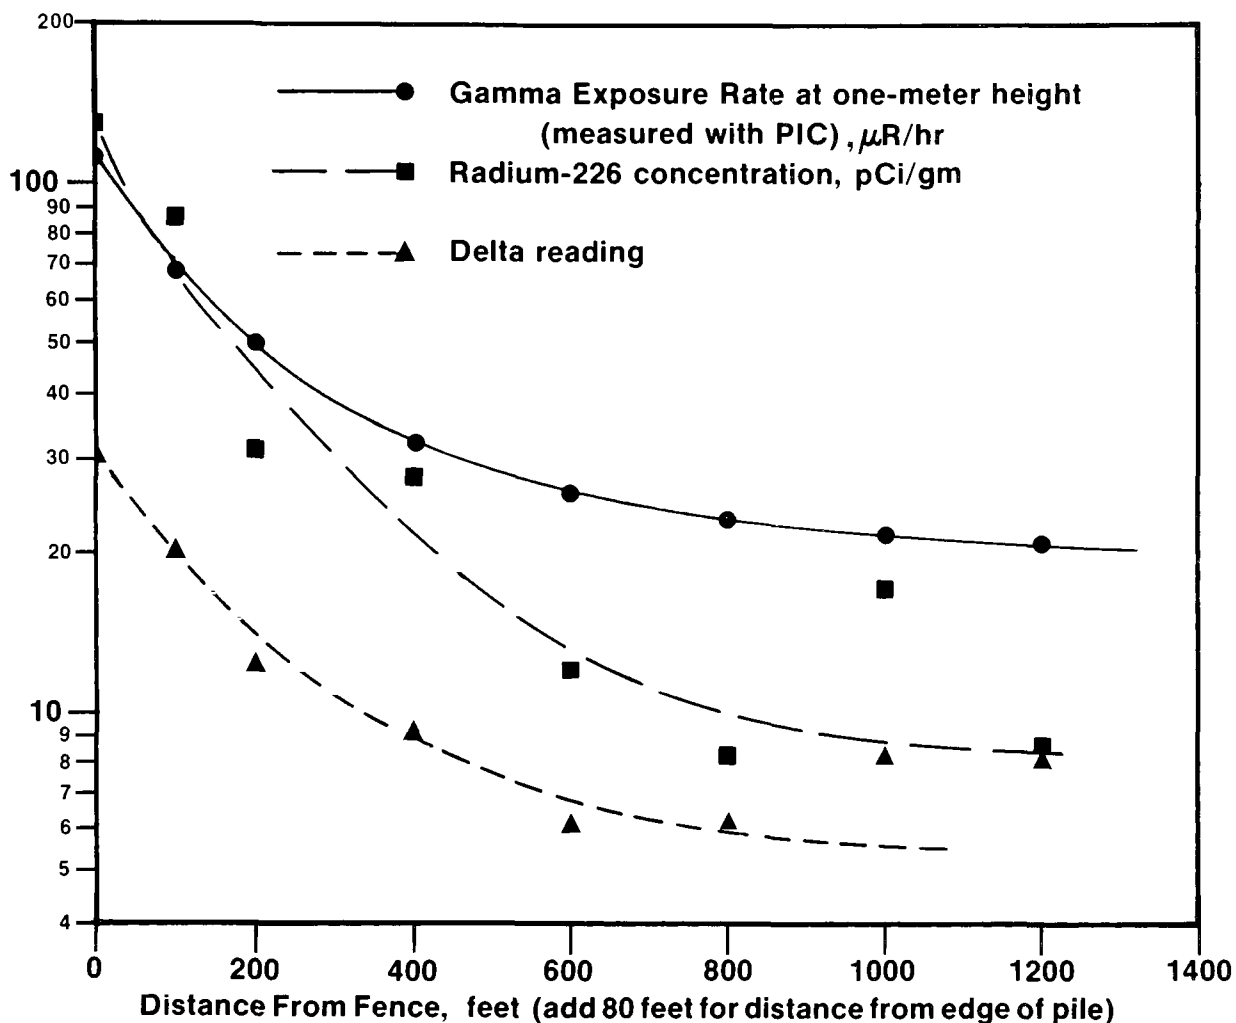
Figure 2. Radiological parameters as a function of distance from the tailings pile

The results of the special measurements to correlate gamma exposure rate, delta readings, and radium-226 concentration in the soil are shown in Table 2. Figure 2 shows the one-meter gamma exposure rate (PIC), delta readings, and radium-226 concentrations as a function of distance from the pile. In a relatively undisturbed area, such as the one chosen for this test, these parameters are shown to correlate very well. An unexplained source of activity (probably ore spillage) was

detected by both the delta and the radium-in-soil measurements about 1000 feet from the pile. This contaminated area was not reflected, however, by the gamma exposure rate measurements. This may be because the small increase was less than the sensitivity of the PIC, or because the one-meter gamma measurements "average" over a larger area than do the surface measurements. Whatever the reason, the delta method is shown to be a sensitive indicator of soil contamination.

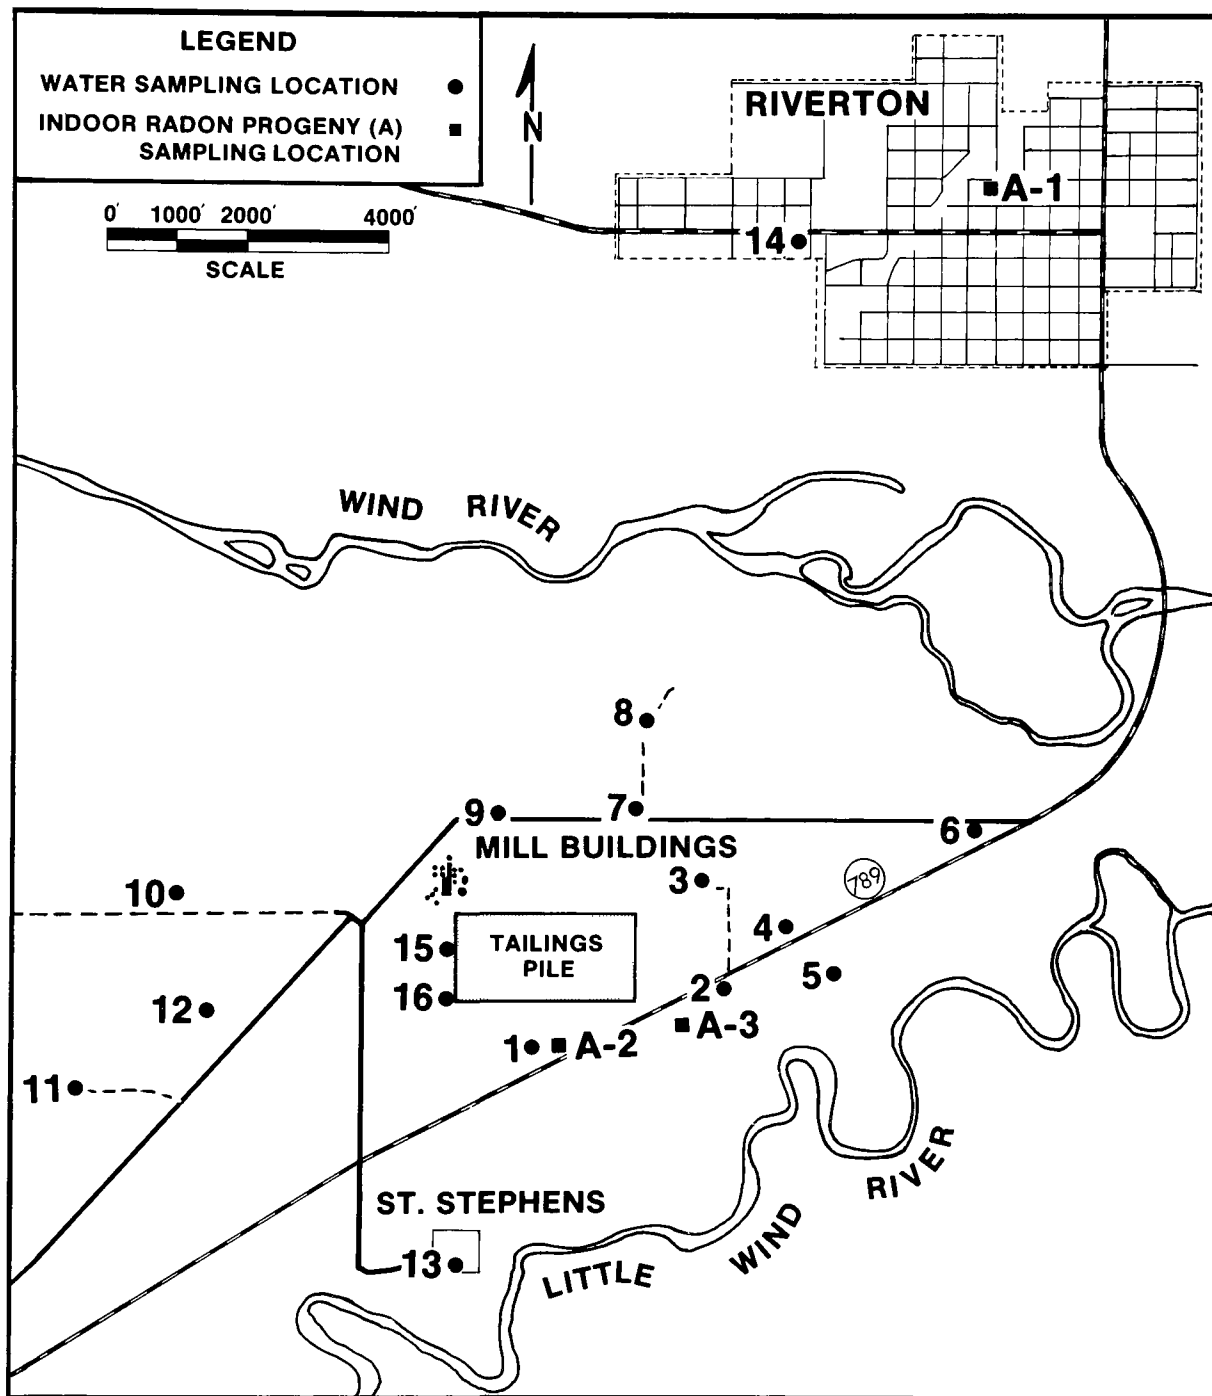
Figure 3. Location of water and radon progeny (working level) samples

The water sampling locations and the dissolved radium-226 concentrations are shown in Figure 3 and Table 3, respectively. Sampling locations #1 through #13 were residential wells in the vicinity of the pile, while #14 was in Riverton and is presumed to be a background sample free of any possible influence from the mill site. The samples were collected primarily to determine any potential radiation exposure to people drinking water from these wells. Consequently, no specific hydrologic information regarding the site was obtained. However, some inferences may be drawn regarding the pile as a possible source of ground-water contamination.

Another basis for evaluating the water sample results is by comparing them to current standards. The Environmental Protection Agency Drinking Water Standards (EPA, 1976) allow a maximum combined level of radium-226 and radium-228 of 5 pCi/l. Although radium-228 was not measured in these samples, it has been reported (EPA, 1976) that it is almost always lower than the radium-226 concentration in the same water sample. Since the maximum radium-226 concentration in these samples is less than 20 percent of the 5 pCi/l standard, it is unlikely that total radium concentrations in water approaching the EPA standard are present in the vicinity of the mill site.

Indoor working level (WL) sampling locations and results are shown in Figure 3 and Table 4, respectively.

With these qualifications in mind, it does not appear that significantly elevated indoor working levels exist in the vicinity of the mill site.
