EPA 330/9-74-003

*Engineering Evaluation
of the
Main Water Quality Control Plant
Stockton, California*

NATIONAL FIELD INVESTIGATIONS CENTERS
DENVER, COLORADO AND CINCINNATI, OHIO

DECEMBER 1974

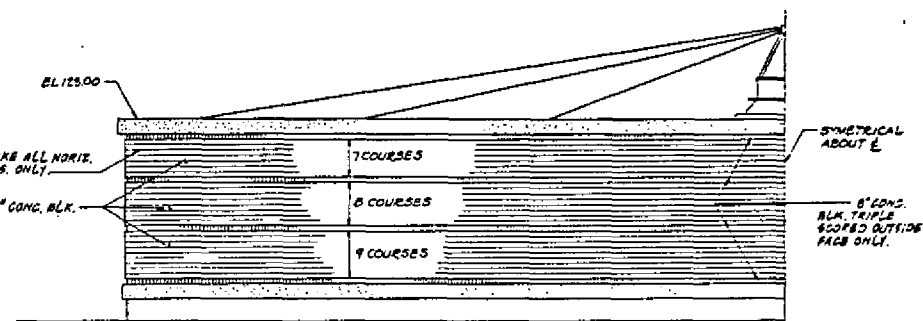
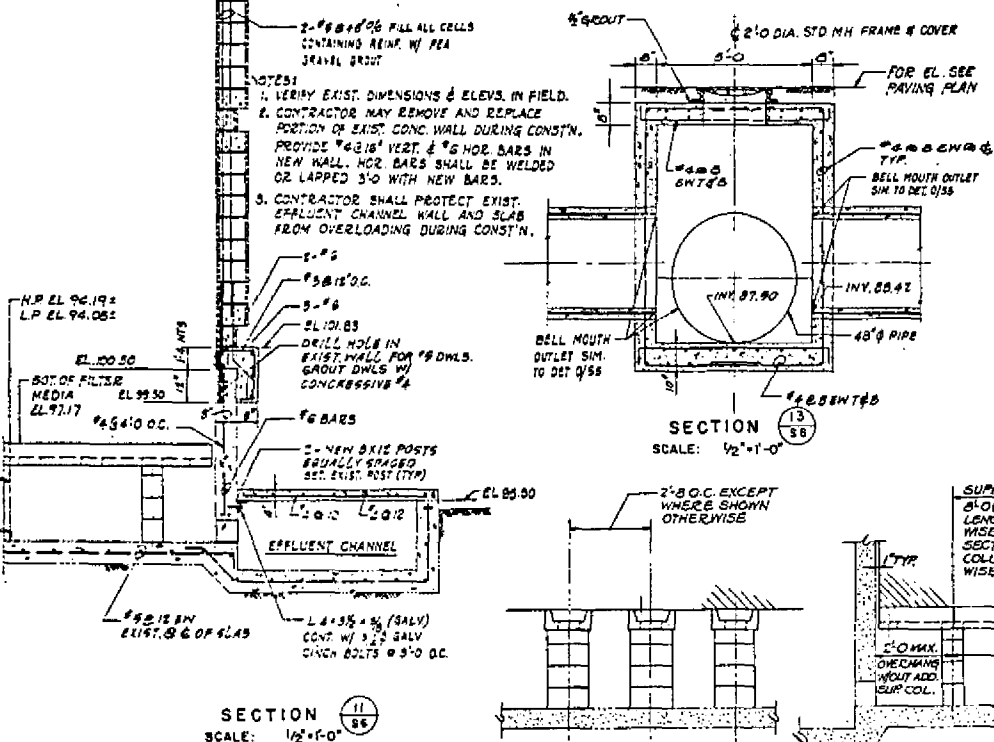
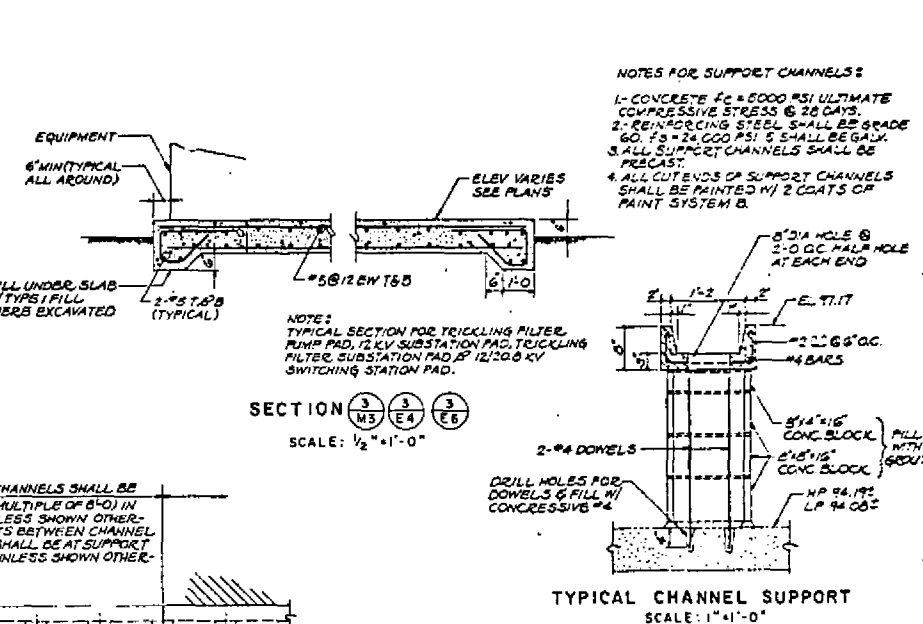
MAIN WATER QUALITY CONTROL PLANT
MODIFICATIONS TO SECONDARY TREATMENT FACILITIES
TRICKLING FILTERS NO.4, NO.5 & NO.6
SECTIONS

The leakage experienced in the walls of trickling filter No. 4 was the result of basic design error complicated by "hurry up" construction techniques to make the filter operational for the 1973 canning season.

A review of the construction details shows vertical rebars every 4 ft. around the perimeter of the filter and the holes in the block filled with concrete grout. This in effect constitutes a reinforced concrete pillar running the height of the wall every 4 ft. This pillar is tied into the existing foundation wall by drilling and grouting at the bottom and given support at the top by a reinforced concrete cap beam that runs around the entire filter, tying it together at the top.
