On Board Corrosion Analysis of a Recovered Nuclear Waste Container

ON BOARD CORROSION ANALYSIS OF A RECOVERED
NUCLEAR WASTE CONTAINER

Stephen C. Dexter
Assistant Professor
of Ocean Engineering
and Materials Science
College of Marine Studies
University of Delaware

August 1979

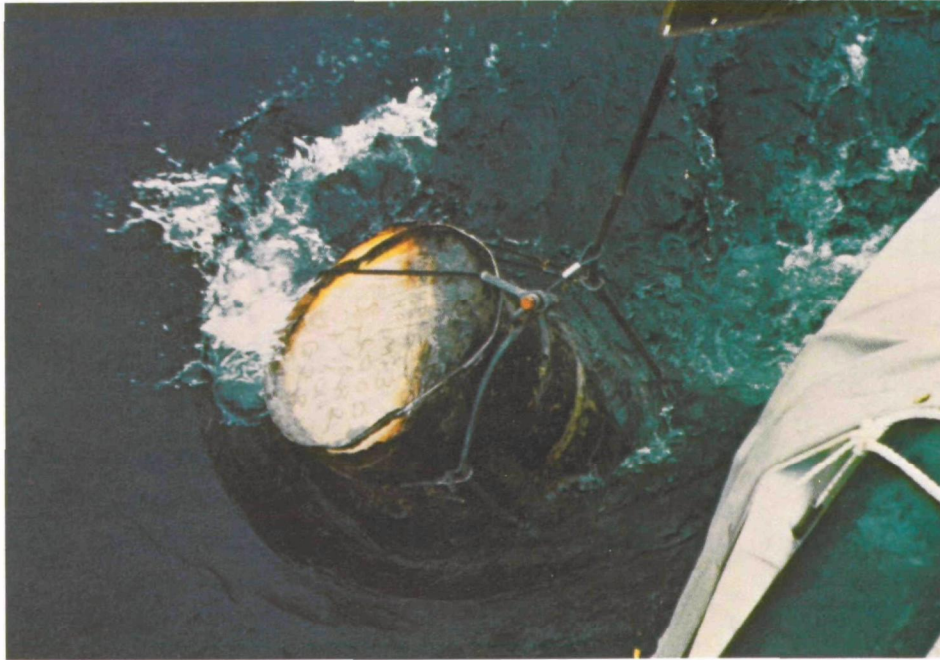
(a)

Figure 2a shows the concrete end of the drum seconds after it first broke the surface of the water. The identifying markings on the concrete end are legible in Figure 2b and include such information as the package number (28), the volume of the waste-matrix mixture (9.0 cubic feet), the weight of the package (1682 pounds), the most hazardous isotope present in the package (cobalt-60) and the dose rate at the surface of the drum at the time of packaging (3 millirads/hour). Information not clearly visible in Figure 2(b) indicated that the radioactive waste package was prepared in 1961. Prior to the start of recovery operations the drum sat partially embedded in the bottom sediments. The sediment line is clearly visible in Figure 2, the black portion of the concrete end having been in the mud.

Figure 2. Nuclear waste container. a) a few seconds after breaking surface of water, b) identification marks on concrete end.

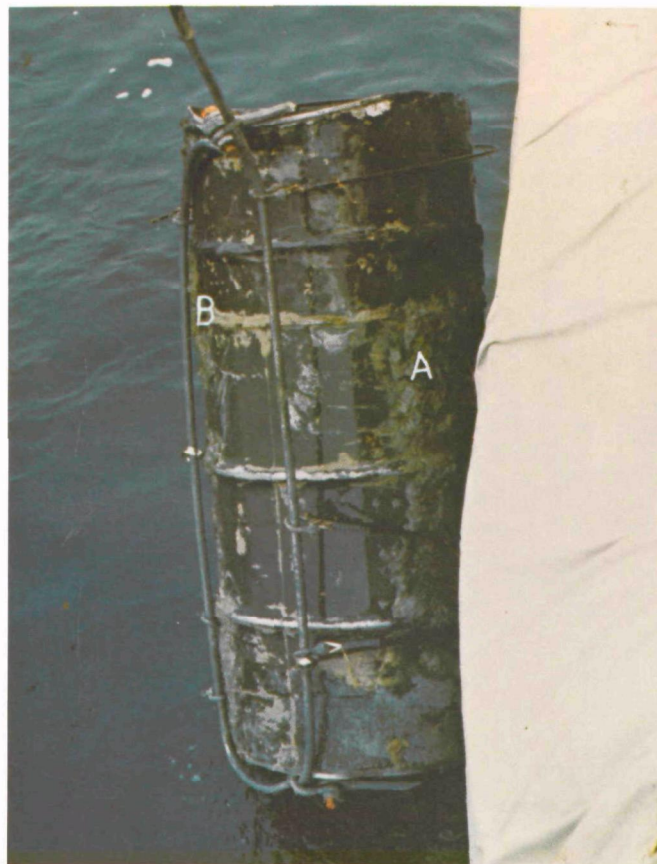
(a)

Figures 3a and 3b show the surface condition of the container after hoisting out of the water but before securing on deck. There was a 10 to 15 minute interlude here while the radioactivity level of the drum was being measured. As seen in the photographs, the container is in remarkably good condition after 14-15 years of immersion. The mud line can again be seen in Figure 3b between the two arrows. Note that the upper half of the drum, which was below the mud line, is less corroded than the lower half which was exposed to the water column. The view in Figure 3a, for instance, shows most of the area that was in the mud, and there is very little corrosion visible. Identical areas on the drum surface are labeled "A" and "B" on Figures 3a and 3b. On seventy-five percent of the metallic surface area of the drum (and on considerably more of the area below the mud line) the original black enamel finish was still intact.

Figure 3. Nuclear waste container showing: a) portion of surface that had been buried in the sediments, and b) the mud line between arrows.

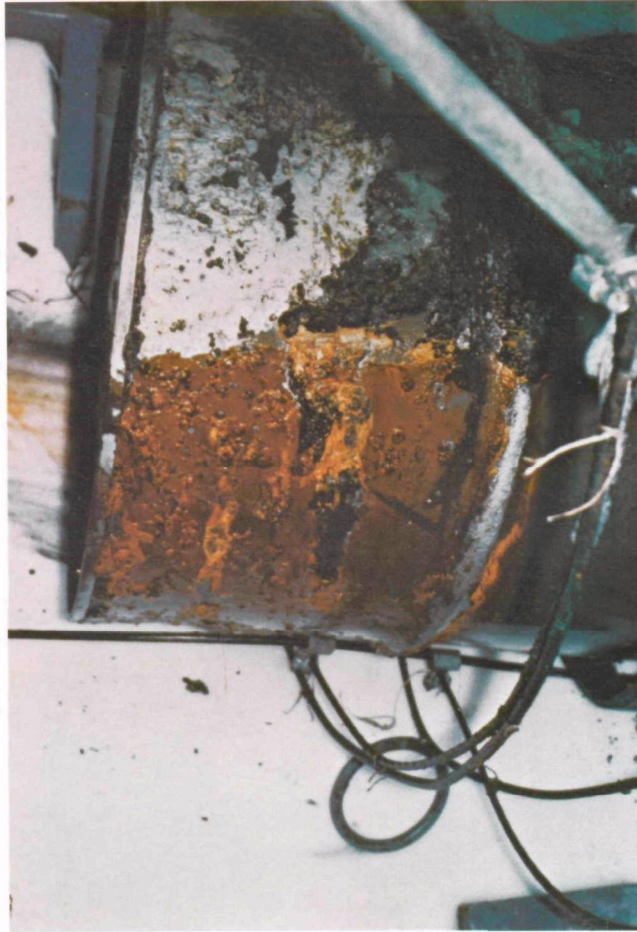
Several of the more interesting areas of the container surface were photographed in detail after the container was secured on deck. These are shown in Figures 4 through 9. Figure 4 shows the surface above and below the mud line on the left portion of the cylindrical surface of the drum as seen in Figure 3b. The large area of bare metal surface showing there as well as the bare metal showing on the raised ribs of the drum in Figures 3a and 3b were probably scraped clean as the drum was dragged along the bottom during the initial part of the hoist procedure. There is little doubt that this happened, as the track of the drum where it was dragged along was clearly visible from the deep submersible, Alvin, upon subsequent inspection of the site.

Figure 4. Left end of cylindrical surface of nuclear waste container as seen in Figure 3(b) after securing on deck.

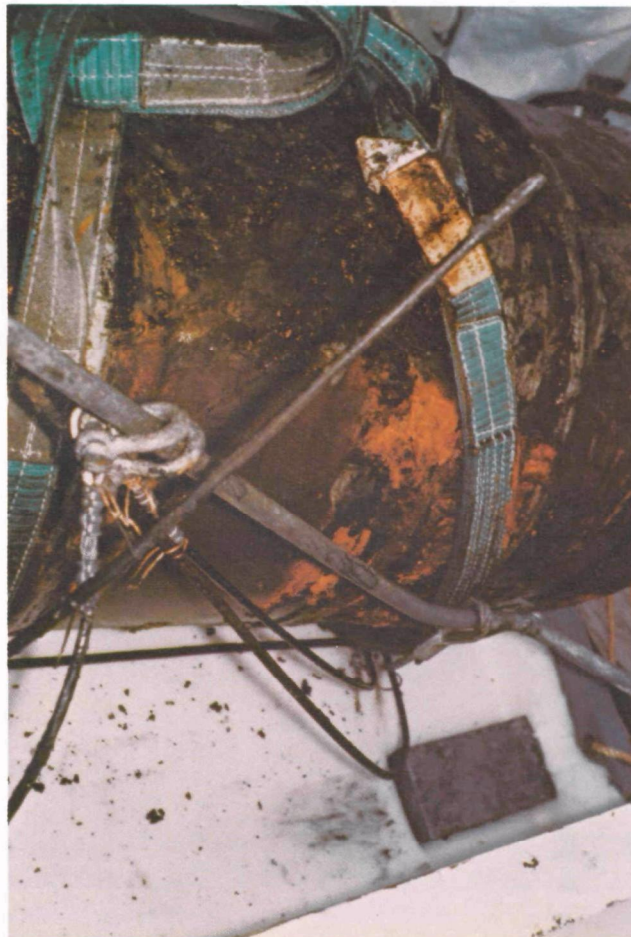
Figure 5 shows the heavy concentration of corrosion products just to the lower right of the letter "A" in Figure 3b. By the time this picture was taken, some of the corrosion product had been scraped off into sample bottles. Other portions of it had rubbed off against the nylon webbing, visible in Figure 5, which had been installed as an additional aid to handling shortly after the picture in Figure 3b was taken. There was no attempt made at this time to scrape all the way through the corrosion product layer to determine the condition of the underlying metal as this was planned for subsequent laboratory operations.

Figure 5. Heavily corroded portion of cylindrical surface of container just to the lower right of letter "A" in Figure 3(b).

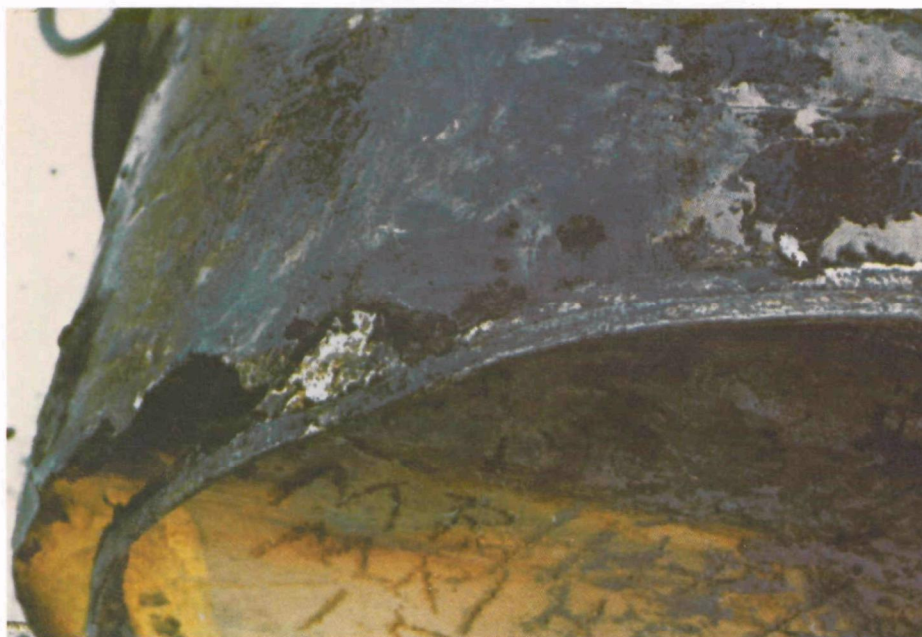
The outer steel container was in the worst condition around the rim at the concrete end as shown in Figure 6. There was no marked difference in the condition of the rim above as opposed to below the mud line. A sample of the corroded edge of the metal was clipped off with metal shears for later examination at the Brookhaven National Laboratory.

seawater, and its pH was reported in the results section to be between 13 and 13.5. This is consistent with other measurements reported for the pH of seawater in concrete⁵. The corrosion rate of the steel on the inner surface of the container should, therefore, have been negligible and corrosion should have proceeded from the outside only. The difference that this can make is illustrated by the fact that the steel container was in the worst condition around the rim at the concrete end where the steel extending beyond the concrete by about two centimeters was exposed to ambient pH seawater on both sides. The perforated condition of the steel in that area was shown in Figure 6.

Figure 6. Corrosion around the rim of the concrete end of the container.

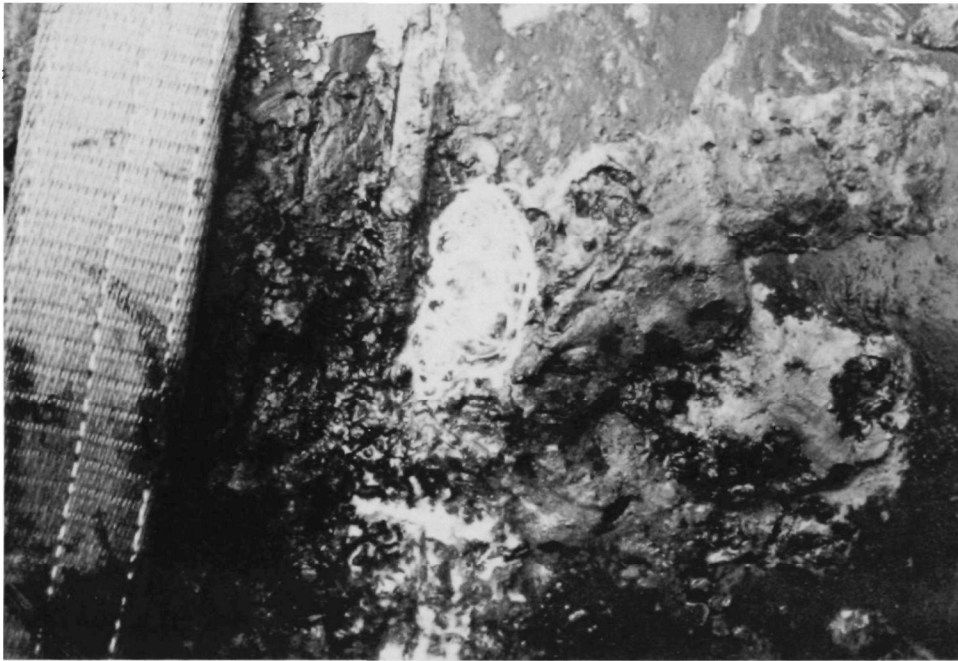
When the container first arrived at the surface, it was apparent that there was a perforation in the metal drum as a stream of seawater was observed coming out as if under pressure. The stream can be seen just below the letter "B" in both Figures 3a and 3b. The area from which the stream came was below the mud line and is shown close up in Figure 7. By the time this photograph was taken, the pressure had nearly equalized and the remaining liquid was seeping out as shown. Some of this liquid was collected by the EPA Project Officer for subsequent laboratory analysis. Upon further examination with a probe, it became apparent that the perforation was not due to corrosion but was a recent puncture. It is suspected that this occurred as the drum was being dragged along the bottom as related above.

found to be between 6 and 8. There was one notable exception. The pH of the water bubbling from the puncture described in connection with Figures 3 and 7 was between 13.0 and 13.5.

Figure 7. Water oozing out of perforation on cylindrical surface of container. Location of the perforation is just below the letter "B" in Figure 3(a) and (b).

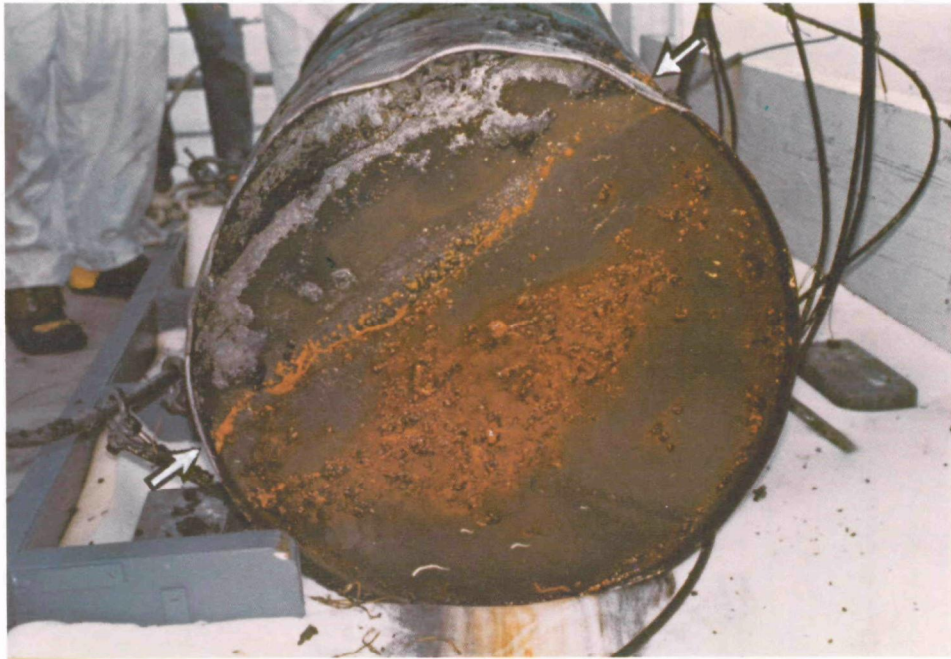
(a)

Figures 8a and 8b show the condition of the metallic end of the drum. The mud line runs between the two arrows from upper right to lower left of Figure 8a, the portion to the upper left having been buried in the bottom sediments. The corroded area in the center of the metallic end is shown in Figure 8b. This appearance is typical of a painted steel surface in the early stages of seawater corrosion. The small white streaks near the lower rim of the metallic end as seen in Figure 8a were the only macroscopic biological growths that were found attached to the drum. They were sampled and identified as polychaete tubes under separate contract by Dr. Donald Reish of California State University.

Figure 8. Metallic end of nuclear waste container: a) mud line is shown between arrows, b) close up of corroded portion.

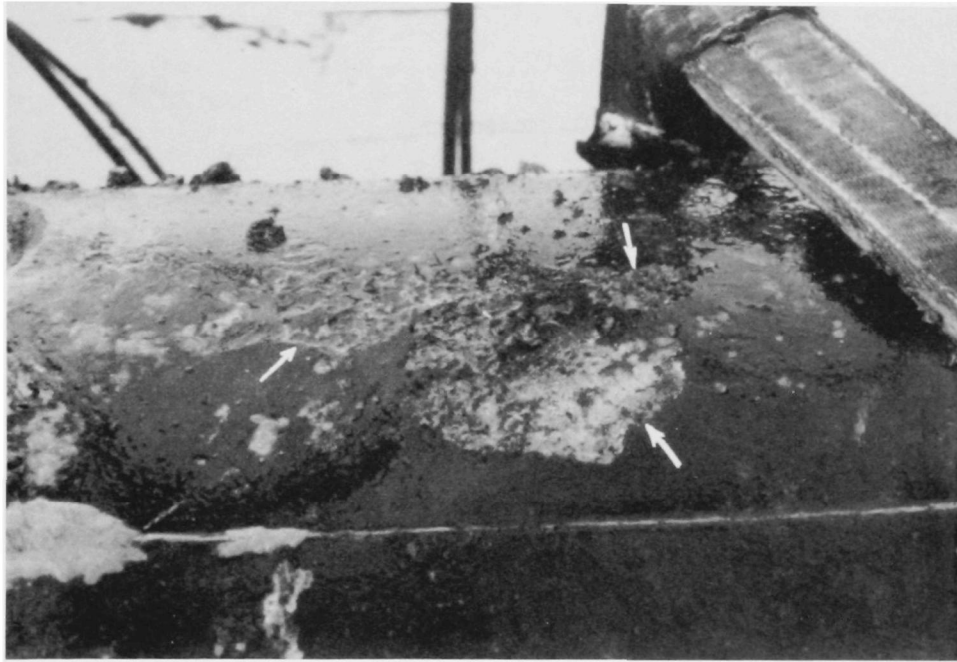
There was very little corrosion below the mud line. Where corrosion did take place, it appeared to be highly localized as in Figure 9. Instead of being spread uniformly over the surface, the corrosion took place in the form of broad shallow pitting (see arrows). It is estimated that the depth of attack was 0.2 to 0.5 mm. As there were no corrosion products associated with these pits upon recovery of the drum, one can only assume that the products were scraped off as the drum dragged along the bottom. This is a reasonable assumption as this portion of the drum was below the mud line prior to recovery.

Figure 9. Localized corrosive attack (see arrows) on cylindrical surface below the sediment line.
