Demonstration of Remedial Techniques Against Radon in Houses on Florida Phosphate Lands

**Final Report
EPA Contract 68-02-3559**

Report No. 1168/1199

A.G. Scott and W.O. Findlay

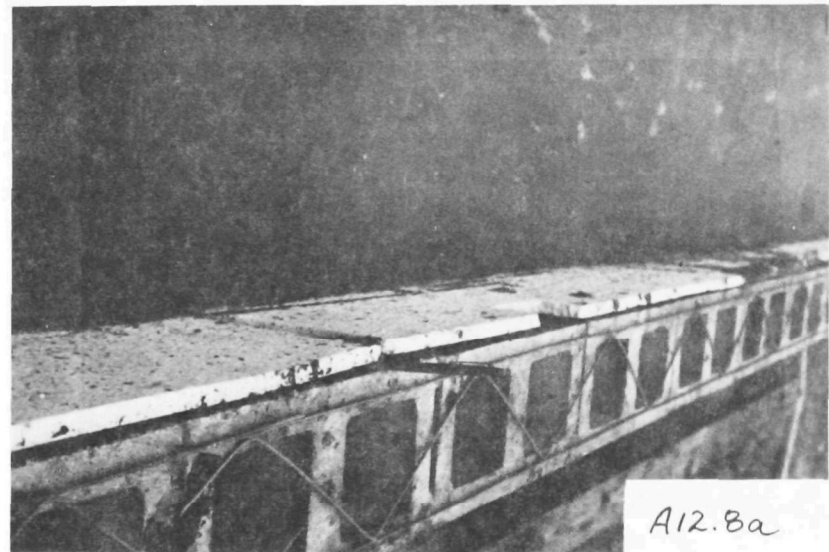
A12.8a

- A-12.8a Styrofoam "expansion joint" placed between the foundation wall and floor slab.
- A-12.17a Pen inserted into gap between the "expansion joint" (styrofoam still in place) and the foundation wall.

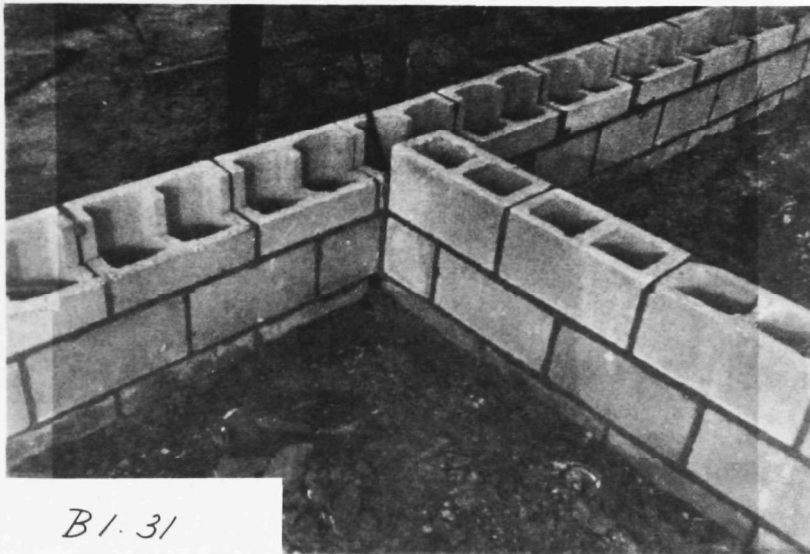
B1.31

- B-4.1a Foundation wall under construction on footing.
- B-1.31 Constructed foundation wall showing special notched block. Note interior block wall (unusual).

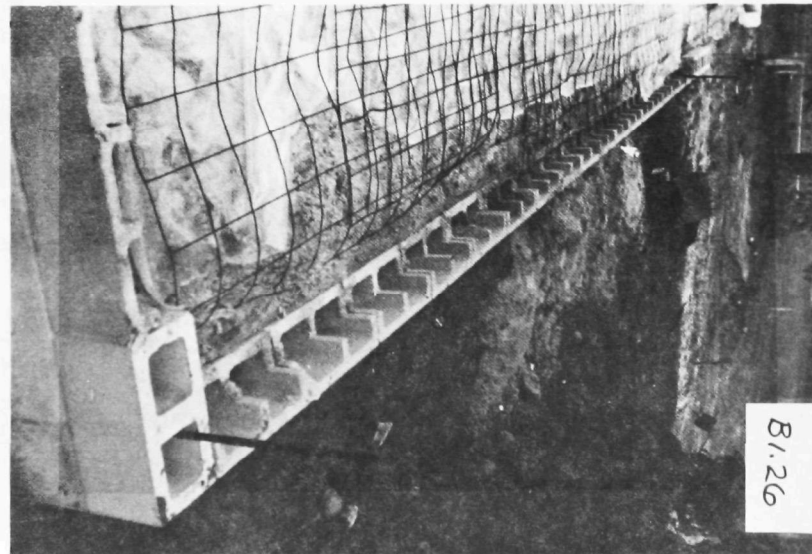
B1.26

- B-1.26 Foundation wall with floor support sand in place. Note (a) that the block cavities are open, and (b) the plastic does not reach the wall (unusual).

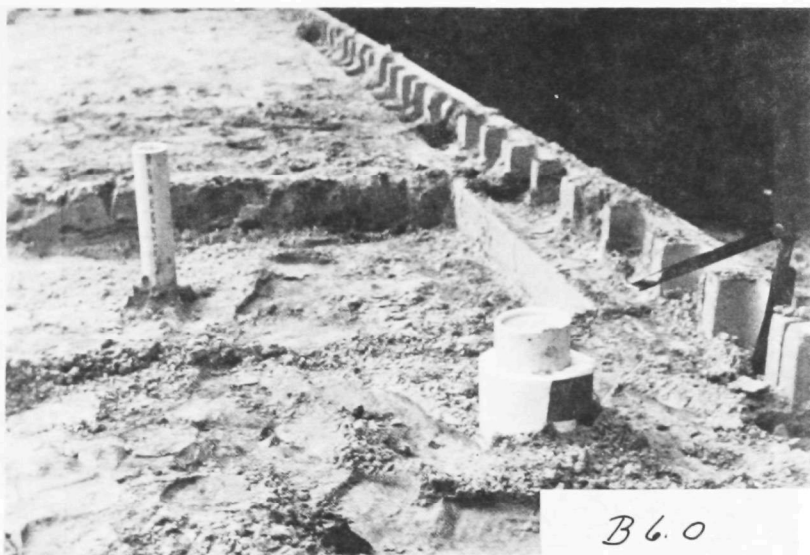
B6.0

- B-6.00 Foundation wall with floor support sand in place. Note that (a) sand fills the block cavities, (b) the styrofoam collar around a toilet connection, and (c) the excavated area for a sunken shower.

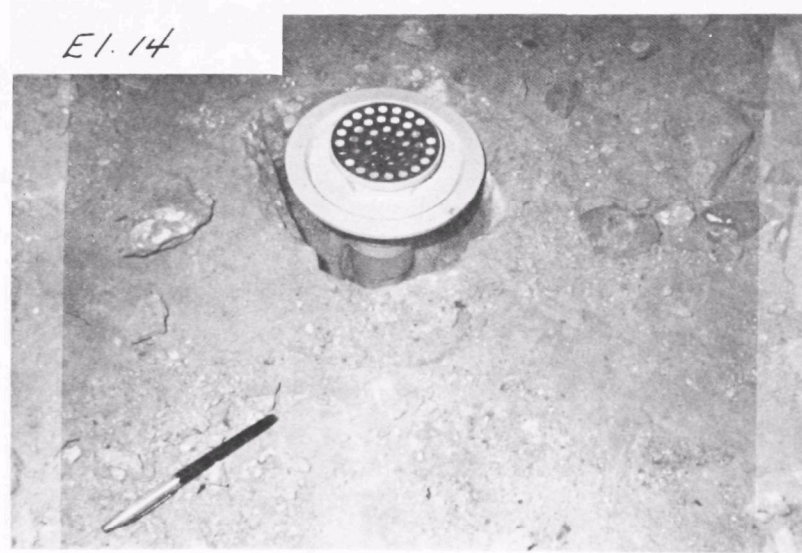
E1.14

<u>Photo #</u>	<u>Description</u>
E-1.14	Shower drain fixture showing opening through slab.
E-8.24	Toilet flange - pencil in opening through slab.
E-7.10	Cardboard collar on shower drain pipe. Note opening in plastic at base of collar.
E-9.0a	Concrete block used as form for shower drain opening.
E-4.34a	Concrete block used as form for bath drain opening. Note opening in plastic.
E-7.4	Wooden form for bath drain opening. Note toilet pipe in background wrapped with styrofoam, and reinforcing bar supported on bricks.
E-1.1	Bath drain opening after concrete block broken out. Bath, at left hand edge of picture, to be moved into position.
E-1.13	Bath with drain connected.
E-9.2a	Asphalt poured into drain opening. Note asphalt does not reach corner at rear left (shown by pen) as sand filling slightly higher there.
E-4.9a	Asphalt poured on top of sand in drain opening. Note larger amounts of sand split around opening, preventing the asphalt from adhering. Asphalt about 1/8 inch thick, and peeled back at left front, shown by pen into sand.

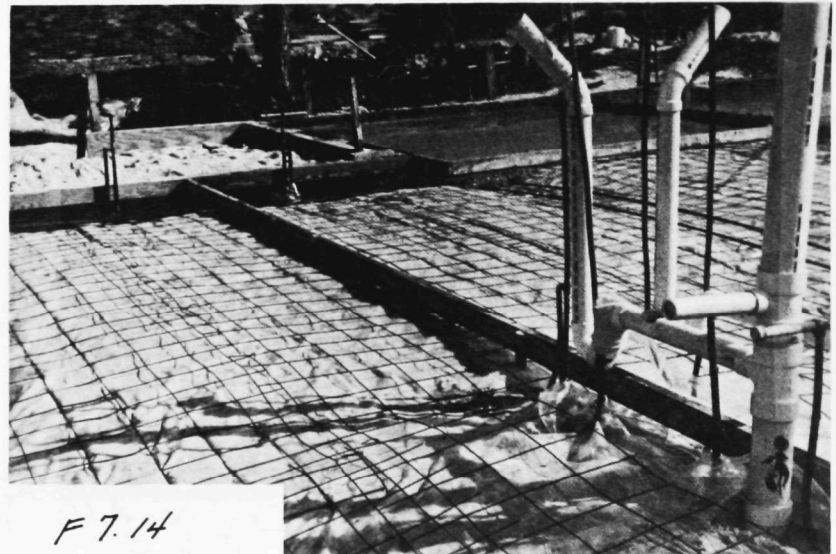
F7.14

F-7.14	"Monolithic" slab during pouring. Note screeding bar and stakes in foreground, and hold back forms for change in floor level in background.
F-4.23a	Opening left in floor to produce a sunken floor section in a second pour. Note the narrow section in the slab (left rear). Tension cracking is likely in this area.
F-1.25	Temporary support for horizontal plumbing run made from a section of pipe.
F-15.5	Temporary support made permanent by concrete. Note the plastic sleeves on the water pipes.
F-1.17	Vent/drain pipe passing through floor at angle, and extending into room. An evident mistake. It appears that the concrete was kept away from the pipe to allow the plumber to make the angle connection after the slab was poured.
F-8.1	Sunken bath. The forms will be removed and the bath placed in the opening.
F-1.7	Sunken shower outside the foundation wall. Note the concrete slab is kept from filling the blocks by the plastic, leaving direct connections to the soil.

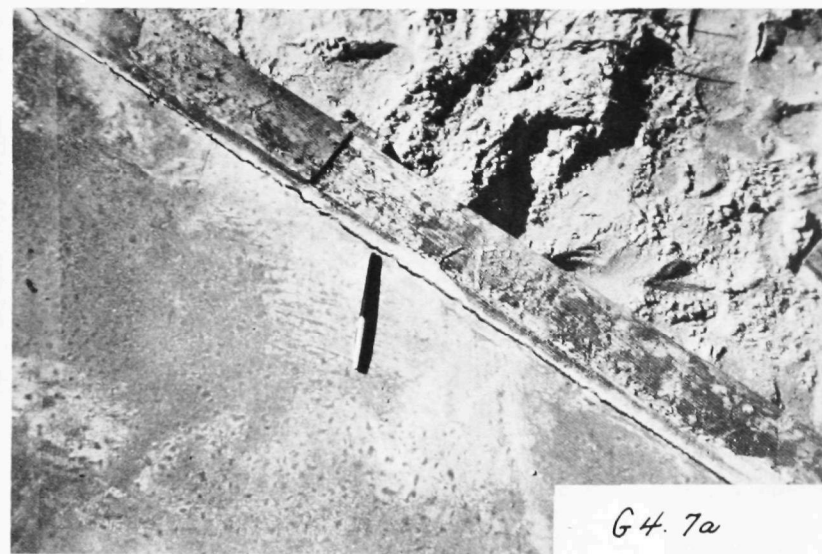
G4.7a

<u>Photo #</u>	<u>Description</u>
G-4.7a	Monolithic slab has shrunk about 3 mm in from the wood forms, but there was no cracking in the rectangular slab.
G-4.36a	Tension crack in corner of large L shaped floor slab on block foundation.
G-10.5	Tension crack at narrow part of L shaped slab passing through shower opening in that area.

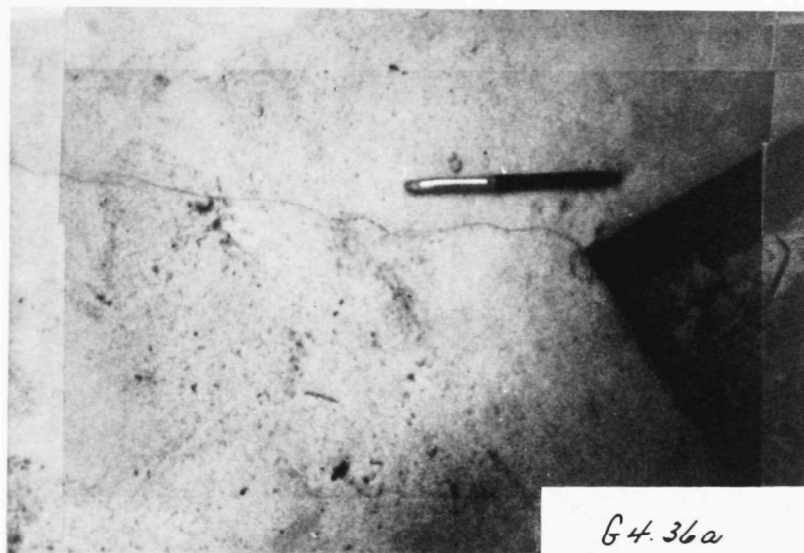
G4.36a

In simple houses with a basically rectangular slab with no changes of section, the slabs were found to be free of cracks. More elaborately designed houses with 'L' or 'U' shaped slabs were often found to have one crack across the narrowest part of the slab, usually starting at an inside corner which acted as a stress-raiser.

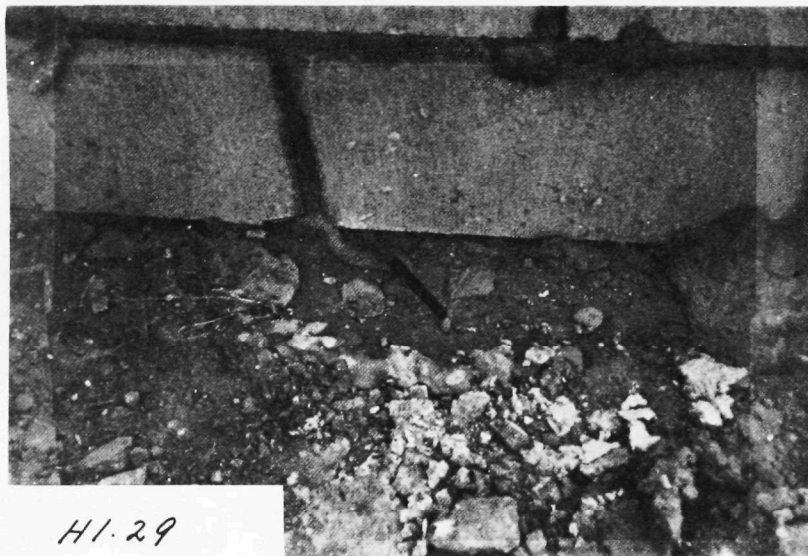
H1.29

H-1.29	Inside face of foundation wall. Note gaps in mortar at footing (shown by pen) and in vertical joint.
H-4.14a	Outside face of constructed foundation wall. Note gap in mortar (shown by pen), and hole made for water line which will be covered by soil after landscaping. Also note that though the concrete floor slab is run to the outer edge of the wall, the space between the blocks is still open.
H-1.34	Drain/vent pipe, and water pipes. Note broken blocks below slab level. Note also the piping laid in shallow excavation for piping, and cardboard collar round toilet connection.
H-5.19	In wall plumbing. Drain/vent pipe. Note the concrete floor slab has been kept away from pipe, providing an opening direct to the wall cavity.

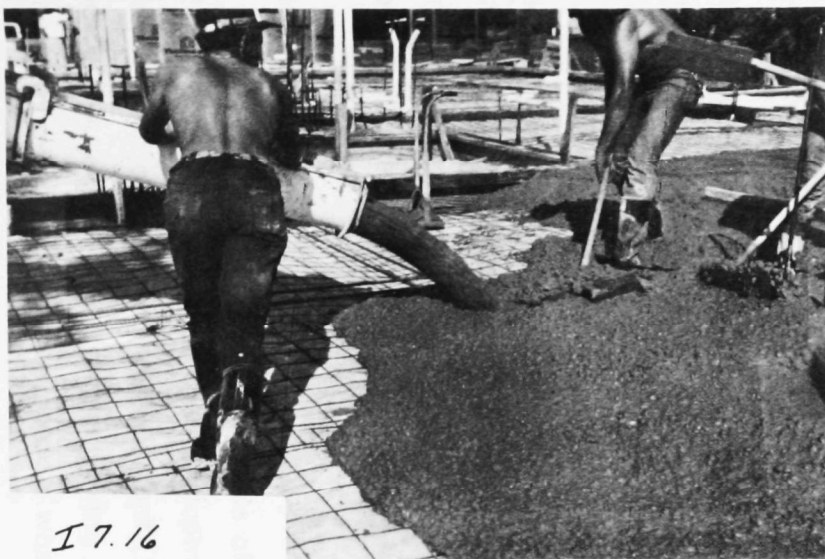
I 7.16

I-7.16	Placing concrete. Extra water was added to this mix to make it flow more readily. Note that there is no significant pile of concrete where the discharge strikes the ground.
I-5.8	Workmen levelling concrete. Note that they are standing in the concrete, on the mesh and plastic.
I-5.7	Reinforcing mesh trapped beneath concrete. Note the opening in the plastic around the water pipes.
