OBSERVATIONAL STUDY OF FINAL CLEANING  
AND AHERA CLEARANCE SAMPLING AT  
ASBESTOS-ABATEMENT SITES IN NEW JERSEY

John R. Kominsky  
Ronald W. Freyberg  
PEI Associates, Inc.  
Cincinnati, Ohio 45246

James A. Brownlee  
James H. Lucas, Jr.  
Donald R. Gerber  
Asbestos Control Service  
New Jersey Department of Health  
Trenton, New Jersey 08625

EPA Contract No. 68-03-4006

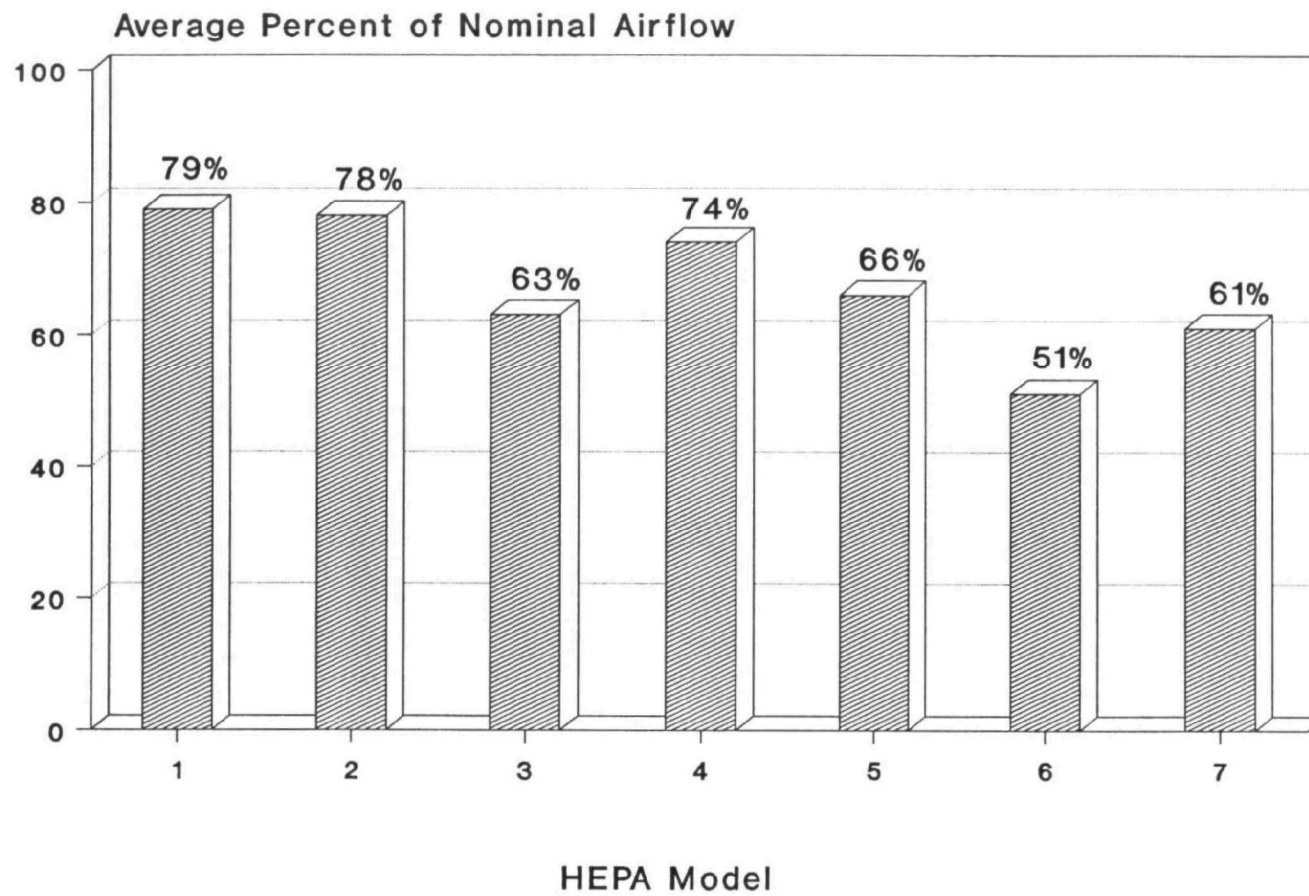
Figure 1. Airflow performance of HEPA filtration systems.

- 2) HEPA-filtration units used under normal operating conditions at asbestos abatement sites tend to perform below the manufacturer's nominal airflow. The average operating airflow ranged from 50 to 80 percent of the rated nominal airflow for 93 units representing seven model types.

Air-intake volumes for each HEPA-filtration unit in operation during final cleaning and AHERA clearance sampling were measured at each of the 20 sites in this study. Seven different models were observed and evaluated. The average operating airflow for each model was compared with the manufacturer's nominal airflow, i.e., the manufacturer's advertised rated peak capacity. Actual average operating airflow ranged from 50 to 80 percent of the nominal airflow for these models. This reduction in airflow performance is comparable to another study which showed a 50 to 60 percent reduction in airflow capacity.<sup>4</sup> Figure 1 illustrates the actual average operating airflow as a percentage of nominal airflow for the seven observed models. The reduced airflow performance of the filtration units is probably due to the increased static pressure associated with extended and obstructed exhaust duct conditions and to increased particulate loadings on the filters. The significance of this reduced operating flow rate is in the procedure used to determine the number of air-filtration units necessary to achieve the desired minimum ventilation rate (i.e., four air changes per hour). Assuming the air-filtration units are operating at the manufacturer's specified nominal airflow rate could result in actual ventilation rates significantly below project design specifications.

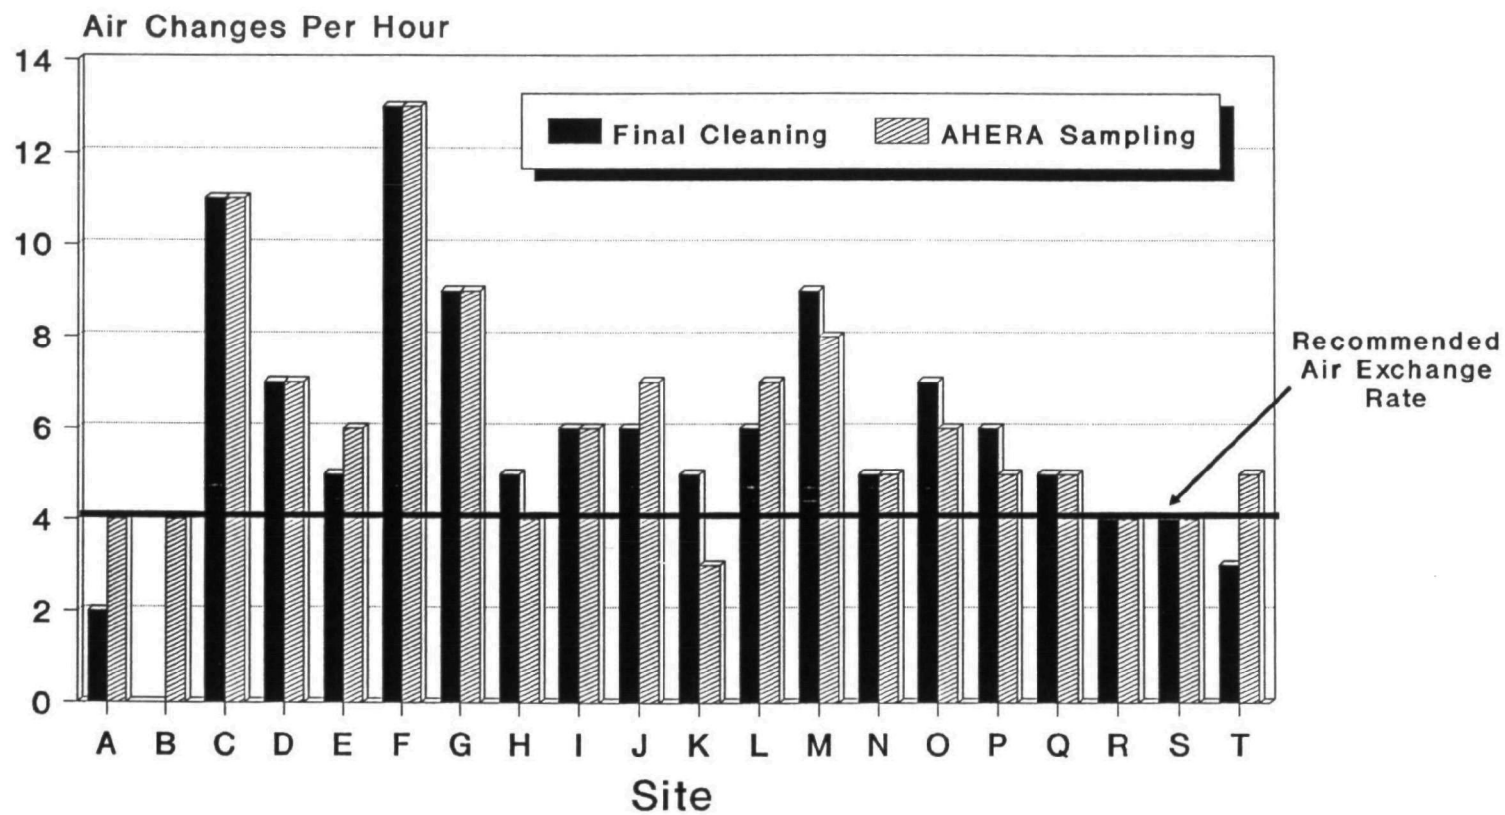
Figure 2. Air exchange rates in the abatement area at 20 asbestos abatement sites during final cleaning and AHERA clearance sampling.

Despite the lower-than-assumed ventilation rates of the observed HEPA-filtration units, enough units were used at all but one site to achieve a minimum of four air exchanges per hour during AHERA clearance sampling. Also, only two sites failed to meet the recommended air-exchange rate during final cleaning. Figure 2 shows the air-exchange rates during final cleaning and AHERA clearance sampling at each of the sites. Actual air-exchange rates ranged from 2 to 13 per hour during final cleaning and 3 to 13 per hour during AHERA clearance sampling.

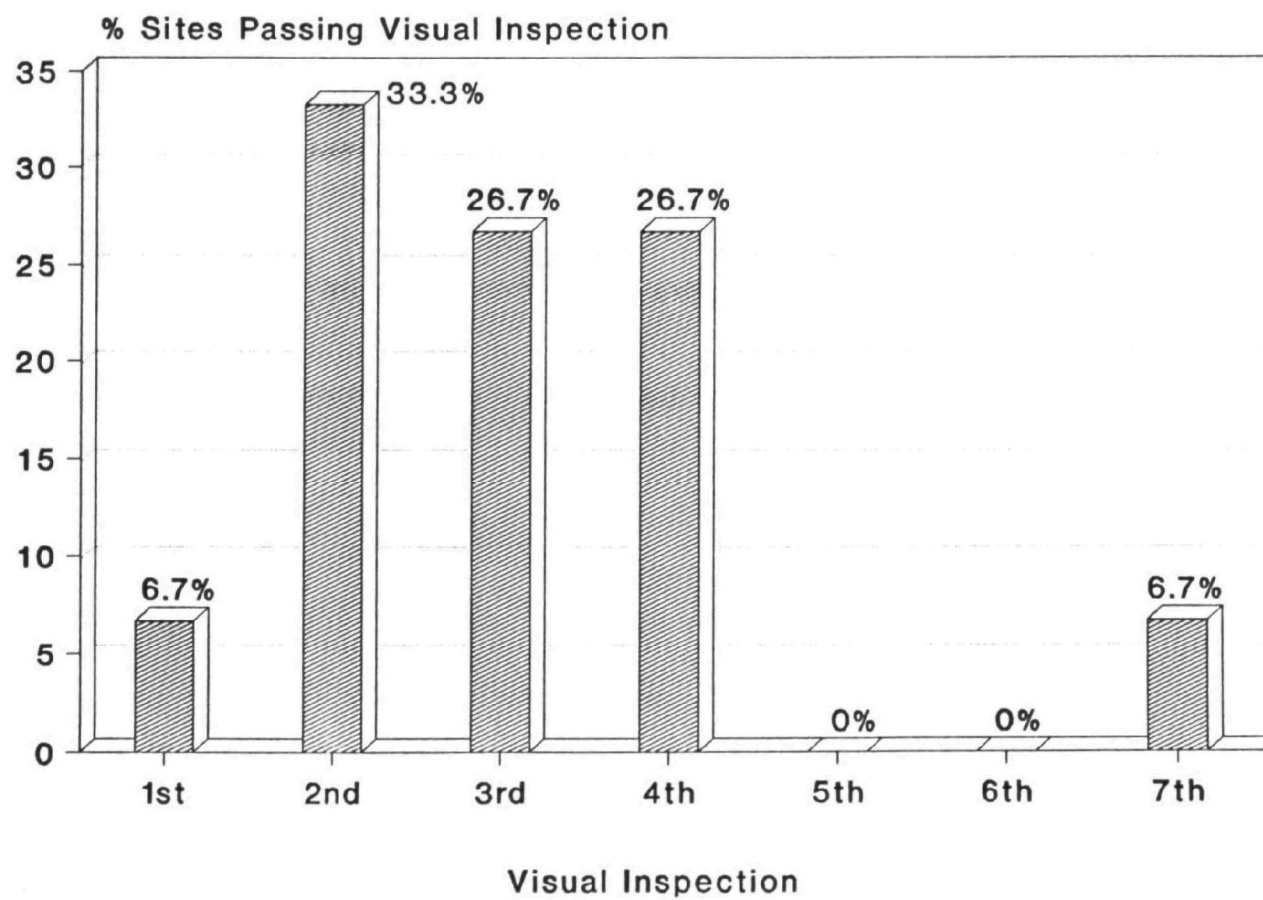
**Figure 3. Percentage of 15 sites passing the ACS's visual inspection for each attempt.**

From one to seven visual inspections were conducted at each abatement site. Figure 3 shows the percentage of sites that passed the visual inspection per given attempt. The largest percentage of sites (33.5%) passed the visual inspection on the second attempt. The cumulative percentages of sites passing the visual inspection were as follows: 40 percent by the first and second attempts, 66.7 percent by the third attempt, and 93.4 percent by the fourth attempt.

Table 6 lists the reasons why sites failed the ACS inspectors' visual inspections at 15 sites. Fourteen of the 15 sites failed visual inspection for more than one reason. The most commonly identified reason (cited at 8 of the 15 sites) was the presence of debris on pipes, pipe fittings, and hangers. The next most common reason was debris on floors, on horizontal surfaces, and in wall-penetrations. Table 6 also lists 23 other less commonly reported reasons for failing the visual inspection.

- 1) Procedures for visual inspections. This study suggests that work sites passing a stringent visual inspection are less likely to fail the clearance test and incur the expense of multiple rounds of sampling and analysis. Guidance for performing a thorough visual inspection would benefit both the building owner and abatement contractor.

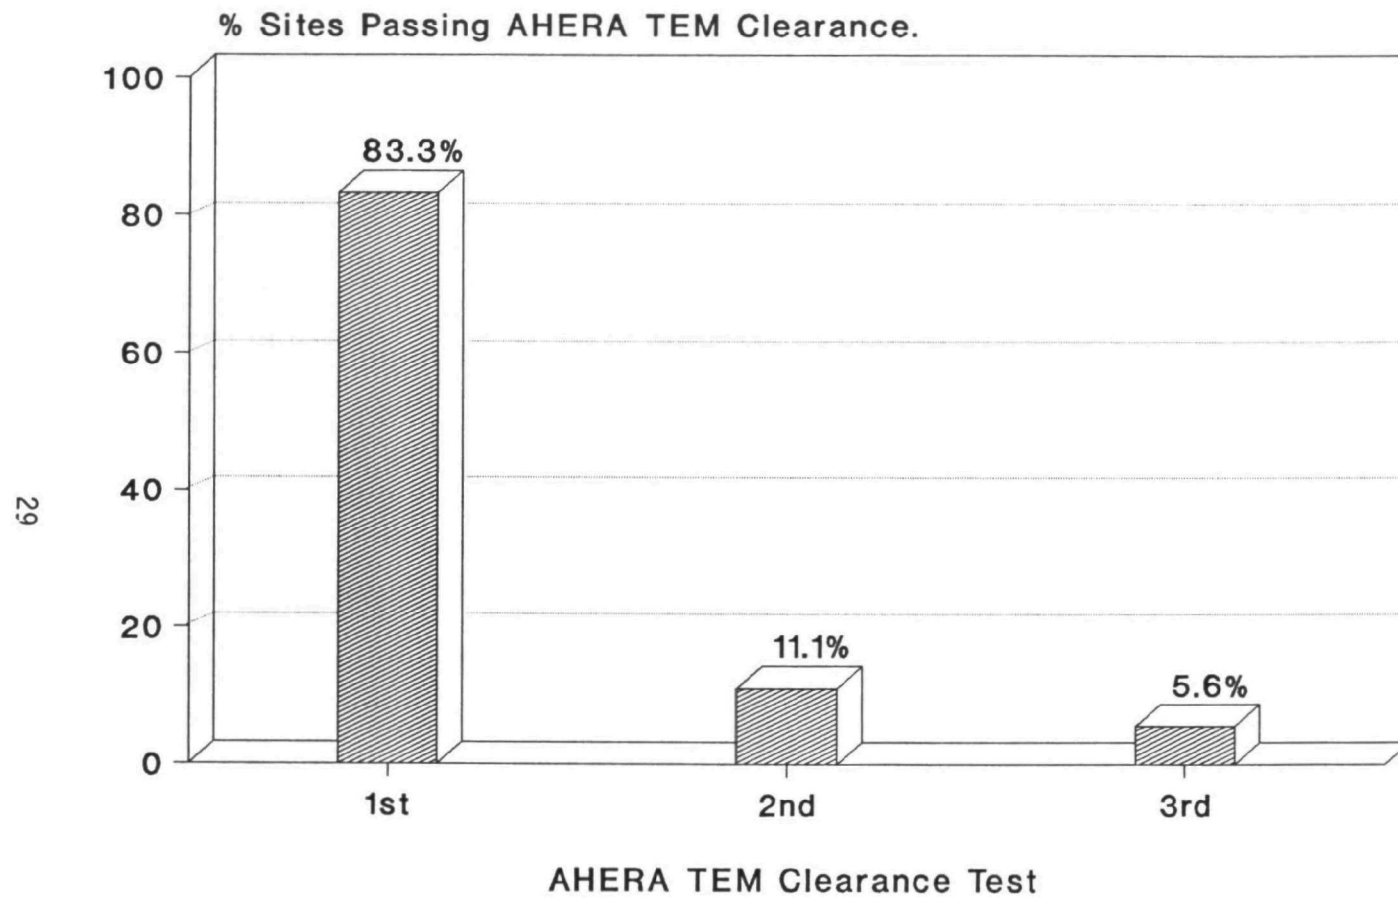
Figure 6. Percentage of 18 sites passing AHERA TEM clearance for each clearance attempt.

All of the 18 sites ultimately passed the AHERA TEM clearance criterion of the initial prescreening test (i.e., the average asbestos concentration of the samples collected inside the abatement area was less than or equal to 70  $\text{s}/\text{mm}^2$ ). Three sites initially failed the prescreening test, and two of

these sites subsequently tried to use the Z-Test to pass clearance. In each case, the site also failed the Z-Test and had to be recleaned. The Z-Test was used only twice at the 20 sites observed in this study, and it was never used to clear the abatement site. Figure 7 presents the average asbestos concentrations for each clearance attempt for the 18 sites that were cleared by TEM.

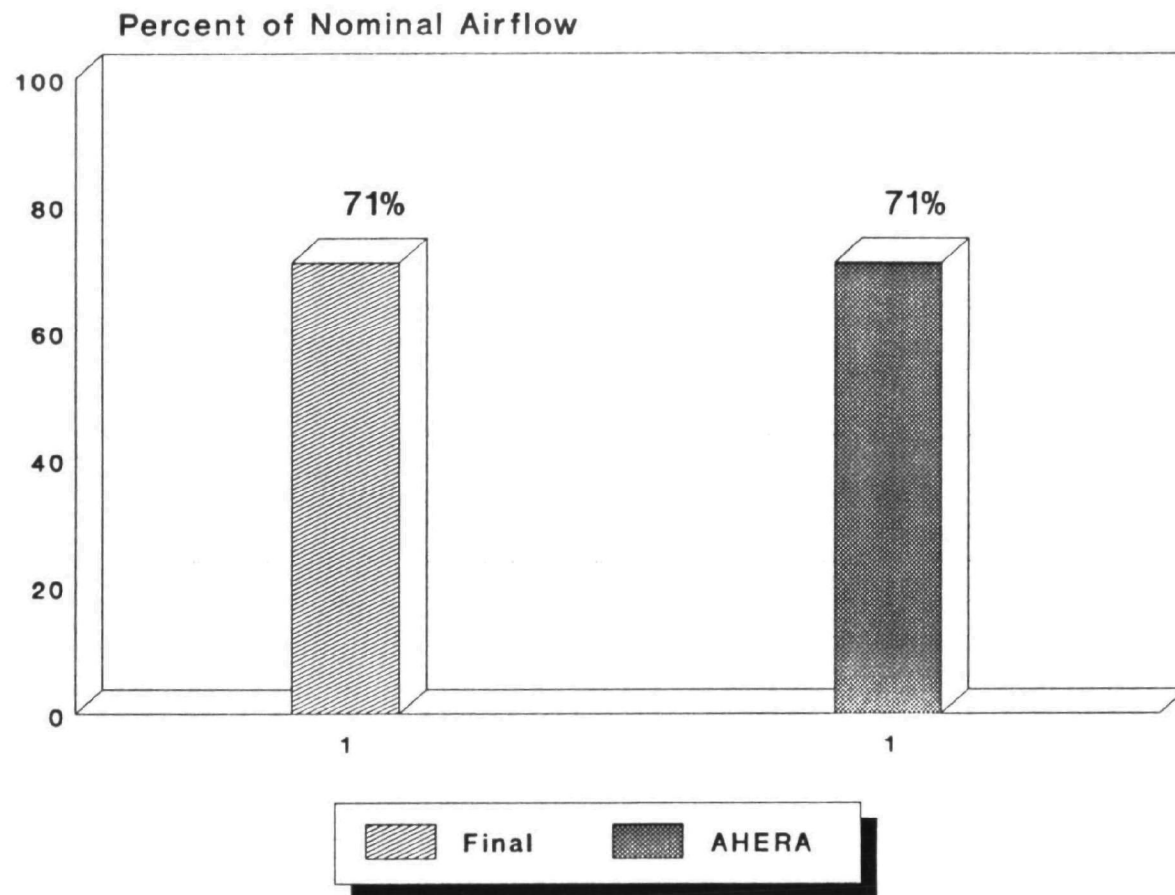
Figure F-1. Airflow performance for HEPA filtration systems operating during final cleanup and AHERA clearance.

Figure F-1 compares the measured air-intake volume for each HEPA-filtration unit operating during final cleaning and AHERA clearance sampling, with the unit's nominal air flow.
