REMOTE SENSING REPORT

GALVESTON BAY, HOUSTON SHIP CHANNEL,

HOUSTON, TEXAS

FEBRUARY 1972

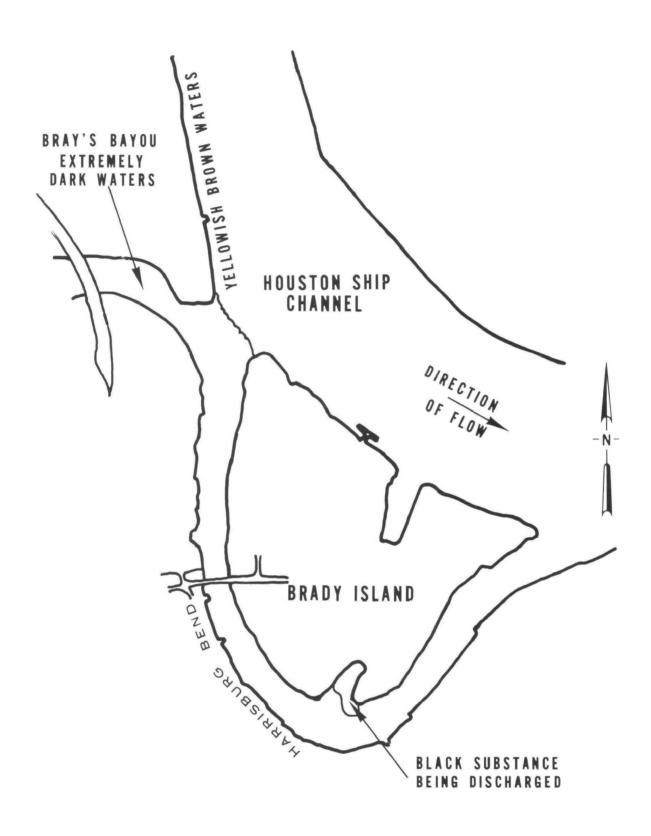
Figure I Brady Island Area

- 3. Bray's Bayou The water, which was slowly flowing into the Ship Channel from Bray's Bayou, was extremely dark in color exhibiting septic tendencies. The mixing of these two waters was quite slow to the point of well defined boundaries existing between them. This is shown in Figure 1.

- 5. A black substance was being discharged into the Harrisburg Bend waterway from a cove or indentation located on the southern tip of Brady Island, as shown in Figure 1. This cove was 160 feet wide at its mouth and extends 208 feet inland from the loading dock. The plume extended 97 feet into the above mentioned water-

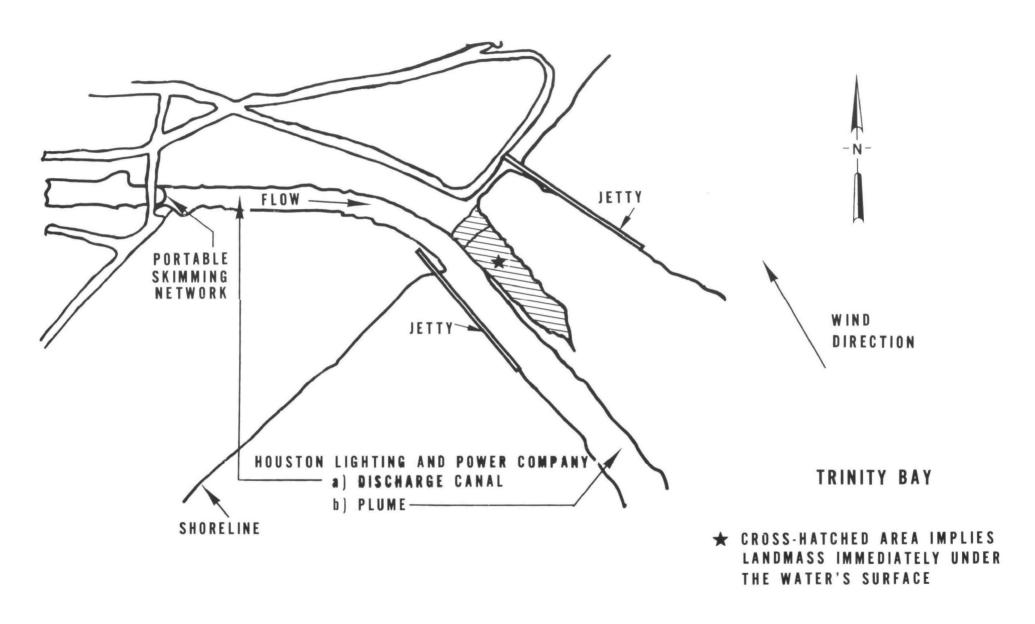
Figure 2 Optical Imagery of H.L. & P. Canal

The area in the vicinity of the Houston Lighting and Power Company's cooling water discharge canal was covered photographically and with the Infrared Line Scanner. The water being discharged from the above-mentioned location was a relatively dark grayish-green color. The resultant plume shape is shown in Figure 2. This figure was derived from the respective
