Materials for Oxygenated Wastewater Treatment Plant Construction

July 1978

H. K. Uyeda
B. V. Jones
T. E. Rutenbeck
J. W. Kaakinen

Division of General Research
Engineering and Research Center
Bureau of Reclamation
Denver, Colorado 80225

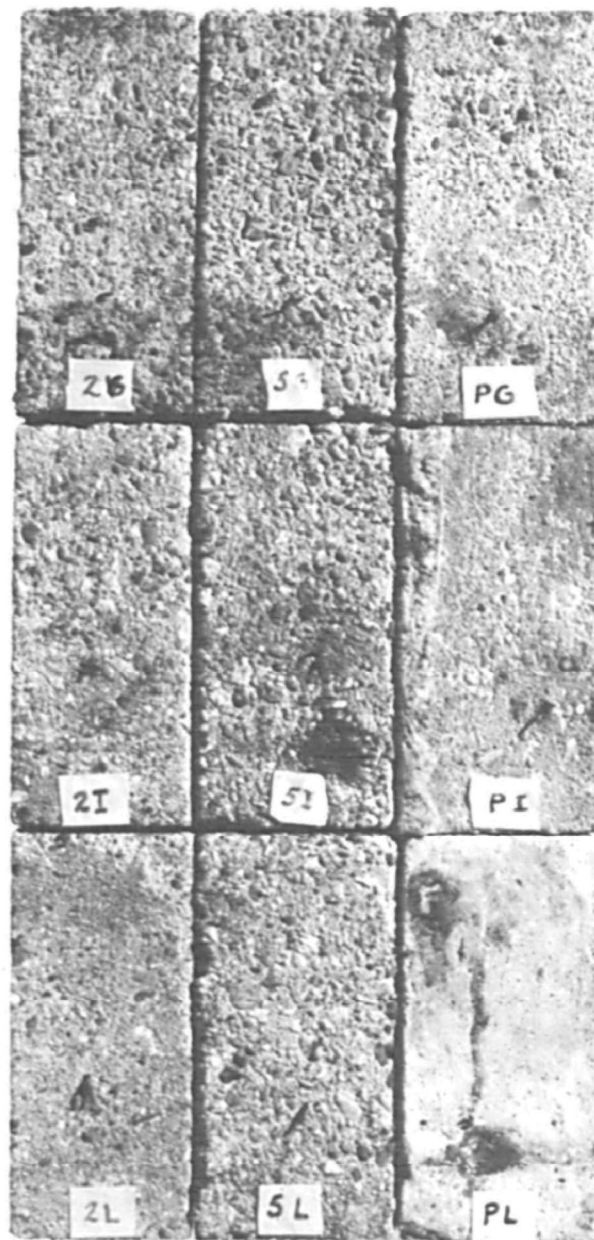
3. Surface conditions. - Generally, only minor changes in surface appearance have occurred at sites 1 and 2. At site 3, erosion of the surface was experienced as shown in figure 15.

a. Concrete made with Type V cement suffered the most severe erosion damage.

b. Less severe erosion damage was observed on concrete made using Type II cement.

Figure 15. - Concrete prisms exposed at site 3 for 28 months depict the damage due to surface abrasion. Prefix of specimen code denotes concrete type, i.e., 2-Type II, 5-Type V, and P-PIC; suffix indicates exposure, i.e., G-gas, I-interface, L-liquor.

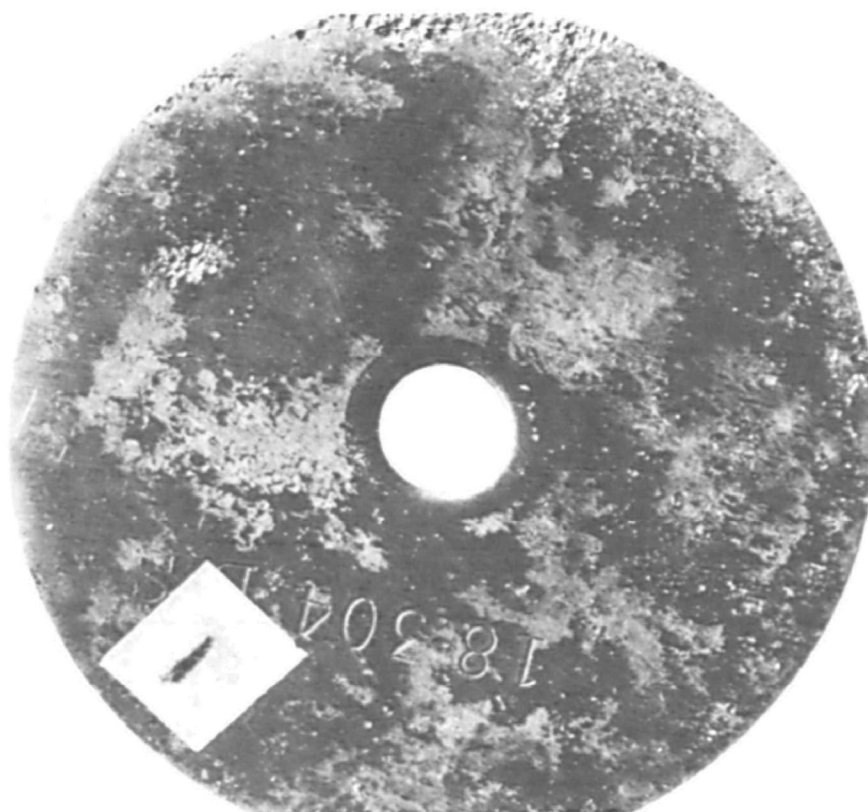
Figure 16. Sensitized Type 304 stainless steel specimen exposed in the gas zone at site 1 for 22 months. Note pitting due to sensitization.

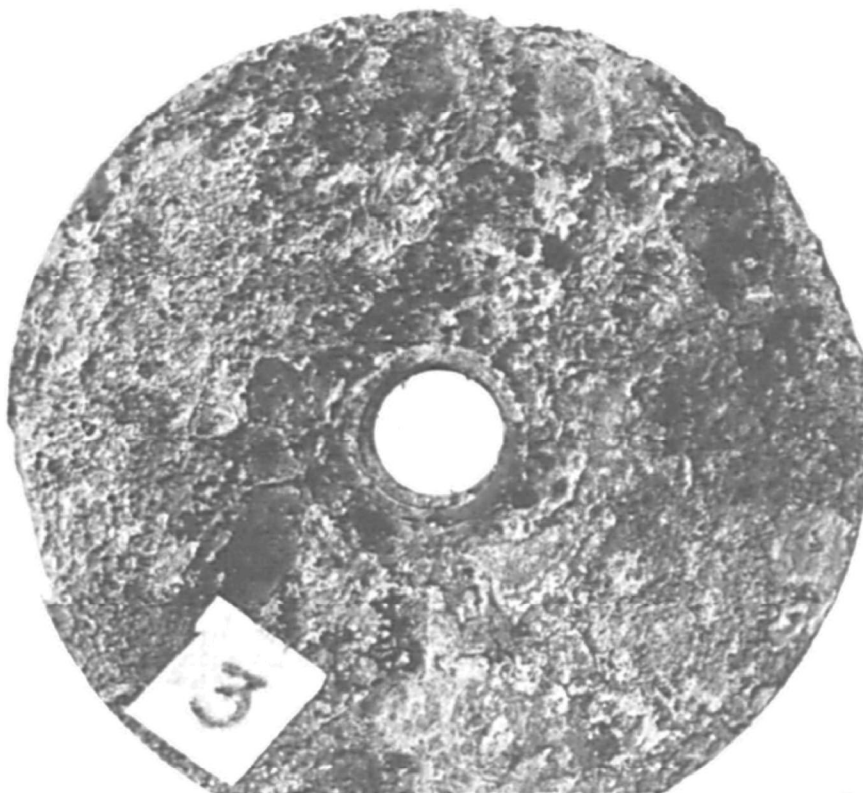
Figure 17. Mild steel specimen exposed in the gas zone at site 2 for 28 months. Surface is deeply pitted.

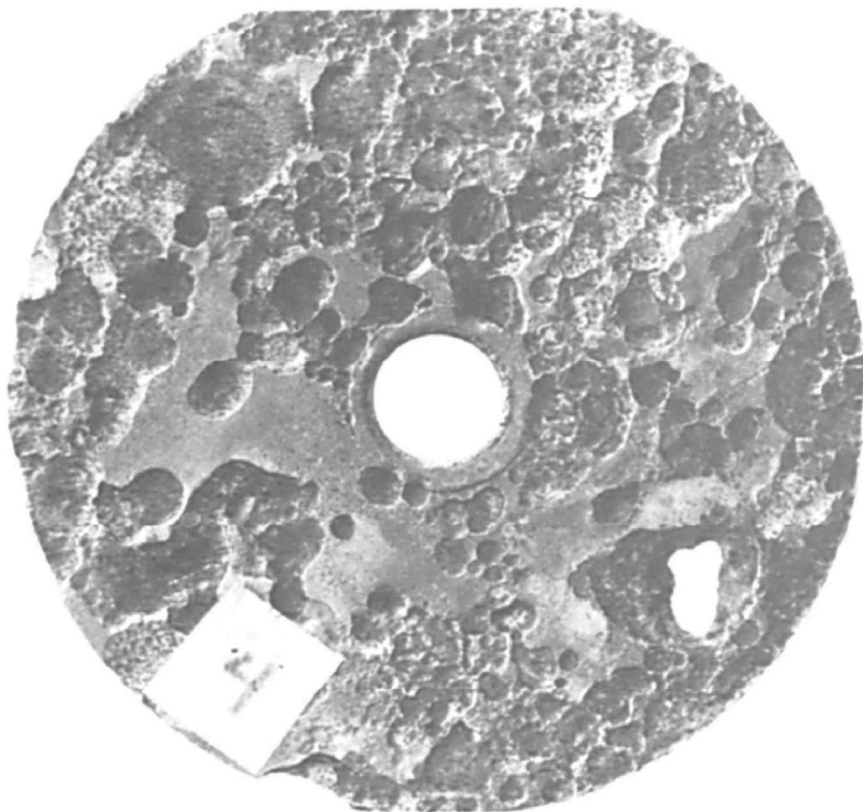
Figure 18. Low alloy steel specimen exposed in the liquor at site 2 for 28 months. Specimen is perforated.

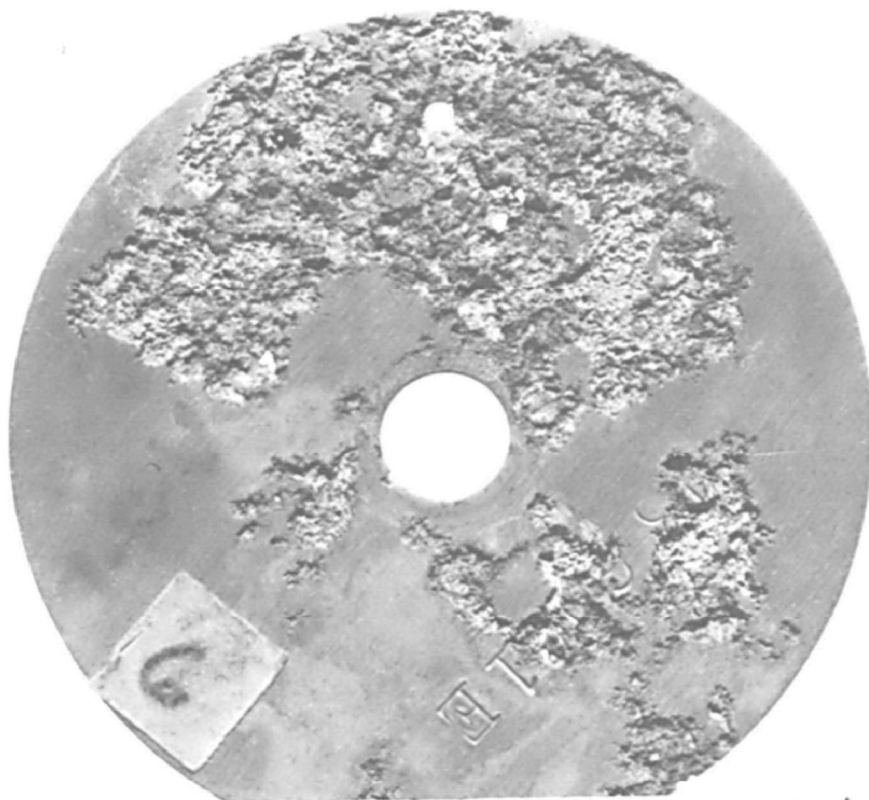
Figure 19. Aluminum alloy 6061 exposed in the gas zone at site 2 for 28 months. Sample is perforated.

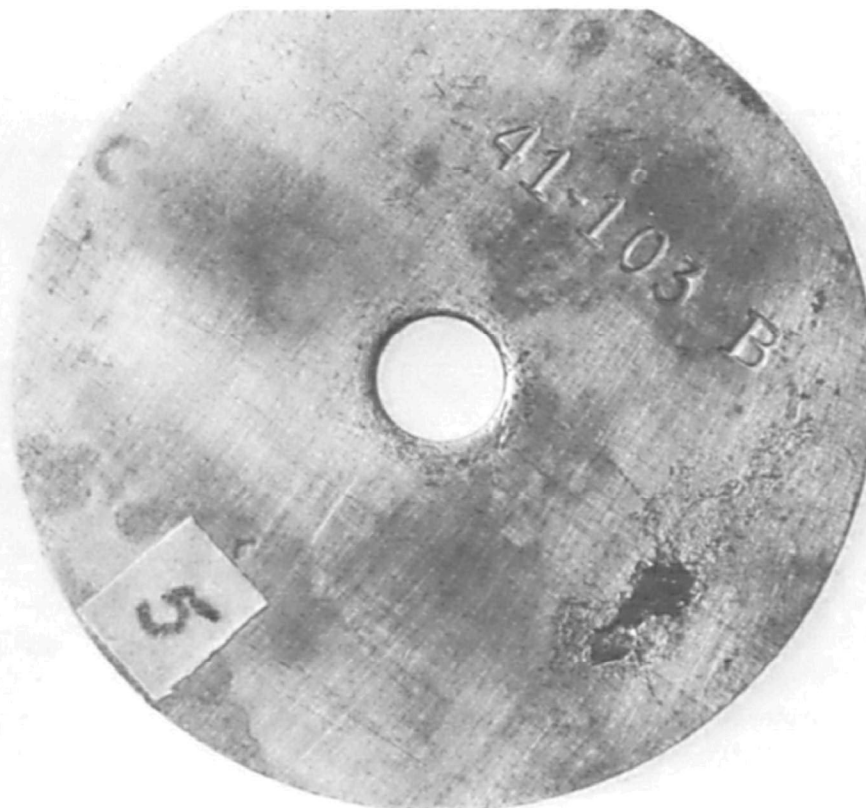
Figure 20. Copper specimen exposed in the gas zone at site 2 for 28 months. Sample is pitted in one localized area only.

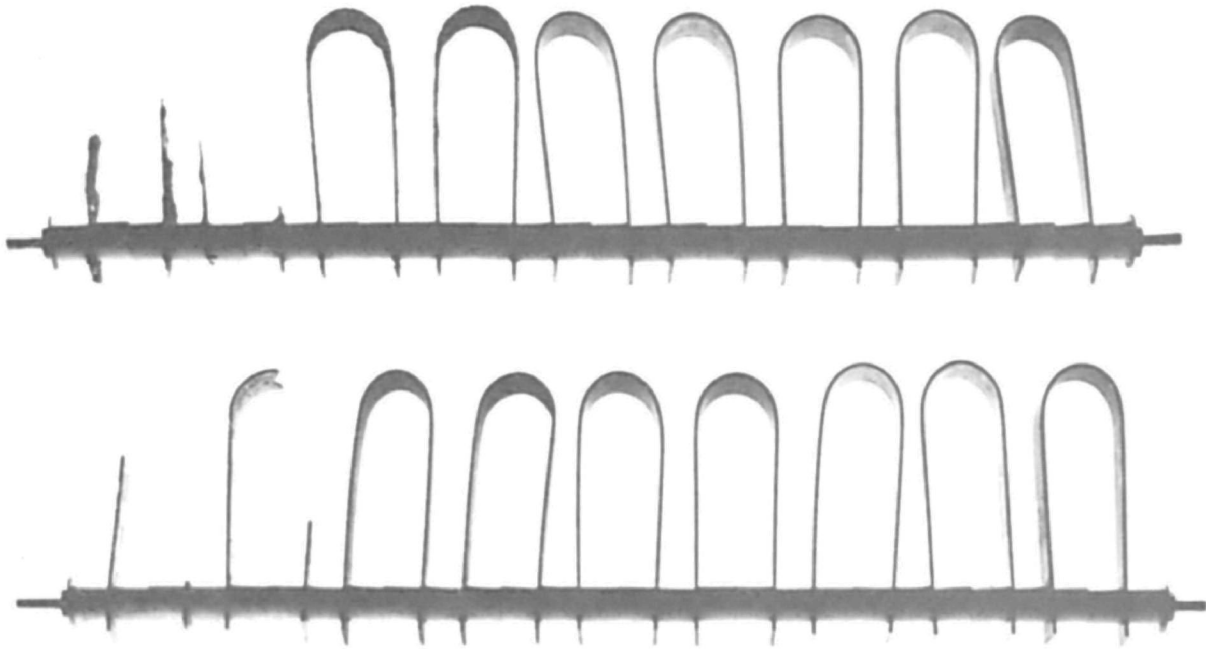
Figure 22. - Duplicate mild steel (top left) and aluminum alloy 6061 (bottom left) stressed specimens failed after 28 months' exposure in the liquor at site 2.

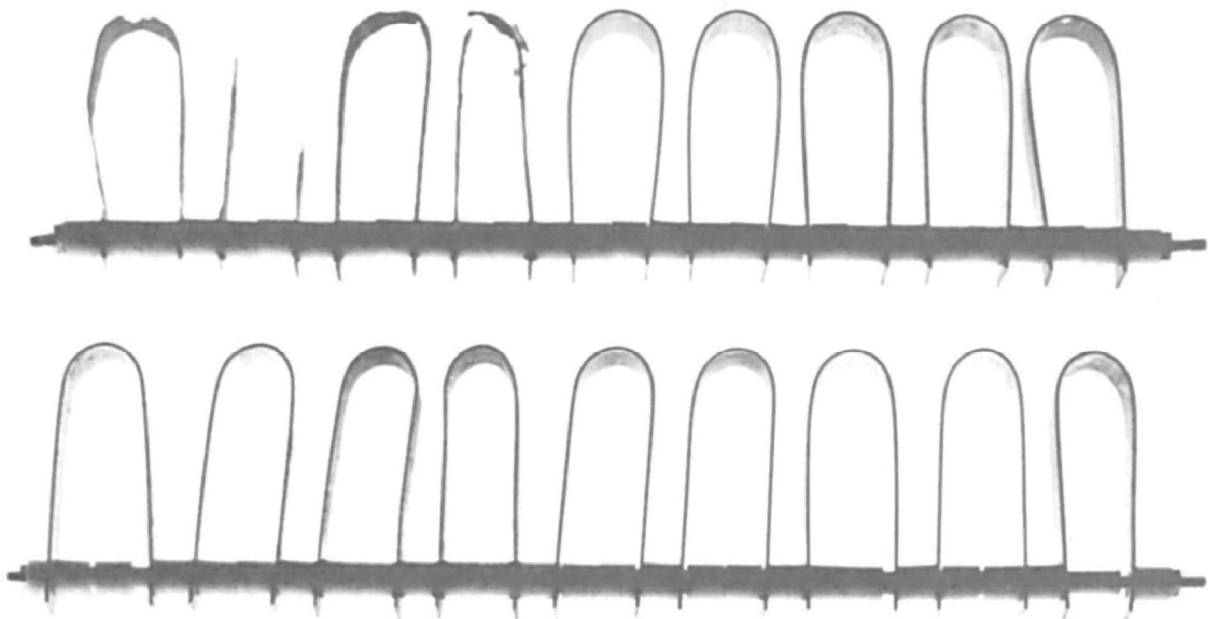
Figure 23. - Duplicate mild steel (first two samples, top row) and low alloy steel (second two samples, top row) stressed specimens failed after 28 months' exposure at the interface at site 3.

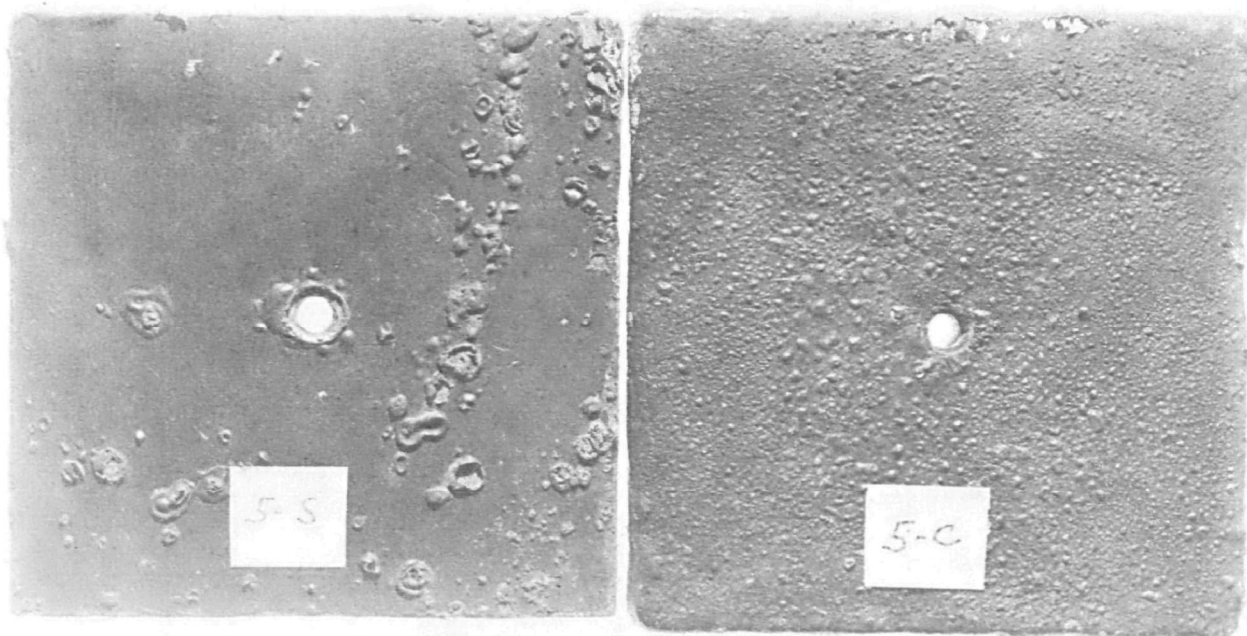
Figure 24. Blistering of proprietary butyl coating (No. C-6) on steel (left) and concrete substrates.

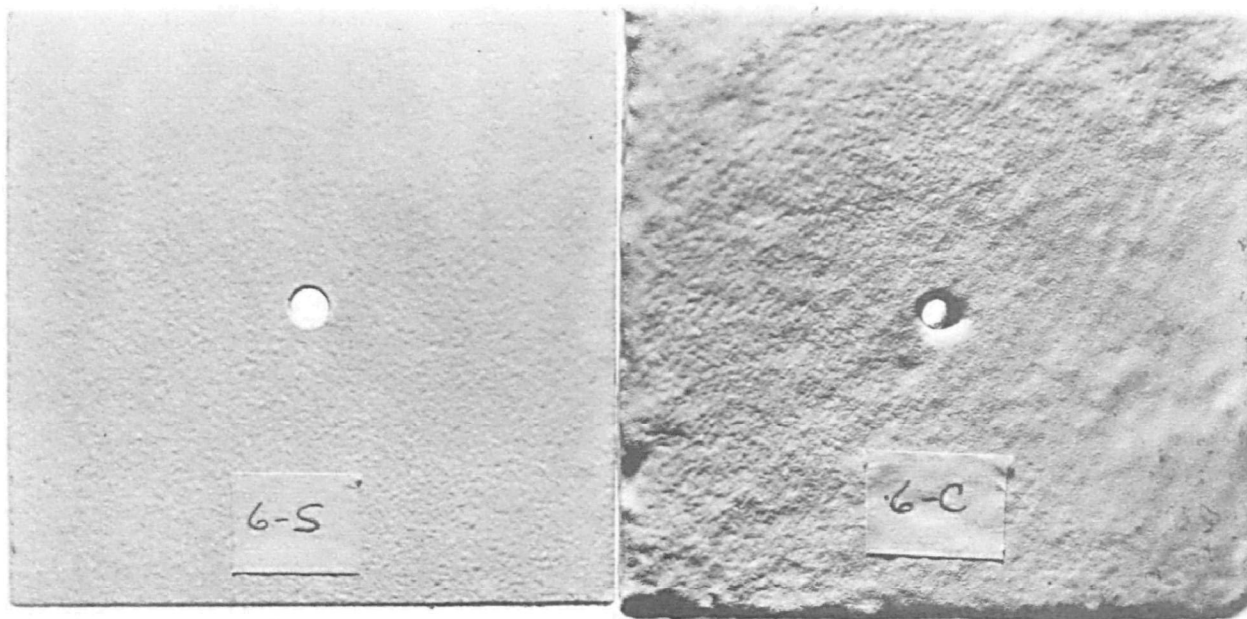
Figure 25. Defect-free proprietary urethane coating (No. C-9) on steel (left) and concrete substrates. Roughness is characteristic of application.

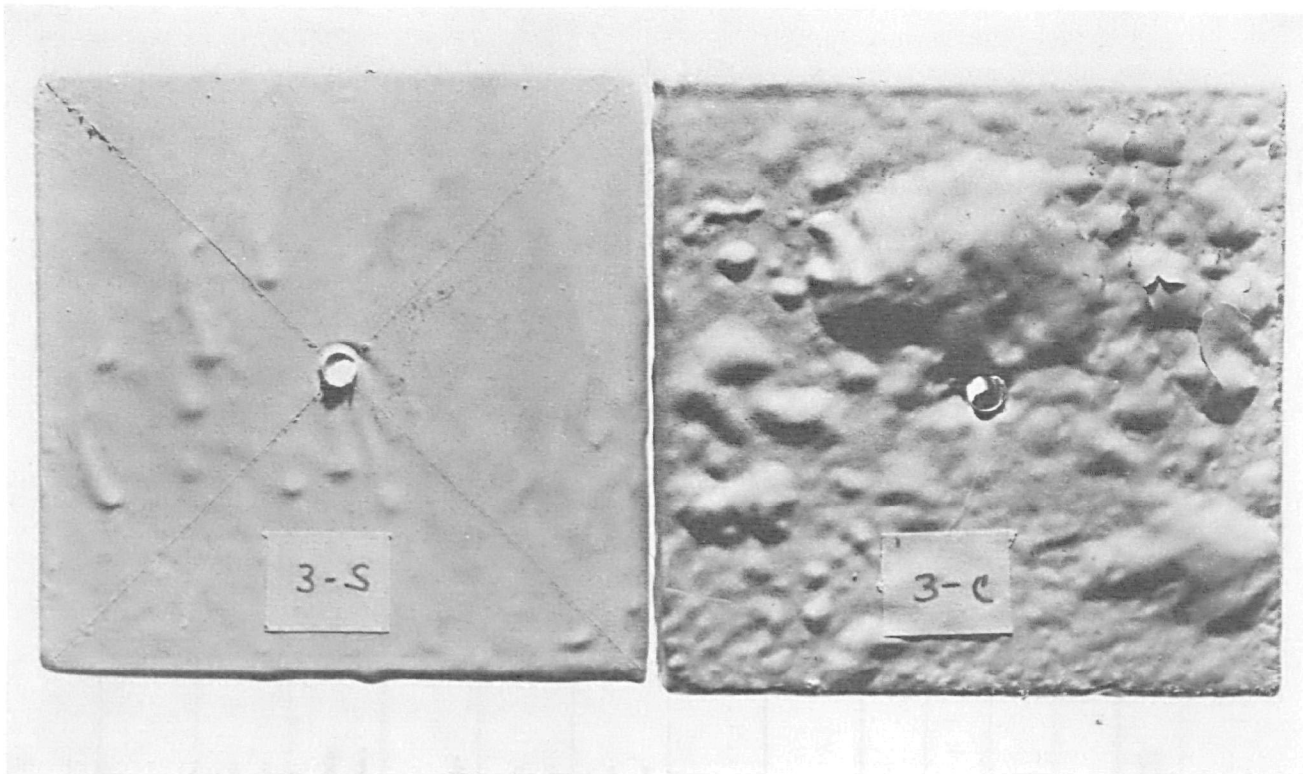
Figure 26. Blistering of proprietary, one-component urethane coating (No. C-13) on steel (left) and concrete substrates.

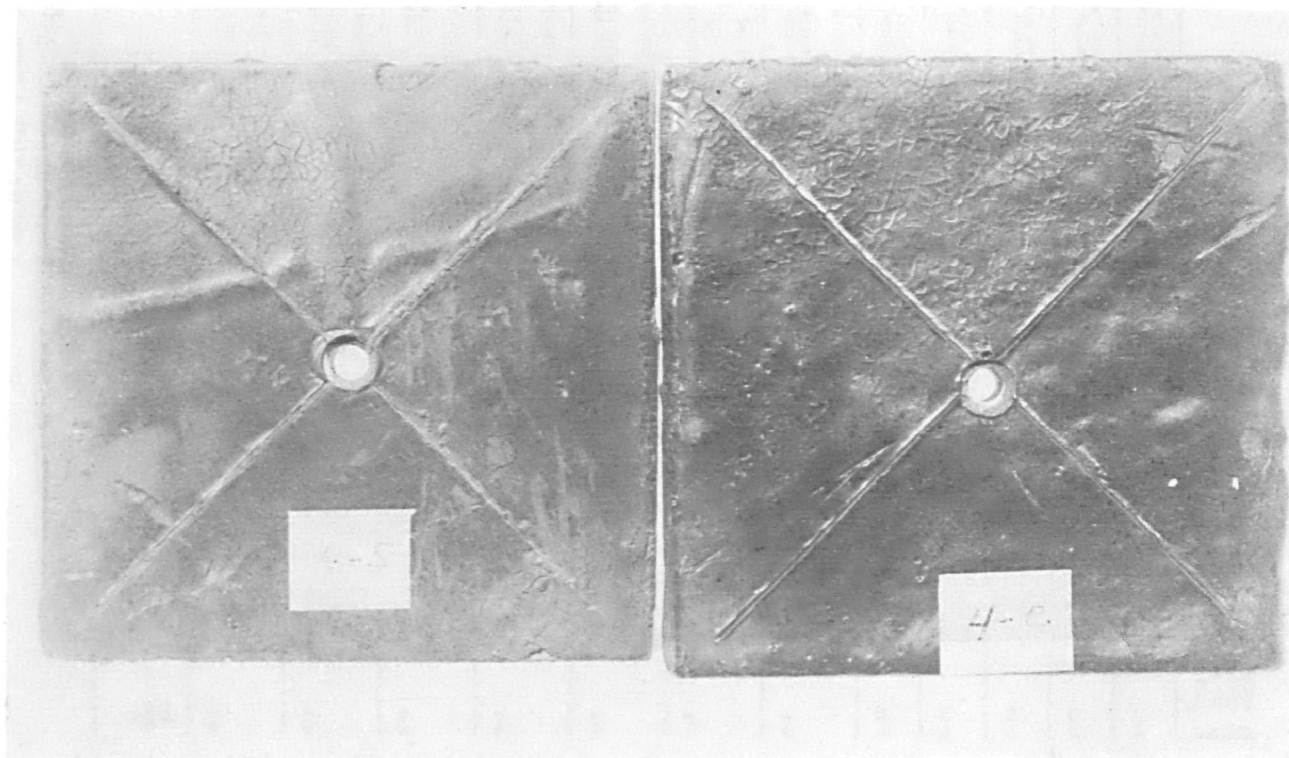
Figure 27. Cracking of coal-tar enamel coating (No. C-3) on steel (left) and on concrete substrates.

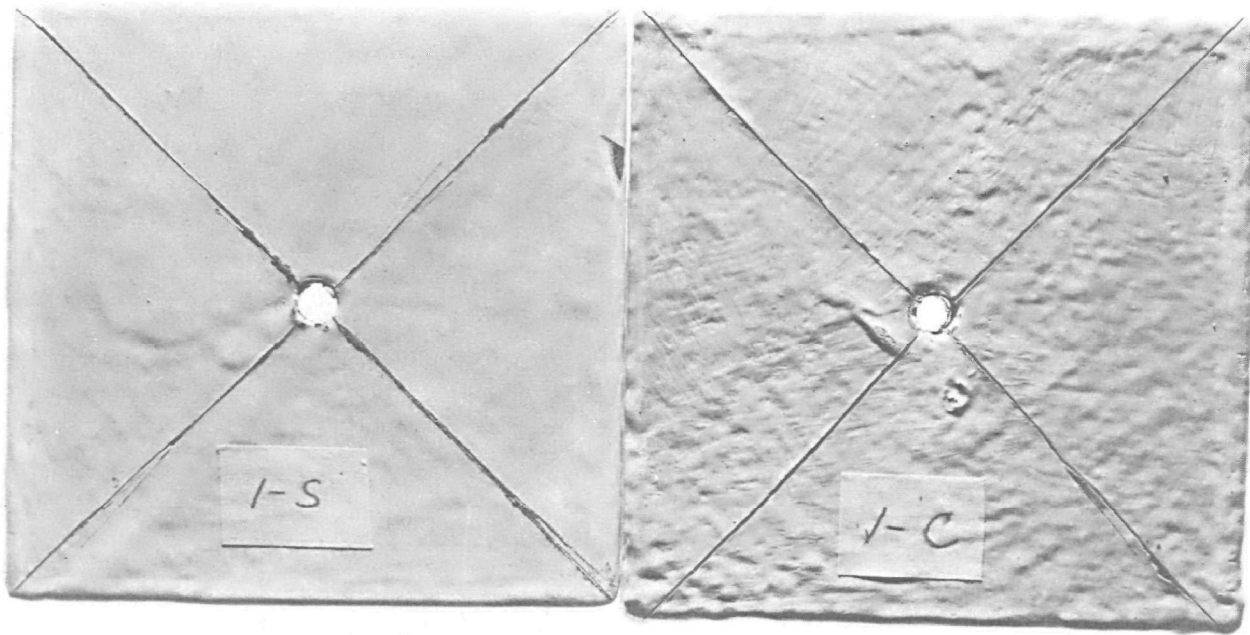
Figure 28. Defect-free phenolic-epoxy coating (No. C-12) on steel (left) and concrete substrates.

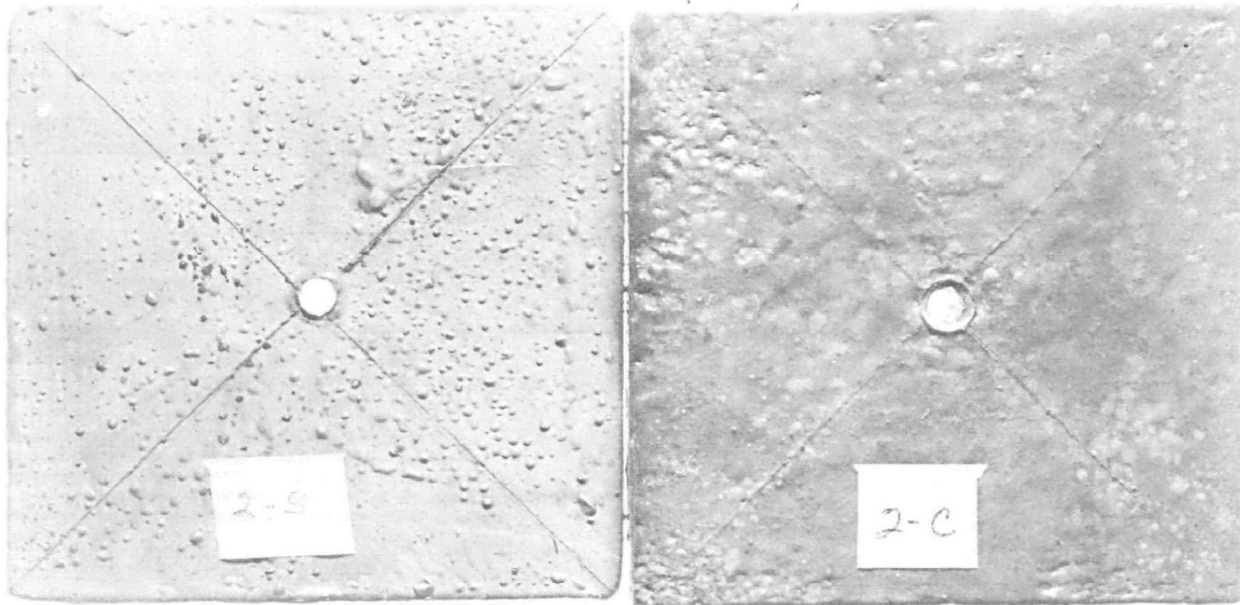
Figure 29. Severely blistered proprietary urethane coating (No. C-14) on steel (left) and concrete substrates.

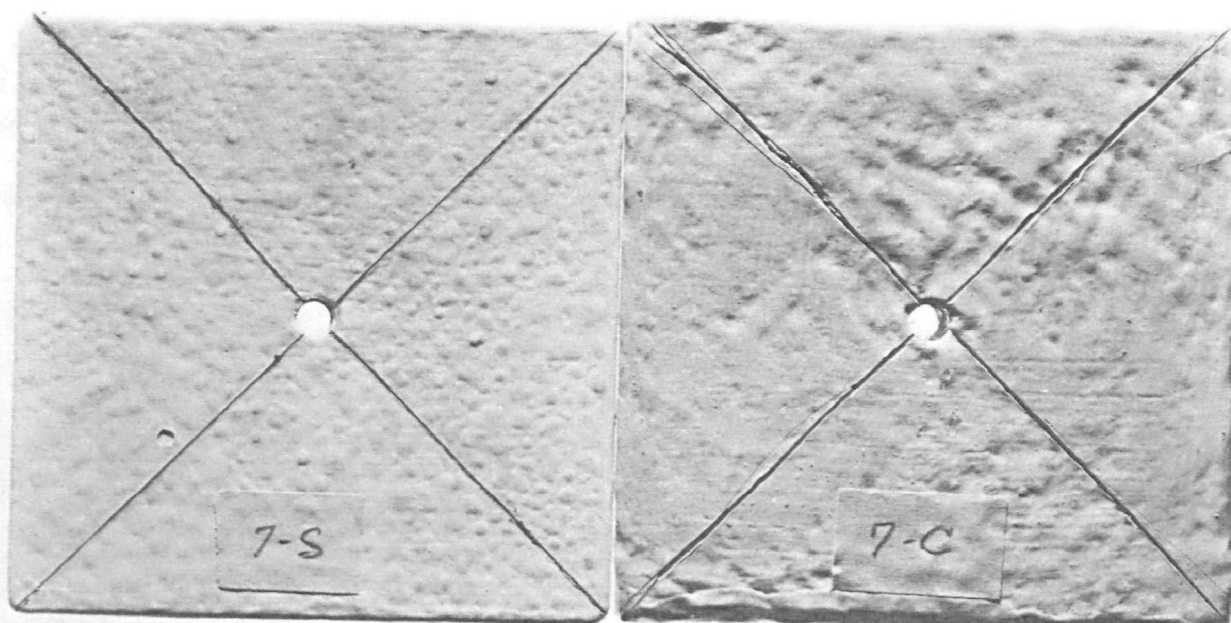
Figure 30. Blistering (topcoat only) of proprietary phenolic-epoxy coating (No. C-16) on steel (left) and concrete substrates.

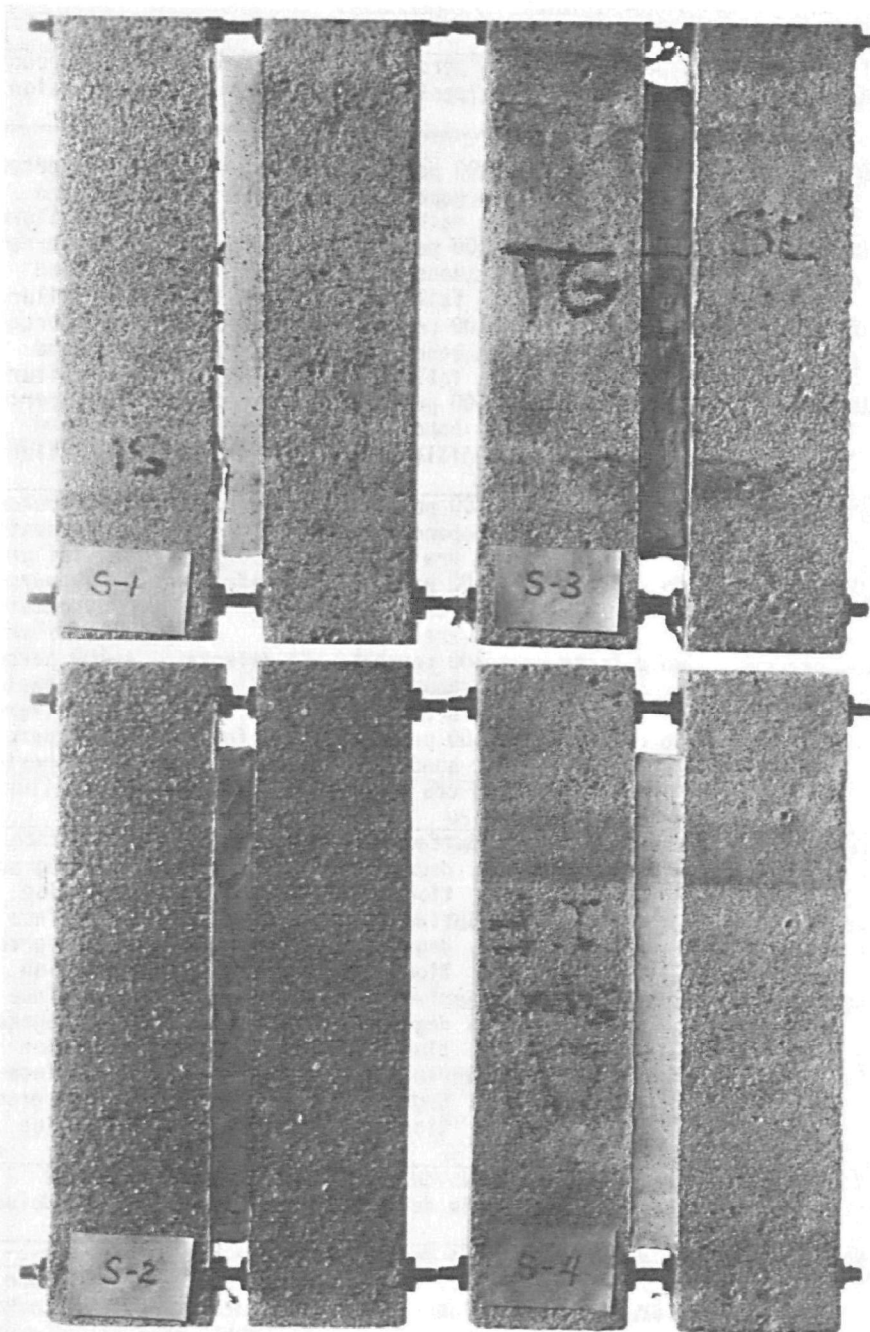
Figure 31. Typical joint sealer performance in these tests. S-1 is a two-component silicone sealant which has incurred bond failure, S-2 and S-3 show surface degradation of two-component polysulfide base material exposed in compressed (S-2) and stretched (S-3) condition and S-4 is intact one-component, low-modulus silicone.
