# Field Demonstration of Innovative Condition Assessment Technologies for Water Mains: Leak Detection and Location

**FIELD DEMONSTRATION OF INNOVATIVE CONDITION ASSESSMENT TECHNOLOGIES  
FOR WATER MAINS: LEAK DETECTION AND LOCATION**

**Bruce Nestleroth, Stephanie Flamberg, Wendy Condit, and John Matthews  
Battelle**

**March 2012**

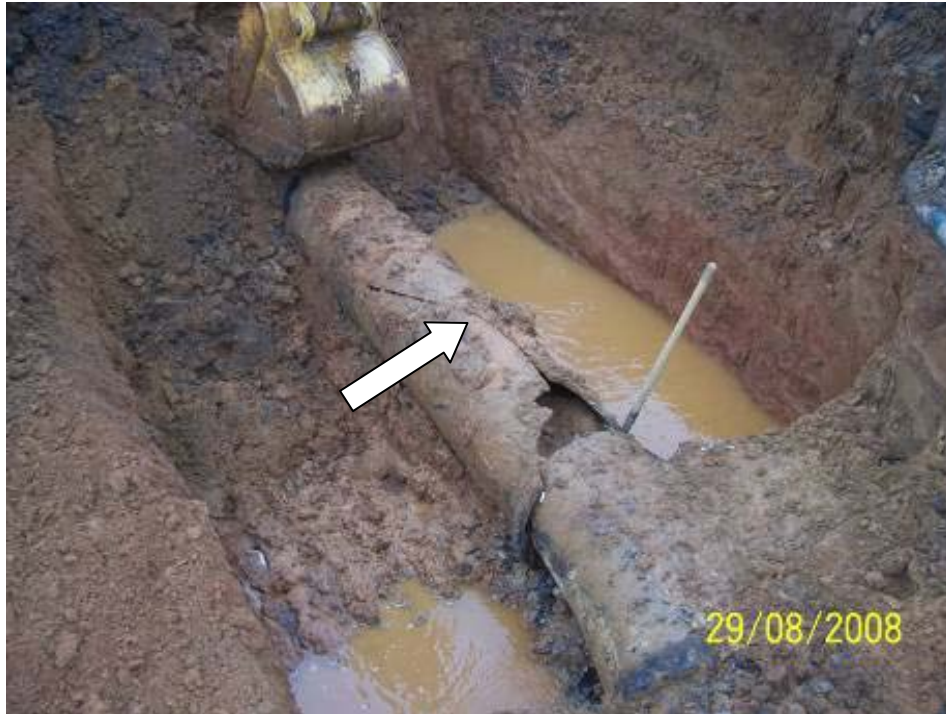
**Figure 3-3. Pipe Break along Westport Road Adjacent to Test Area in August 2008**

The only recorded pipe break occurred on August 29, 2008, approximately 12 ft north of the centerline of Ridgeway Avenue and 40 ft east of the centerline of Westport Road. The break appears to have occurred near a joint and propagated longitudinally along the pipe (see Figure 3-3), resulting in complete failure. The pipe break was caused by an attempt to operate the line at its full capacity, which indicated that the pipe might have lost part of its original structural integrity due to aging. It should be noted that the location of the pipe break is outside the test area (that is, not strictly part of the test pipe). However, it is noteworthy because of the nature of the break and because it occurred just a few days before the EPA Forum, which prompted LWC to offer the pipe for this demonstration.

Note: arrow pointing to longitudinal propagation of crack

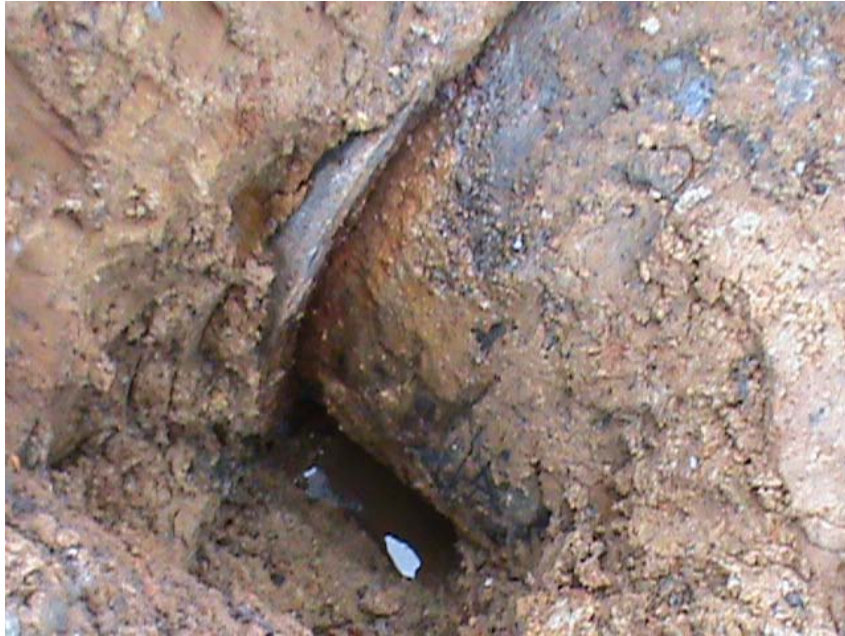
**Figure 3-27. Leak ID L7 – Small Leak at Bell-and-Spigot Joint**

<sup>14</sup> EPA’s contractor was only able to pressurize the line to witness four of the leaks (L3, L4, L6, and L7). Shortly after verifying these leaks, the stem broke on the control valve near Chenoweth Lane, prohibiting the line from being pressurized for remaining leak verification. As such, other external cues, such as wet soil and possibly odor from leaching leadite in joints, were used to indirectly decide if a leak could have been present in the line.

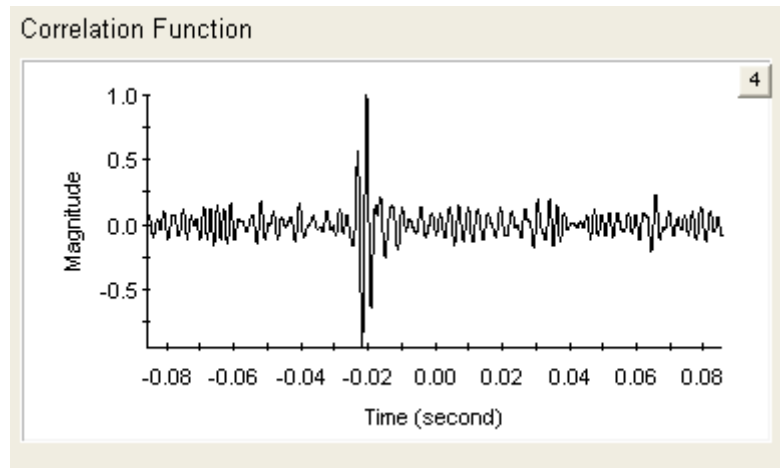
**Figure 4: Correlation result for File #2**

The evidence presented here strongly indicates the presence of a leak and if this pipe were to remain in service, it would be suggested to perform remedial action.

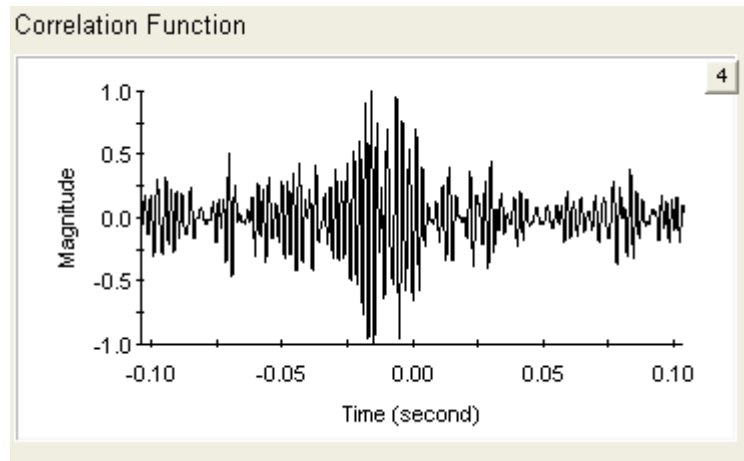
**Figure 5: Correlation Result for File #7**

The evidence presented here is not entirely conclusive because the correlation peak is not defined. If this pipe were to remain in service, it would be suggested to perform further investigation by either using a ground-microphone to confirm a noise source or potholing to confirm the presence of water.
