**FINAL REPORT TO U.S. EPA/OUST**

# **CAUSES OF RELEASE FROM UST SYSTEMS**

**EPA CONTRACT: 68-01-7053  
SUBCONTRACT: 939-5  
WORK ASSIGNMENT: 24**

**September 30, 1987**

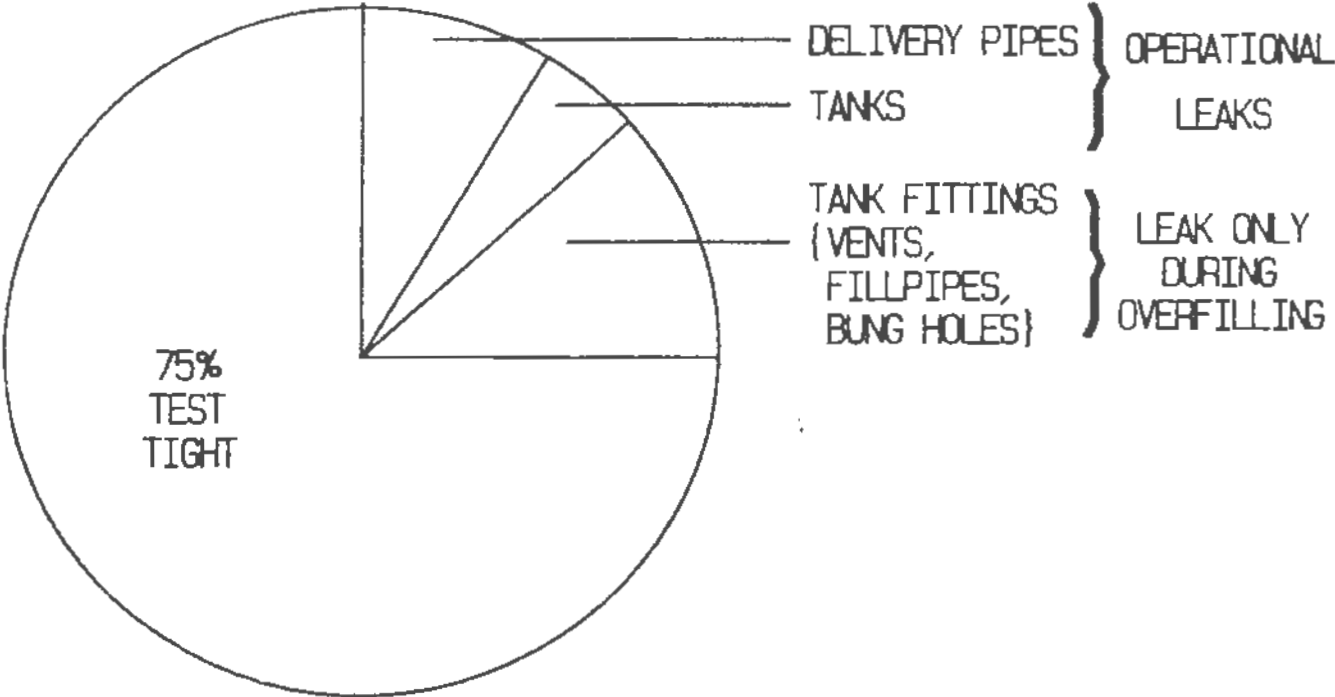
What's happening in the existing UST world? Service Station Testing Company, Inc. of San Antonio, Texas (64), has kept very accurate data on their testing work (which is their sole business) over a period from 1981 to mid-1987. The results of their overall data are represented in the graph on page 5. If the available data is examined, which does not encompass spills and overfills, initial testing of existing UST systems would find that 5% of the tanks are leaking, 10% of the UST systems have leaking product delivery lines, and 15% of the UST systems have vents or tank fittings that are not tight under overflow conditions; thus for the non-tight systems, 16% of the total was due to tanks leaking and 84% was due to faulty vents, fittings or delivery piping problems. (Service Station Testing performed 3,746 tightness tests and of those that were non-tight, 92 were due to tank incidents, 176 were due to the product delivery lines, 272 were due to loose tank fitting and vents or fill pipes on top of the tanks.) Of a total of 1,921 tanks that were tested: 228 were FRP, 57 were FRP steel composite and 1,636 were bare steel. All 92 leaking tanks were made of bare steel and all but 4 were over 10 years old when found to leak.

TOTAL SYSTEMS TESTED = 1921

25% OF SYSTEMS  
FAIL TIGHTNESS TEST

GRAPHICAL REPRESENTATION OF DATA FROM SERVICE STATION TESTING COMPANY, INC. OF SAN ANTONIO, TEXAS
