EPA/OSHA JOINT CHEMICAL ACCIDENT INVESTIGATION REPORT

Napp Technologies, Inc.
Lodi, New Jersey

The EPA/OSHA Accident Investigation Program

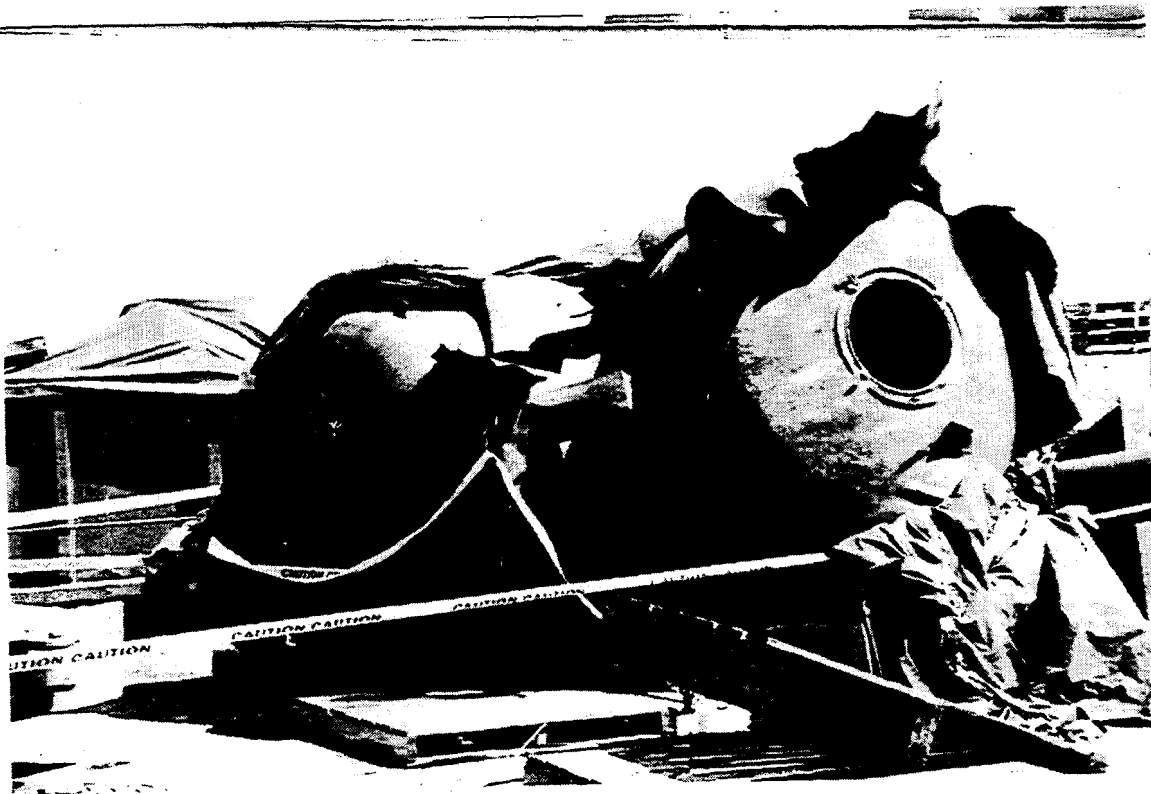
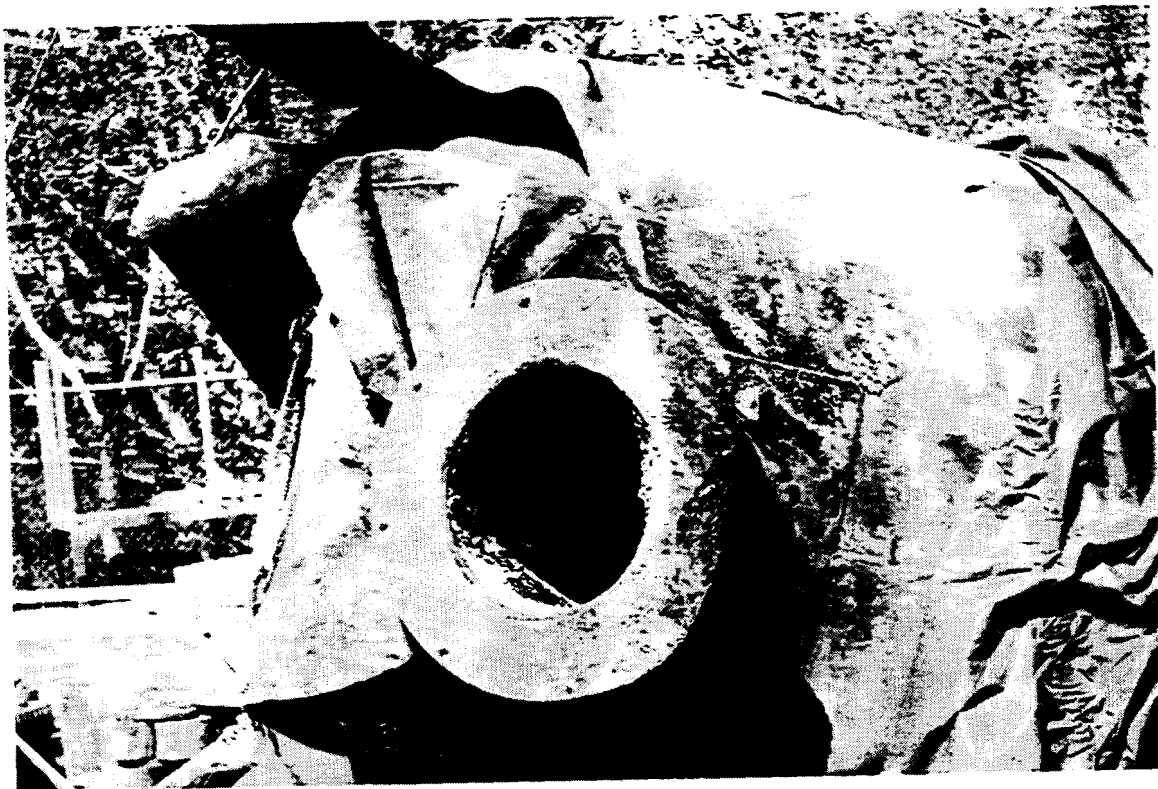
Figure 9: The general condition of the 125 cubic foot blender: a) the top access ports and damaged insulation jacket, and b) the flange to which the belt drive attaches.

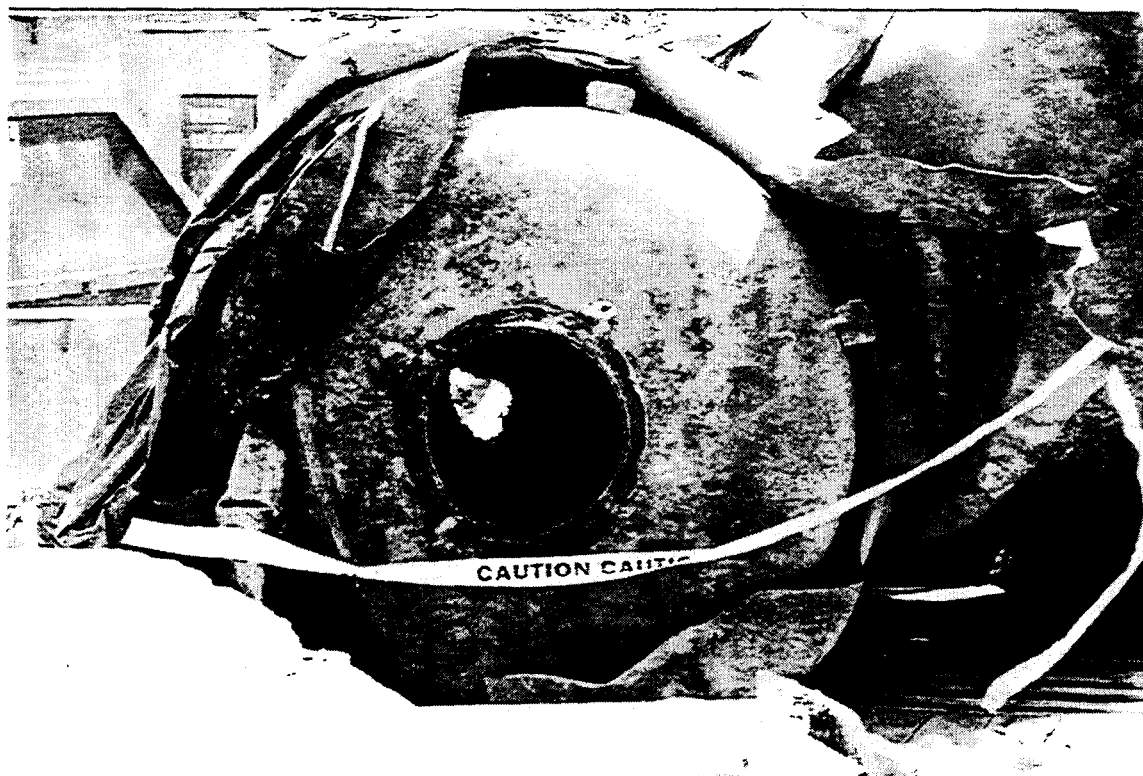
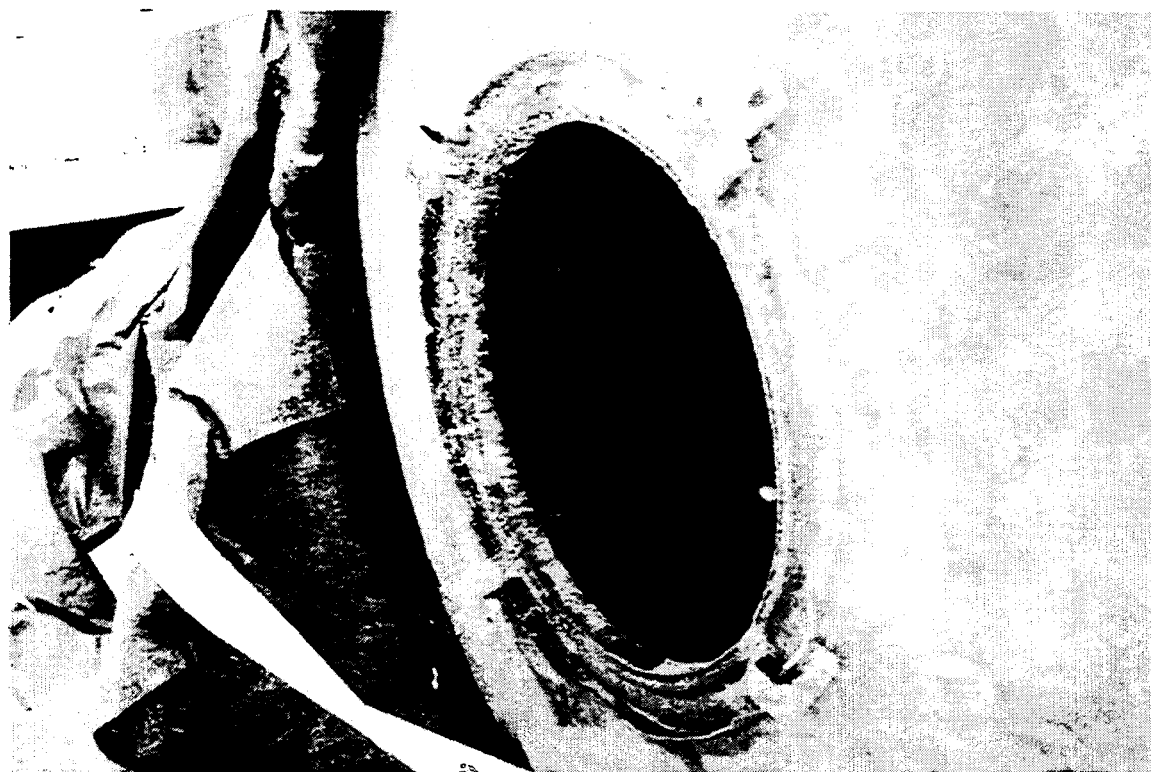
Figure 10: Top access port: a) looking through a top port and out the bottom off-load port, and b) close-up view of a top port.

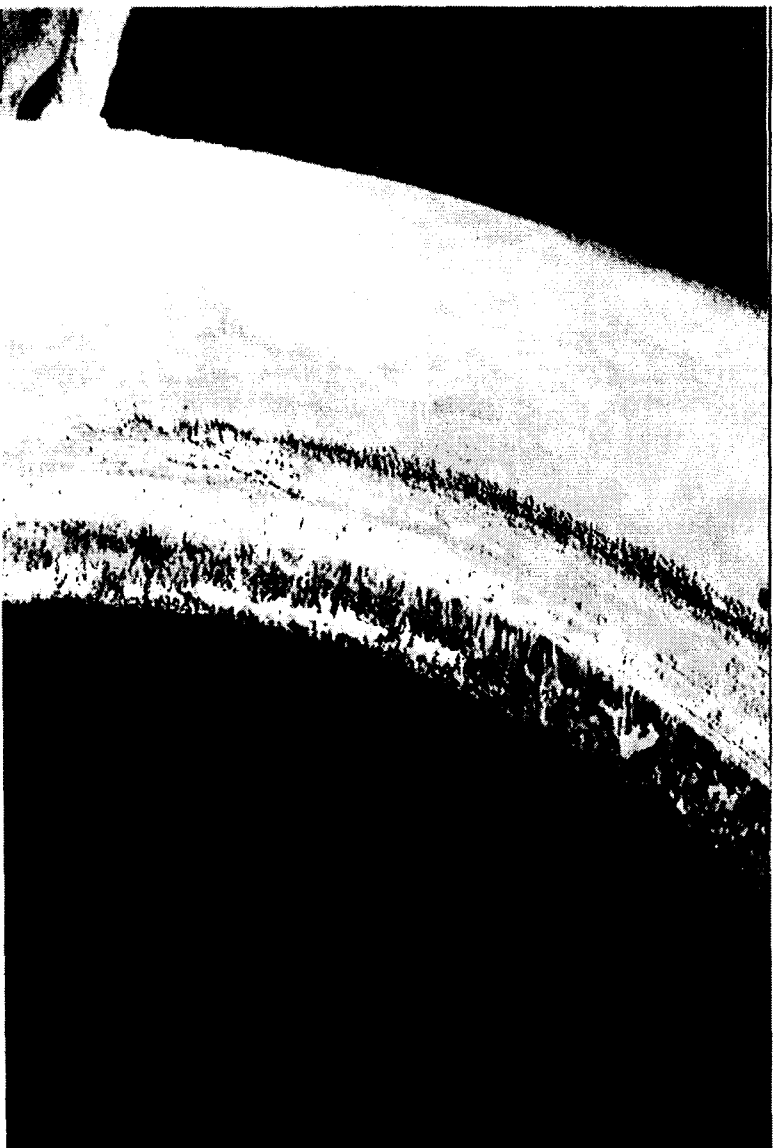
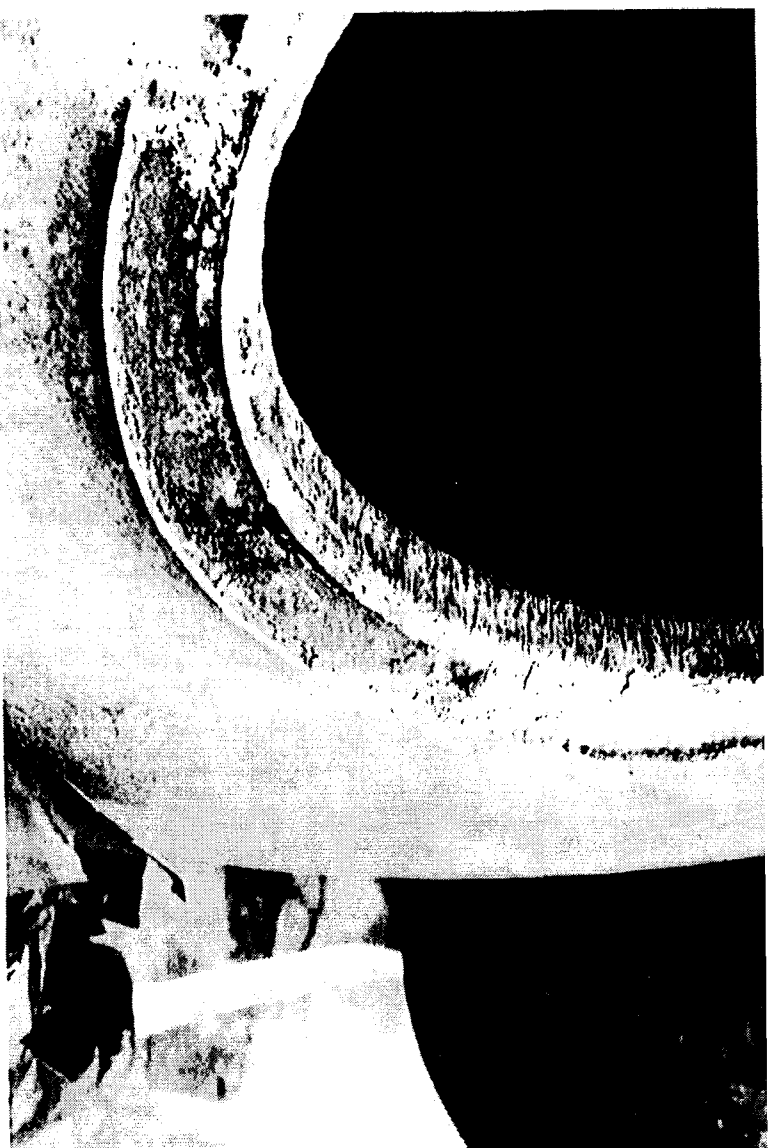
Figure 12: The striation markings on the top access ports.

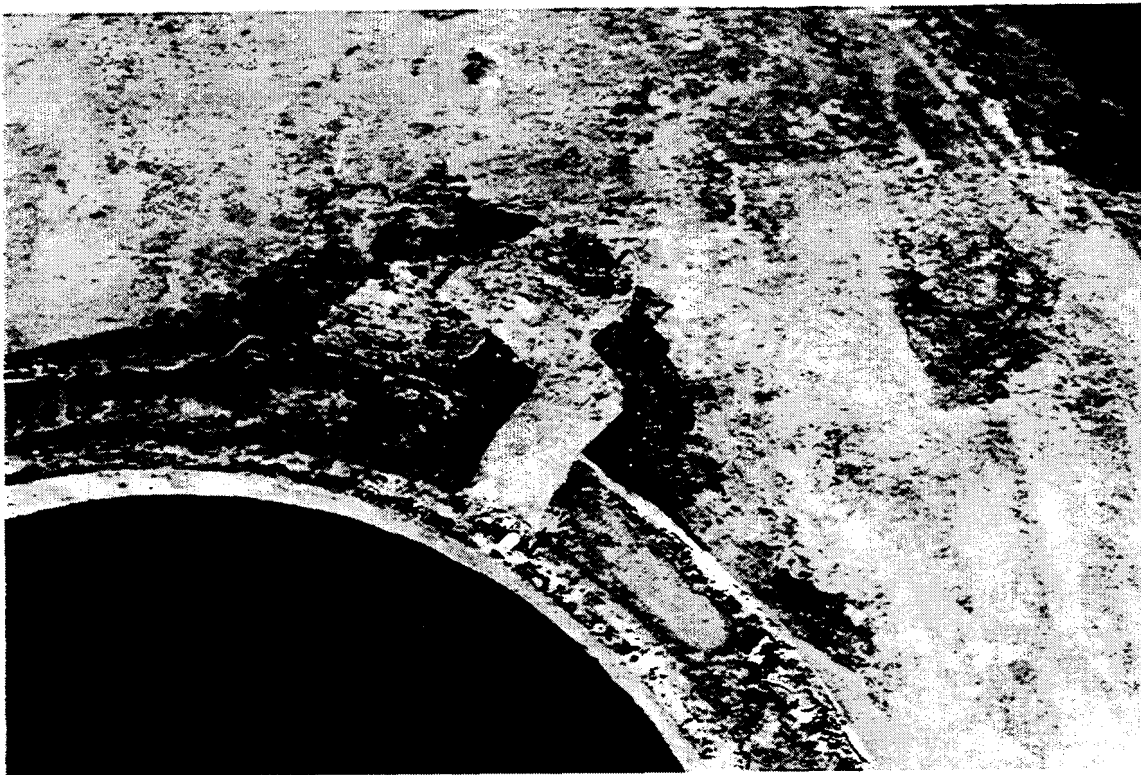
Figure 13: The tabs that held the to access port door are bent down against the stainless steel shell.

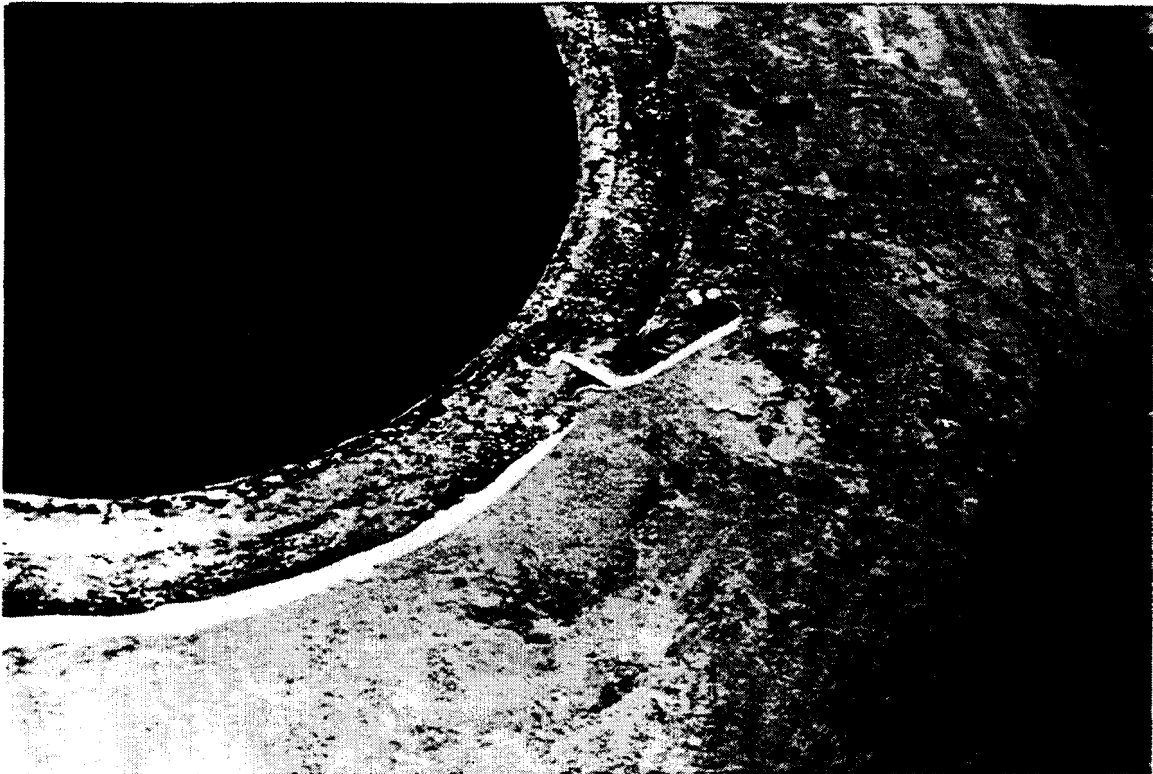
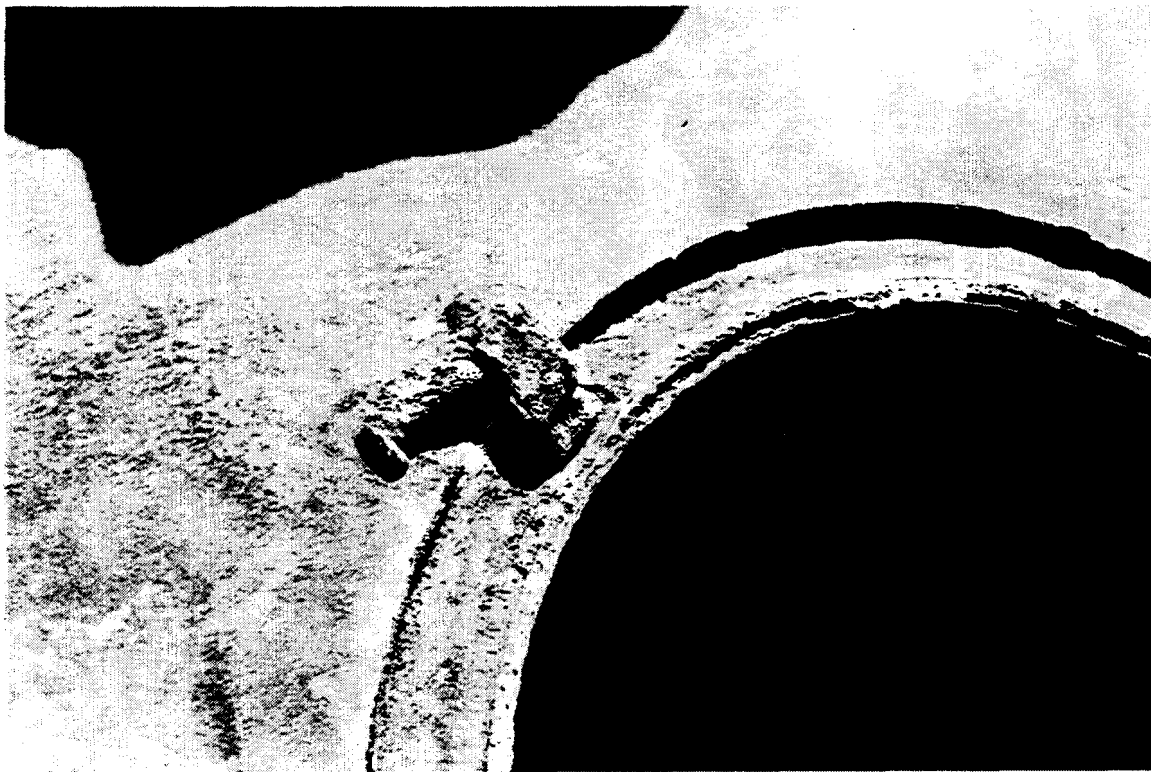
Figure 14: The insulation jacket has torn away from where it was attached to the stainless steel shell and the access door tabs are bent over against the shell.

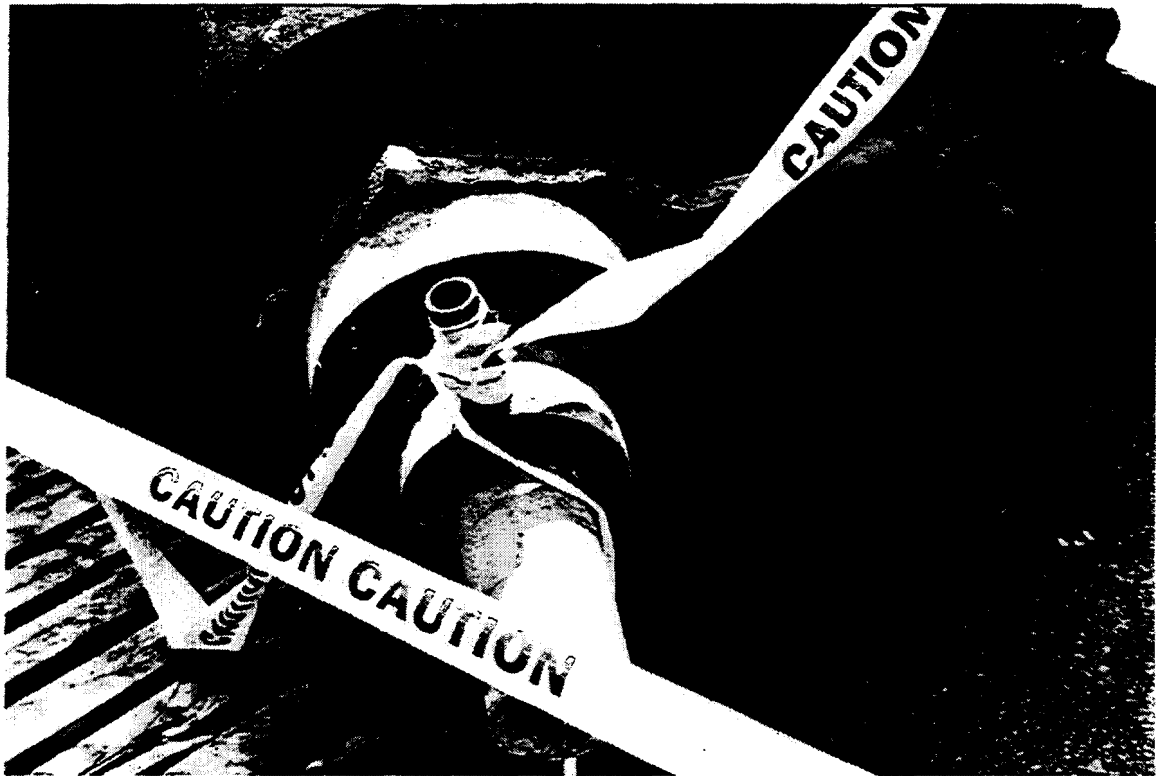
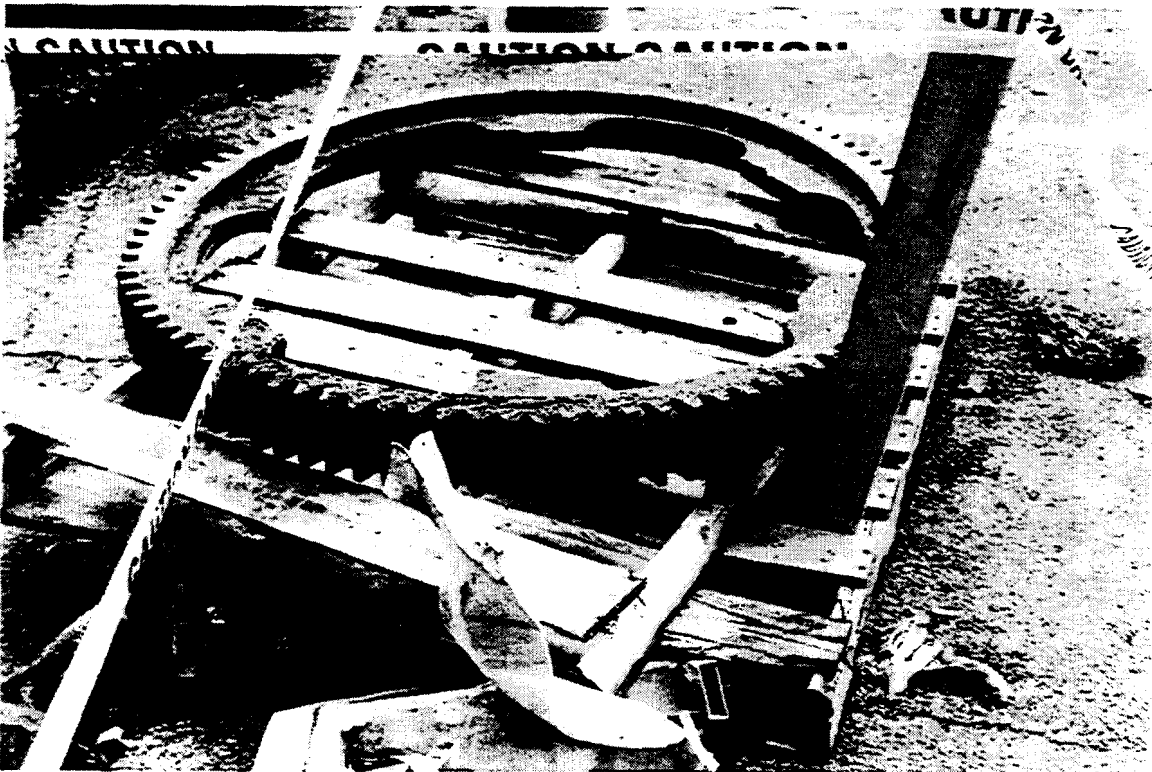
Figure 16: The gear drive side of the blender: a) the shaft (drive side) and b) the portion of the gear that fractured and separated from the blender in the accident.

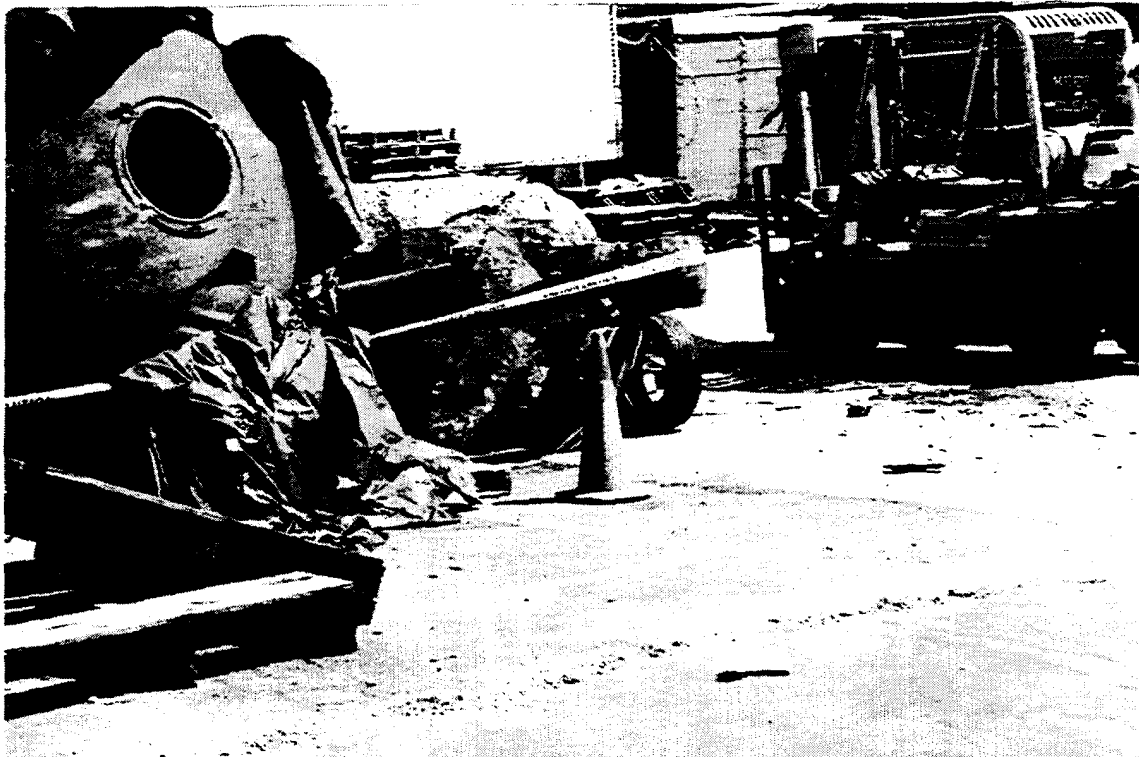
Figure 17: The concrete support and bracket that secured the bearing on the gear drive side of the blender.

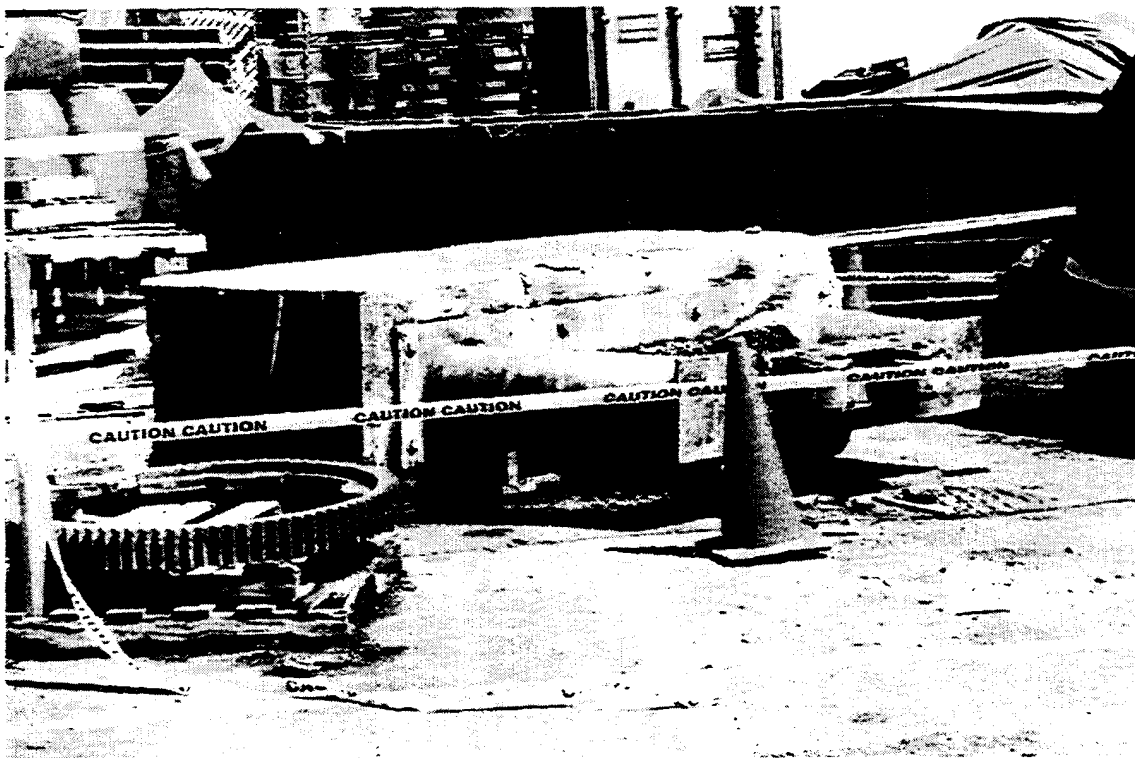
Figure 18: The concrete support and rollers that supported the belt drive side of the blender.

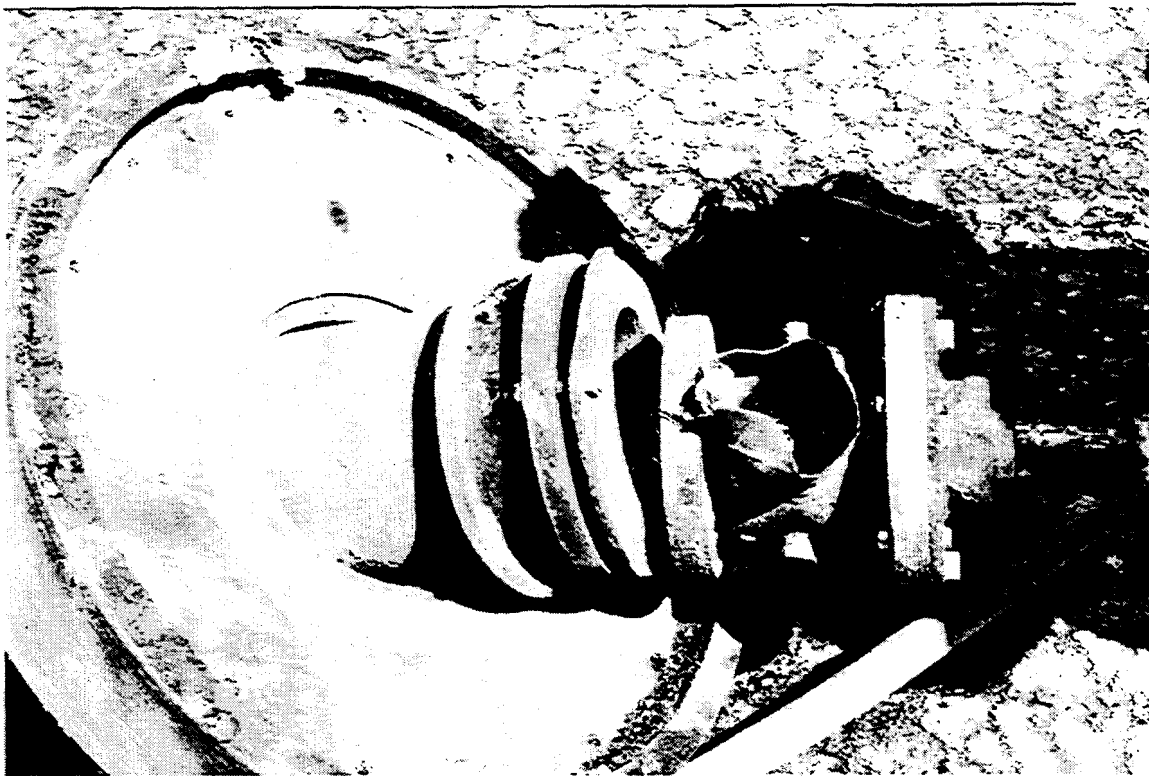
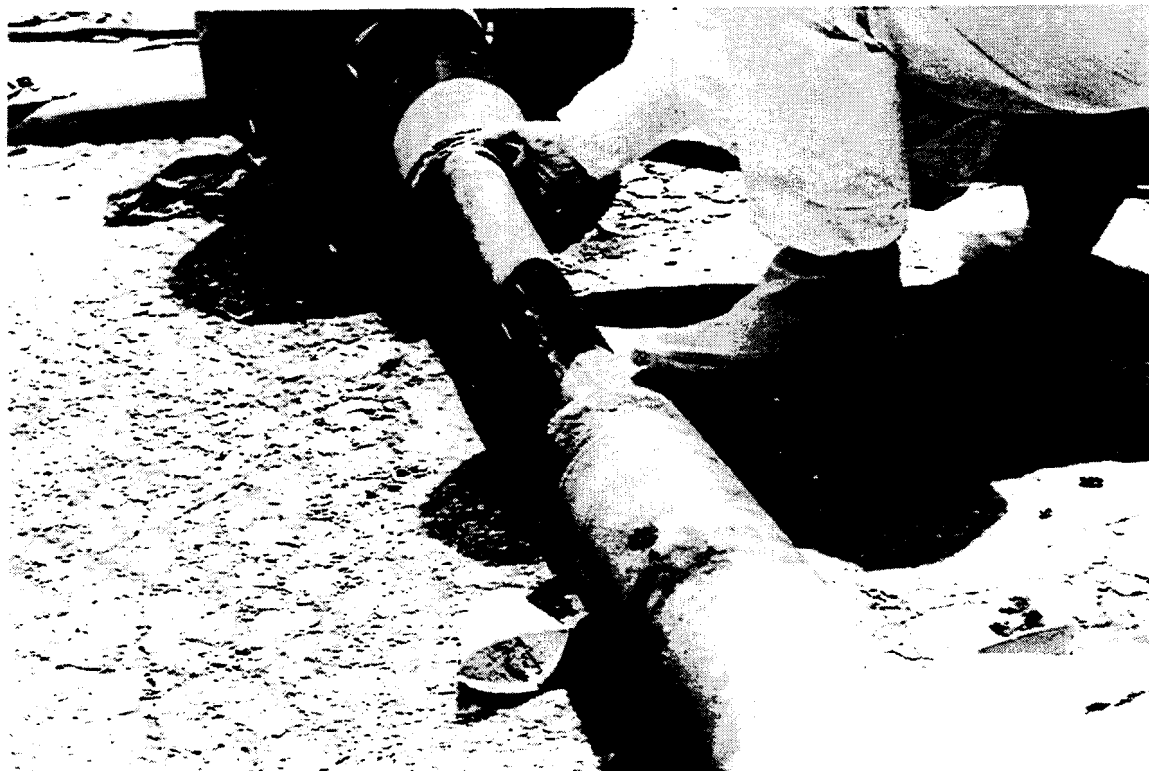
Figure 20: The wheel that supported the blender on the belt drive side and the shaft components: a) the wheel and shaft, b) the concentric shafts and tube that went into the interior of the blender.

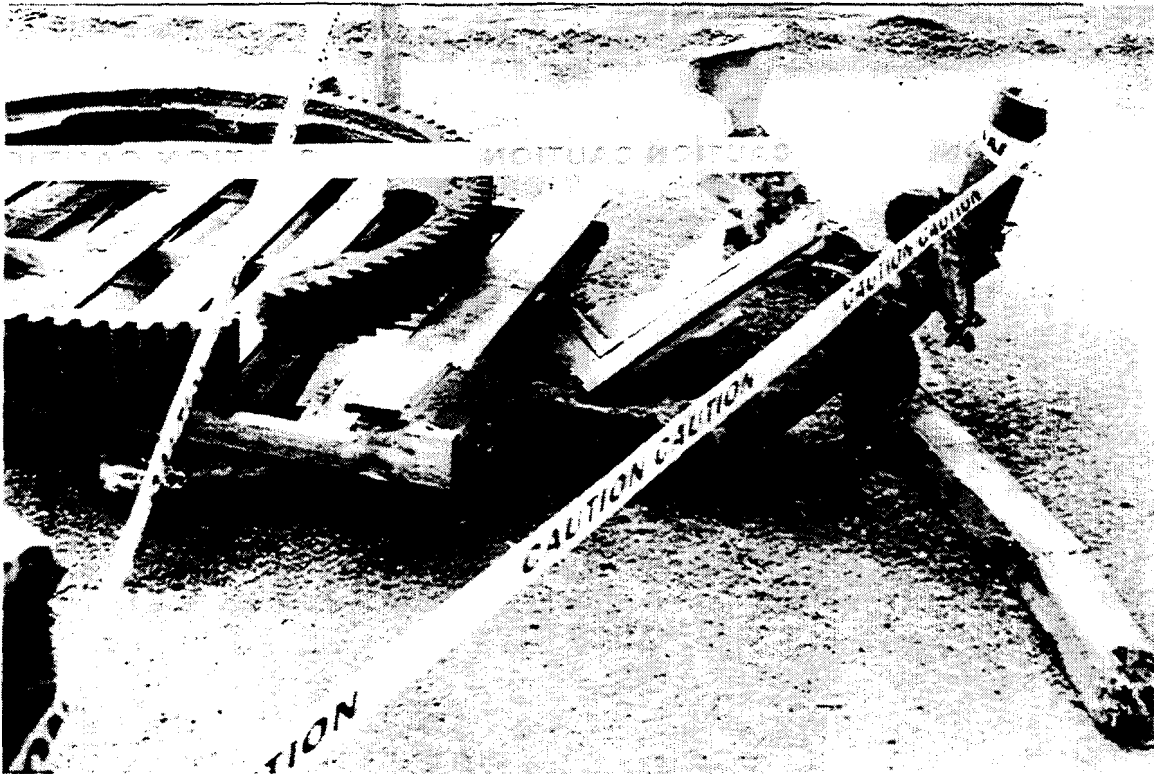
Figure 23: The intensifier bar: a) the shaft of the bar is severely deformed, b) two of the mixing plates are left, both are broken away from the shaft.

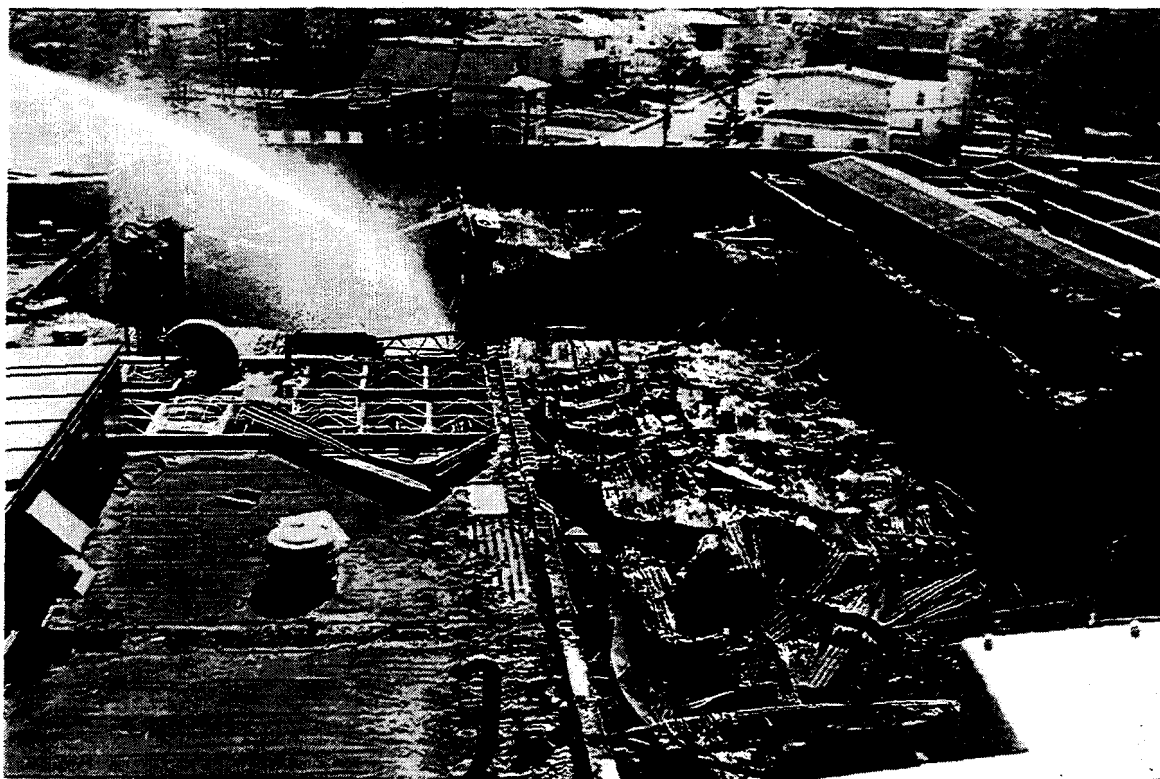
Figure 24: The Napp facility after the explosion and fire showing location in the plant where the processing took place and the location of the facility with respect to residential area in background.
