EPA CHEMICAL ACCIDENT INVESTIGATION REPORT

**Powell Duffryn
Terminals, Inc.
Savannah, Georgia**

EXECUTIVE SUMMARY

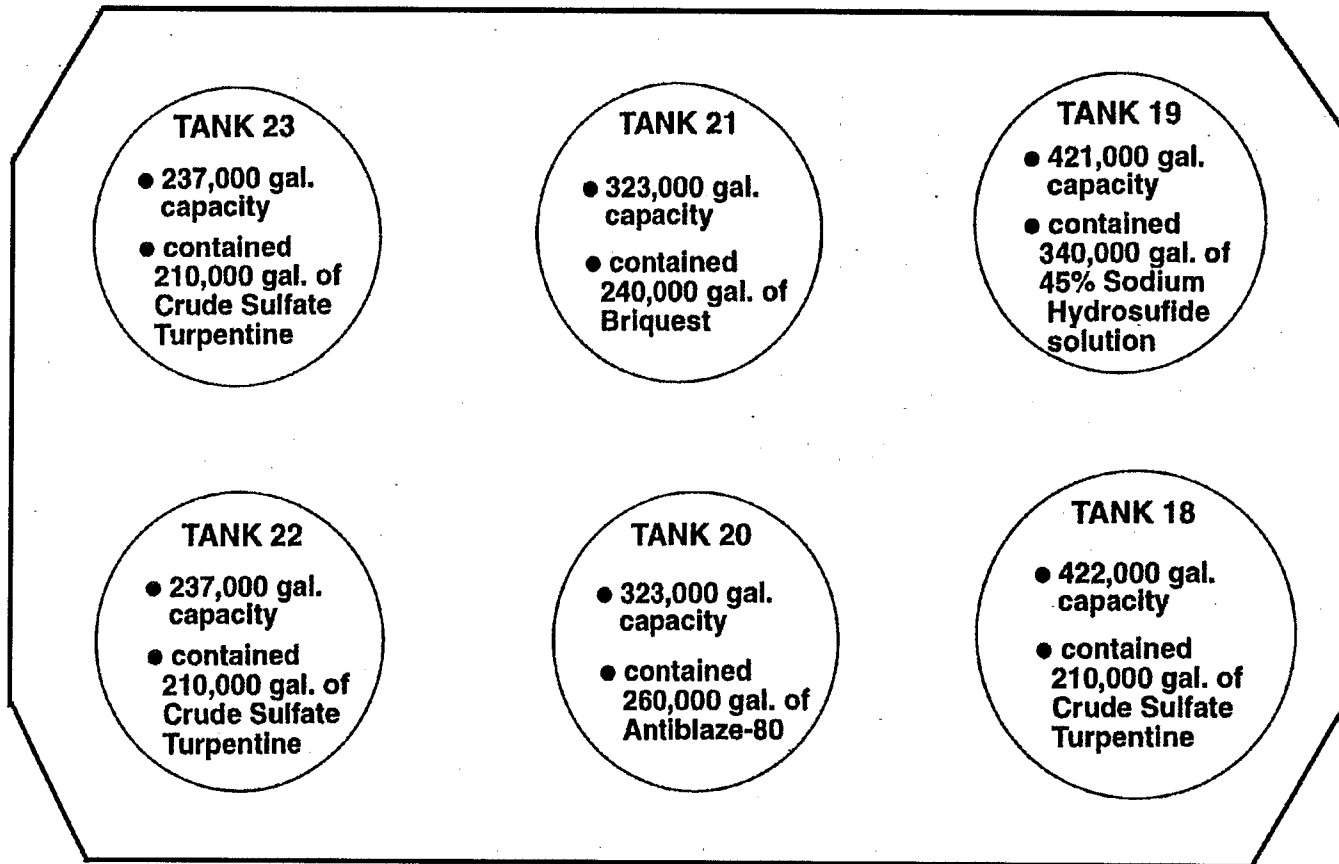
Exhibit 2
Six-Tank Enclosure, Site of Fire
(100 x 200 feet, surrounded by 5-foot Concrete Berm)

The six-tank enclosure area is about 100 by 200 feet (20,000 square feet in area). A diagram of the enclosure area along with the approximate capacity and contents of each tank is presented in Exhibit 2. The enclosure area is located slightly north of the midpoint of Powell Duffryn's southern property line. Five other tanks, much larger than the tanks in the enclosure, are located to the north and east of the enclosure.^{8,9} (These other tanks are also shown in Exhibit 1.)

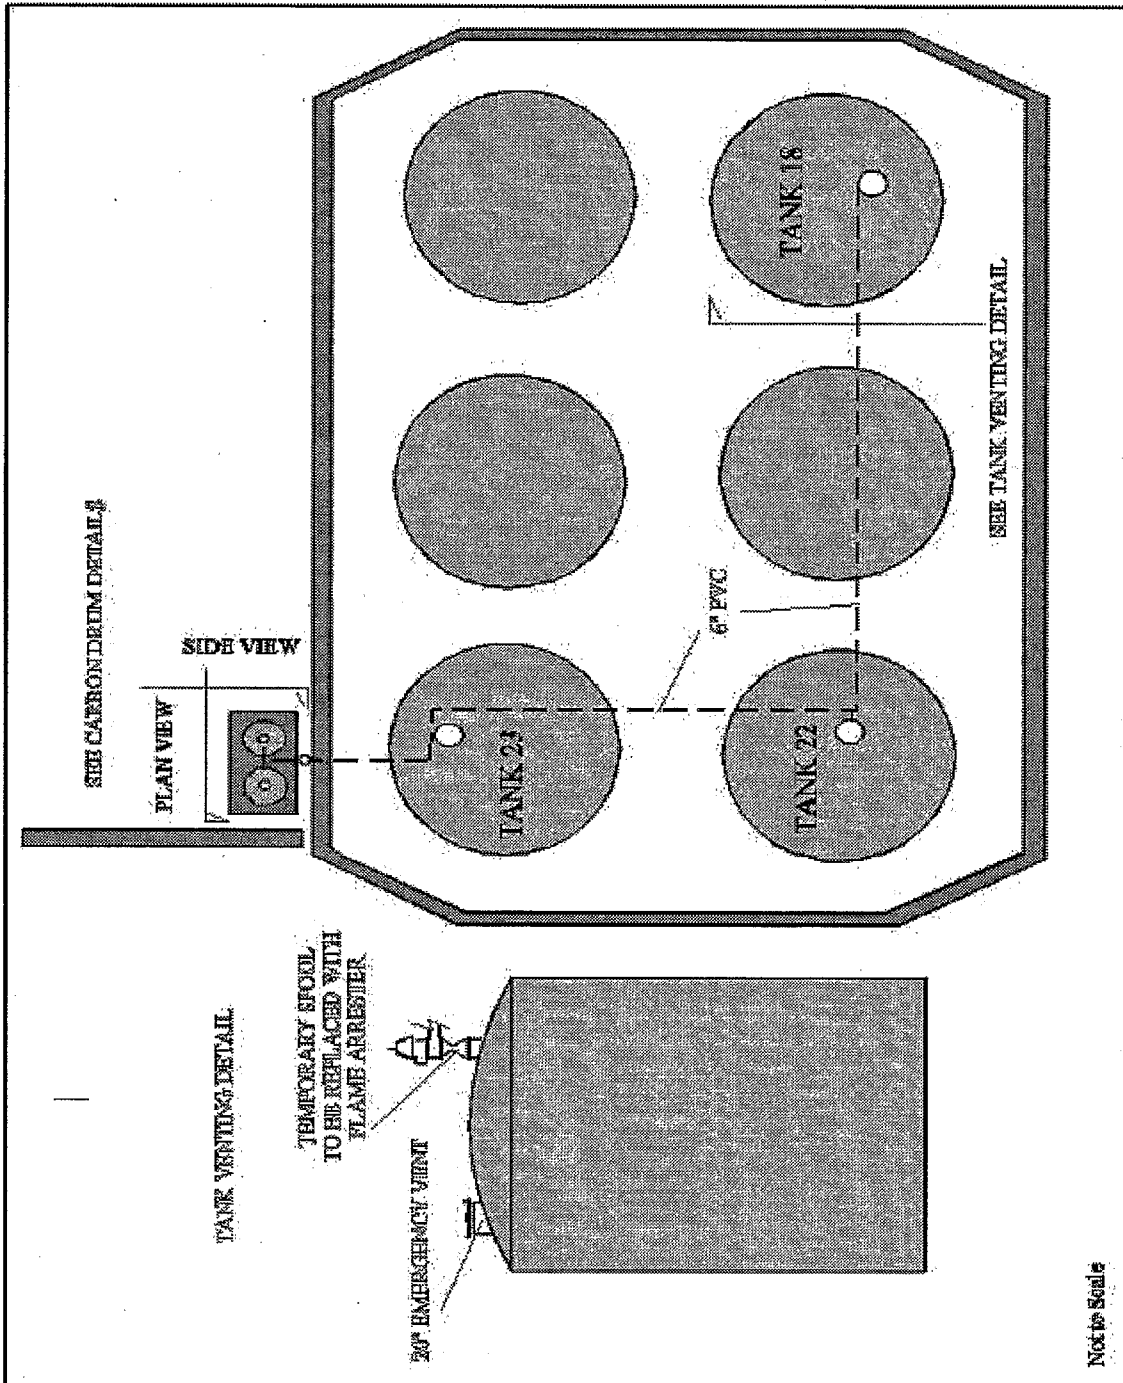
Exhibit 3. Vapor Control System

The system consisted of two metal drums (50-gallon size) containing activated carbon used for absorbing CST vapor, polyvinyl chloride (PVC) piping connecting the drums to the three flame arresters, and three pressure release vents located on the storage tanks.²⁵ It was intended that vapor from the tanks would travel through the flame arresters to the PVC piping that was mounted to existing cat walks and enter two drums of activated carbon located at ground level just outside of the enclosure area. Each tank was supposed to be equipped with a

flame arrester at its connection to the PVC pipe; however, at the time of the accident, the flame arresters were not installed. The VC system was in place, with the exception of the flame arresters, for more than a month before the accident. Piping "spools" (small fixed sections) were installed in place of the flame arresters. (However, the system was not completely closed to the atmosphere until the last foamer was installed and sealed at 2 p.m. on the afternoon of the accident - see below.)

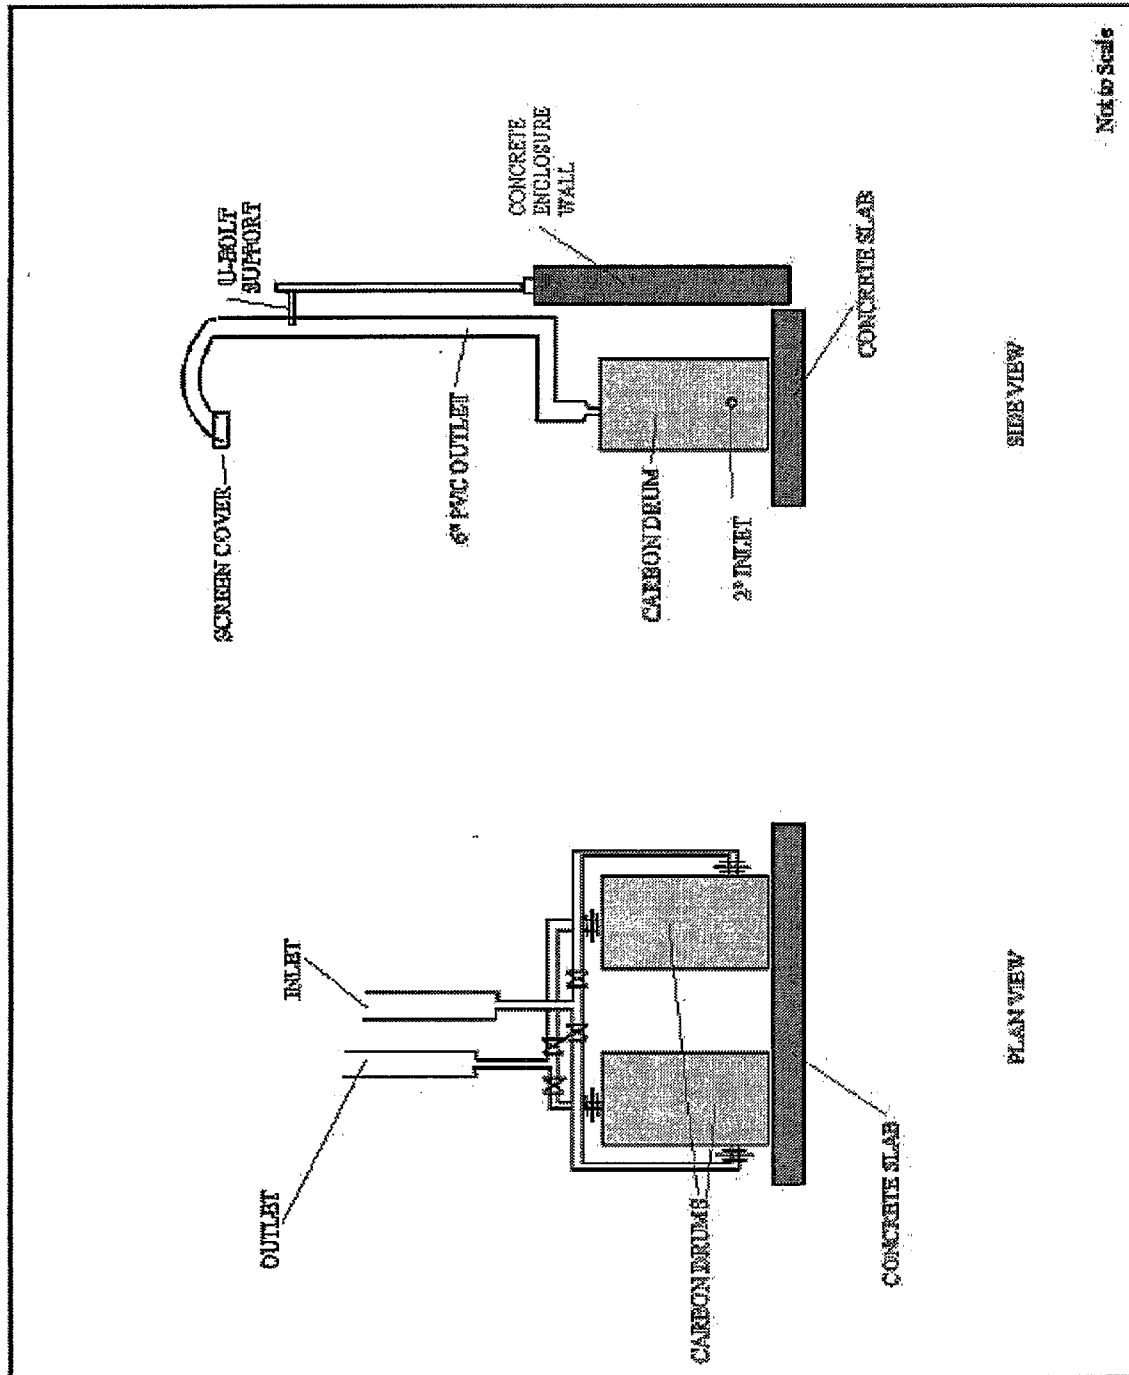
Exhibit 4. Carbon Drums

Although the temperature of the activated carbon may have become hot when CST vapor was vented from the storage tanks to the carbon drums, the low level of oxygen present in the drums probably averted a fire. However, the VC system did not have a bypass for preventing outside air from being drawn into the drums when cool outside temperatures caused vapor in the storage tanks to contract. The introduction of air provided the needed oxygen to trigger a fire.

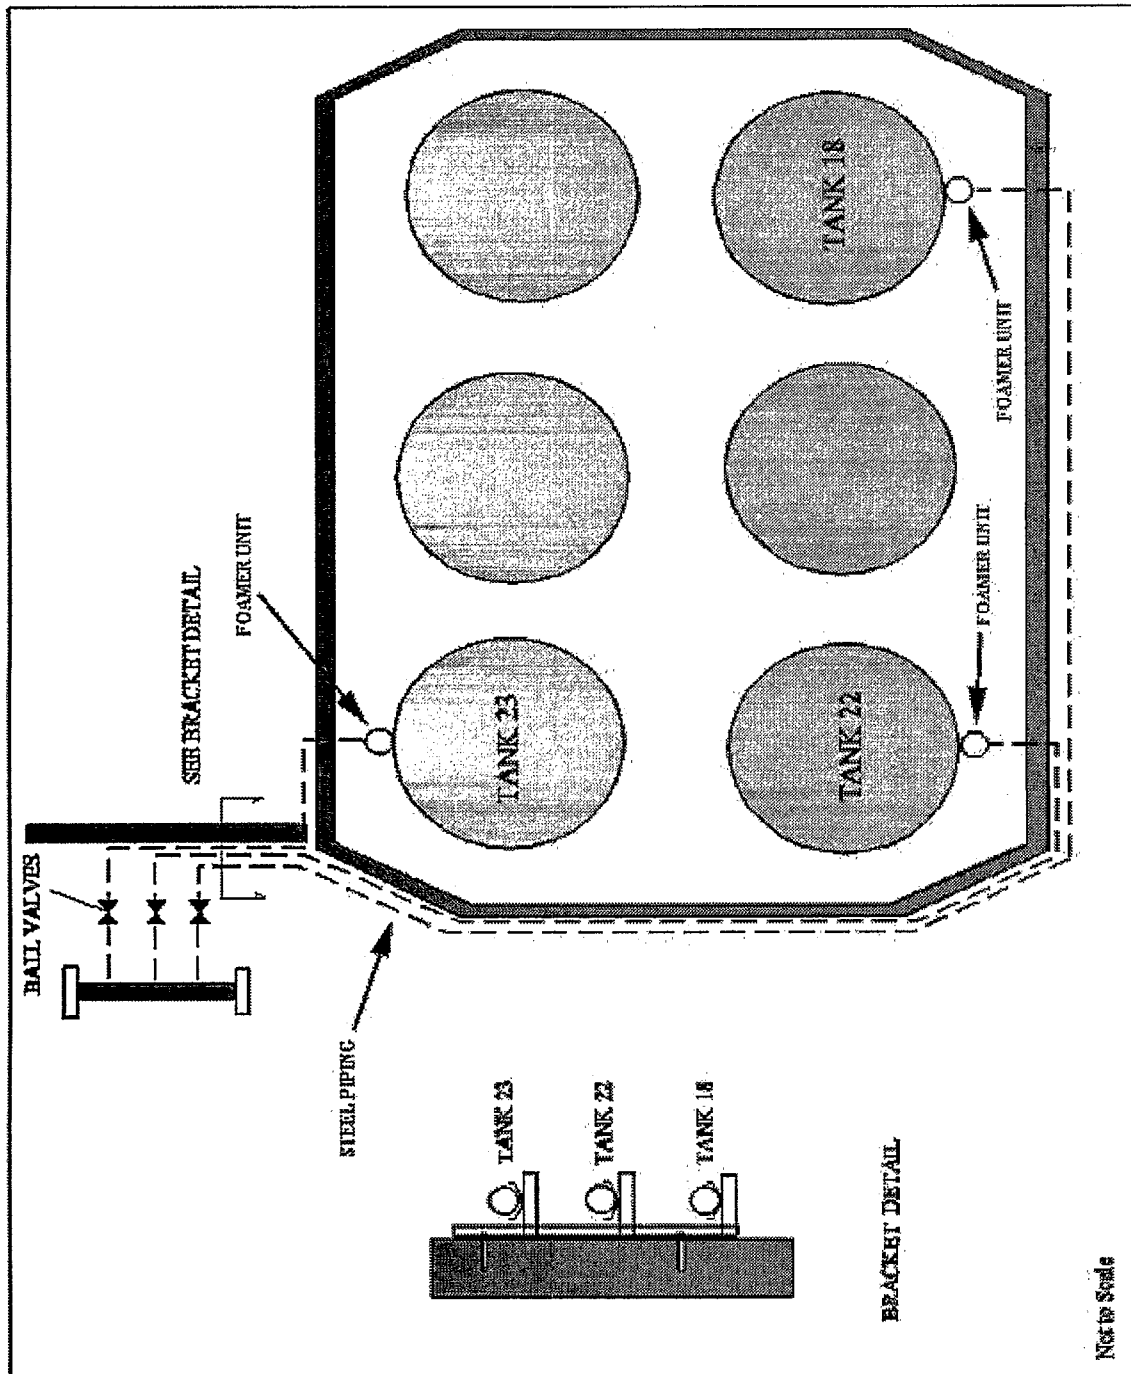
Exhibit 5. Fixed Piping Foam Fire Protection System

- The facility had been broken into and vandalized on two occasions -- two months prior to the fire and two weeks prior to the fire.⁴
- On March 3, 1995, PDTI's contractor began installing the foam fire protection system. The installation of the foam fire protection system had not been completed, and the system was not operational at the time of the fire.^{41, 44}

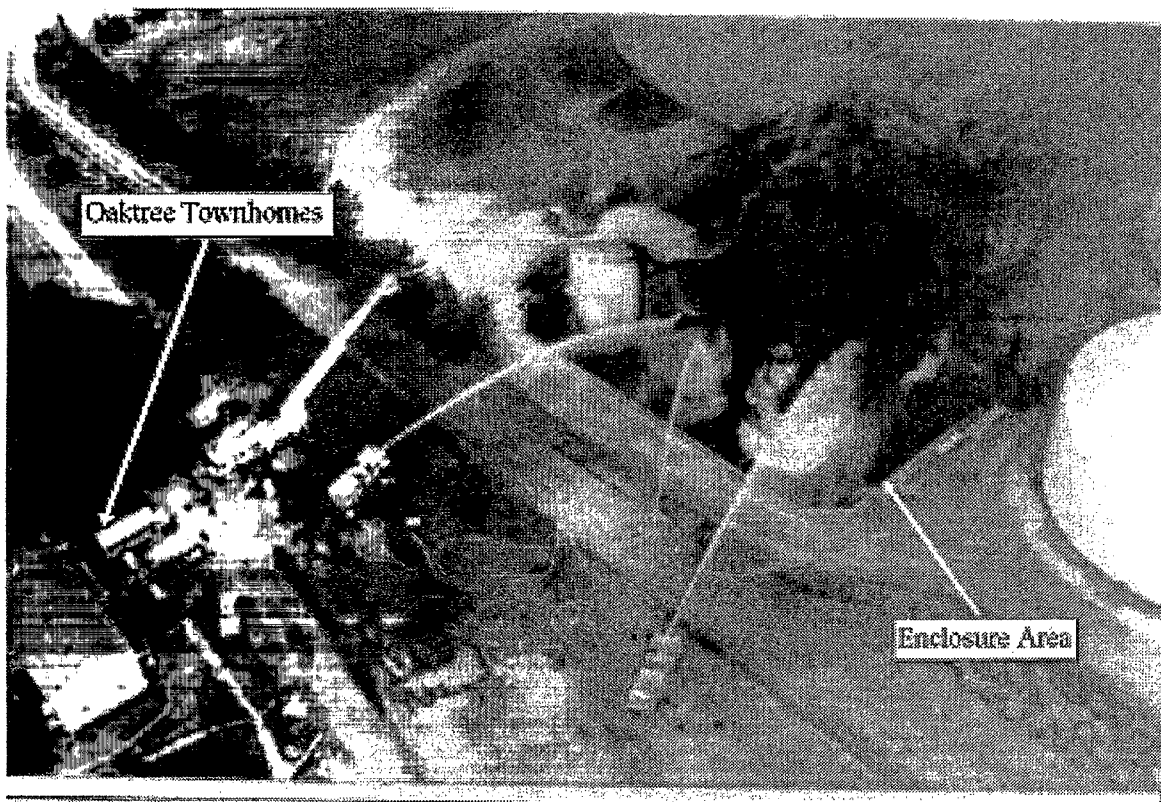
Exhibit 6
Area of Fire and Firefighting Efforts ²⁹

The intense fire forced the nearby residents of the Oaktree Townhomes complex to immediately evacuate. The fire was sufficiently intense to cause damage to some trees and buildings in the Oaktree complex. The location of the Oaktree Townhomes in relation to the fire can be seen in the photograph in Exhibit 6.^{3, 7, 30, 31}

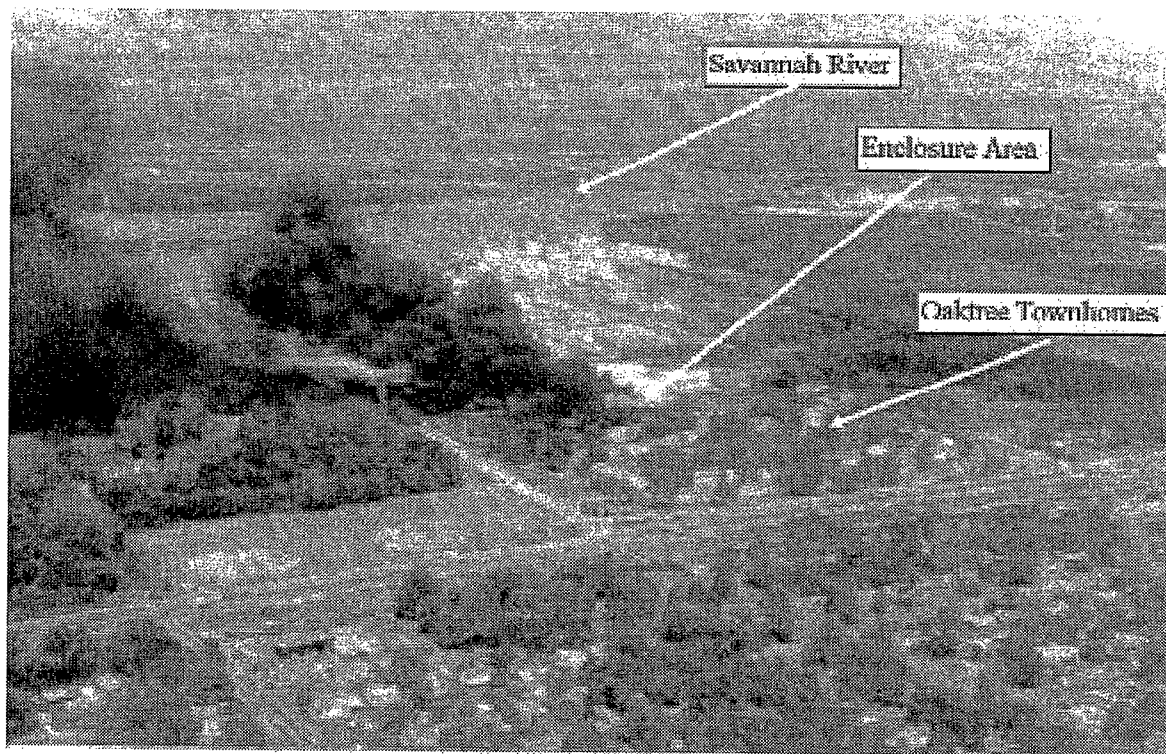
Exhibit 8
Area of Fire and Savannah River²⁹

River in relation to the fire in the six-tank enclosure area can be seen in the photograph in Exhibit 8. The fire burned on and off for approximately three days before being extinguished late on April 12, 1995.^{3, 30, 31, 32} The three tanks containing CST (18, 22, and 23) were destroyed, and the other three tanks in the six-tank enclosure were damaged. The company's office building, located about 100 yards north of the enclosure, was also destroyed in the fire. Some of the large tanks to the north and east of the enclosure area suffered some degree of radiant heat and smoke damage, but none of them leaked as a result of the damage.⁷ Some of these large tanks are shown in Exhibit 9.

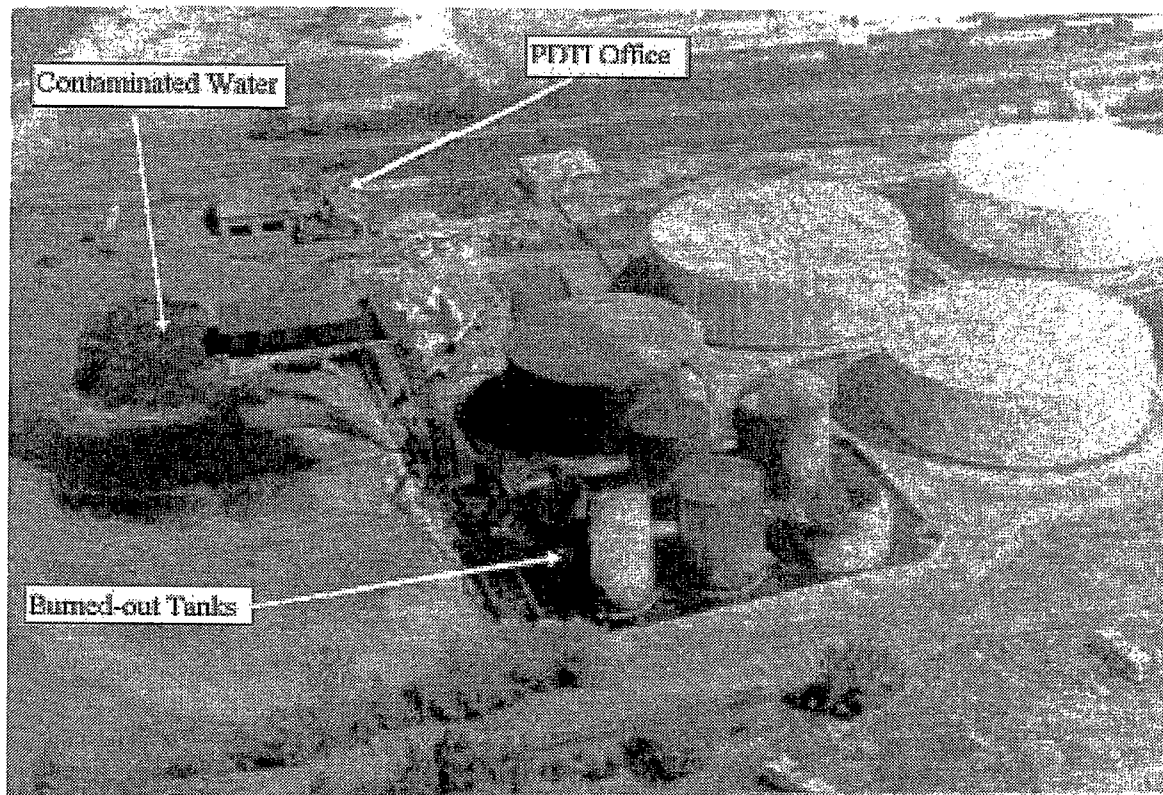
Exhibit 9
Burned-out Tanks and Pool of Contaminated Water²⁹

The damaged tanks and firefighting effort left approximately 12 million gallons of contaminated water covering an area of about 25 to 40 acres of marsh. The photograph in Exhibit 9 shows the area after the fire was extinguished. A large pool of water that overflowed from the enclosure area can be seen. The contaminated water was determined to be hazardous

because of the high pH and the presence of reactive sulfides that produced hydrogen sulfide. Hydrogen sulfide is toxic, with an Immediately Dangerous to Life and Health (IDLH) level of 100 parts per million (ppm). (IDLH levels are developed for worker protection by the National Institute for Occupational Safety and Health (NIOSH).) Hydrogen sulfide is also flammable, with a flammability range between 4.0 and 44.0 percent. An extensive cleanup of the area was required.⁹

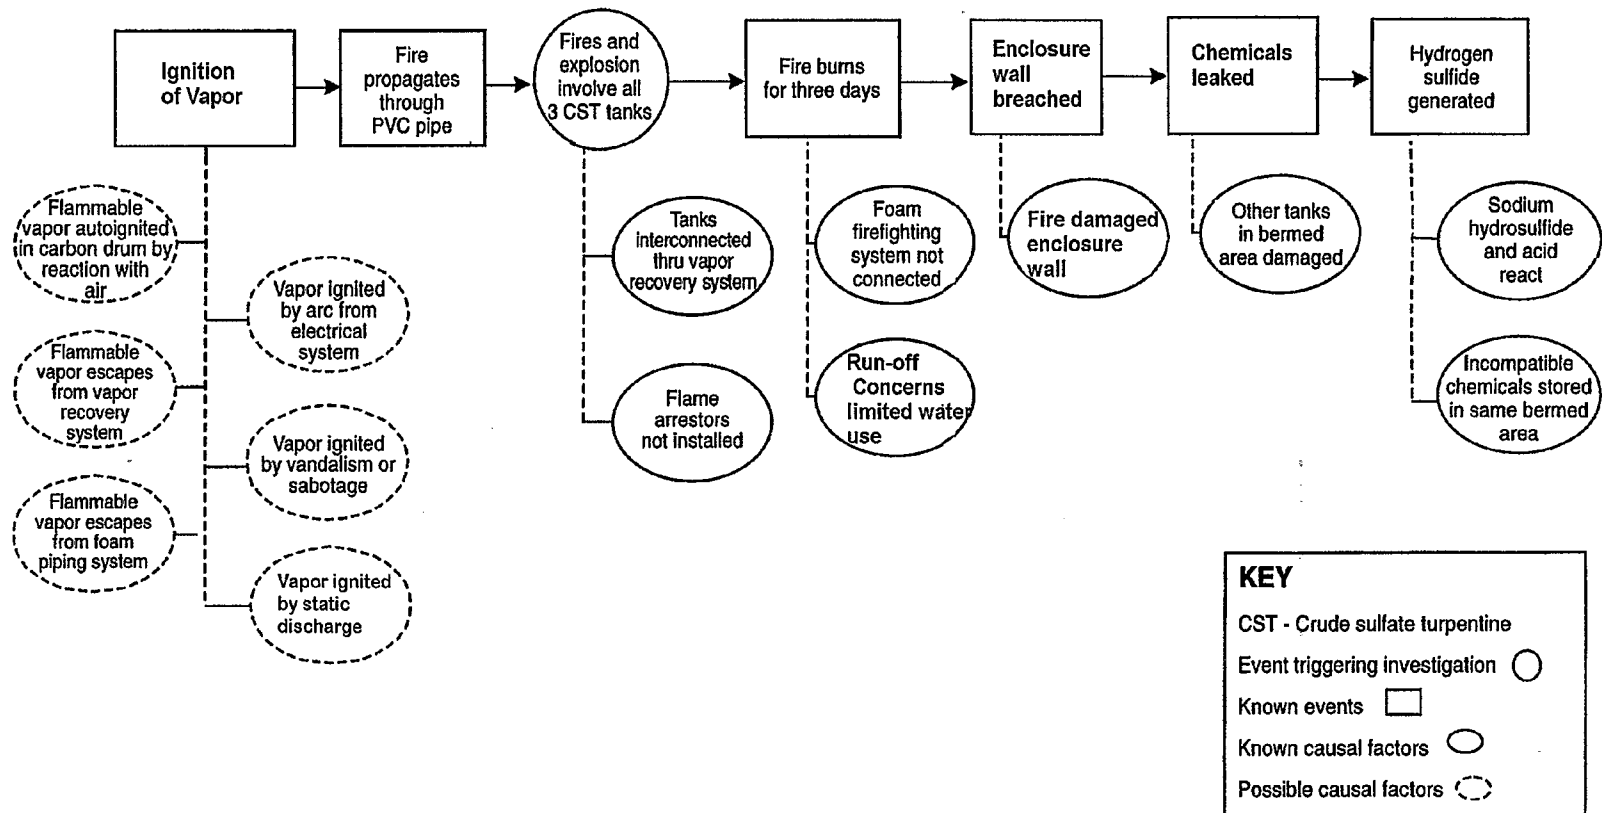
An Event and Causal Factors Diagram for the PDTI accident is presented in Exhibit 10. This diagram presents the sequence of events and causal factors that may have contributed to the occurrence of each of the events. Possible scenarios for immediate cause of the accident, and contributing factors are discussed below. They are included in the Events and Causal Factors Diagram.

The CAIT concludes that the most likely cause of the incident at the PDTI facility was ignition of CST vapors in the carbon adsorption drums due to the inadvertent addition of atmospheric air. The fire then traveled back to the storage tanks through the vent piping, igniting the contents triggering explosions and fire.
