# **EXPERT REVIEW OF EPA/OSHA JOINT CHEMICAL ACCIDENT INVESTIGATION REPORT**

**Napp Technologies, Inc.  
Lodi, New Jersey**

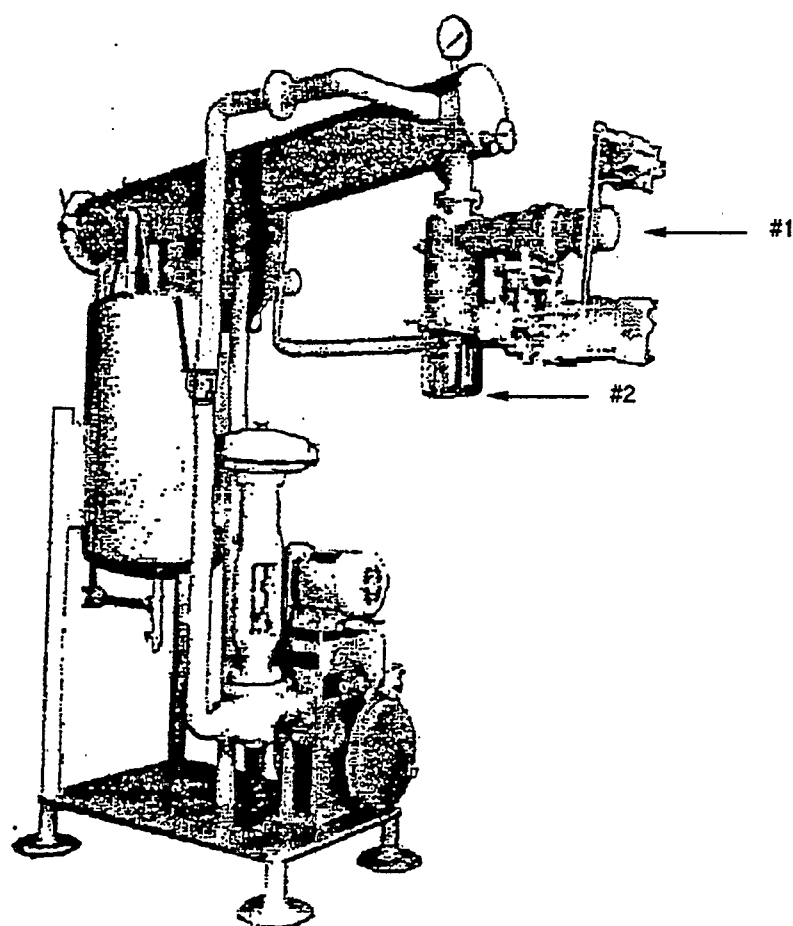
FIGURE 3A: TYPICAL VACUUM COLLECTION SYSTEM AS SUPPLIED BY PATTERSON-KELLEY. #1 SHOWS APPROXIMATE LOCATION OF INLET FROM BLENDER VACUUM LINE; #2 SHOWS VACUUM SEPARATOR BOWL.

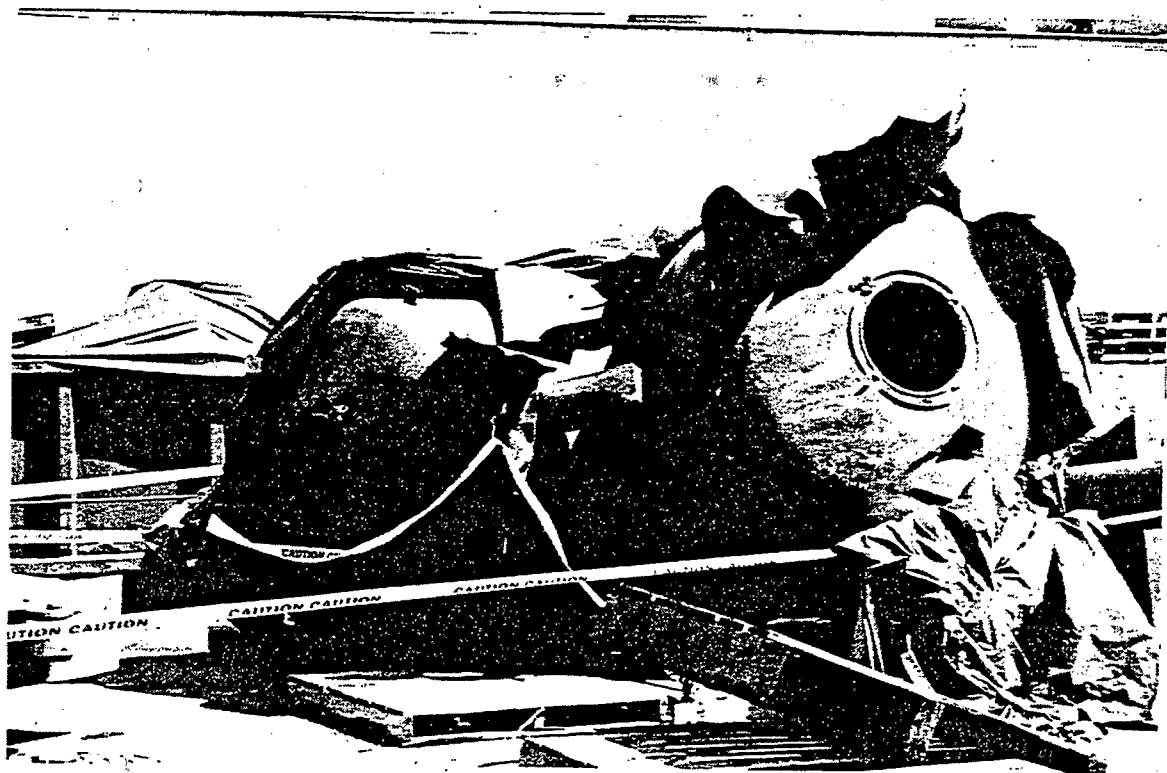
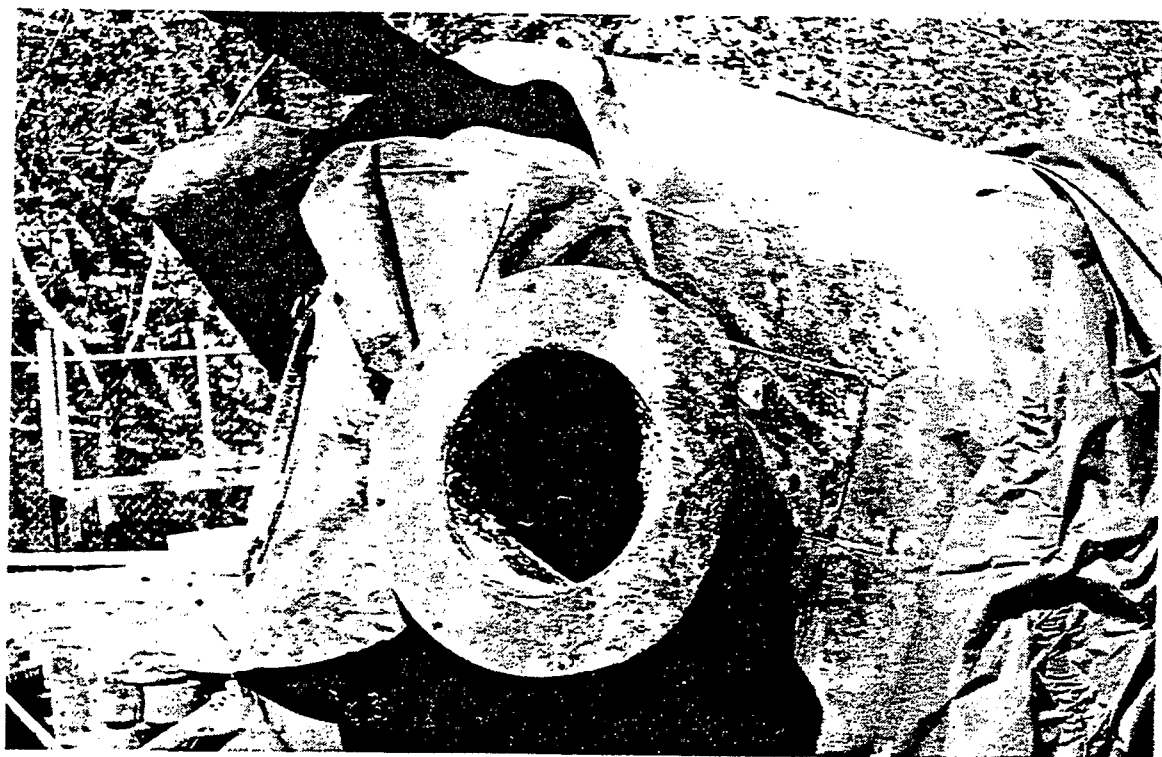
Figure 9: The general condition of the 125 cubic foot blender: a) the top access ports and damaged insulation jacket, and b) the flange to which the belt drive attaches.

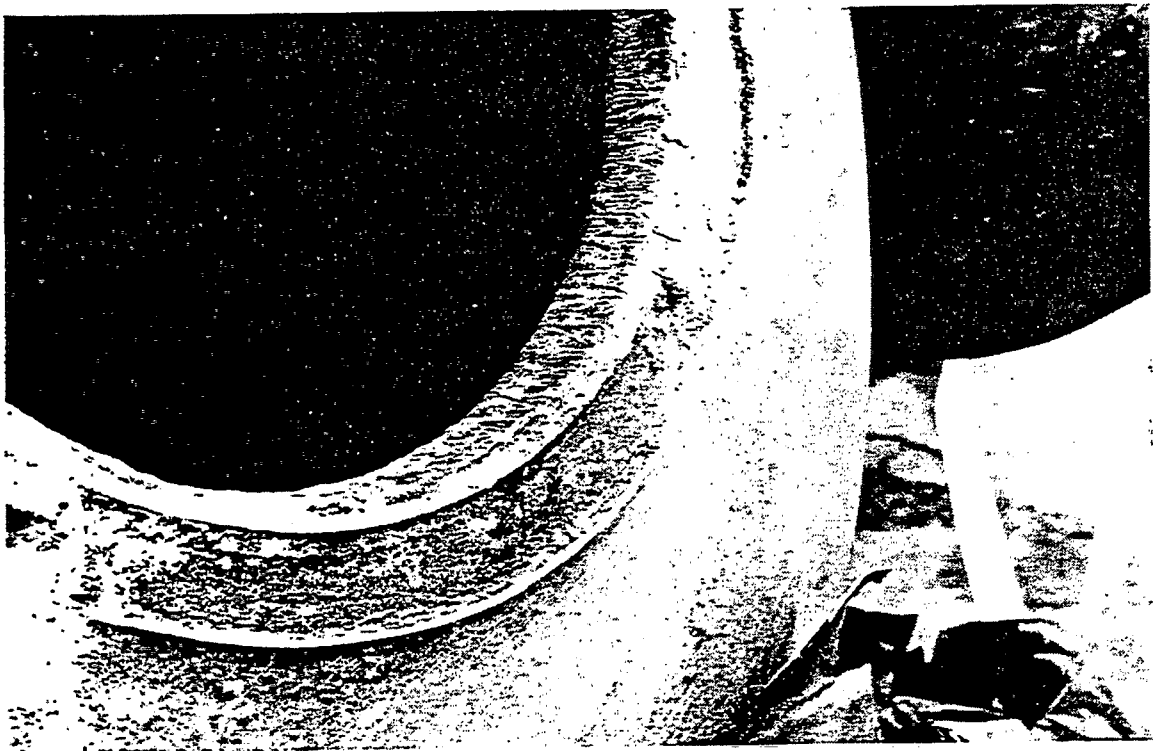
Figure 12: The striation markings on the top access ports.

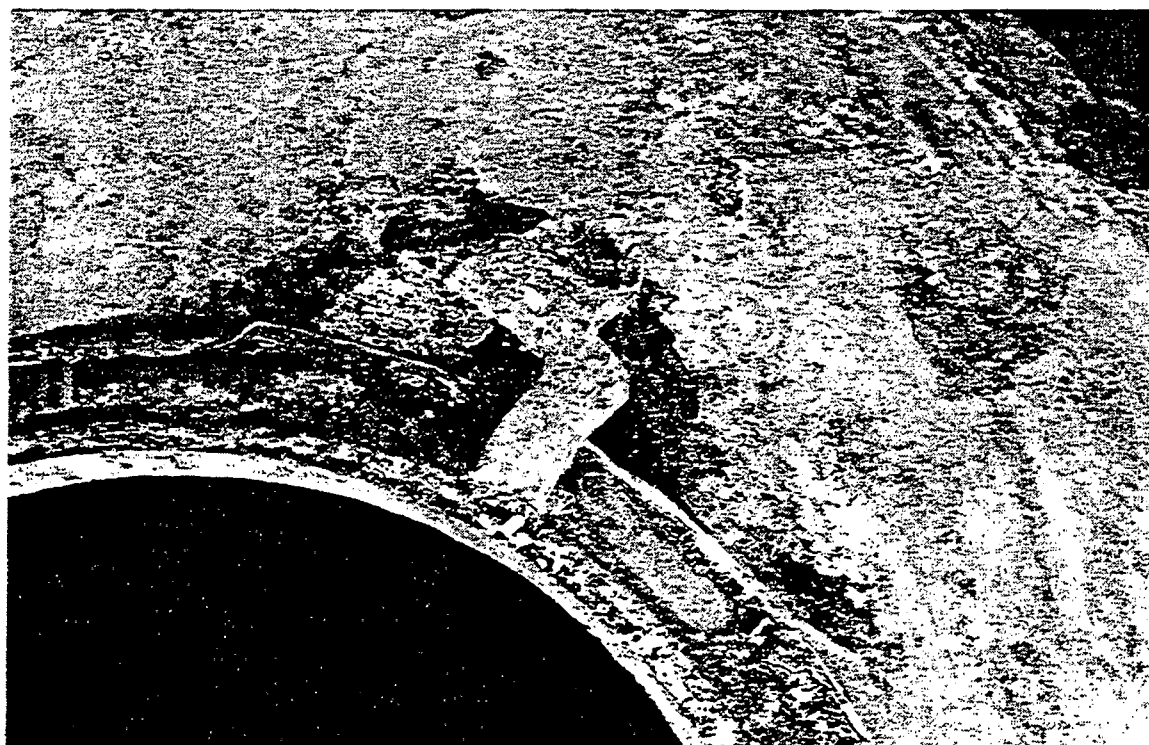
Figure 13: The tabs that held the top access port door are bent down against the stainless steel shell.

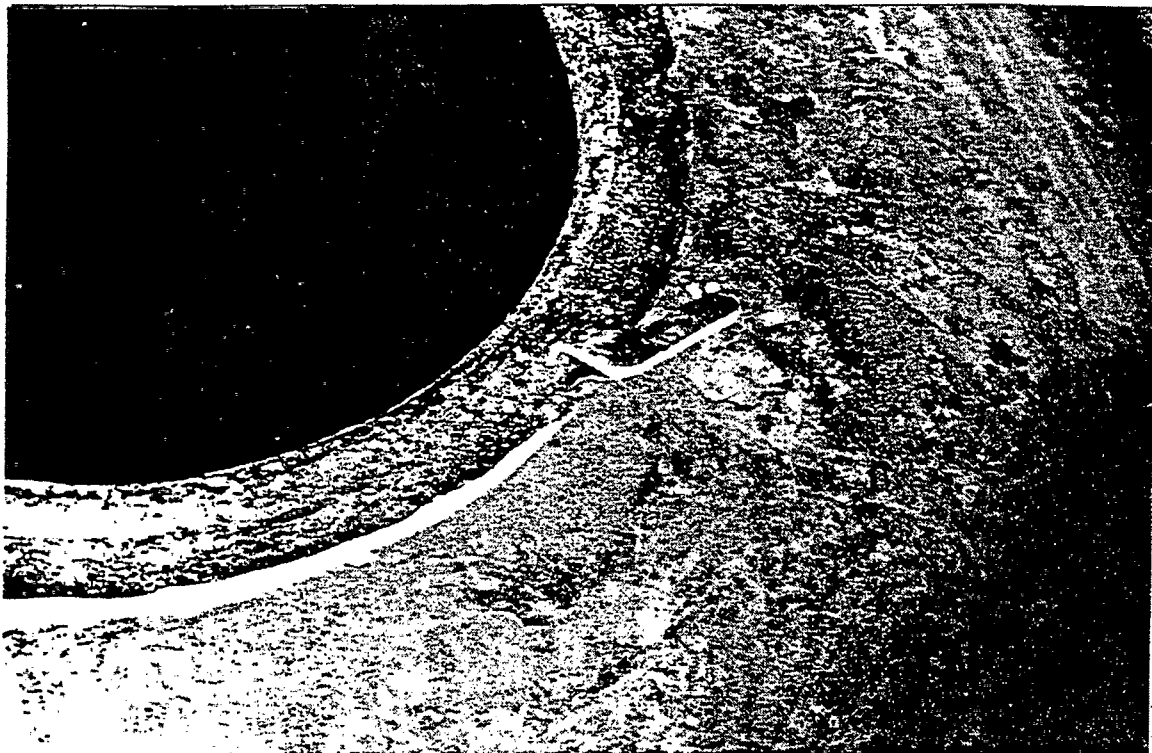
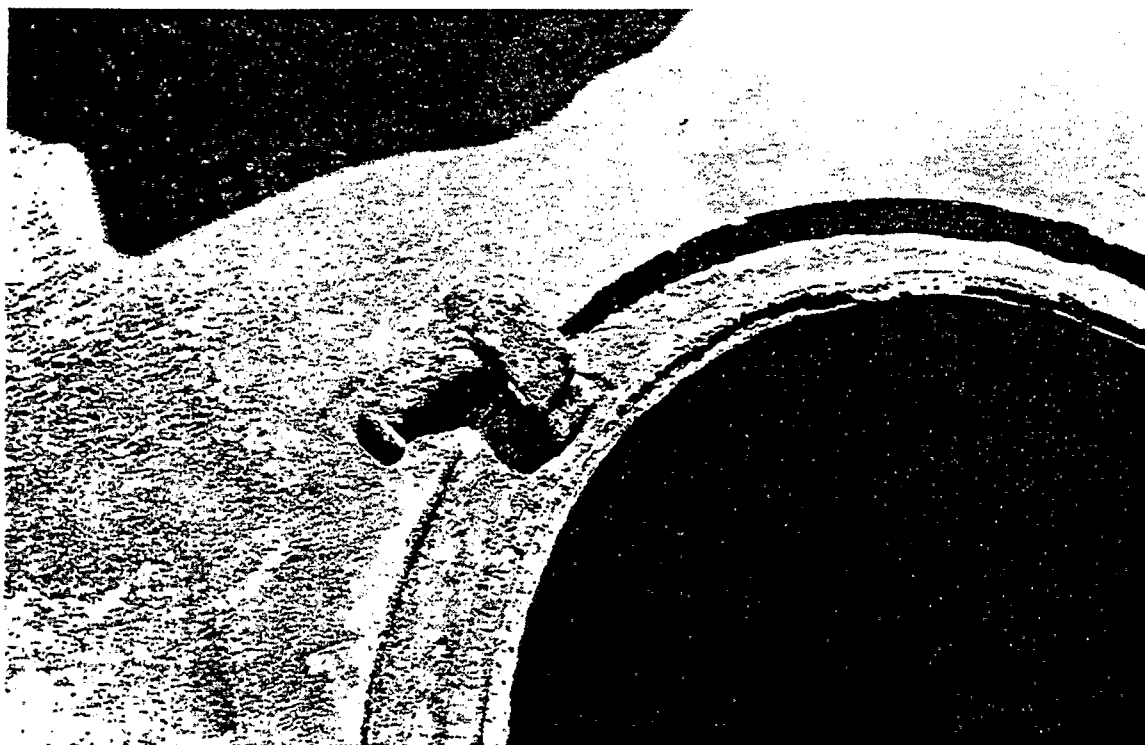
Figure 14: The insulation jacket has torn away from where it was attached to the stainless steel shell and the access door tabs are bent over against the shell.

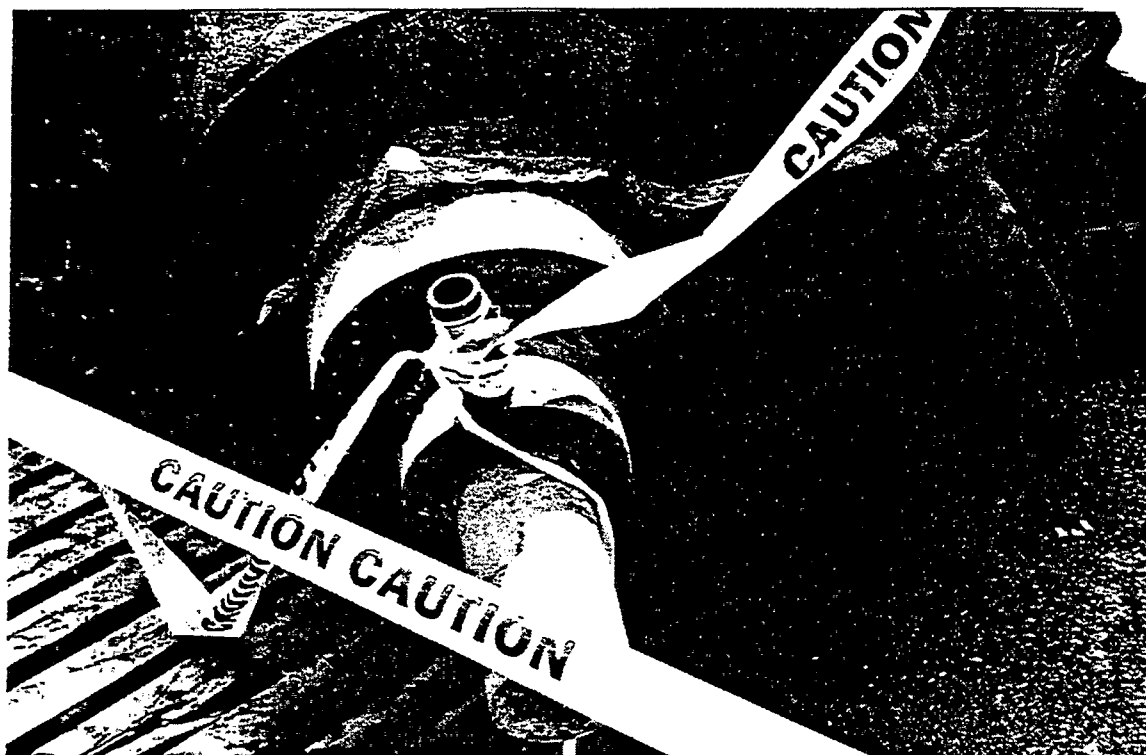
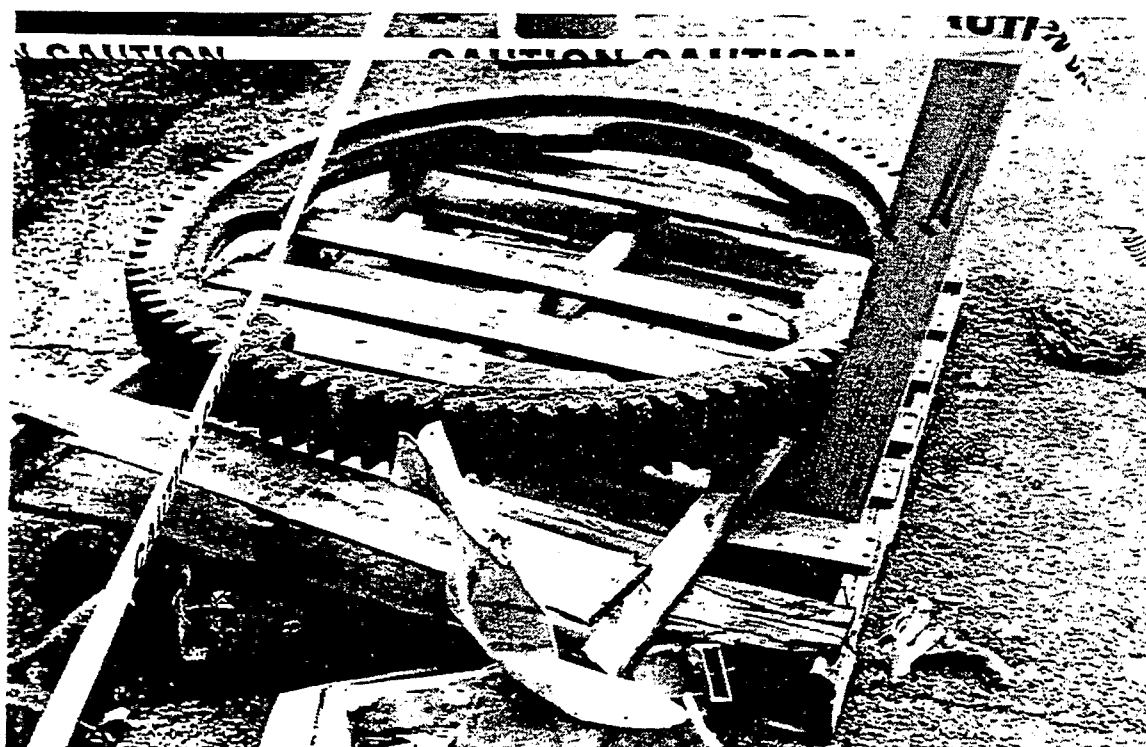
Figure 16: The gear drive side of the blender: a) the shaft (drive side) and b) the portion of the gear that fractured and separated from the blender in the accident.

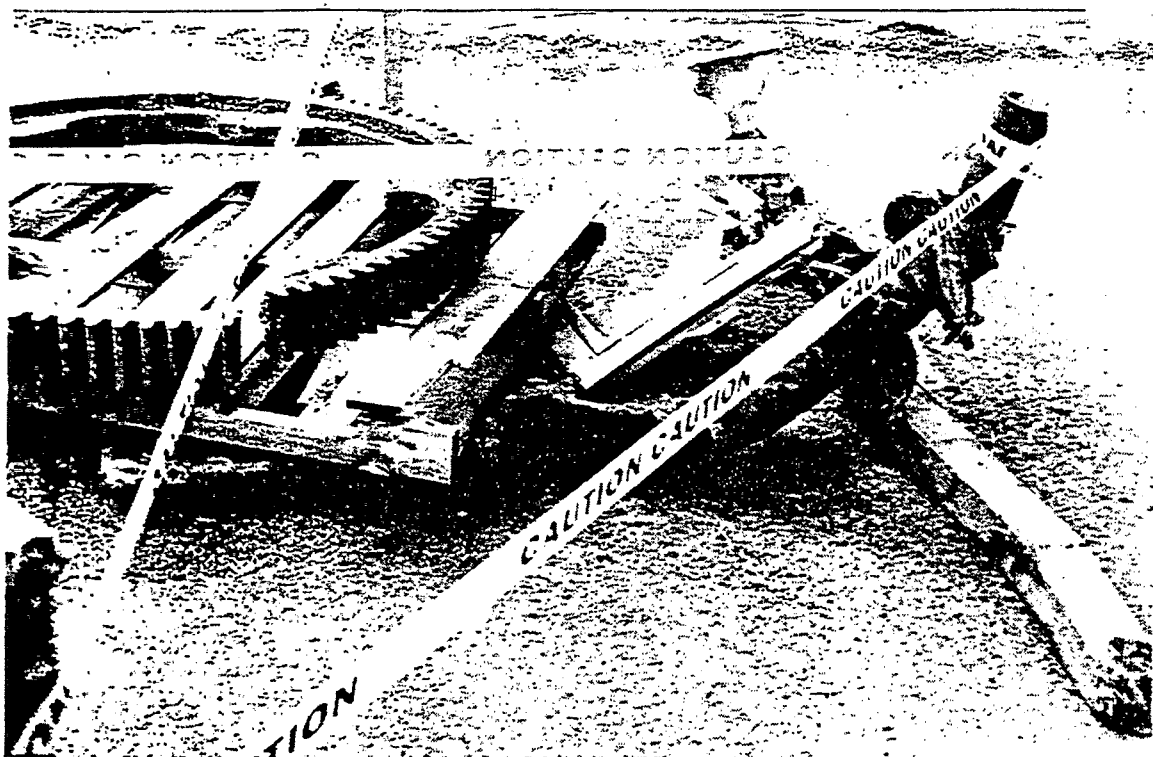
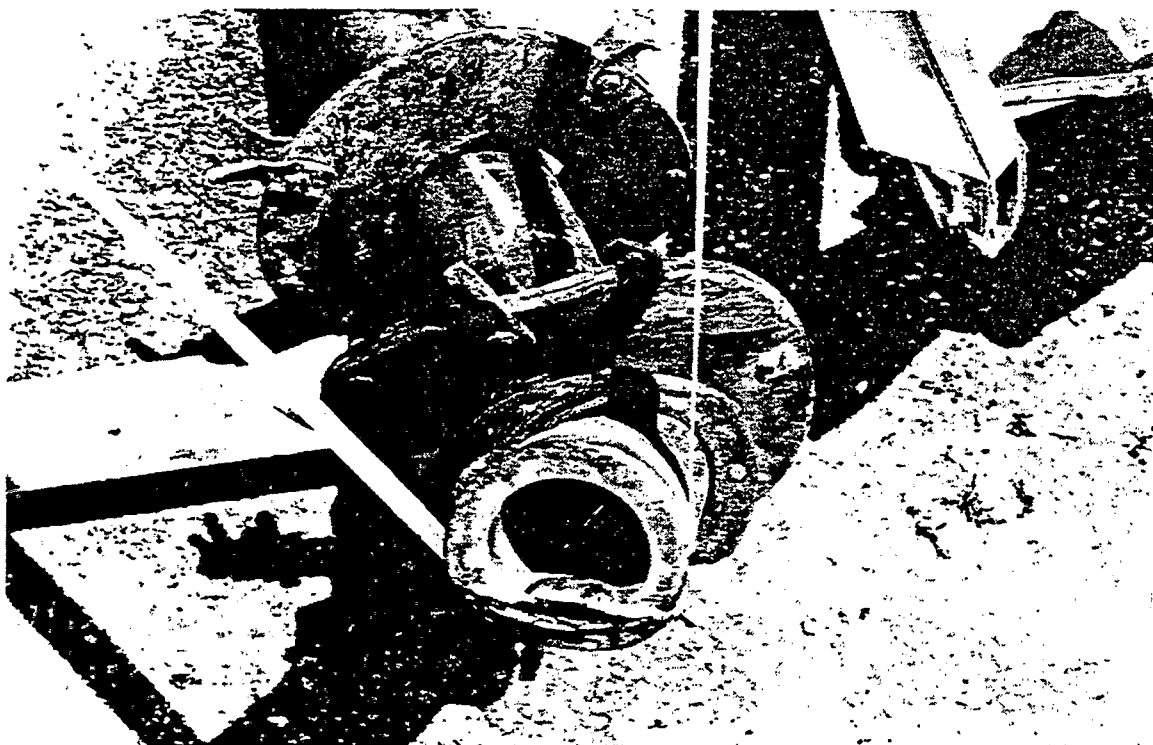
Figure 23: The intensifier bar: a) the shaft of the bar is severely deformed, b) two of the mixing plates are left, both are broken away from the shaft.

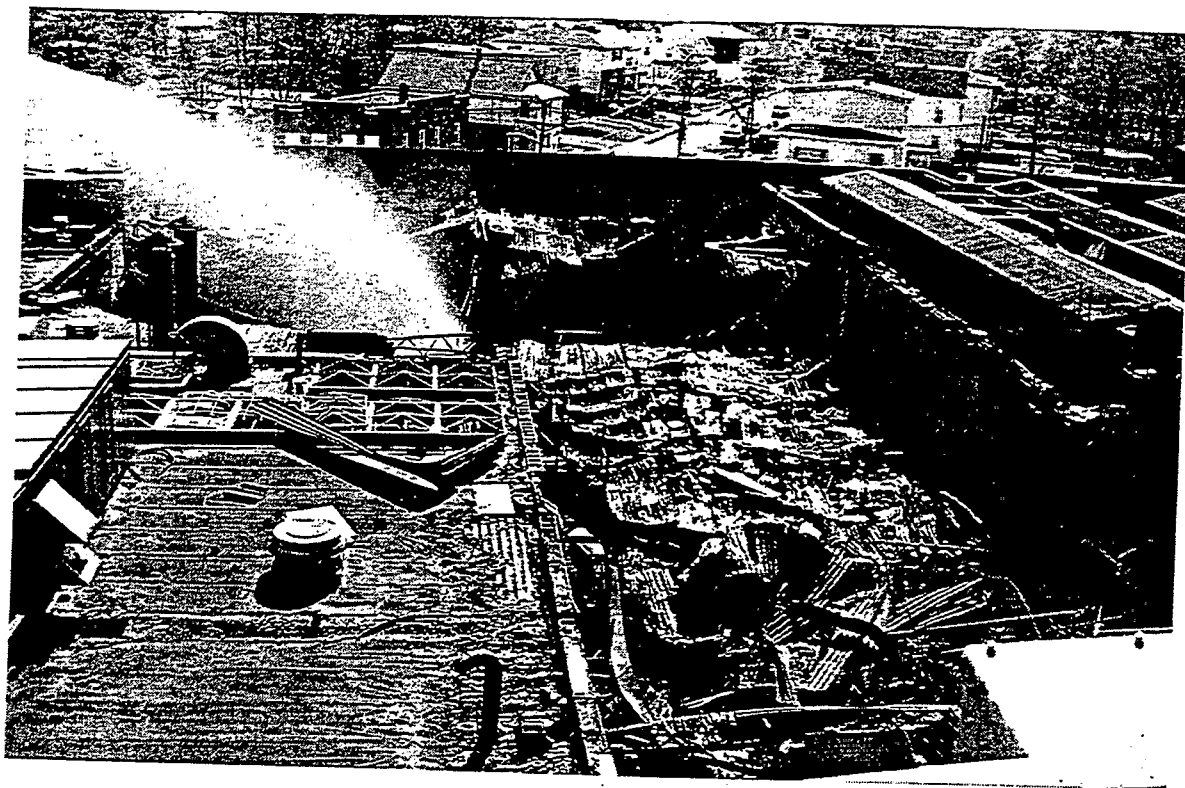
Figure 24: The Napp facility after the explosion and fire showing location in the plant where the processing took place and the location of the facility with respect to residential area in background.
