EVALUATION OF A CONTAINMENT BARRIER
FOR HAZARDOUS MATERIAL SPILLS IN WATERCOURSES

Thomas N. Blockwick
Samson Ocean Systems, Inc.
99 High Street
Boston, Massachusetts 02110

Contract No. 68-01-0103
and
Contract No. 68-03-2168

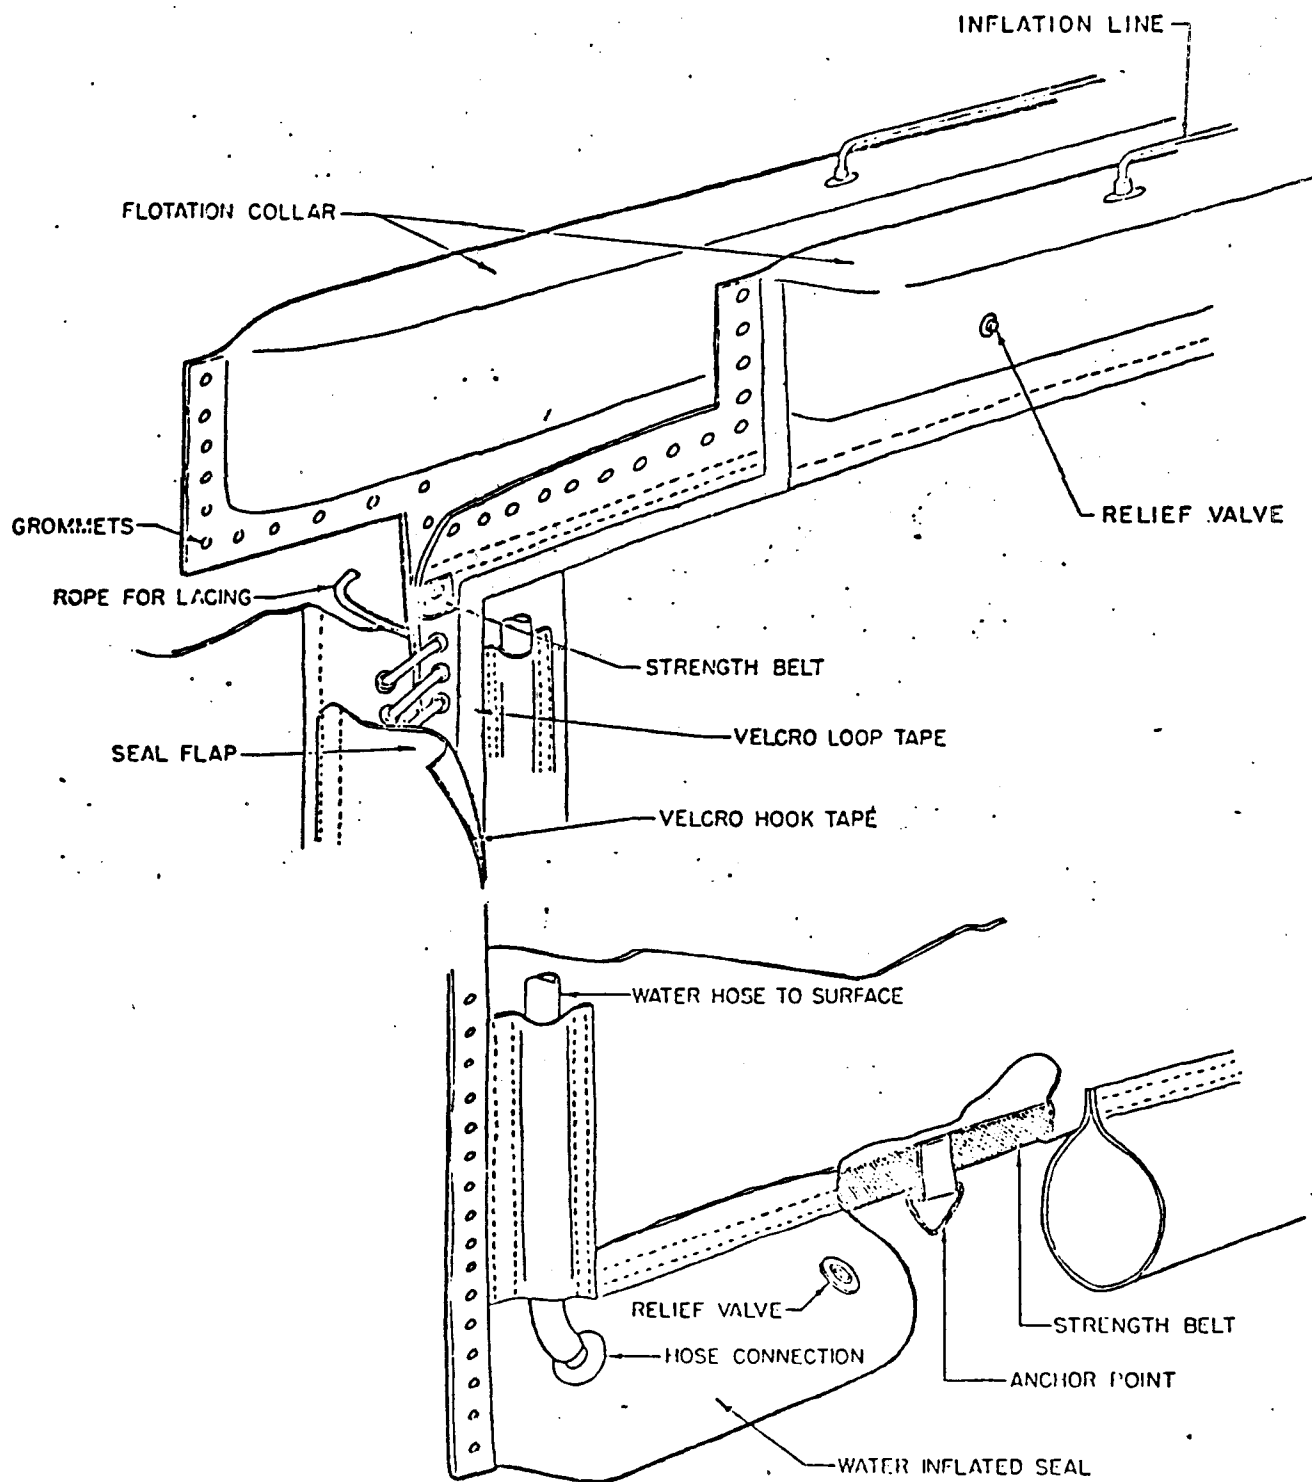
Figure 3. Details of barrier construction.

Also, if the shackle on top of the mooring grip were replaced with some type of quick-connecting hook, this grip would be easier to connect to the anchor's ring on the barrier. In addition, some type of quick attachment device on the bail of the mooring grip would make attachment of the end of the pull-down line quicker. The present method requires that the line be knotted and then taped to prevent the knot from possibly becoming untied. In making both of these modifications, it should be realized that it is very important to minimize the combined height of the pull-down grip and the mooring grip, since the strength belt on the barrier (Figure 3) cannot be brought any closer to the bottom than this distance.

It is believed that dynamic pressure on the barrier wall caused the fabric to pull very hard at the sewn seam. The pressure of the stitches on the fabric caused the fabric to begin to fail in a tensile mode. As soon as a short length of the wall had failed in this mode, the fabric began to fail in a tear mode. The fabric will, of course, fail much easier in the tear mode since all of the load is put on the few fibers at the tear point. After tearing for a few yards through the double layer of material at the sewn seam, the tear jumped up the barrier wall just above the welded joint where it continued for the circumference of the barrier.

In the direction of the No. 5 anchor, the tear spread for almost the full length of the barrier, while in the direction of the No. 2 anchor it went only approximately 20 ft until it was checked by the 2-in. webbing in the vertical joint. Here it continued upward along the webbing until it reached a point just under the flotation collar. That the tear was checked by the 2-in. webbing and then ran up alongside the webbing, suggests that had vertical belts been included in the barrier, they would not have prevented failure.

Another area of the barrier design where failure occurred is that of the seams in the bladders. The barrier, as presently designed and constructed, uses a simple type of seam for the bladders. Although this seam has an adequate vertical strength, and material tests during the construction of the barrier indicated adequate strength of the joint, the electronic weld did fail by peeling and the row of stitching down the middle of the electronic weld prevented the bladder from bursting. The flotation collar was pneumatically tested after construction by pumping it up with the air compressor until the relief valves vented. All of the valves operated properly, which indicates that failure of the seam was not caused by overpressurization. Instead, it is believed that the electronic weld "peeled" in a long-term creep mode when the bladders were pressurized during the first field test.
