# **EPA/OSHA JOINT CHEMICAL ACCIDENT INVESTIGATION REPORT**

**Surpass Chemical Co., Inc.  
Albany, NY**

### **Surpass Chemical Company, Inc., Albany, New York, April 8, 1997**

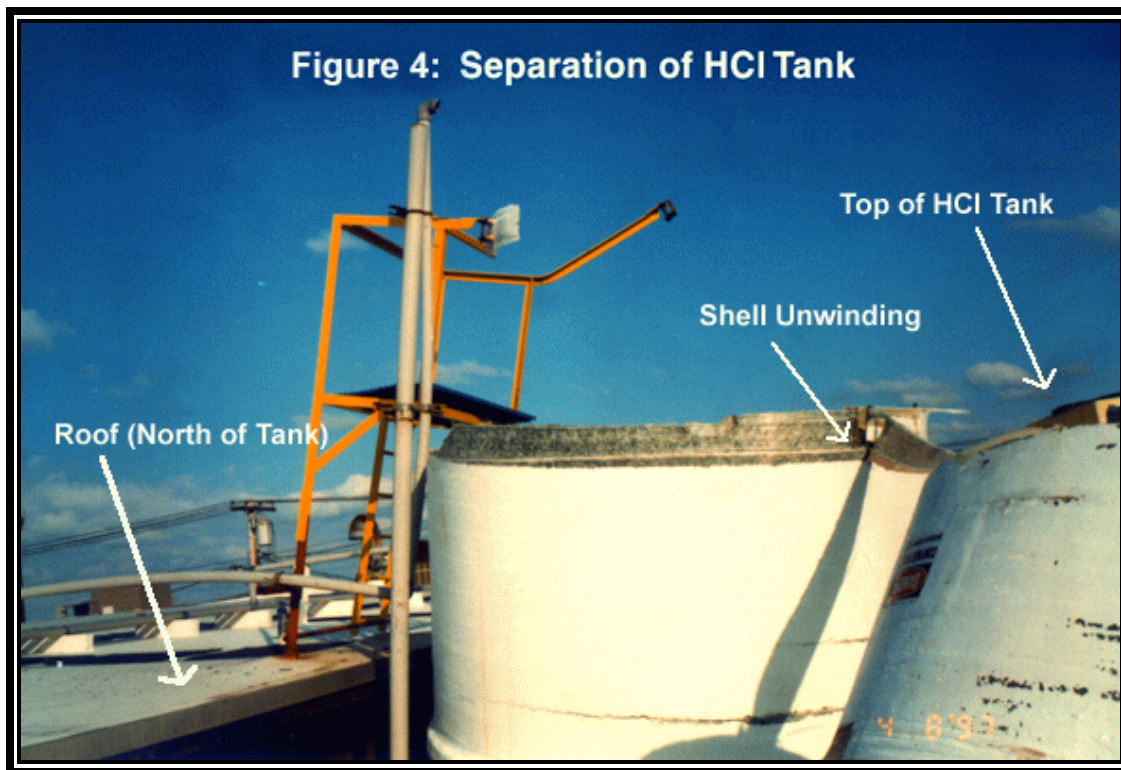
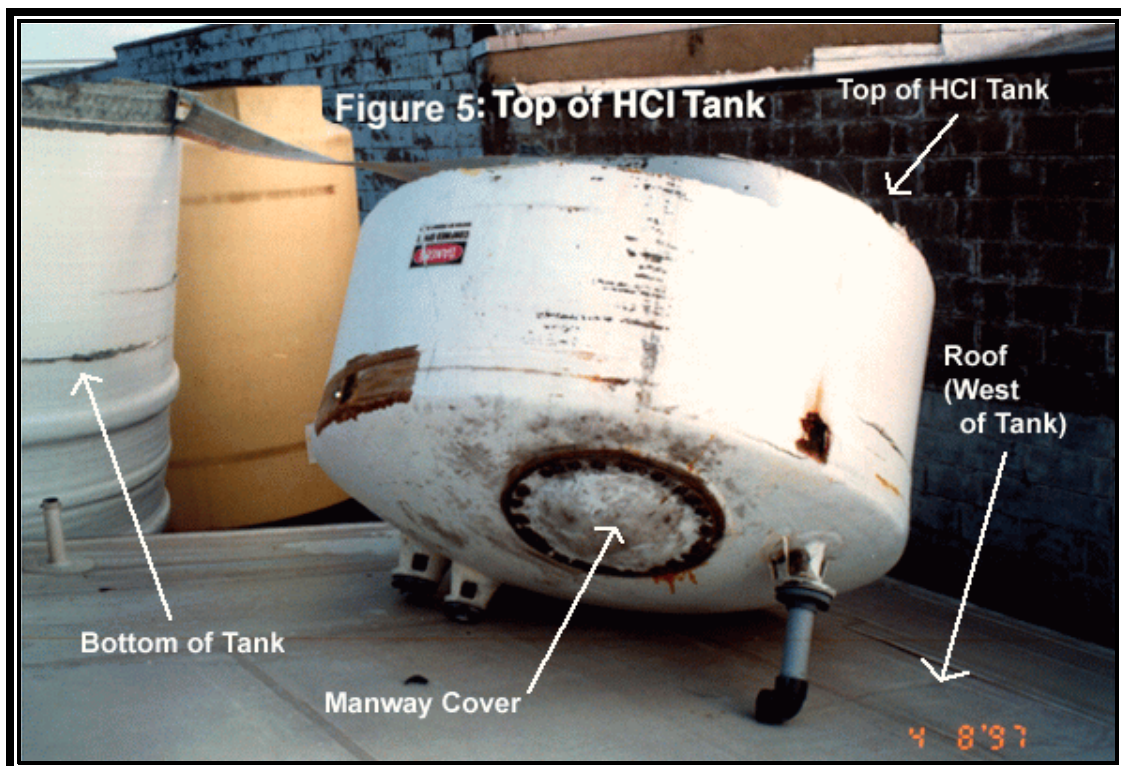
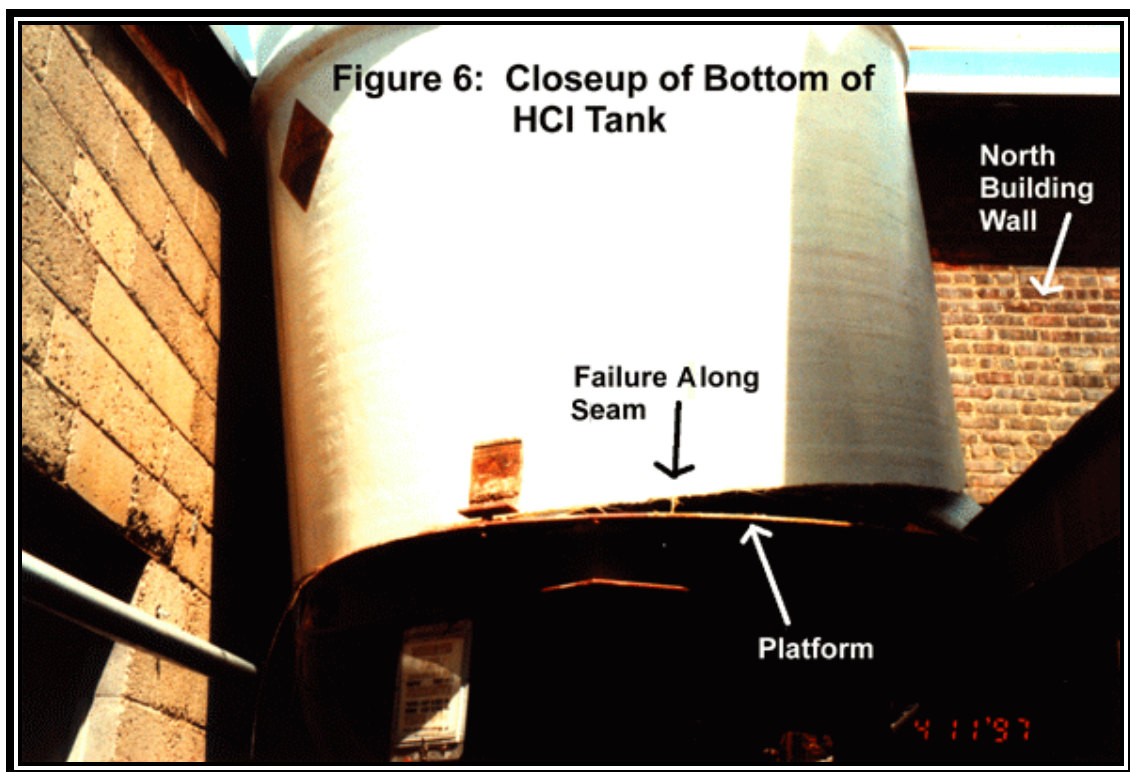
The HCl tank head separated at a point about 5 feet from the top of the tank and flew about 15 feet west to the roof of an adjacent building. **Figure 4** shows the separated tank after the incident, and **Figure 5** shows the top of the tank. The bottom of tank failed in the knuckle area where the cylindrical part of the HCl tank meets the flat bottom, as shown in **Figure 6**. The tank bottom remained on the platform. The cylindrical part of the fiberglass shell began to unwind itself at the top edge (see **Figures 4 and 5**). The shell also remained on the platform but collapsed, leaning toward the west building wall (see **Figure 6**). The scrubber tank was not affected by the tank failure; it was found intact in its original position after the incident, as shown in **Figure 7**.

At the time of rupture, the HCl tank contained about 4,800 gallons of material. The failure of the HCl tank caused a sudden surge of liquid over the secondary containment wall. The force of the liquid also caused a break in the masonry of the secondary containment wall. Surpass has estimated that as a result of this release, about 150 gallons were absorbed by soil within the property boundary and about 2,300 gallons entered storm drains located on Broadway. The storm drains emptied into an underground stream, the Patroon Creek, a tributary of the Hudson River. Surpass also estimated that 1,900 gallons were contained within the secondary containment dike and that 400 gallons entered a nearby building through a window in the north wall and through an exhaust fan in the west wall.

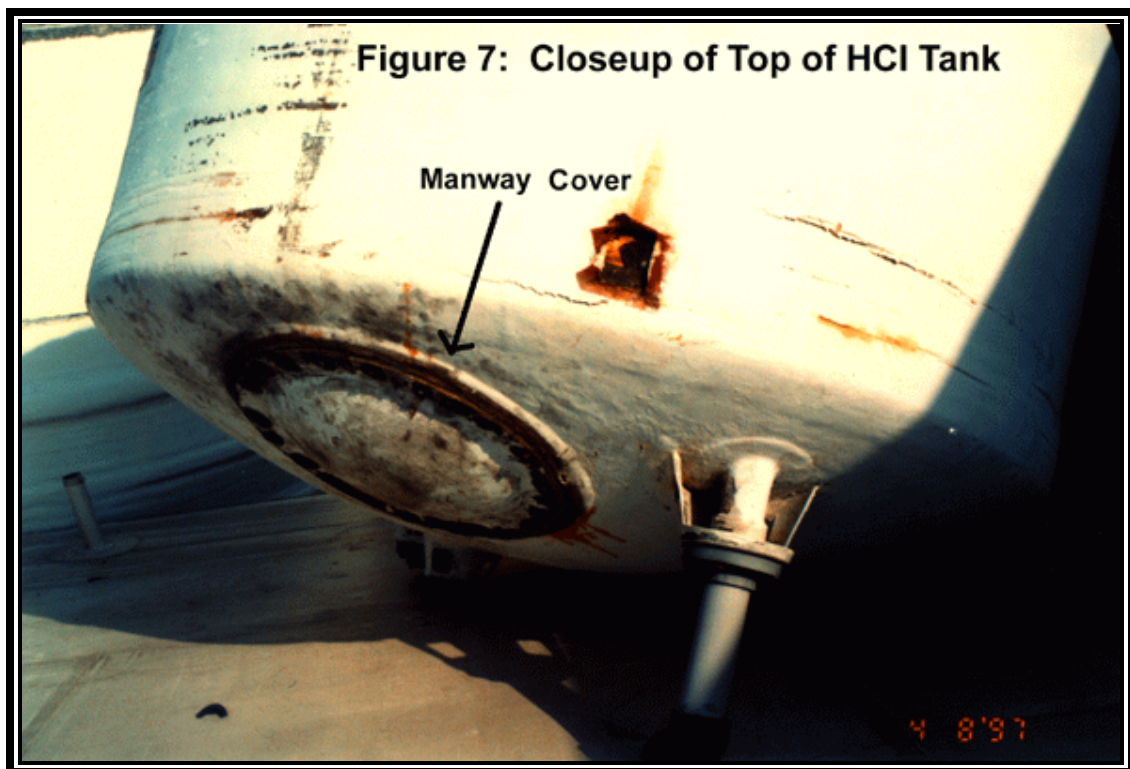
- The HCl tank ruptured into three pieces, as described in Section 3.2.
- The manway on the tank top was sealed shut, and the only way for vapor to escape from the tank was through the vent line. (See **Figure 7**.)

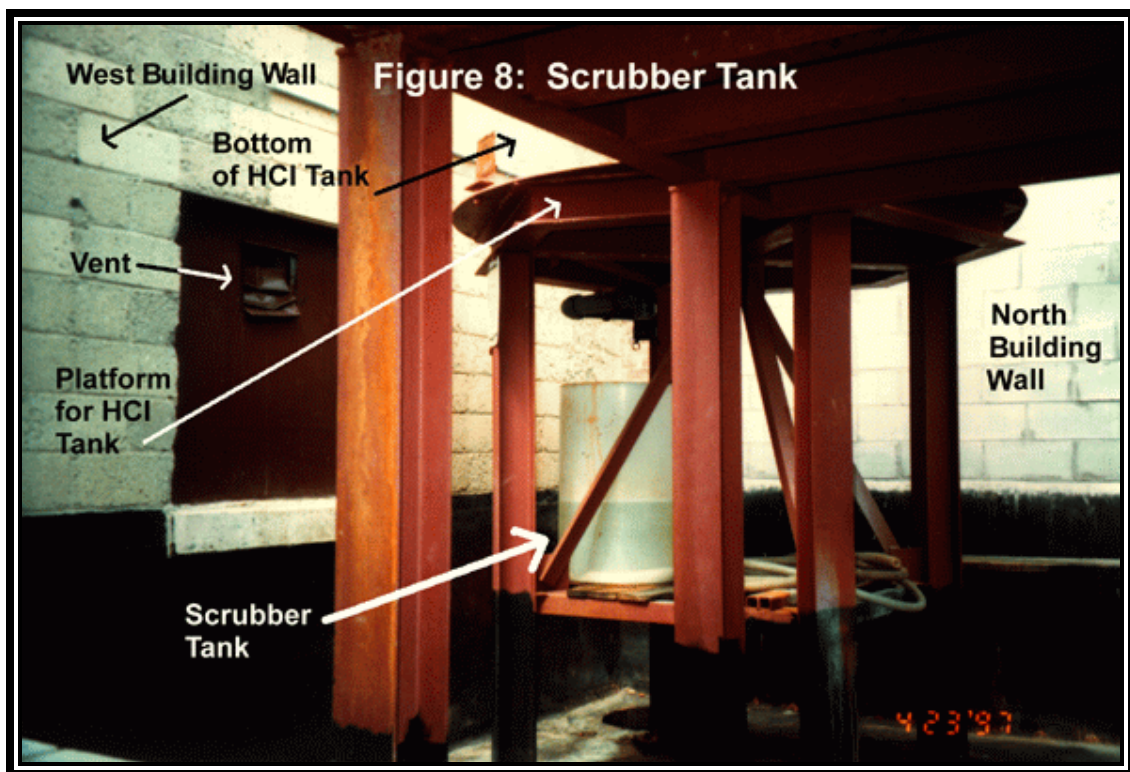
- The scrubber tank was not affected by the tank failure; it was found intact in its original position after the incident. (See **Figure 8**.)
- After the incident, the diffuser in the scrubbing tank was removed by disconnecting the vent line quick connect and removing the lid from the scrubber tank. The holes in the diffuser were found to be clogged with a white crystalline substance, as shown in **Figure 9**. This substance was sodium chloride, according to laboratory analysis.

- A layer of white crystalline material was also found in the bottom of the scrubber tank. This substance also was sodium chloride, according to laboratory analysis.
