# **EXPERT REVIEW OF EPA/OSHA JOINT CHEMICAL ACCIDENT INVESTIGATION REPORT**

**Napp Technologies, Inc.  
Lodi, New Jersey**

EPA  
550-  
R-  
98-008

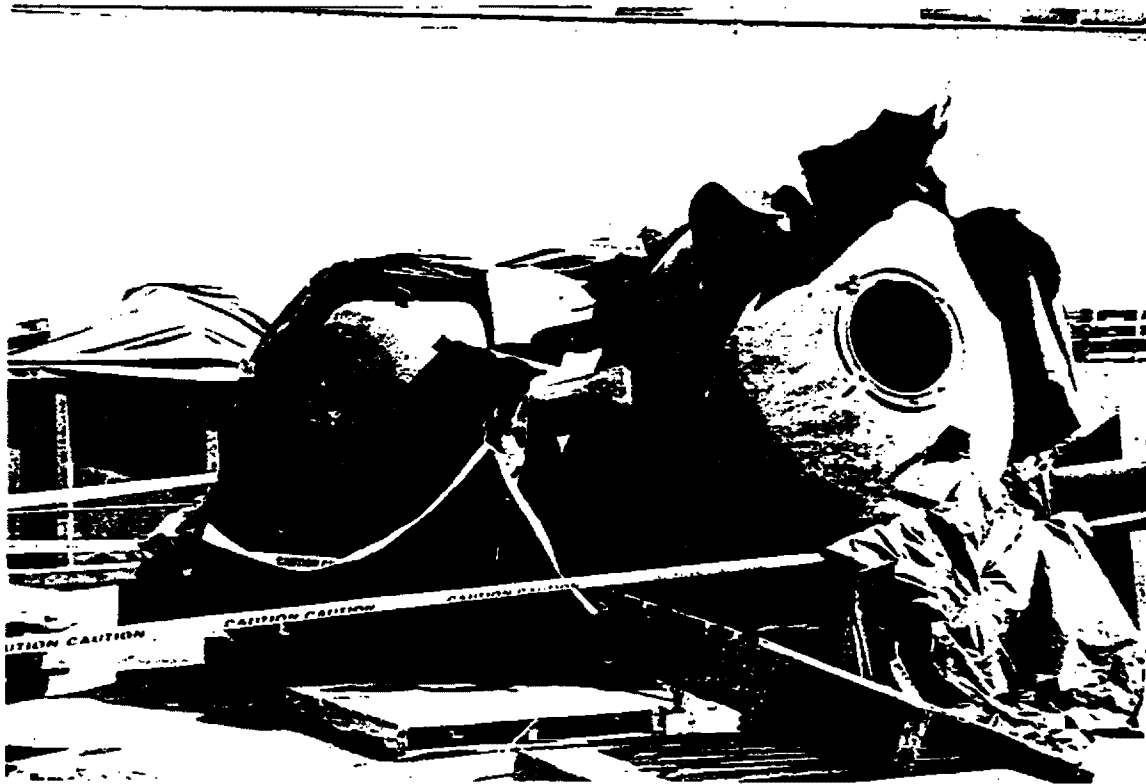
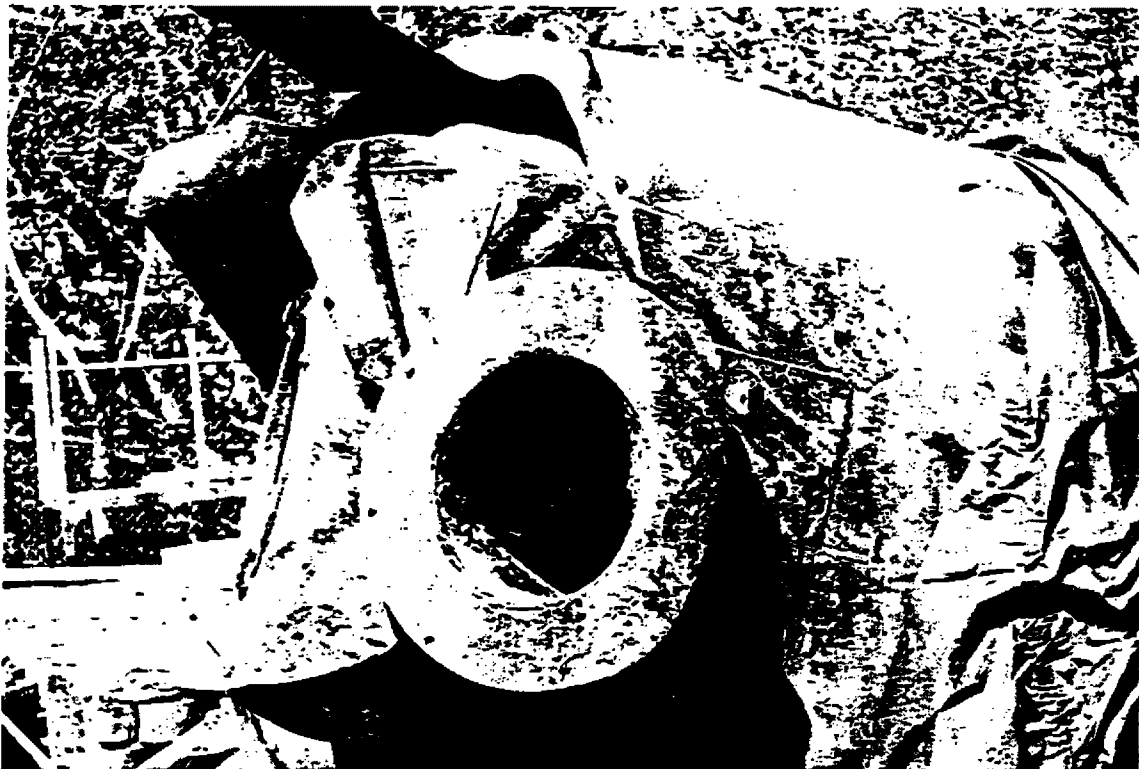
Figure 9: The general condition of the 125 cubic foot blender: a) the top access ports and damaged insulation jacket, and b) the flange to which the belt drive attaches.

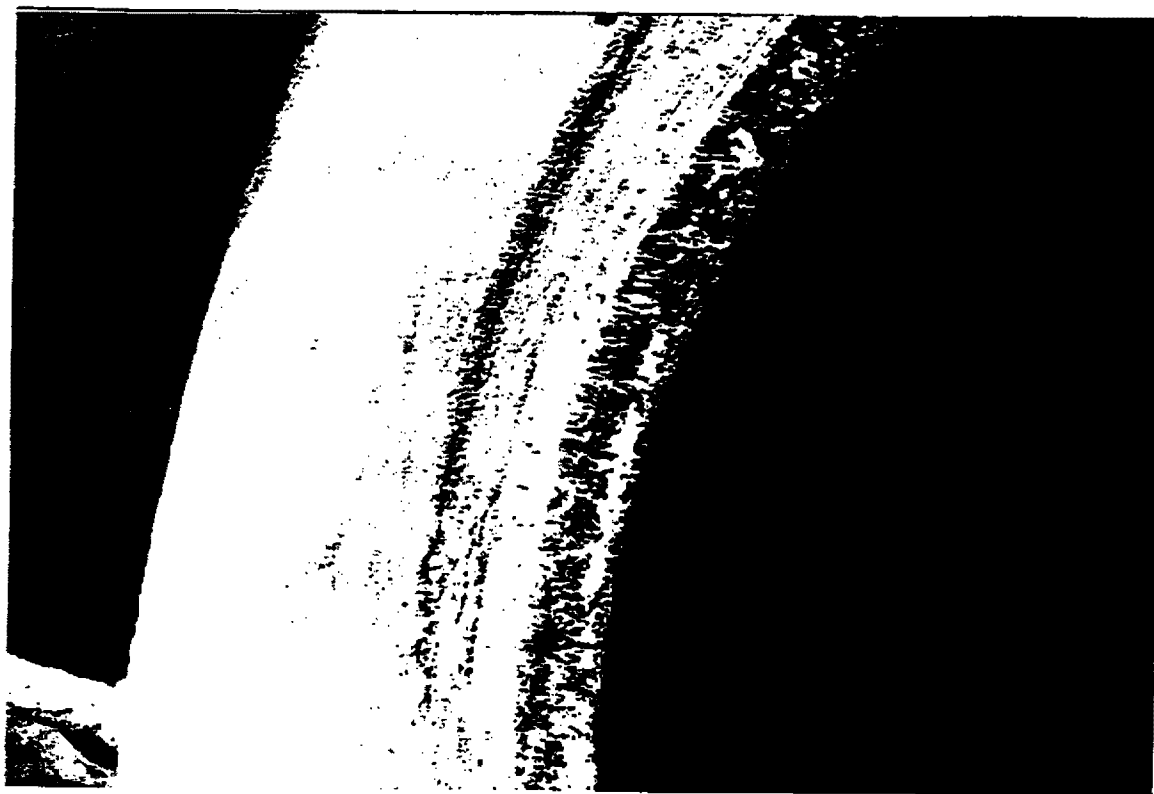
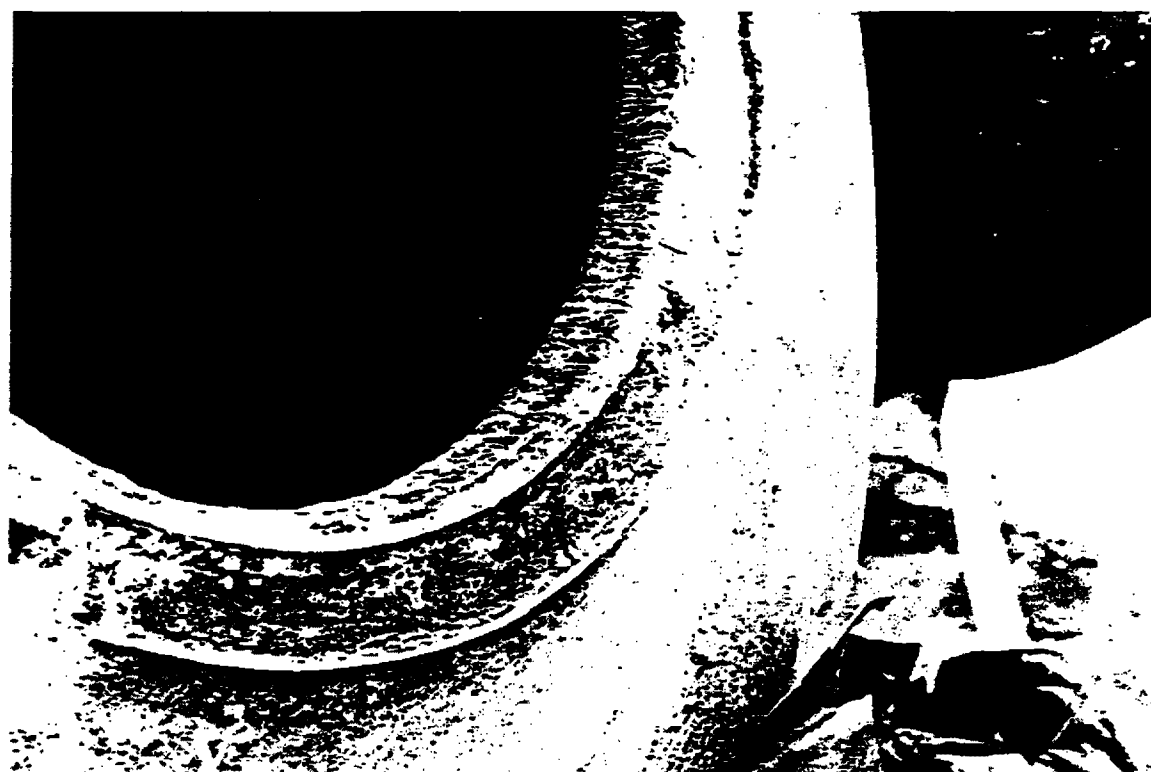
Figure 12: The striation markings on the top access ports.

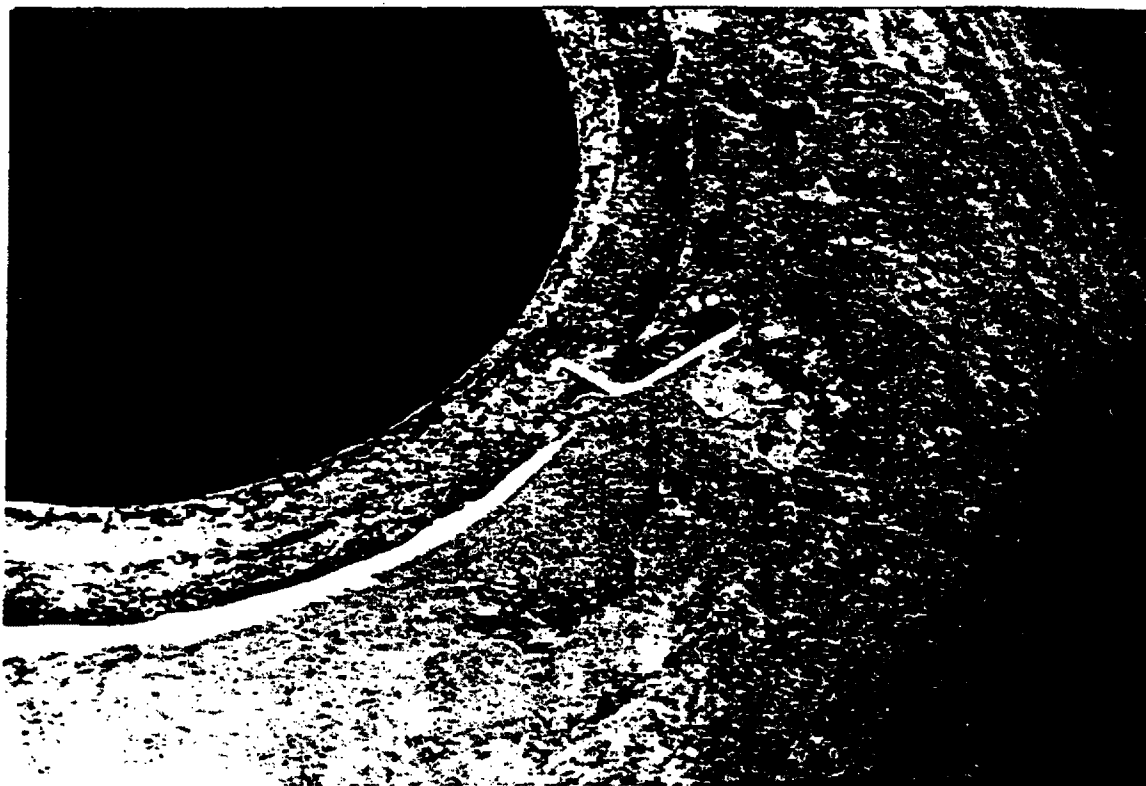
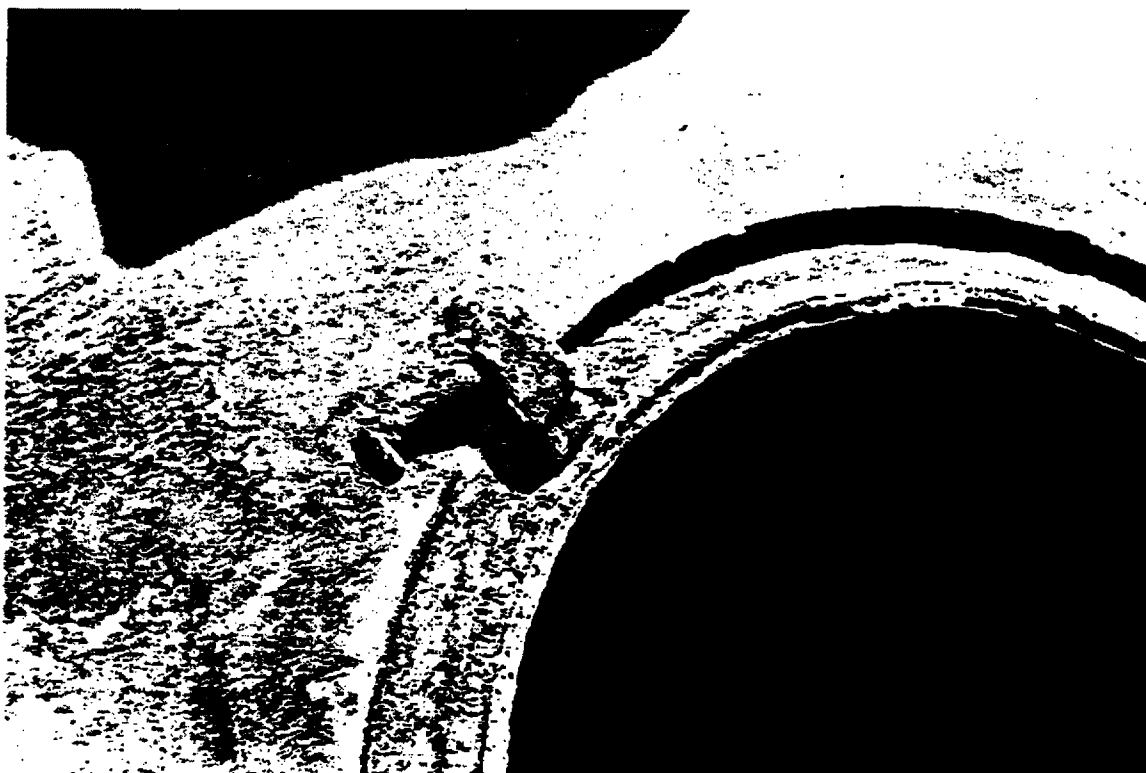
Figure 14: The insulation jacket has torn away from where it was attached to the stainless steel shell and the access door tabs are bent over against the shell.

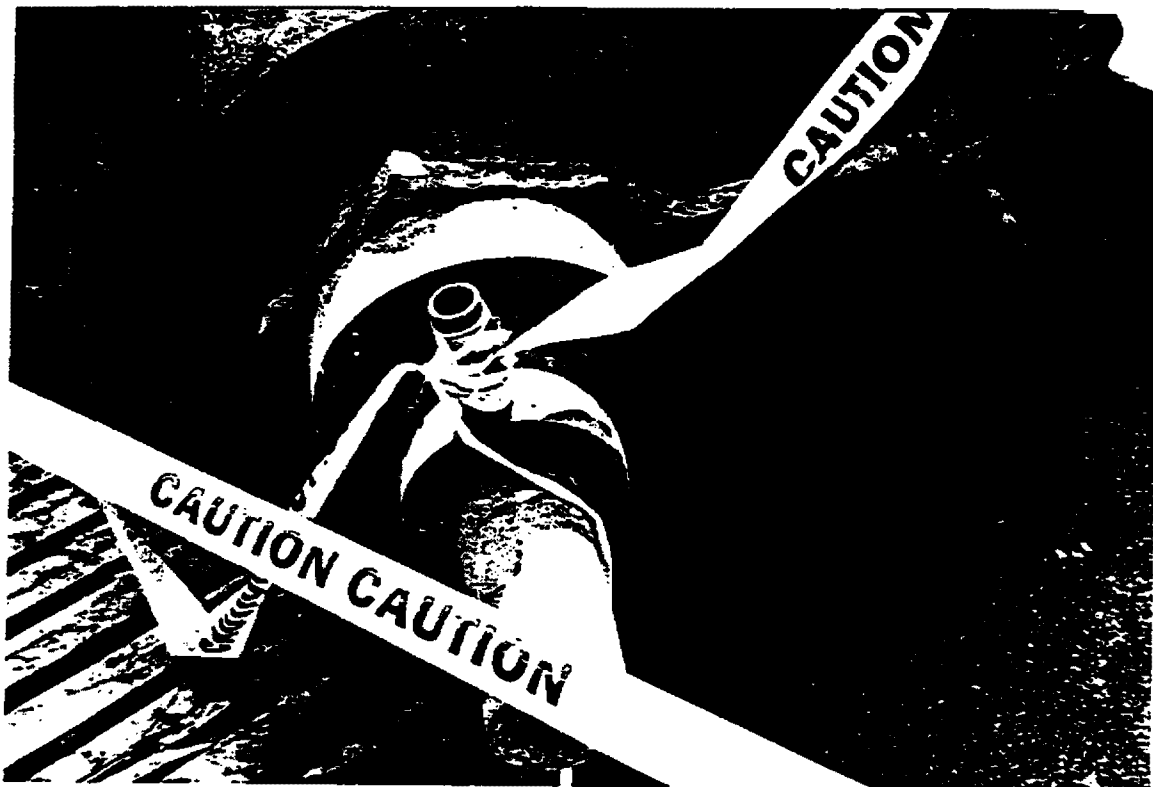
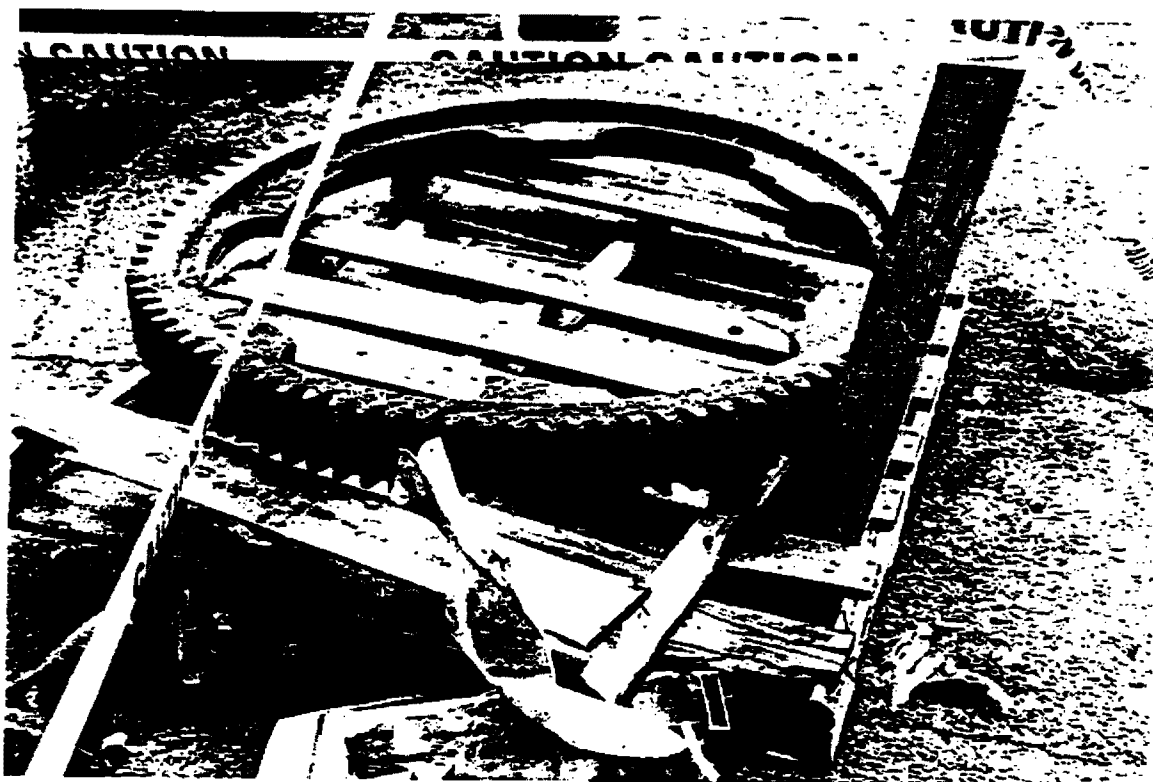
Figure 16: The gear drive side of the blender: a) the shaft (drive side) and b) the portion of the gear that fractured and separated from the blender in the accident.

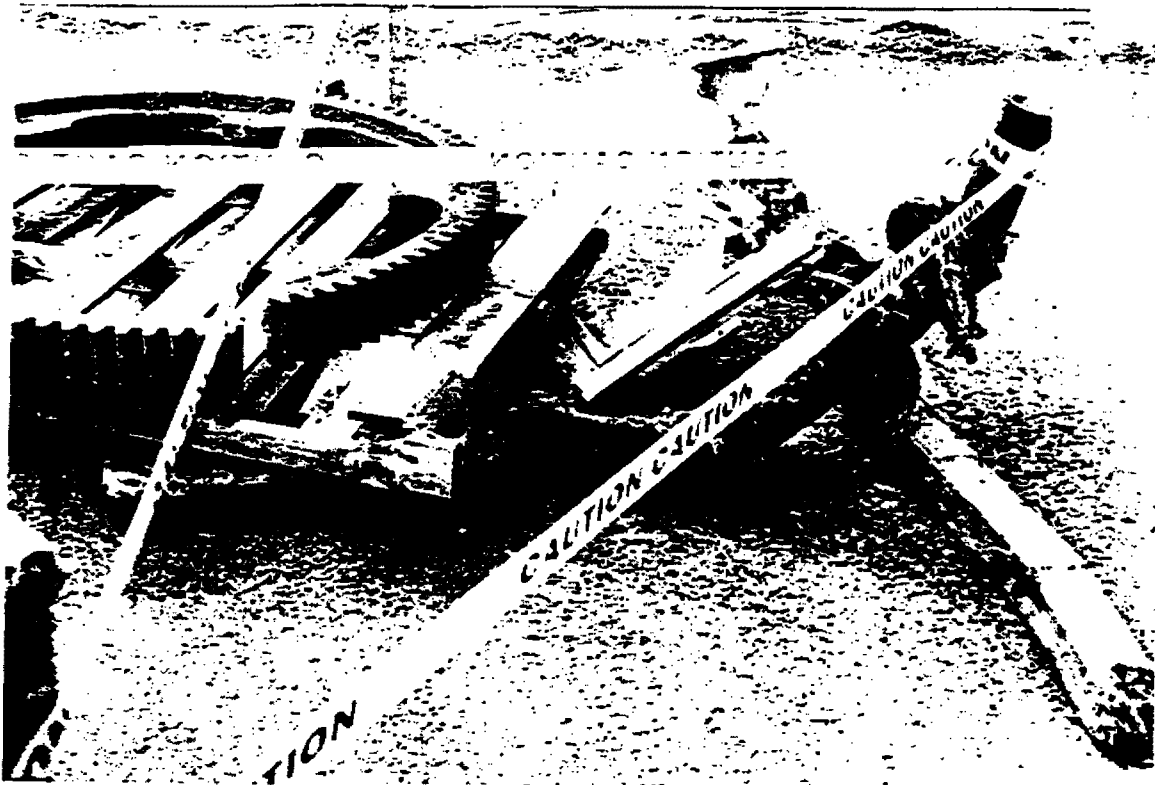
Figure 23: The intensifier bar: a) the shaft of the bar is severely deformed, b) two of the mixing plates are left, both are broken away from the shaft.

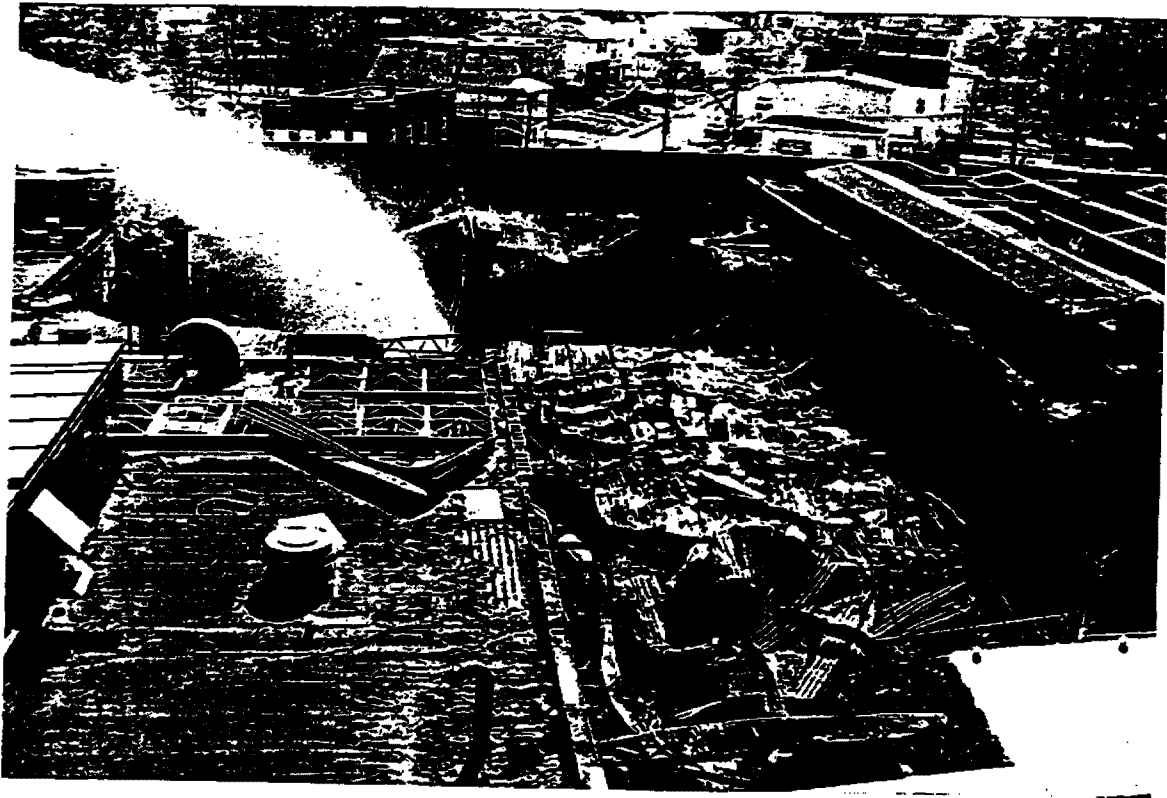
Figure 24: The Napp facility after the explosion and fire showing location in the plant where the processing took place and the location of the facility with respect to residential area in background.
