**PAGOSA SPRINGS  
LANDFILL EVALUATION**

U.S. Environmental Protection Agency  
Region VIII

Fred C. Hart Associates, Inc.

January, 1982

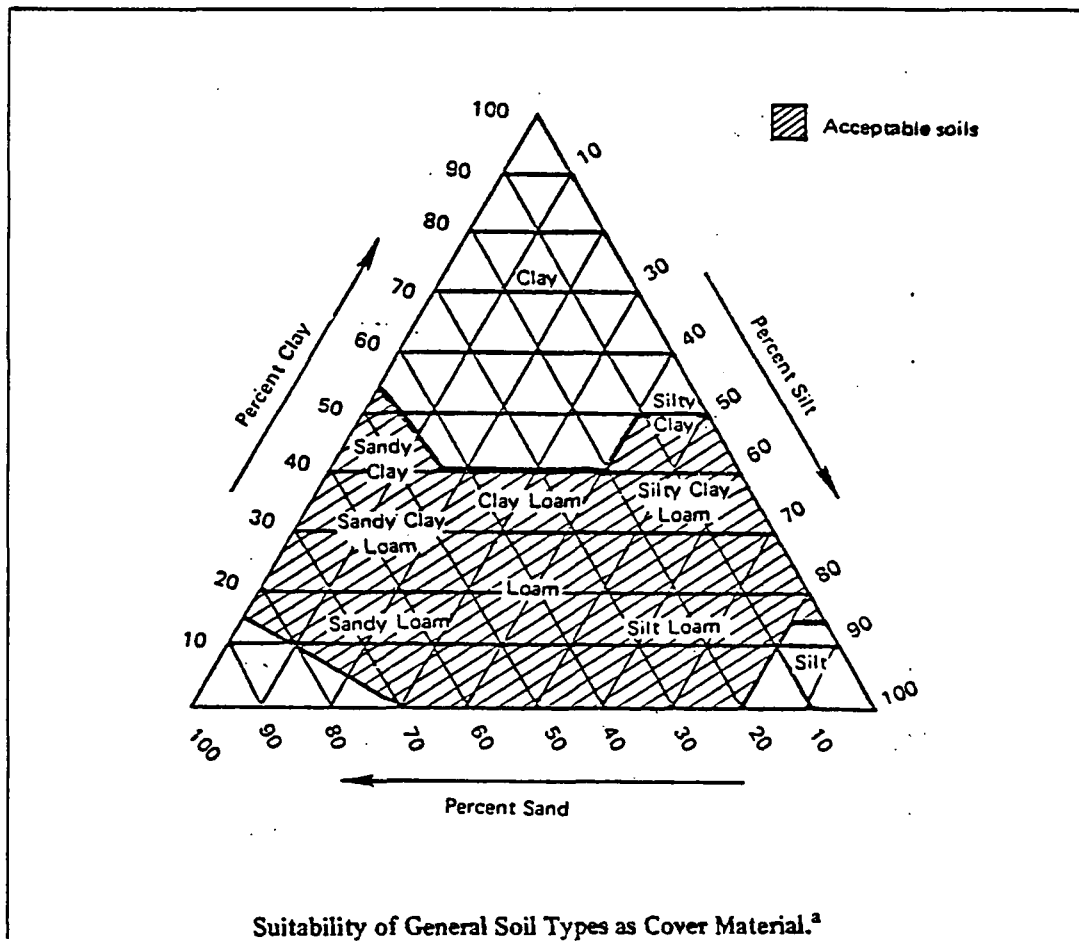
FIGURE 4

**Cover.** The major deficiency of the Pagosa Springs landfill site is its lack of suitable cover material. Suitable soil for covering the refuse each day is of utmost importance for the safe and sanitary operation of a landfill. Cover material is needed to prevent rodents from burrowing into the fill, keep flies from emerging, minimize the entrance of moisture in the fill, provide a pleasing appearance, control blowing litter, and control erosion. Figure 4 depicts in general terms the suitability of various soil types for cover material.

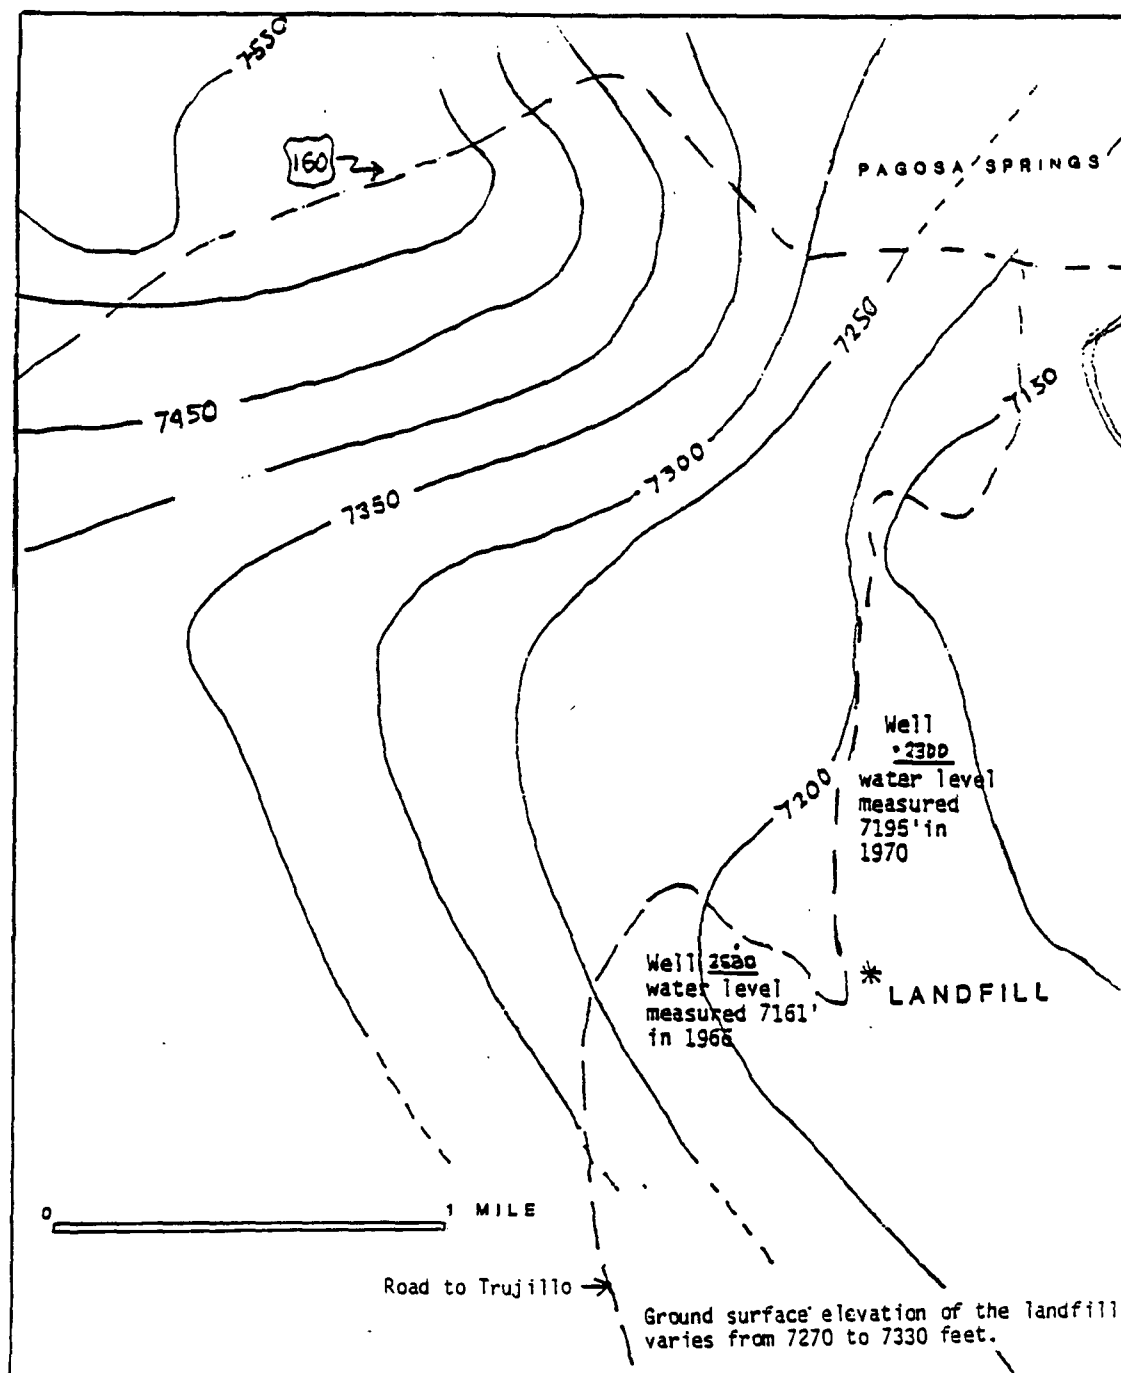
FIGURE 5.

Although some potential for ground water contamination exists by virtue of the soil and hydrogeological conditions, it can be concluded that leachate production should be virtually nonexistent at the site because of the low level of precipitation and high degree of vegetation in the region. Field inspection of the site confirmed that steady leachate seepage from the fill toe could not be observed.
