SEWER BEDDING AND INFILTRATION

GULF COAST AREA

John K. Mayer, Frank W. Macdonald
and Stephen E. Steimle

Tulane University, New Orleans, Louisiana

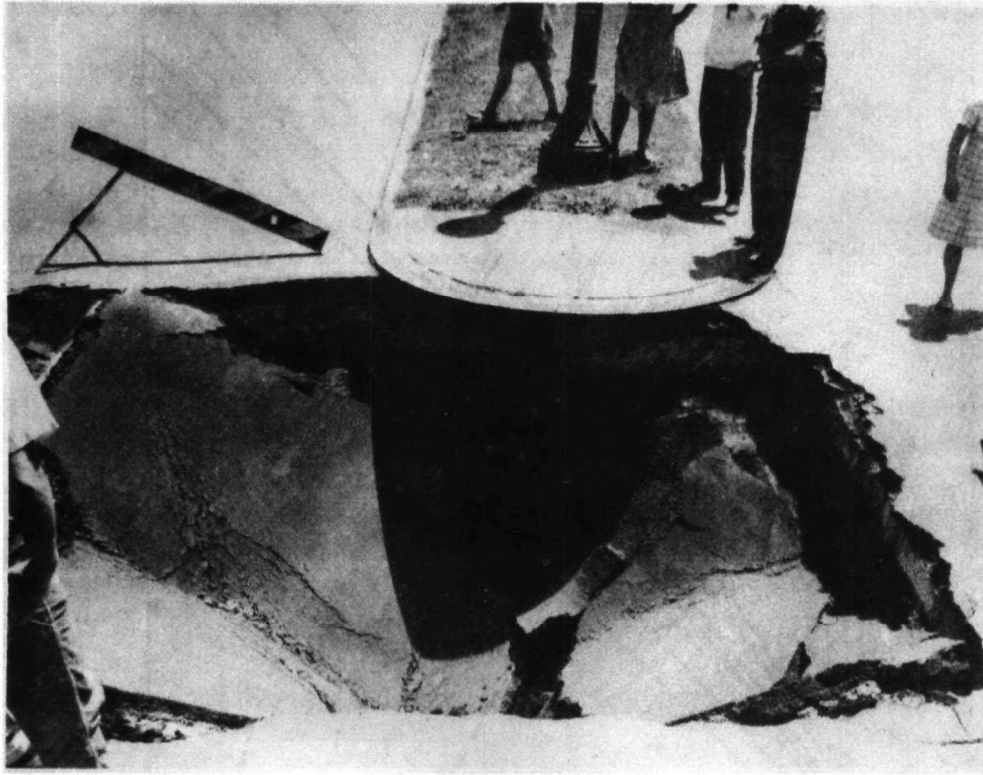
vicinity of the sewer. When the surrounding soil and/or the backfill is a fine non-cohesive material in a loose state, it can be washed into the sewer and carried through the system, thus undermining surface structures and even the sewer itself. Figure 3 shows a street collapse due to infiltration undermining.

STREET COLLAPSE DUE TO INFILTRATION
FIGURE 3

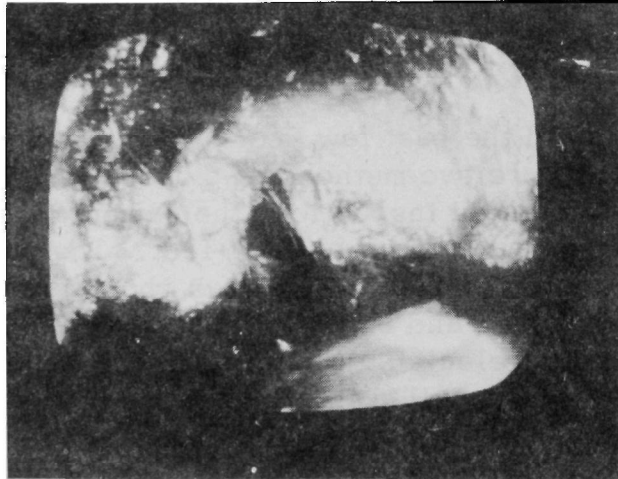
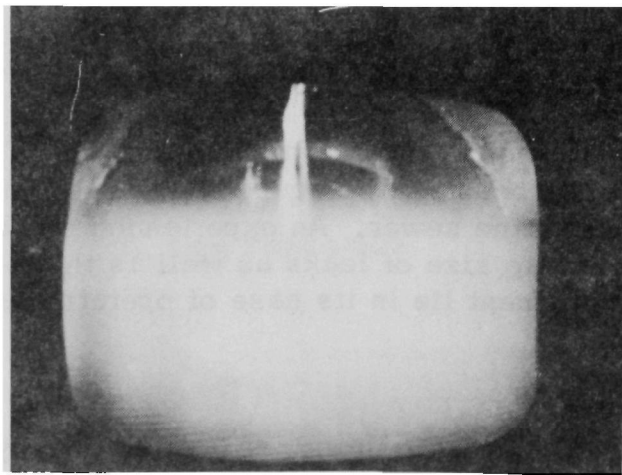
SEWER LEAKS AS OBSERVED BY TELEVISION
FIGURE 16

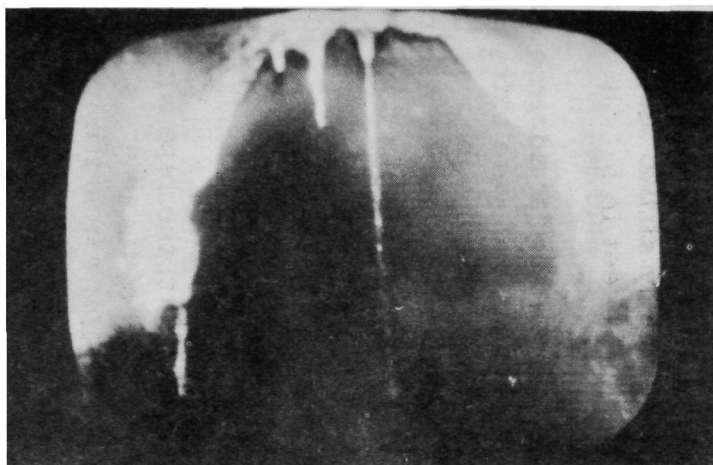
Leaking Joint - Weber Ave.

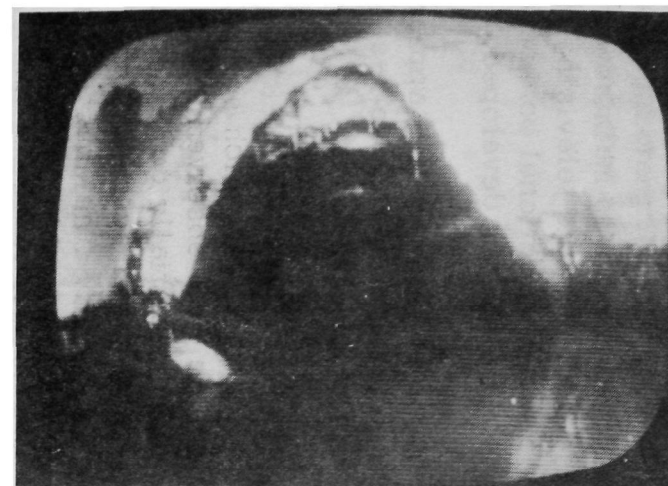
House Connection Broken into Top of Sewer
Mayo Road

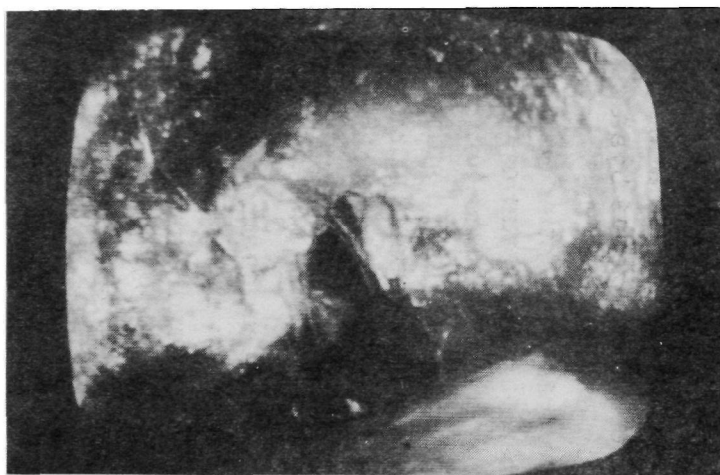
Tree Root - Weber Ave.

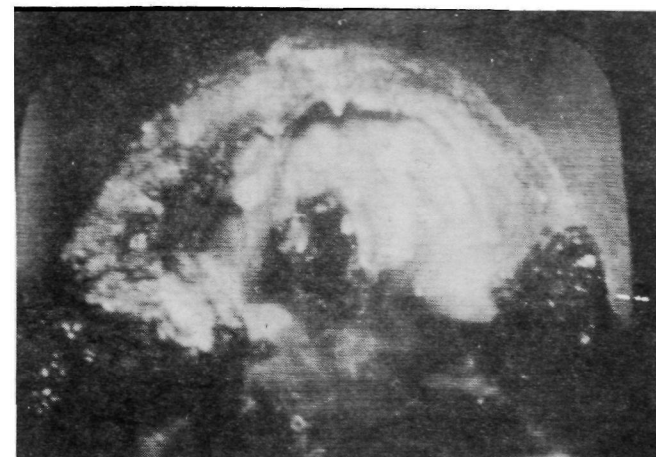
Grease Accumulations at House Connection
Weber Ave.

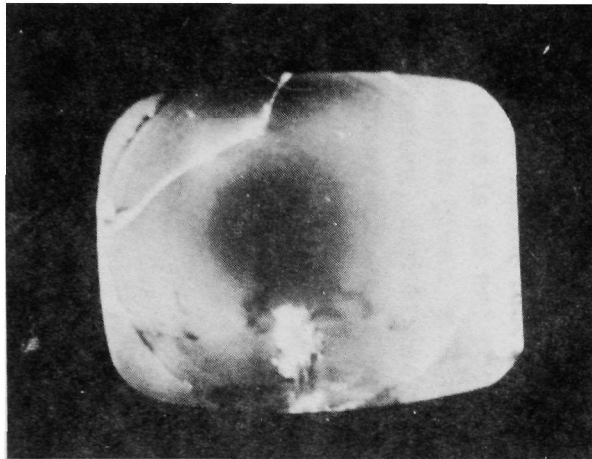
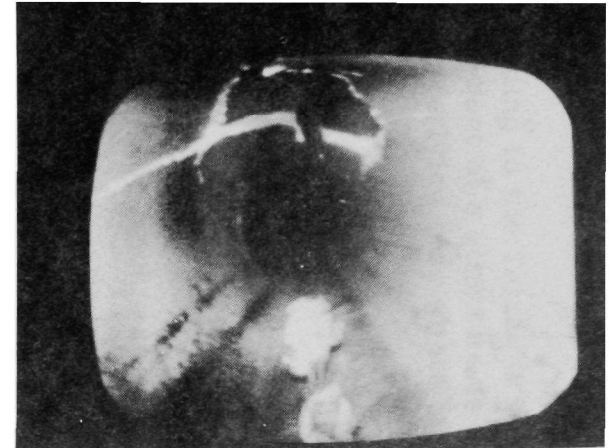
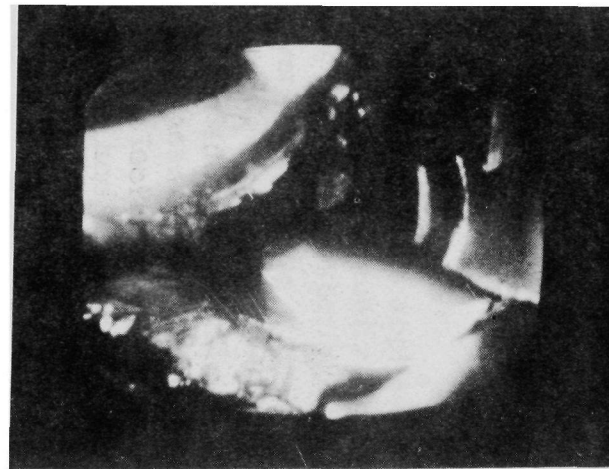
FIGURE 24

During April of 1970 the Hessmer Avenue test sewer was televised again to determine the cause of the high infiltration. The line was found to be so badly damaged and had so many obstructions caused by breaks that it was impossible to run the camera through the entire system. Only portions of Section II and III could be televised. Numerous small leaks were observed along Section III until a collapsed section was reached. In Section II several small leaks were observed, and an obstruction consisting of bedding material (clam shell) and pieces of broken pipe prevented the passage of the camera. Figure 24 shows pictures taken in this line.

PHOTOGRAPHS IN HESSMER AVENUE TEST SEWER 1970

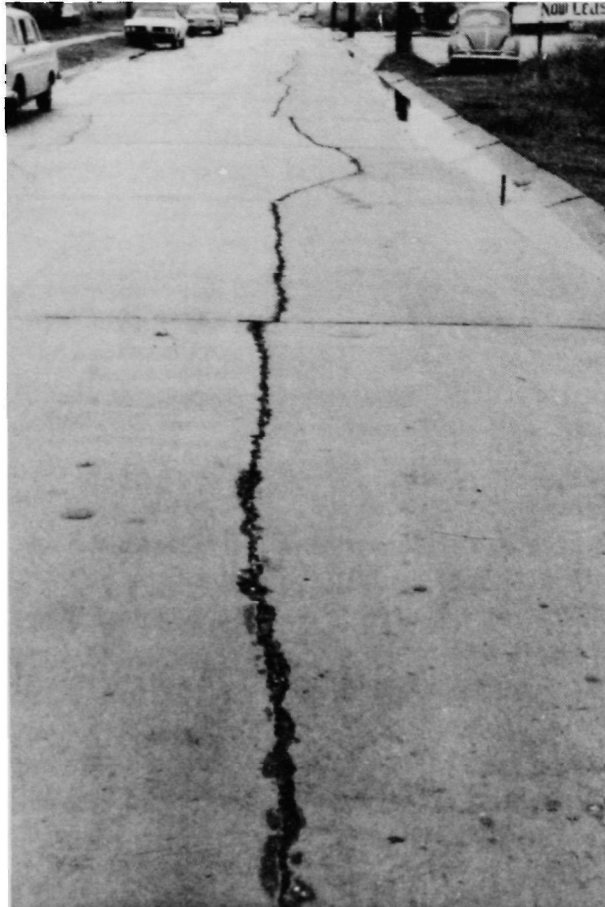
FIGURE 36

STRUCTURAL DAMAGE TO STREET PAVEMENT - HESSMER AVE

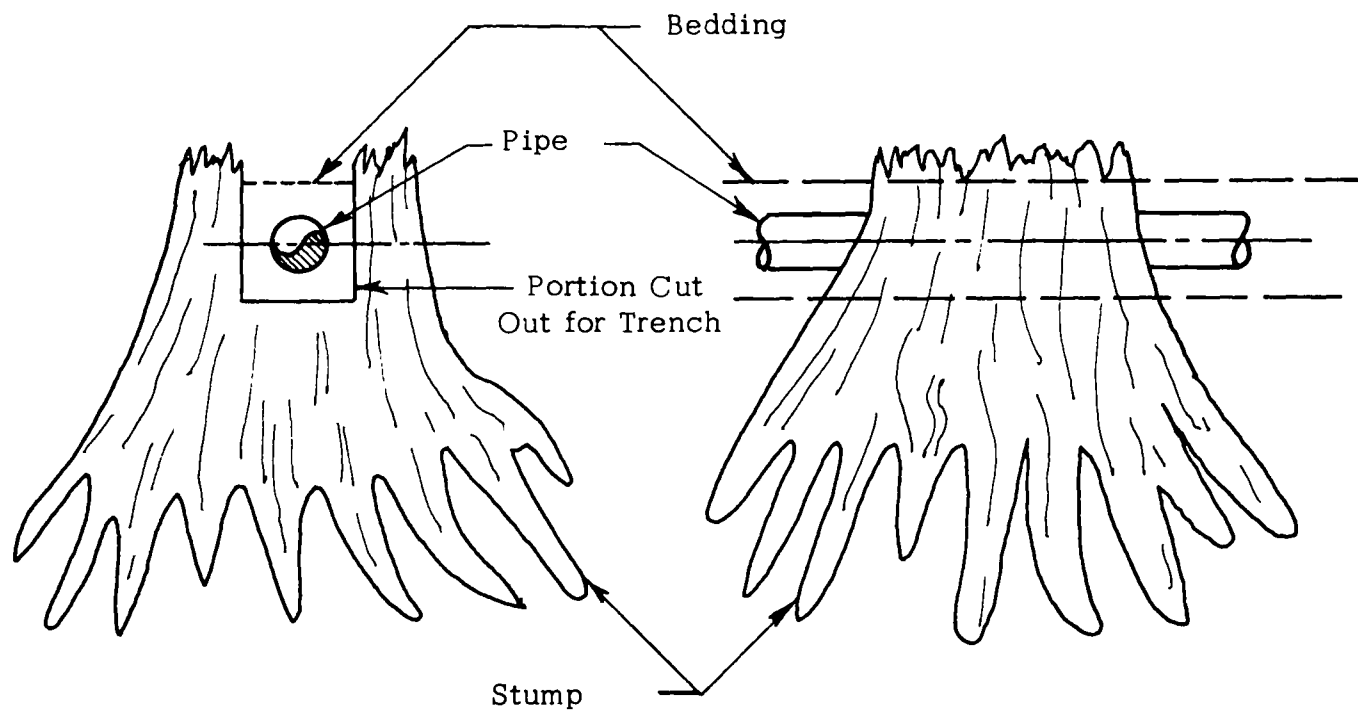
SEWER LAID THROUGH STUMP
FIGURE 38

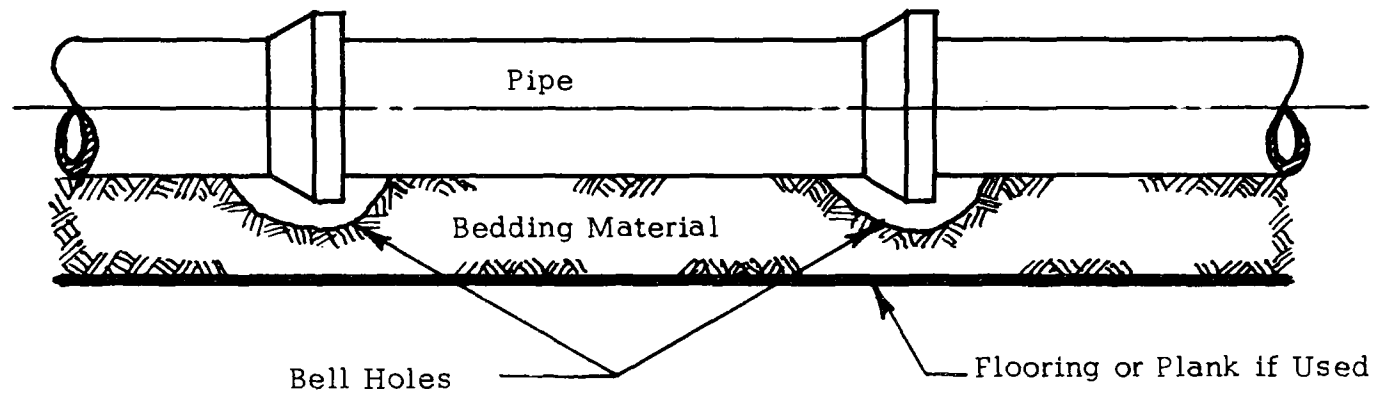
UNSUPPORTED PIPE BELLS
FIGURE 39

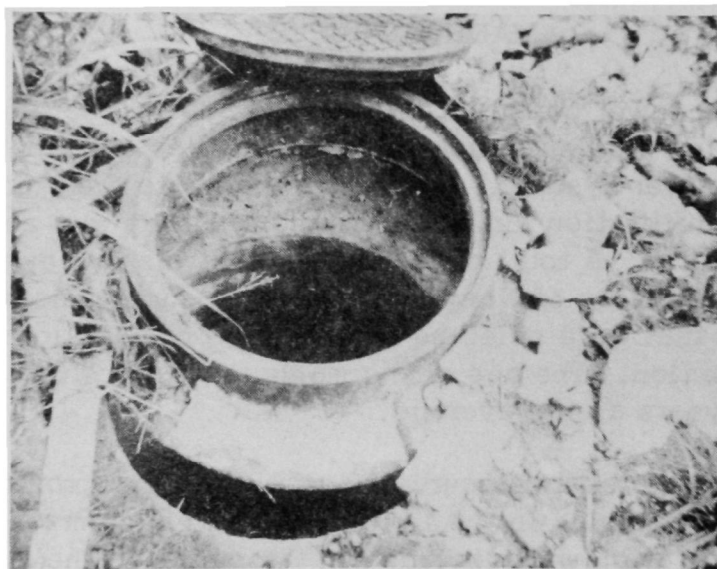
Of the 1600 manholes inspected 56 or 3.5 percent were observed to have infiltration at the time of the inspection. A greater number would no doubt be subject to infiltration if inspections were made during periods of rain-falls. Figure B 1 shows photographs of typical conditions found in the survey.

Displaced Manhole Collar

6. Manholes on sewer systems should be inspected periodically, and the necessary repairs provided where infiltration is observed.
7. Adequate plumbing codes should be adopted for the construction of house sewers with inspection required before connections are permitted to sewer systems. Particular attention should be devoted to the connection of the house sewer to the main system. Breaking into the main sewer system to make the connection should be prohibited.

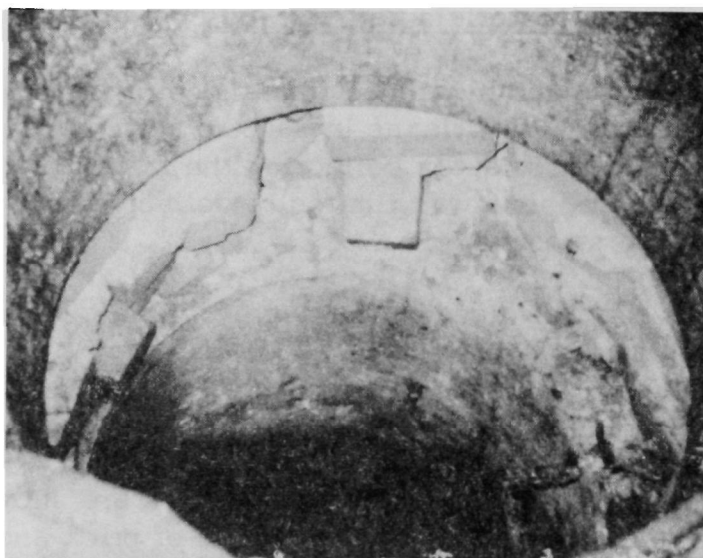
Poor Manhole Construction of Collar and Interior Wall
