EPA 460/3-88-006
May 1988

Intake System Deposits and Gasoline/Alcohol Blends

Southwest Research Institute
6220 Culebra Road
San Antonio, Texas 78284

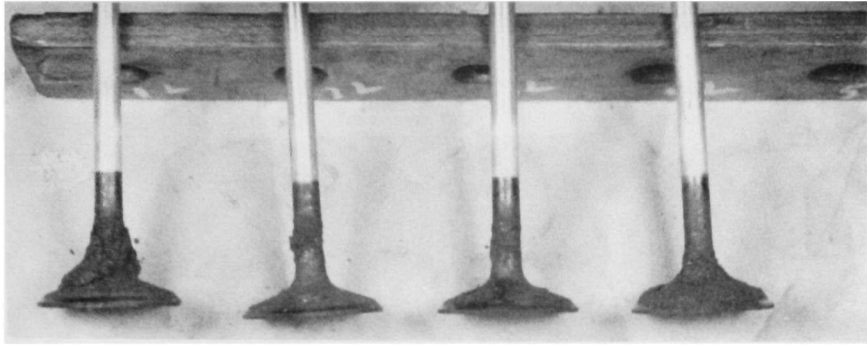
Within each vehicle make grouping, the lightest deposits occurred on the gasoline-fueled vehicle. In addition to being heavier, the valve deposits were quite variable in the blend-fueled vehicles. For instance, among the Escorts, vehicle C239 (gasoline) and vehicle C453 (blend) had almost identical valve deposit ratings, but vehicle C205 (blend) was significantly worse. For the Reliants, vehicle C202 (blend) had deposits which were intermediate between those of vehicle C83 (gasoline) and C232 (blend).

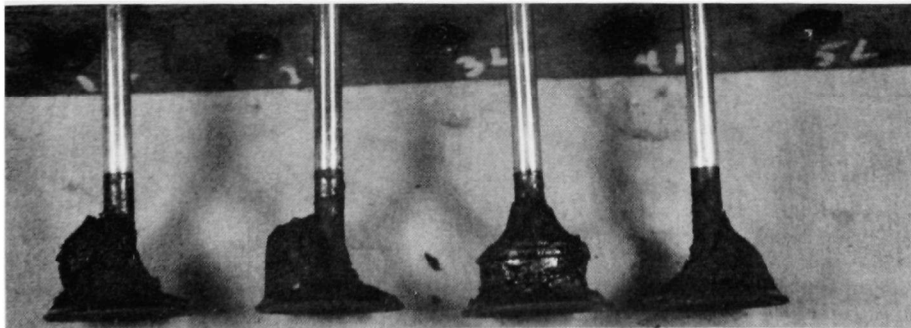
It is inconceivable that the deposits on the intake valves in vehicle C232 had no effect on performance. The fleet manager confirmed that one vehicle had difficulty climbing the ramps onto the vehicle carrier, and we suspect that it was C232.

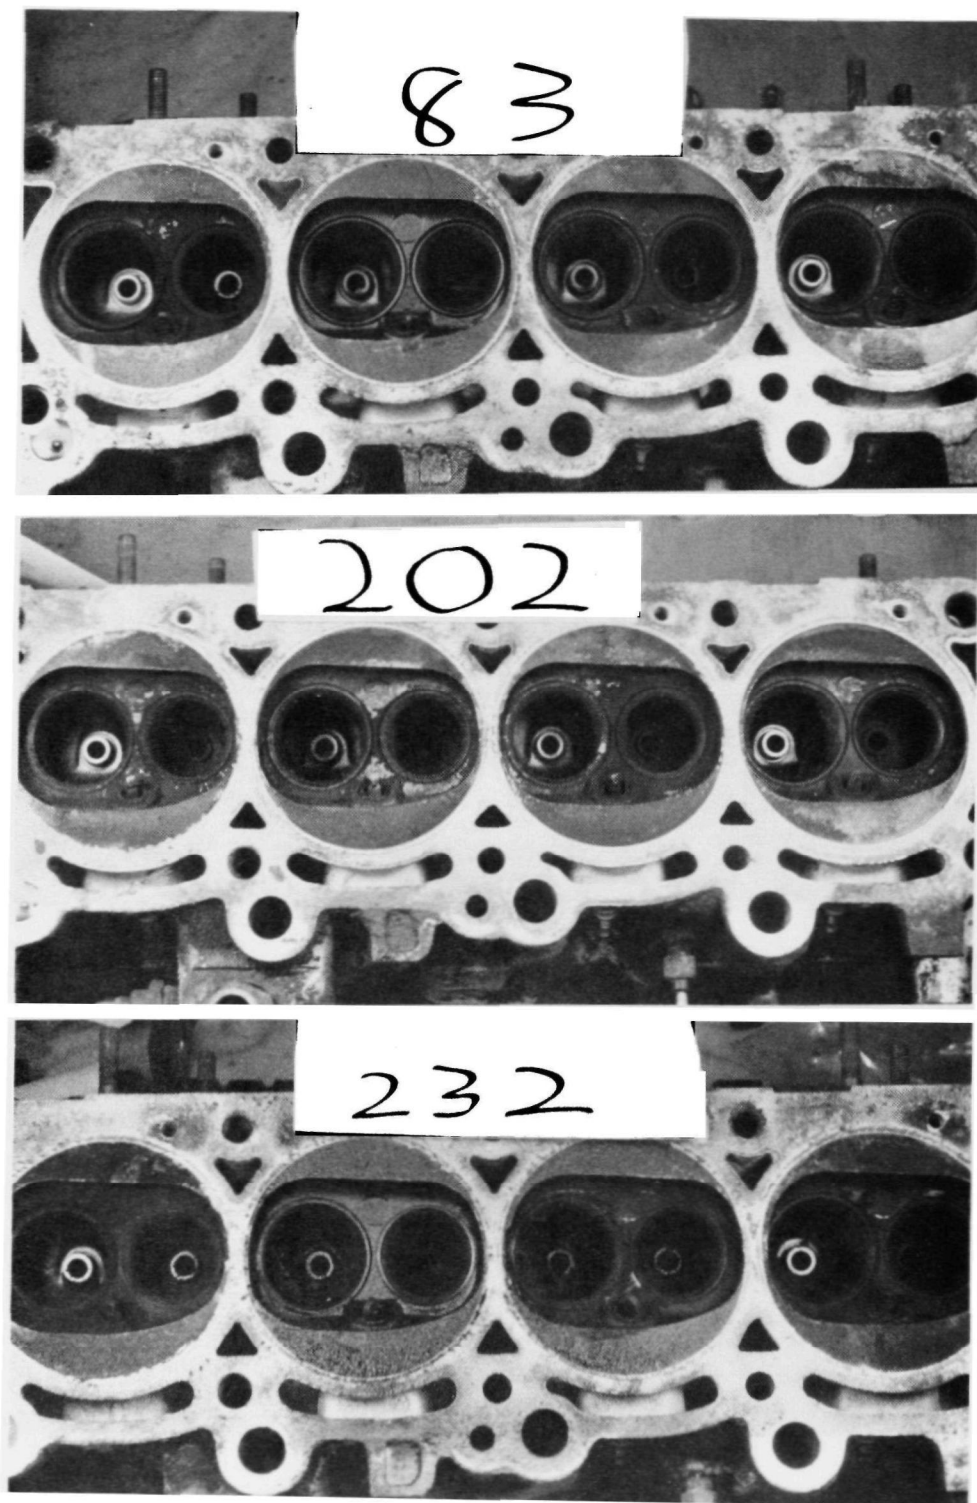
FIGURE 3. CYLINDER HEADS, PLYMOUTH RELIANTS

All of the Escort cylinder heads were visually similar in the combustion chamber areas, therefore only one photograph is shown. The ratings confirm this similarity. The Reliant heads displayed slight visual differences, but the rater's report indicates minimal practical differences. Note that in the head from vehicle C232, some deposits can be seen caked in the area behind the intake valve, which is not part of the combustion chamber.

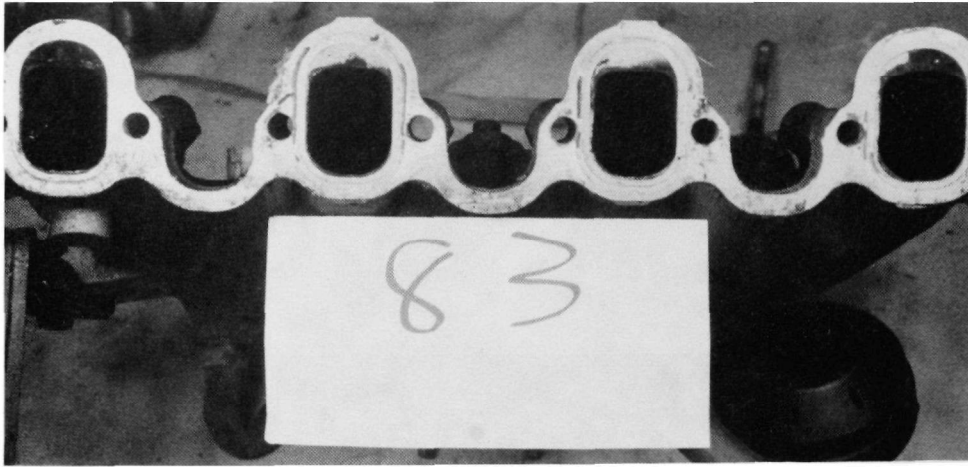
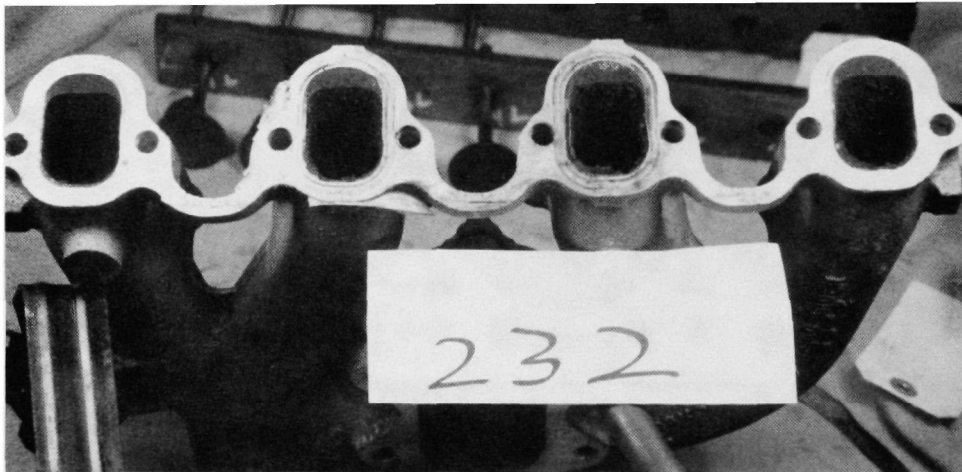
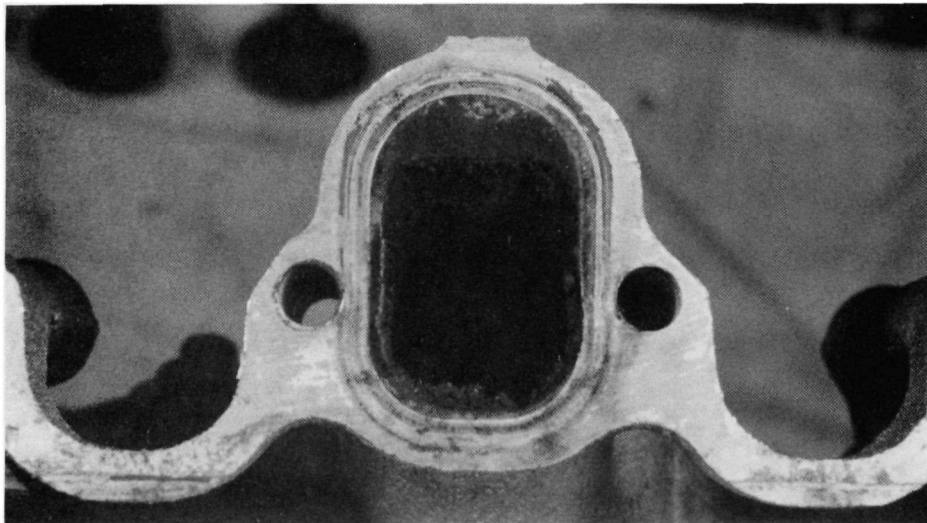
FIGURE 5. INTAKE MANIFOLDS, PLYMOUTH RELIANTS

With the exception of Reliant C232, the intake manifold runners and intake ports showed no correlation with fuel or vehicle. Vehicle C232 rated comparatively low, in line with the valve ratings.

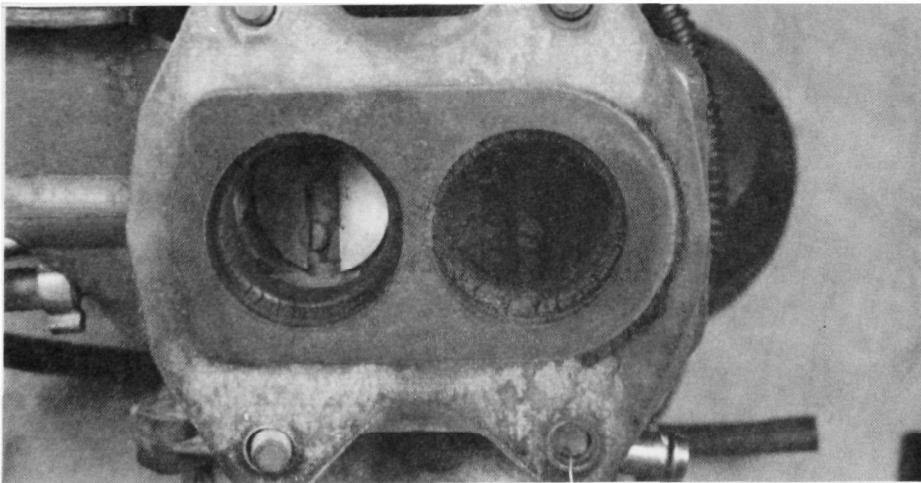
The rater was asked to evaluate only the area of the carburetor bores below the throttle plate. All were fairly normal except for C232. The extremely low rating of the C232 carburetor requires some explanation. From the photograph, Fig. 6, there appears to be very heavy deposits in the bores of the spacer below the throttle body. This material is actually a rubber-like lining which was present in this 1982 Reliant, but not in either of the others, which were both 1983 models. The rater treated this liner material as a deposit.

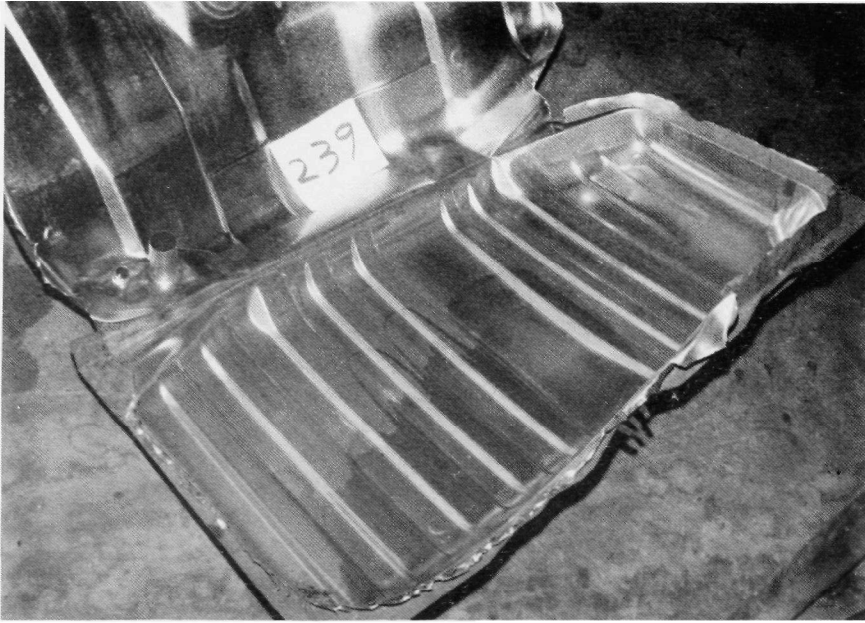
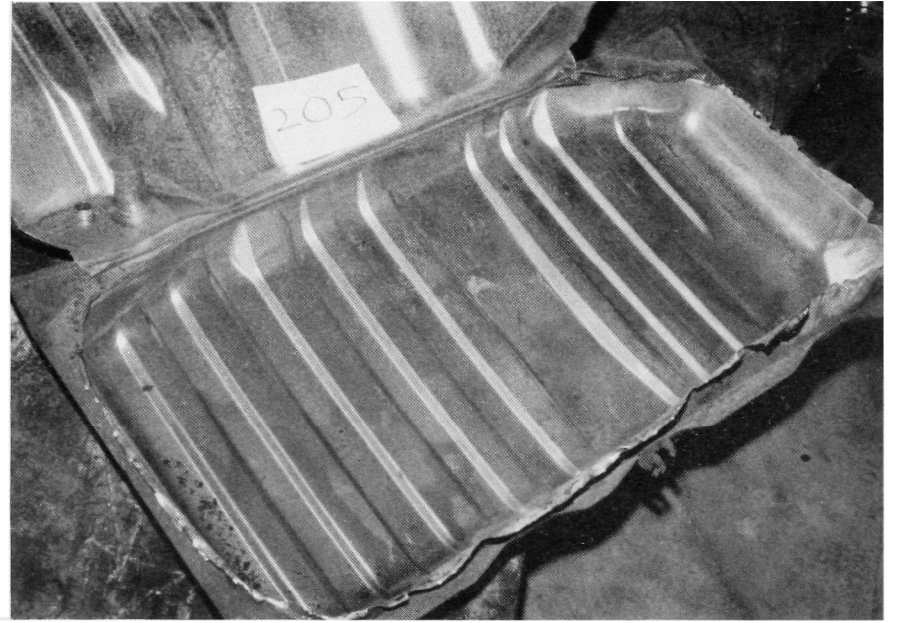
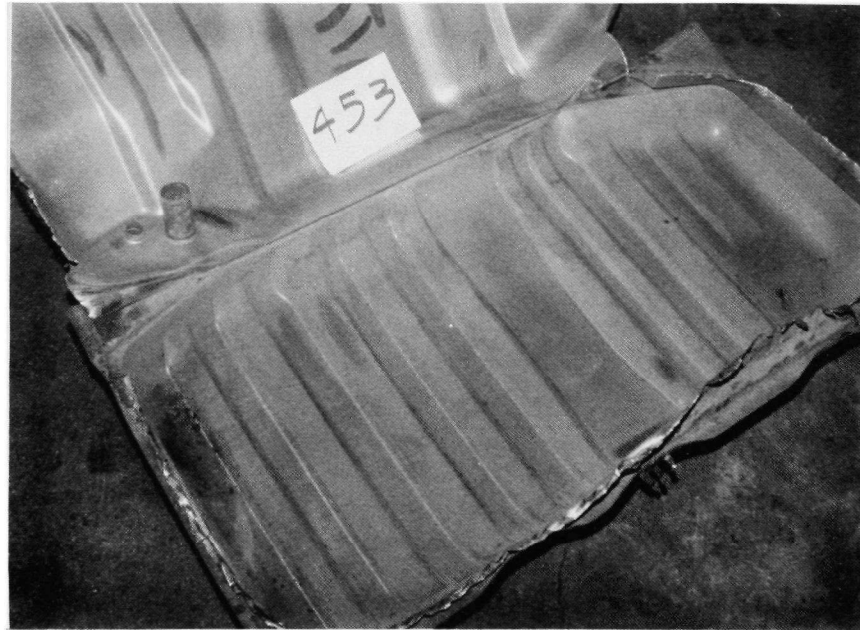
FIGURE 7. FUEL TANKS, FORD ESCORTS

Five of the fuel tanks looked like new inside. The sixth, from one of the blend-fueled Escorts, was free of corrosion, but had a dull gray film inside.

The rater's reports on the fuel tanks (see Appendix B) confirmed the evidence of the photographs. All were in good to very good condition, with one of the Escort blend-fueled tanks (SC453) having a gray film in the bottom half.
