# Illinois Central Gulf Train Derailment Claxton, Kentucky

EPA-430/9-80-012

ILLINOIS CENTRAL GULF TRAIN DERAILMENT

CLAXTON, KENTUCKY

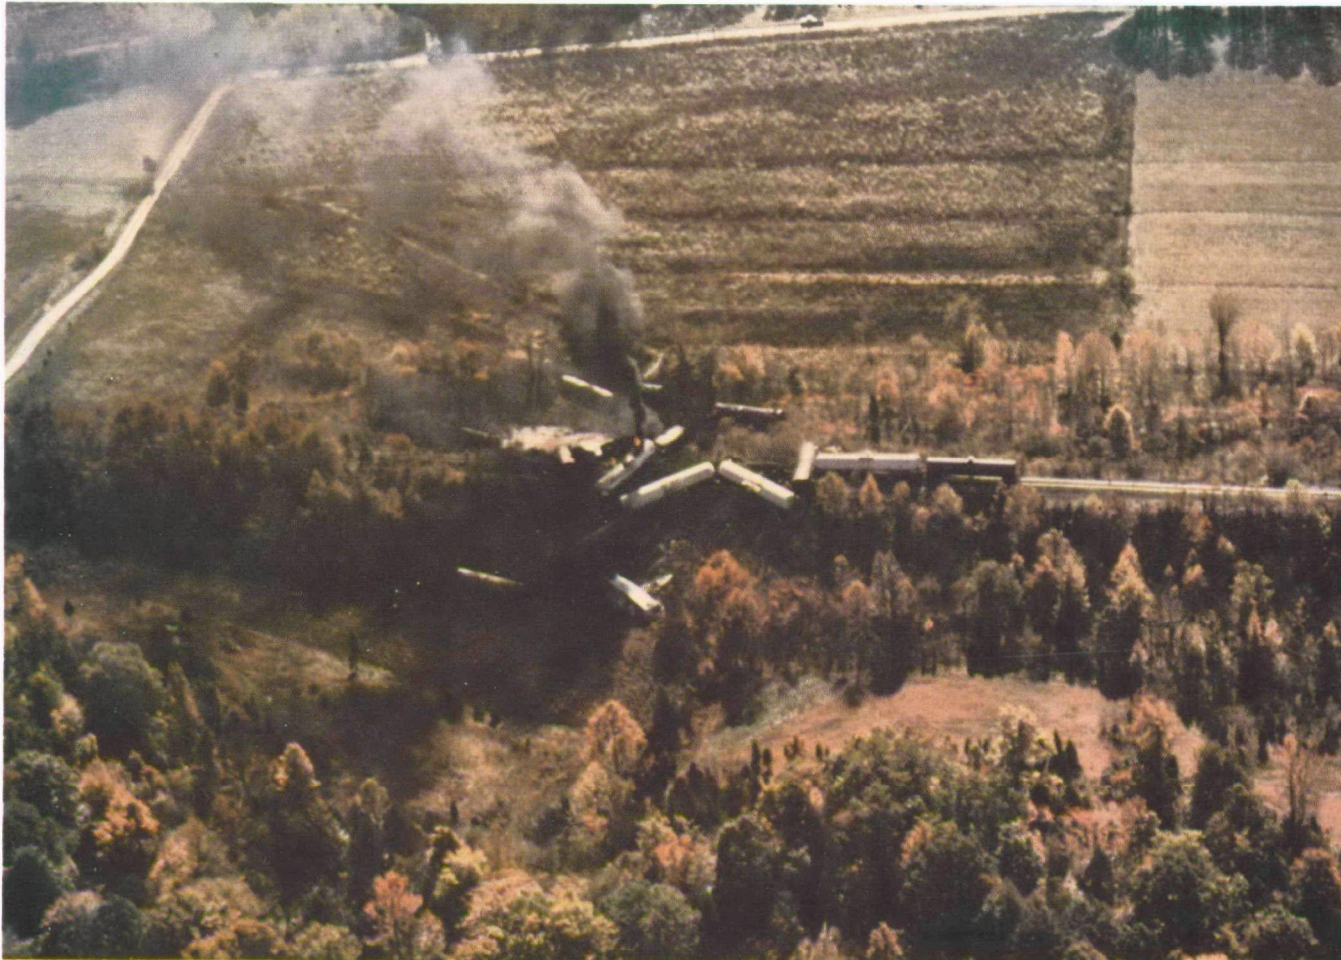
AERIAL VIEW OF 18-CAR DERAILMENT  
NEAR CLAXTON, KENTUCKY

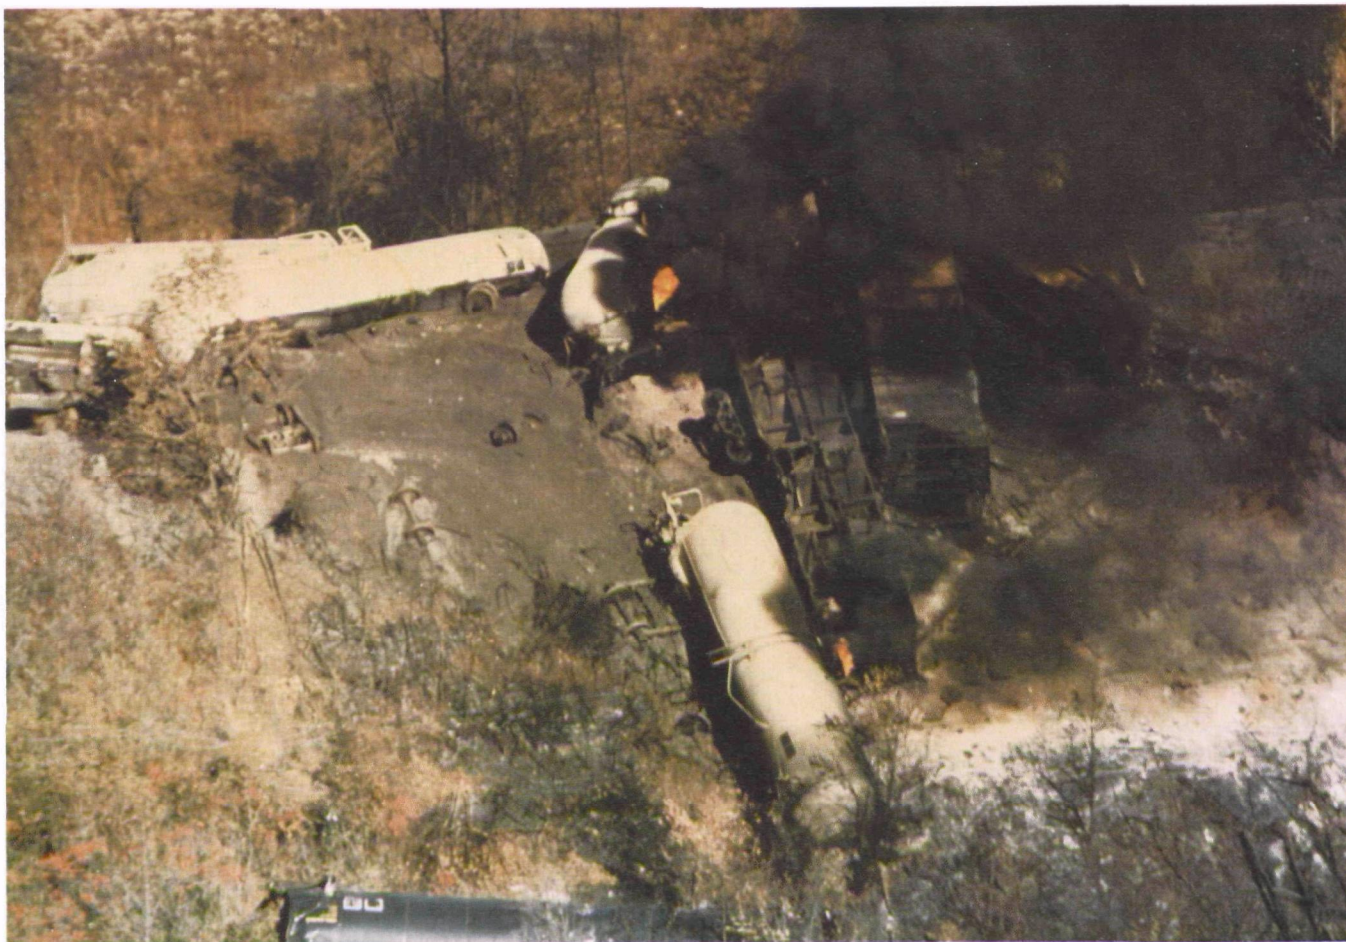
VINYL CHLORIDE TANK CARS ADJACENT TO HOPPER CARS  
CONTAINING BURNING COAL

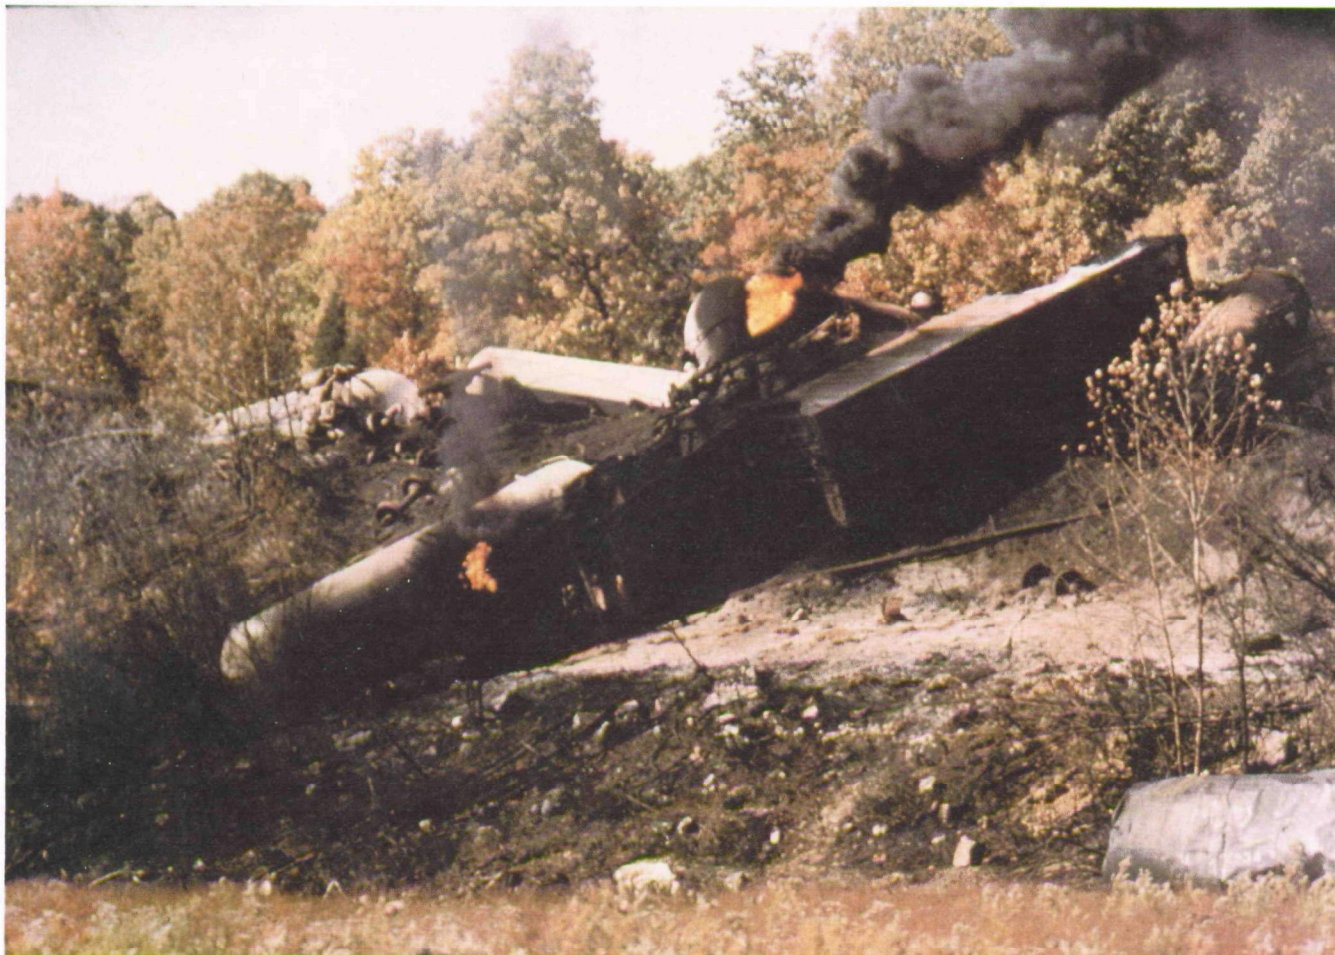
VINYL CHLORIDE TANK CARS. WHITE TANK CAR  
CONTAINS HYDROFLUORIC ACID

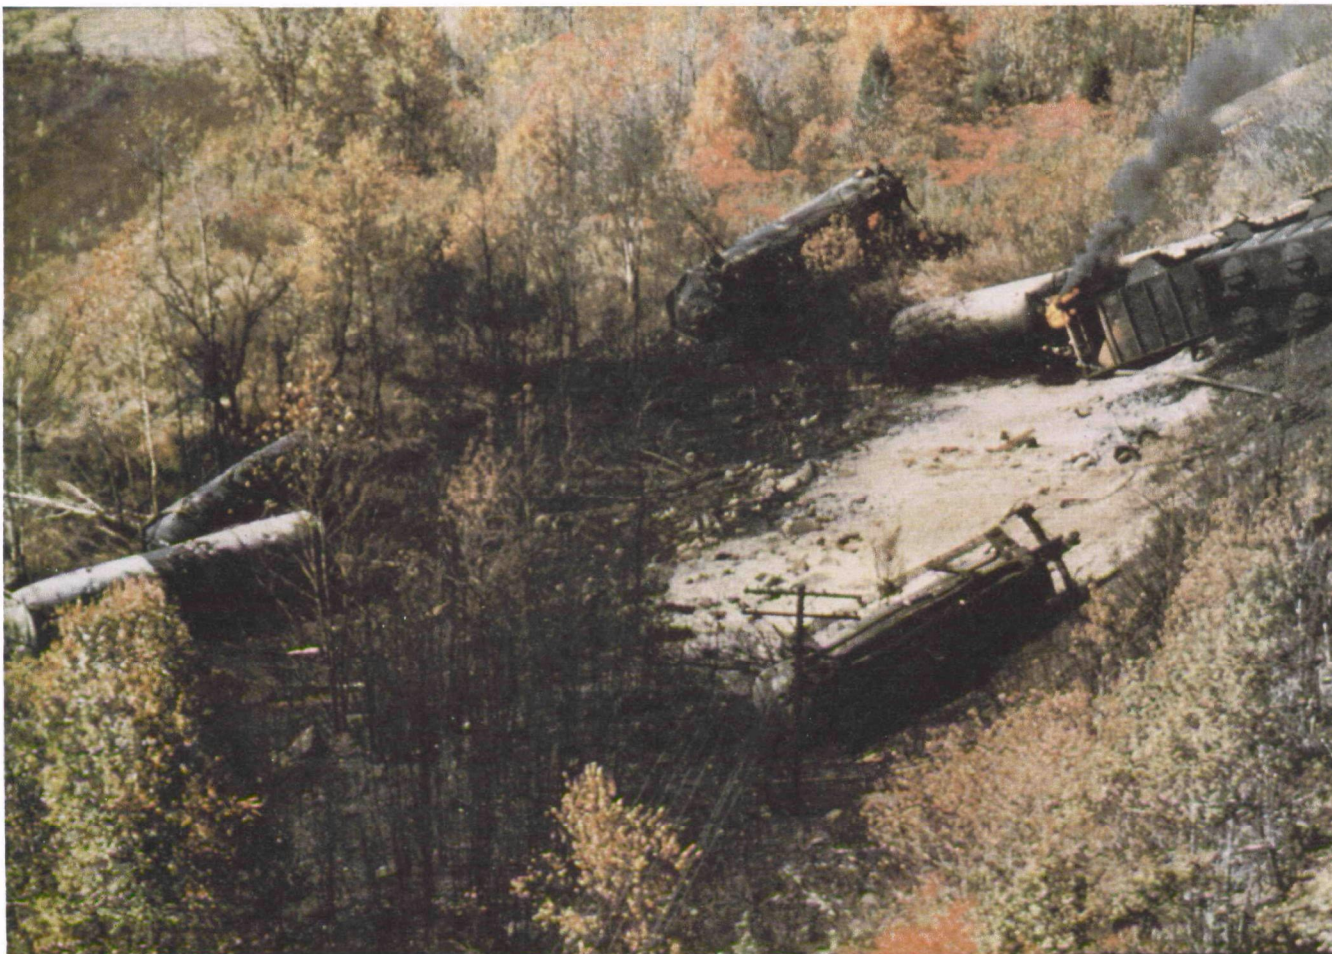
TANK CARS, TWO OF WHICH CONTAIN CHLORINE

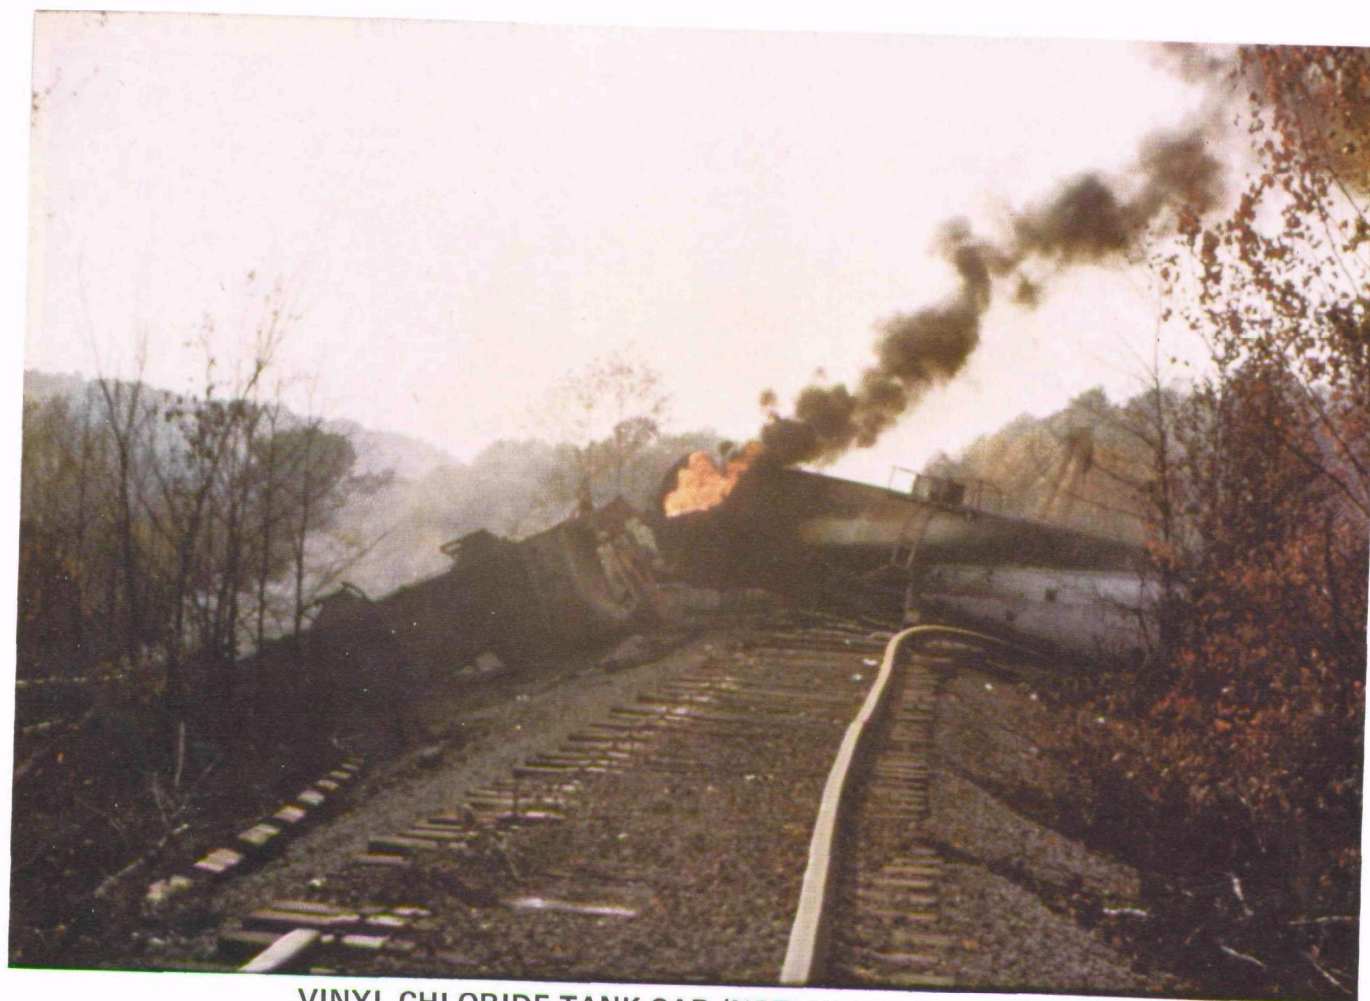
11:00 a.m. - Mr. Profrock returned from inspecting the vinyl chloride tank cars. He reported that a frost line had formed on one of the tank cars. His estimate of the volume of vinyl chloride remaining was 20%, or 4,000 gallons. A frost line had not appeared on the other tank car. Perhaps 75-80% of the liquid remained in the tank car, or about 15,000 gallons.

VINYL CHLORIDE TANK CAR (NOTICE FROST LINE)

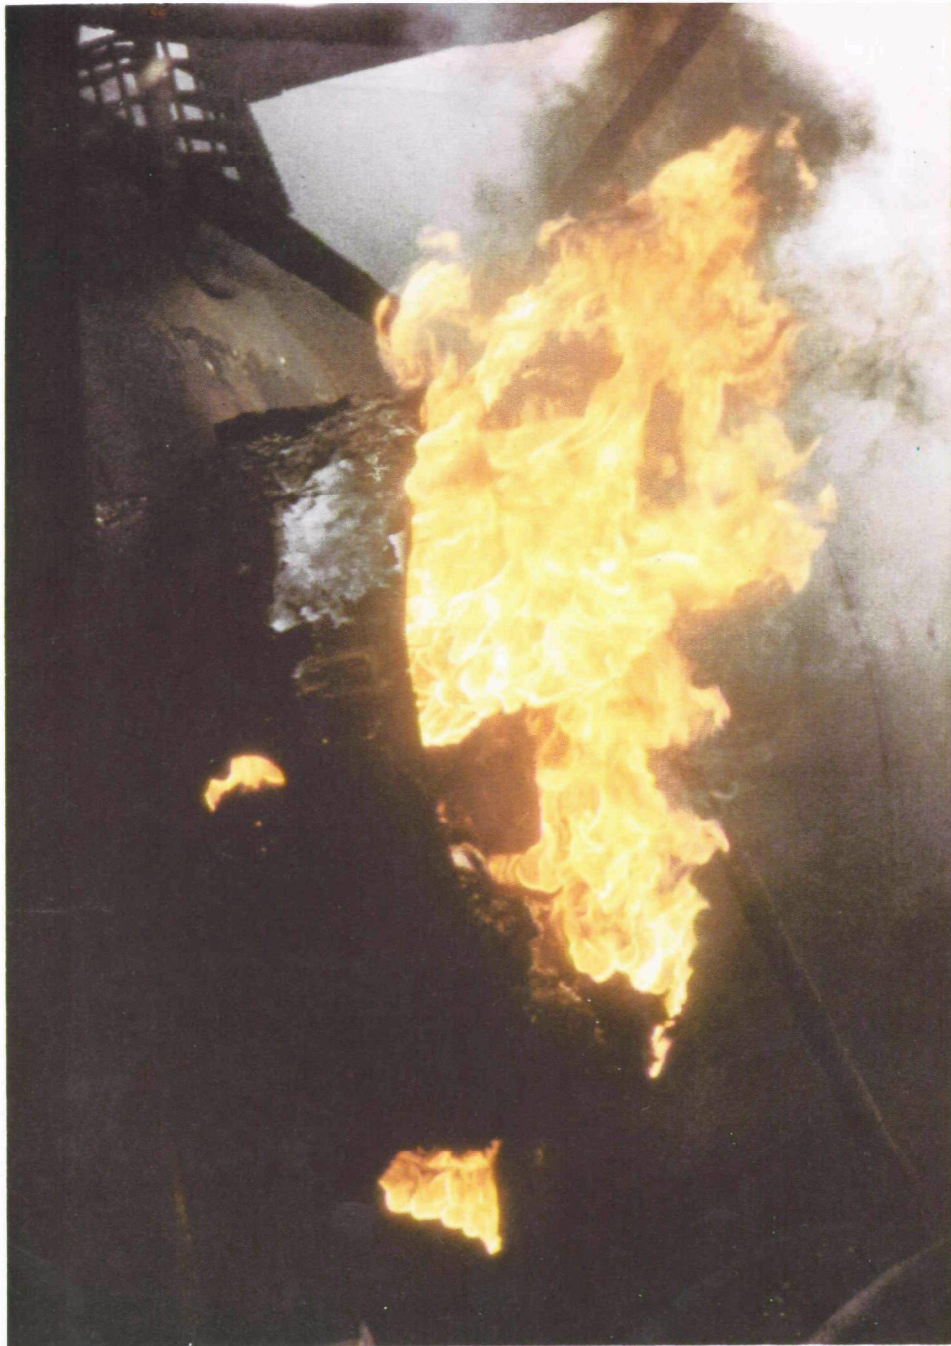
CLOSE-UP OF RUPTURED TANK CAR WITH BURNING  
VAPOR PHASE OF VINYL CHLORIDE

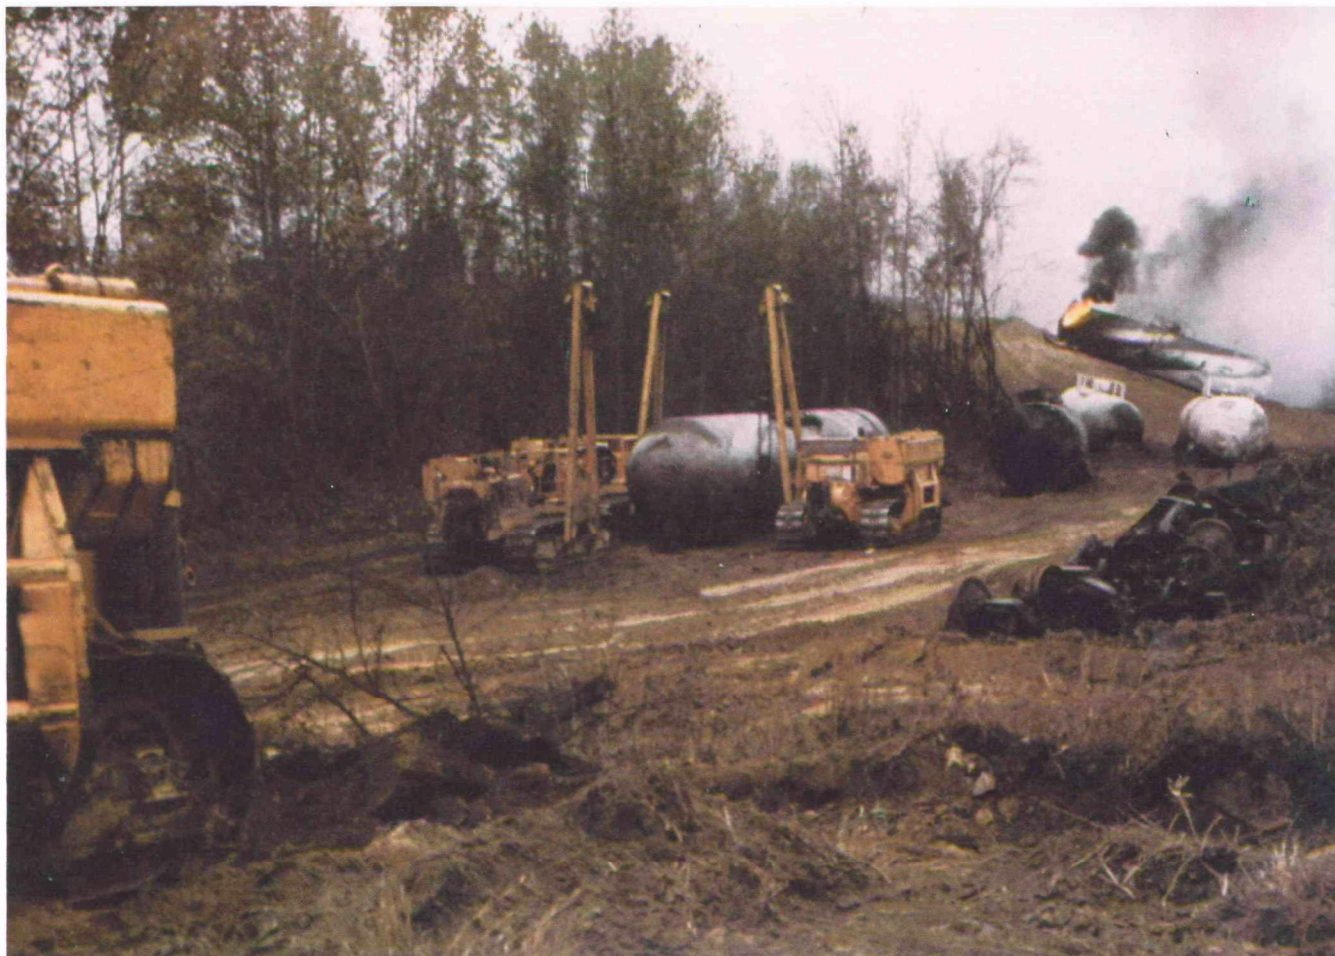
HEAVY EQUIPMENT MOVING TANK CARS TO  
NORTH END OF TRACKS

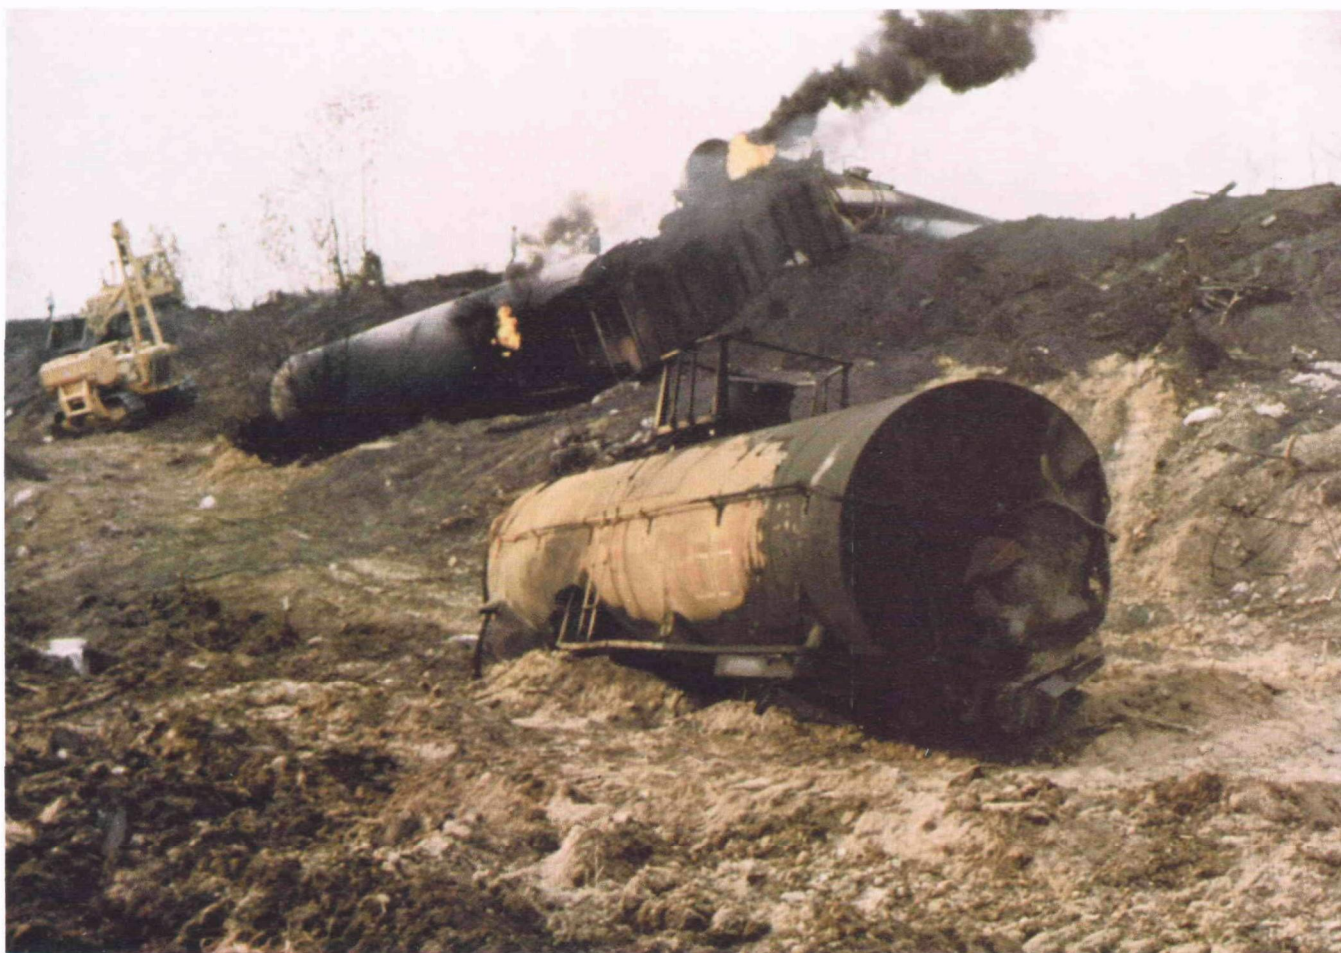
CHLORINE TANK CAR IN FOREGROUND WAS  
REMOVED FROM BURNING COAL CAR

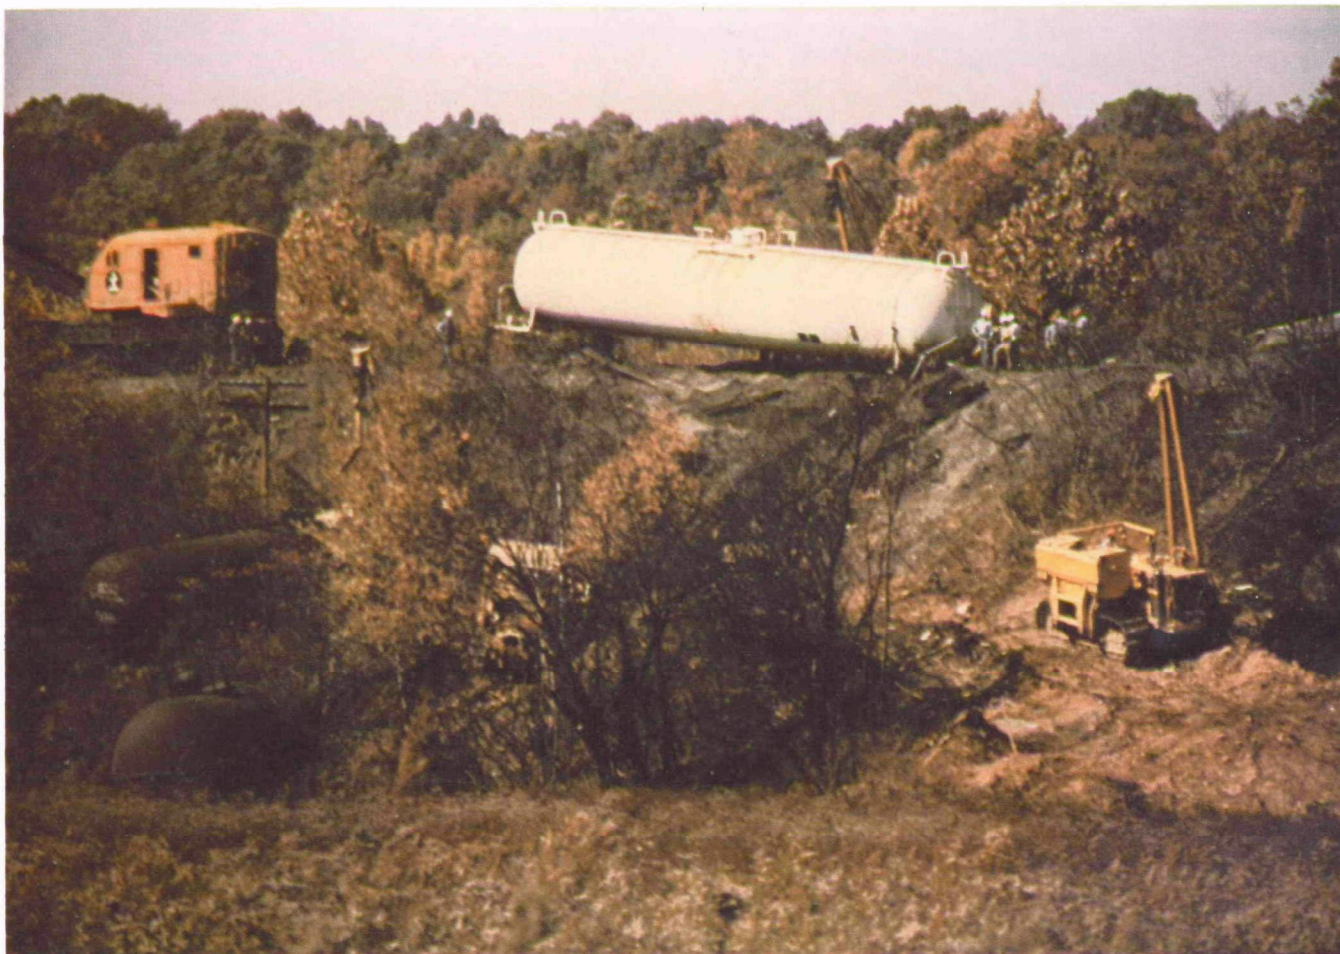
TANK CAR OF HYDROFLUORIC ACID BEING PREPARED  
FOR RELOCATION

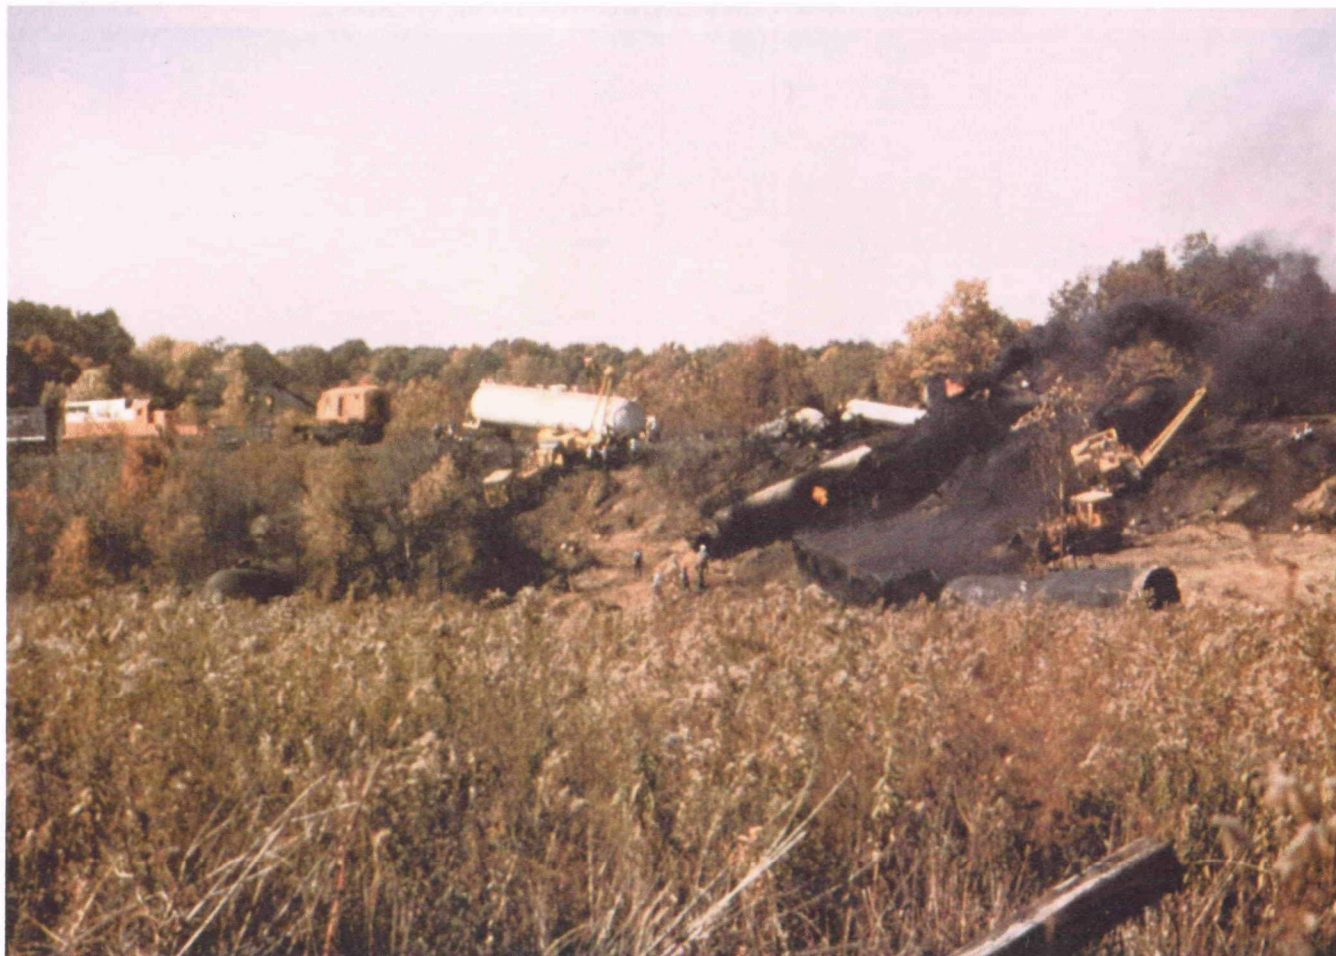
HYDROFLUORIC ACID TANK CARS IN RELATIONSHIP  
TO THE BURNING VINYL CHLORIDE CARS

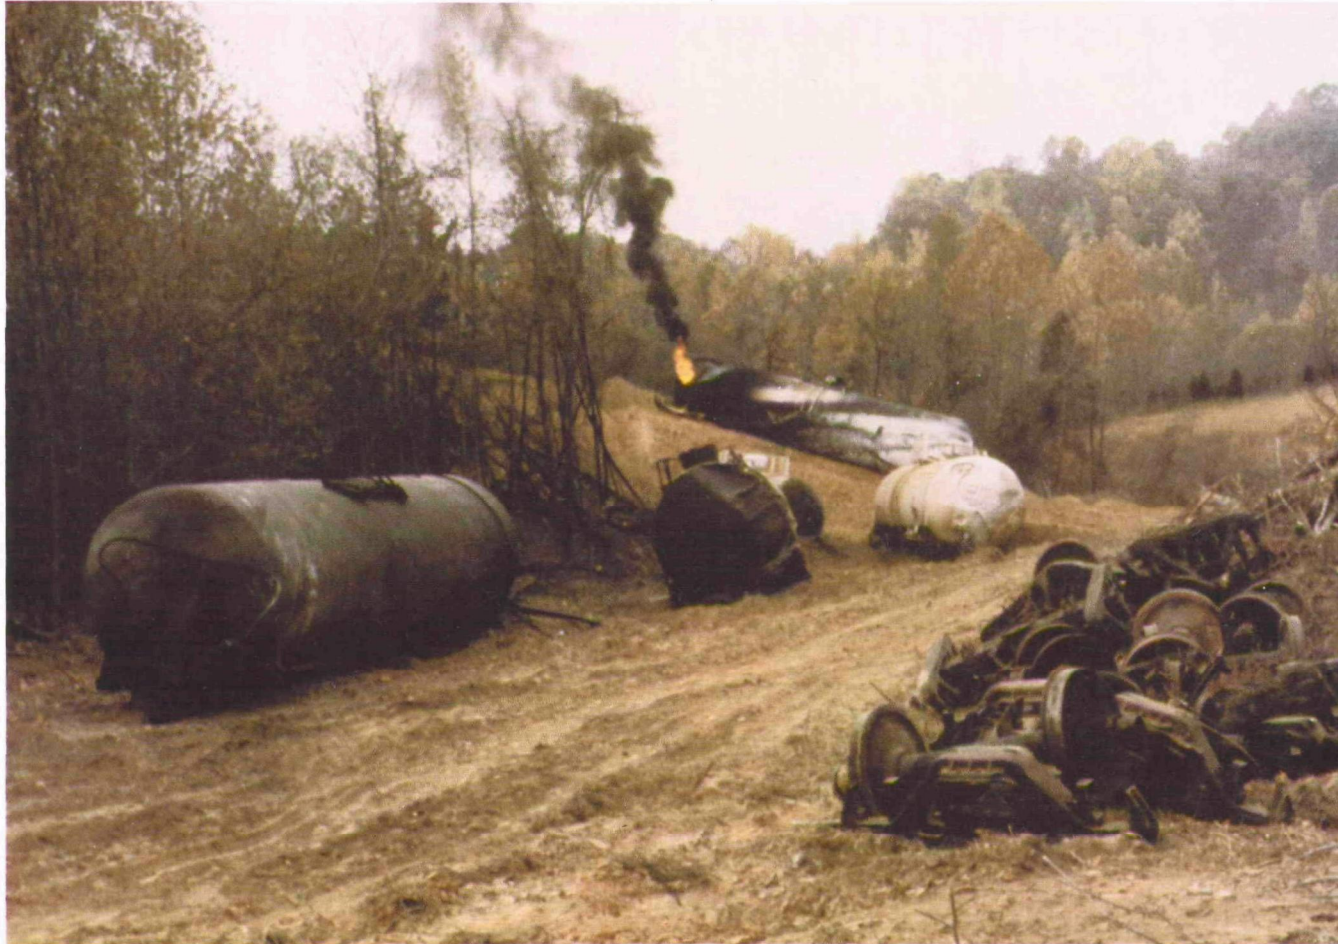
TANK CARS OF CHLORINE AND VINYL CHLORIDE  
REMOVED FROM WRECKAGE

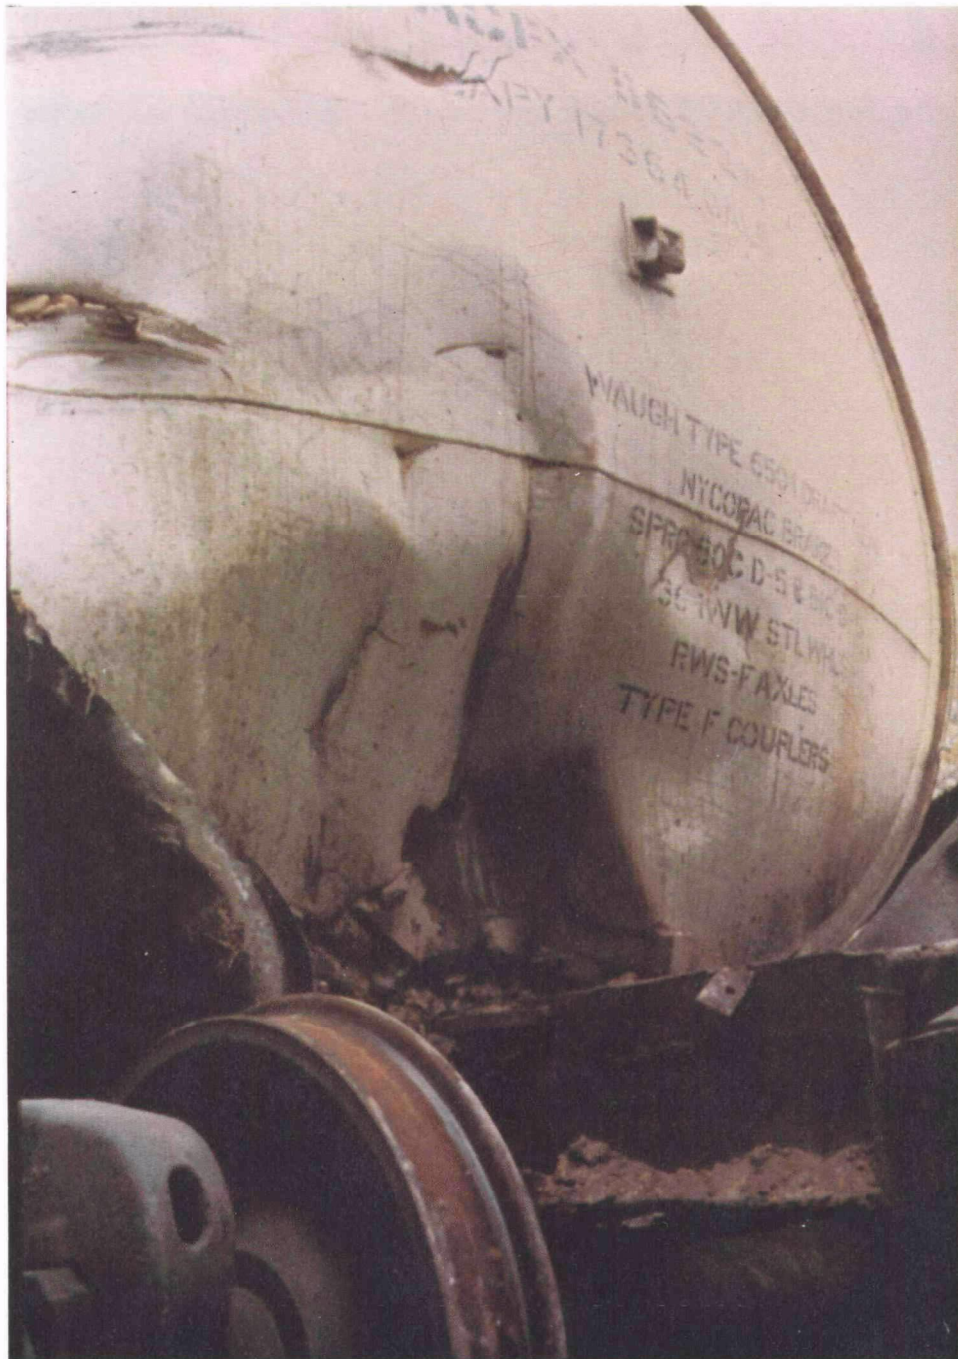
DAMAGE TO OUTER SHELL OF TANK CAR

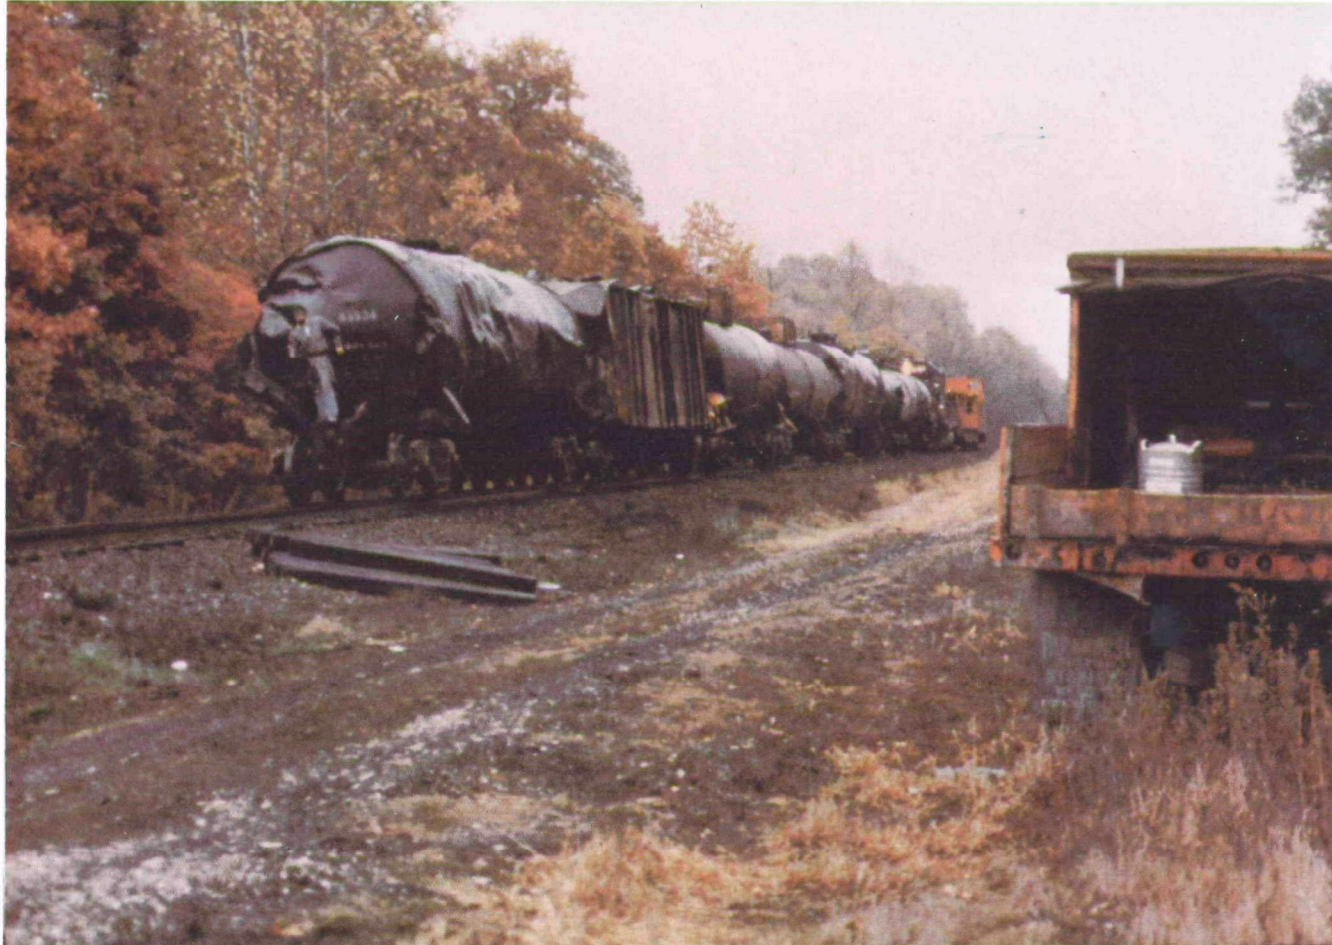
TANK CARS RE-RAILED ON NORTH END OF TRACKS
