S&A-TSB-21

TECHNICAL ASSISTANCE PROJECT  
VAIL WASTEWATER TREATMENT FACILITY

VAIL, COLORADO

MARCH - APRIL, 1973

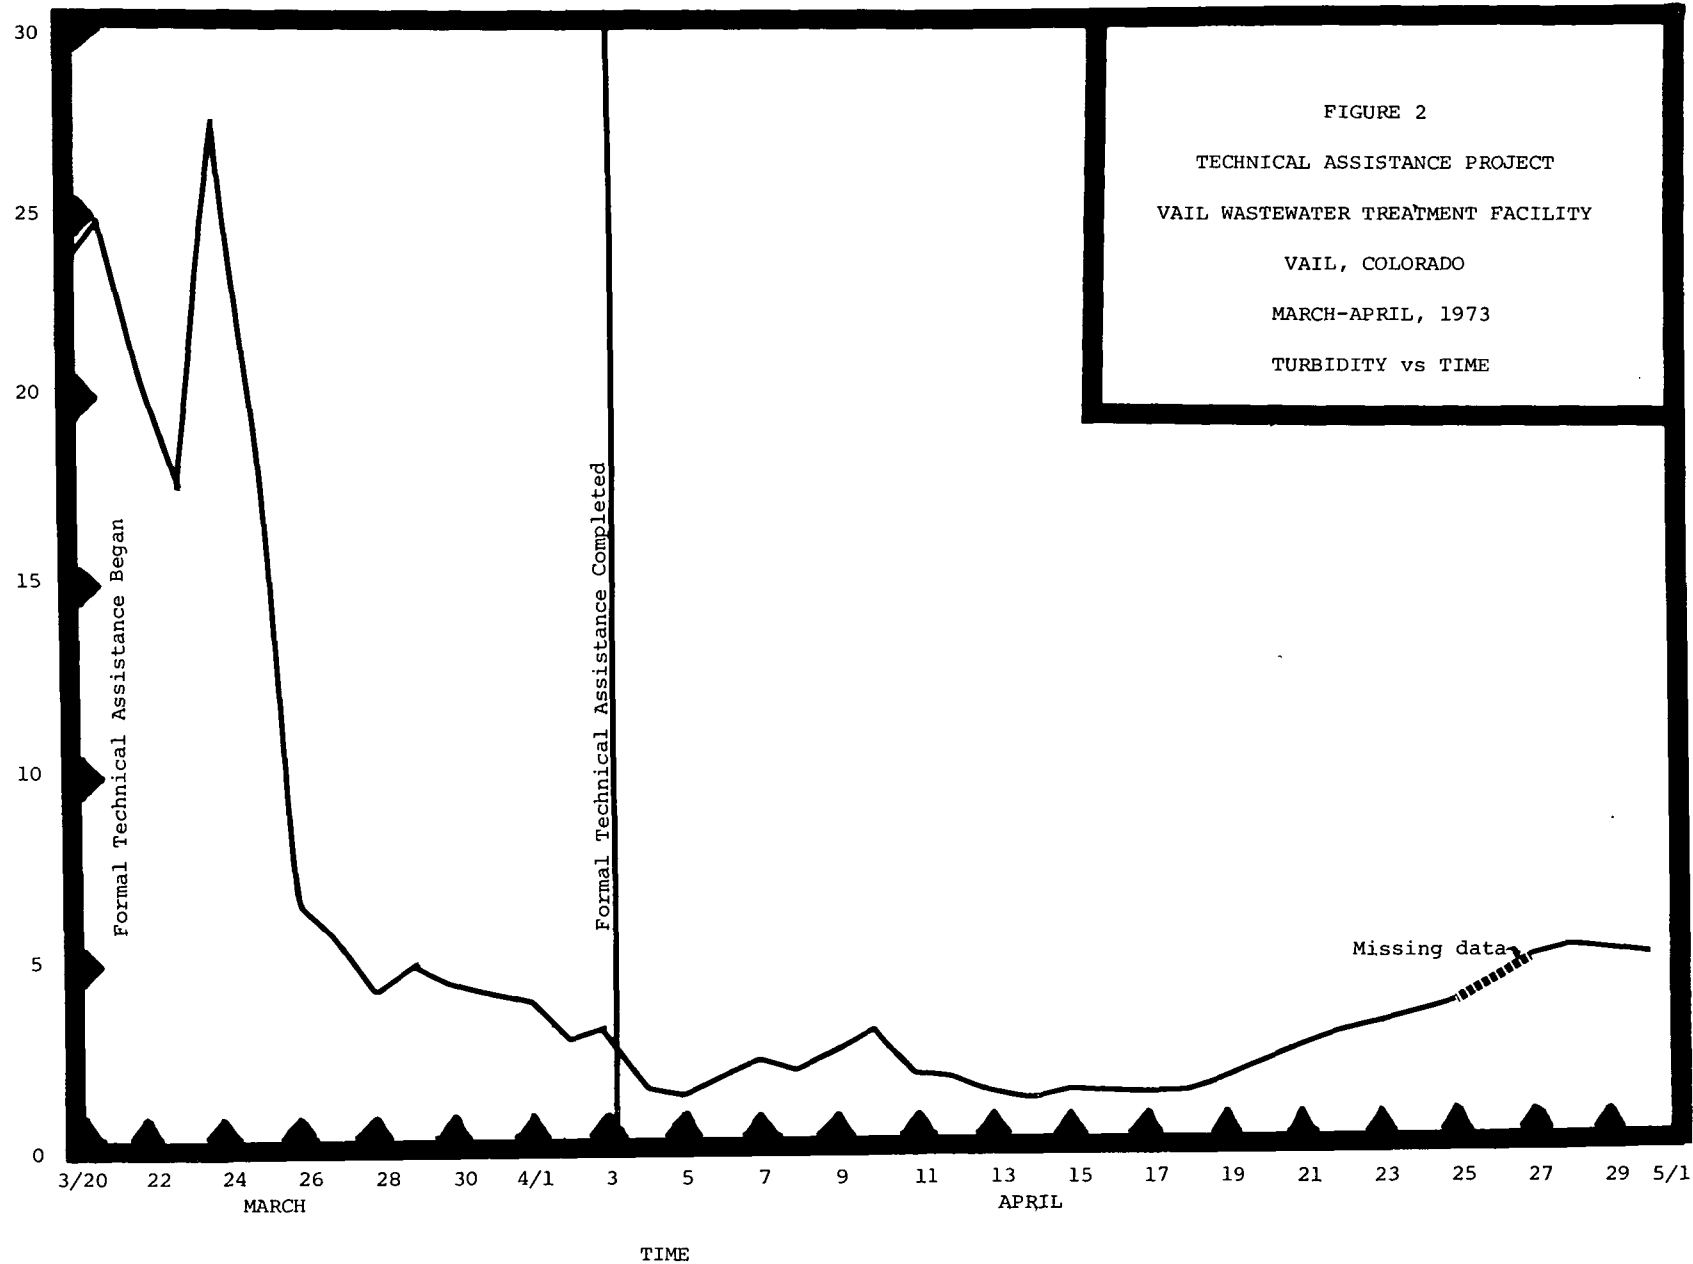
SECONDARY CLARIFIER TURBIDITY-JTU

Figure 2 shows the daily average turbidity values of the clarified effluent during and after the assistance project. It should be noted that in all cases attempts were made to exclude suspended solids in the turbidity sample. The purpose of the turbidity test was to indicate the ability of the mixed liquor suspended solids in the aeration basin to convert colloidal and dissolved BOD<sub>5</sub> in the waste stream to sludge solids. A high turbidity normally indicates a larger quantity of colloidal and dissolved BOD<sub>5</sub> present in the clarifier effluent and low turbidity normally indicates smaller quantities of colloidal and dissolved BOD<sub>5</sub> in the clarifier effluent. It is noted that a low turbidity value reported as outlined above does not necessarily mean low effluent total

Figure 2 shows a dramatic decrease in the turbidity within one week after the beginning of the assistance project and a continued decrease in turbidity until formal assistance was completed. The dramatic decrease in turbidity was the result of the changes in plant operation as discussed earlier in the report, (e.g. changed plant mode of operation, changed return sludge flow operation, changed aerator operator operation, etc.). The continued slower decrease in turbidity after the initial drop indicates the length of time required for the activated sludge biological system to change and develop. After the formal technical assistance project was completed the turbidity increased, then decreased, and then increased again. These changes in turbidity indicate the continued problems encountered with the final clarifiers and the resultant solids loss due to uncontrollable "sludge bulking". Sludge bulking occurred primarily because of inadequate flow distribution to the two final clarifiers. The uncontrolled solids loss caused lower MLSS concentrations resulting in additional colloidal and dissolved BOD<sub>5</sub> in the plant effluent.

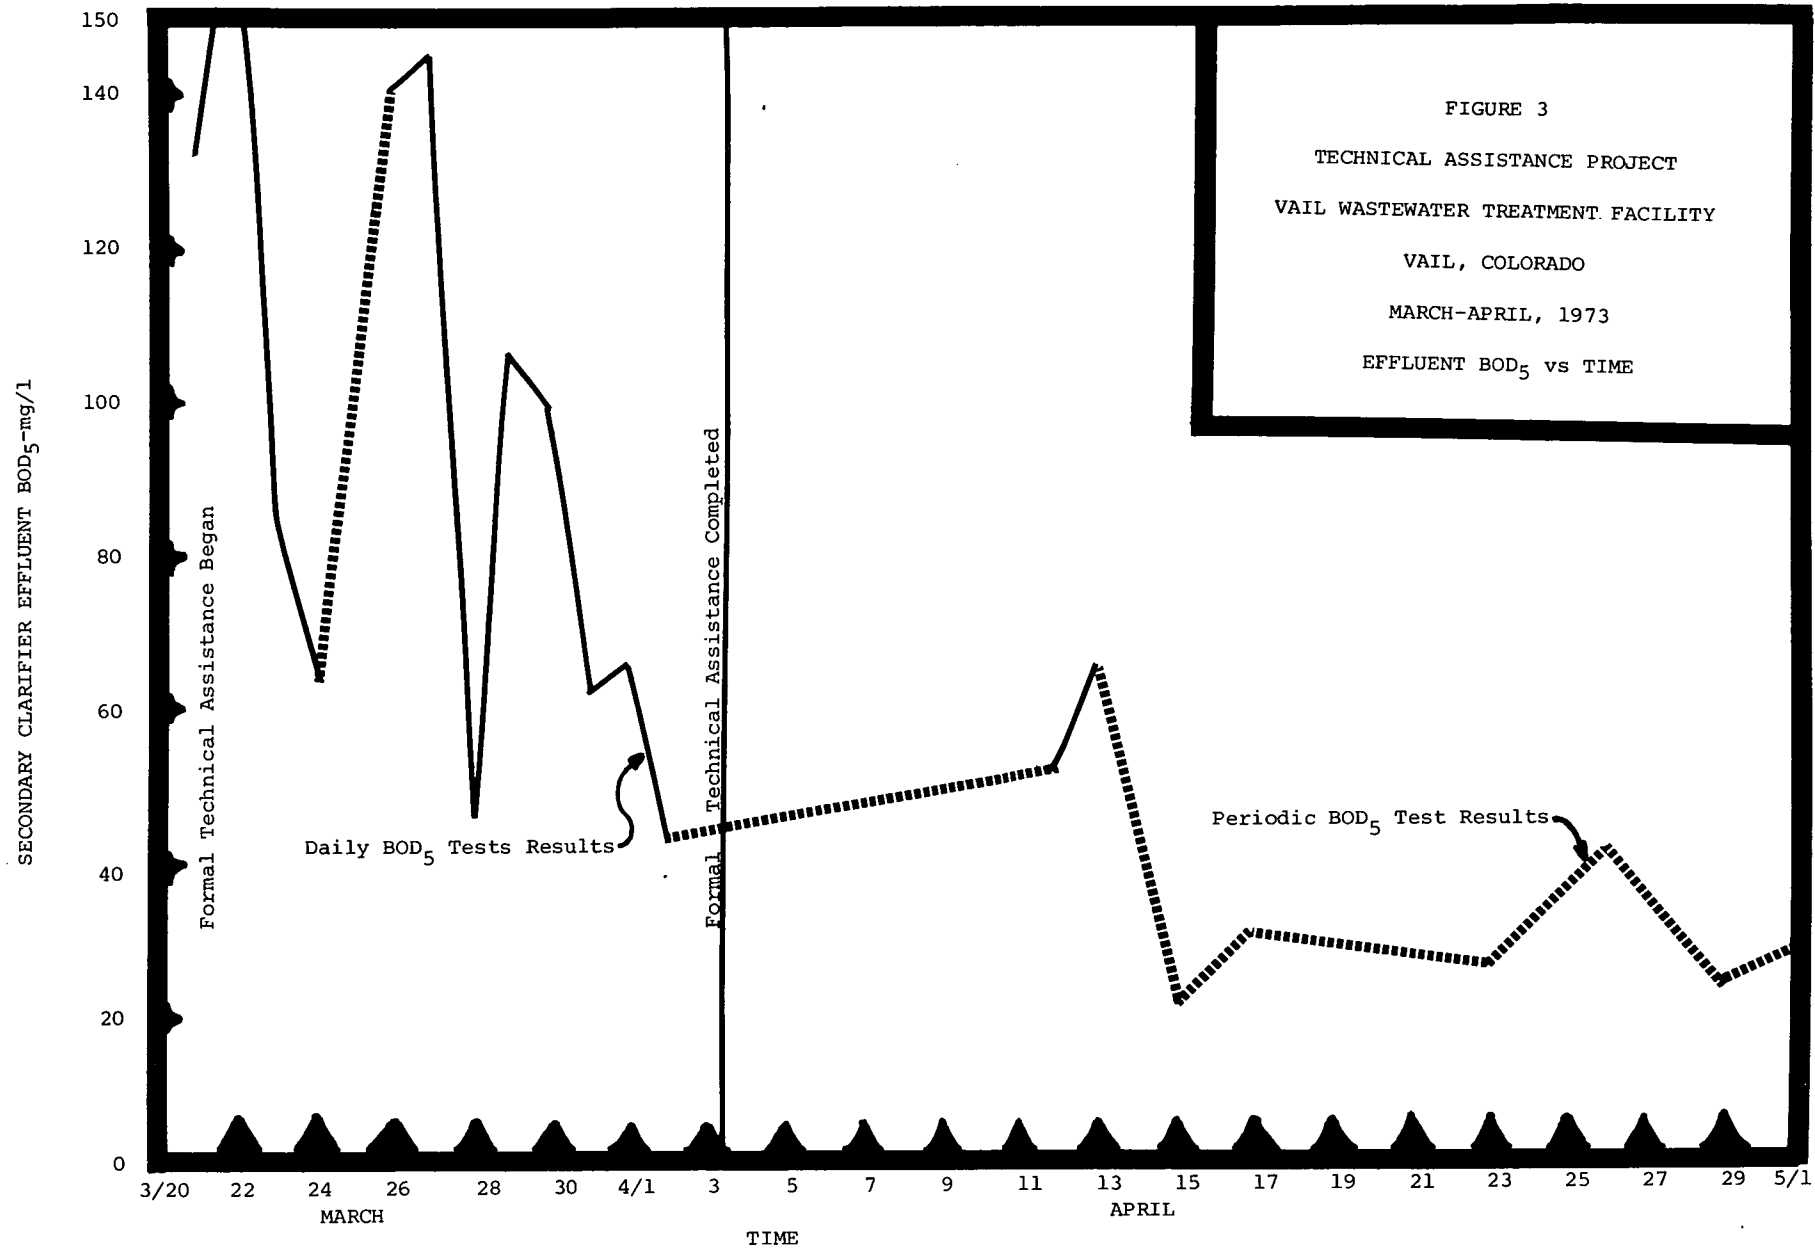
Figure 3 shows the daily composited secondary clarifier effluent BOD<sub>5</sub> test results. At the beginning of the assistance project most of the BOD<sub>5</sub> in the effluent was due to the colloidal and dissolved organic matter, (refer to Figure 2 for an indication of amount of colloidal and dissolved organic matter in the effluent as measured by turbidity). During assistance less of the BOD<sub>5</sub> was due to colloidal and dissolved organic matter and more of the BOD<sub>5</sub> was due to suspended solids "lost" in the effluent. As can be seen from Figure 3, a drastic reduction in the BOD<sub>5</sub> occurred during the assistance project (i.e. approximately 110 mg/l to 45 mg/l) and an even further reduction occurred after

formal assistance was completed (i.e. approximately 45 mg/l to 30 mg/l). However, the present Colorado Water Quality BOD<sub>5</sub> Standard (30 mg/l) was not consistently being met. The primary reason this standard was not met was the continued problems associated with the final clarifier. If the problems with the final clarifiers are eliminated, it is felt that the Vail treatment facility will be capable of consistently discharging BOD<sub>5</sub> and suspended solids concentrations less than 30 mg/l.

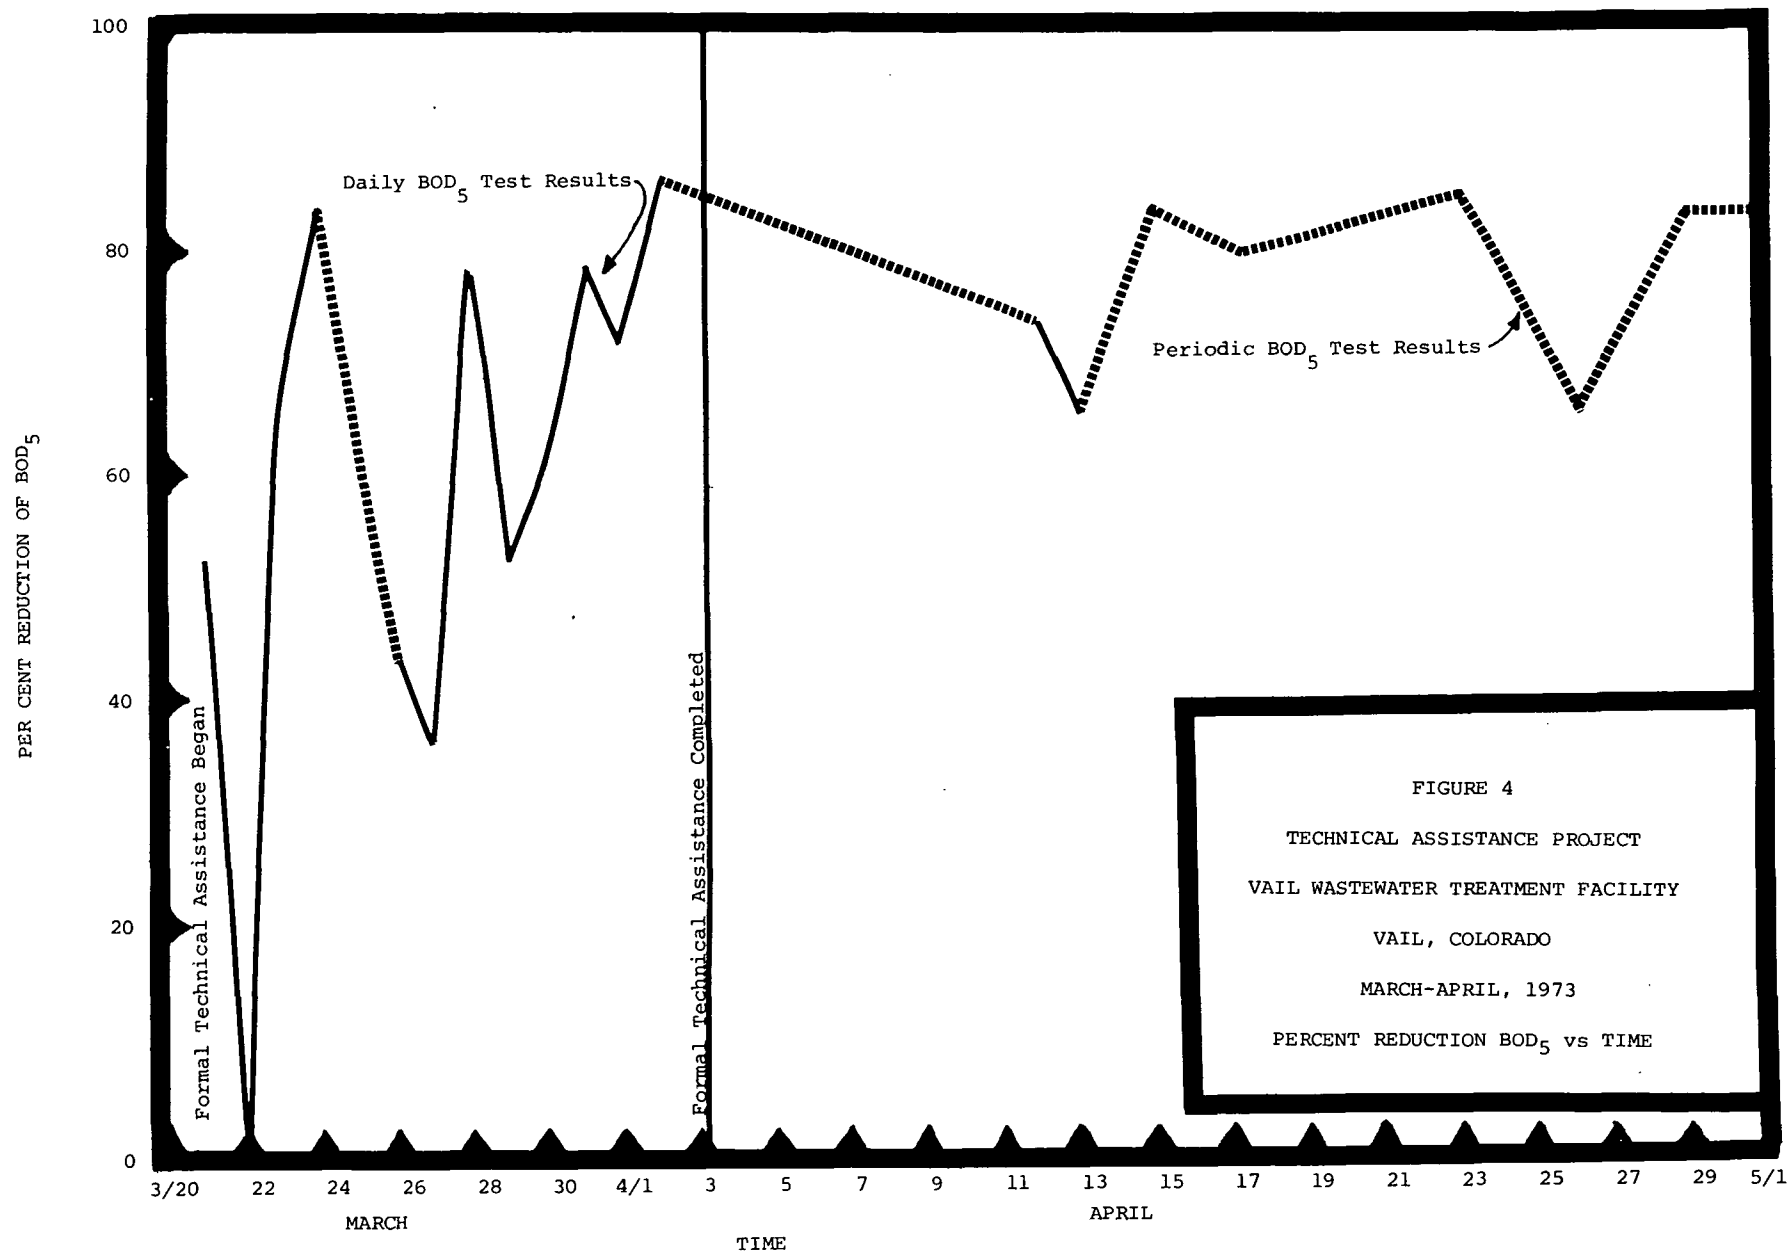
The reduction in clarifier effluent BOD<sub>5</sub> due to technical assistance represents nearly a 73% reduction in BOD<sub>5</sub> or a reduction of about 136.2 Kg (300 lbs.) of BOD<sub>5</sub> per day in the effluent (assume average plant flow of 1,703 cu m/day (450,000 gal/day) during assistance). Figure 4 shows that the present reduction in BOD<sub>5</sub> through the Vail facility increased from about 45% to about 75% due to assistance.

Greater reductions can be expected with appropriate modifications to the secondary clarifiers.
