EPA-650/2-74-010

**EPA ALKALI  
SCRUBBING TEST FACILITY:  
LIMESTONE WET SCRUBBING  
TEST RESULTS**

Bechtel Corporation  
50 Beale Street  
San Francisco, California 94119

This report presents the results, through early January 1974, of limestone and lime reliability verification and long-term reliability testing at the Shawnee Prototype Facility.

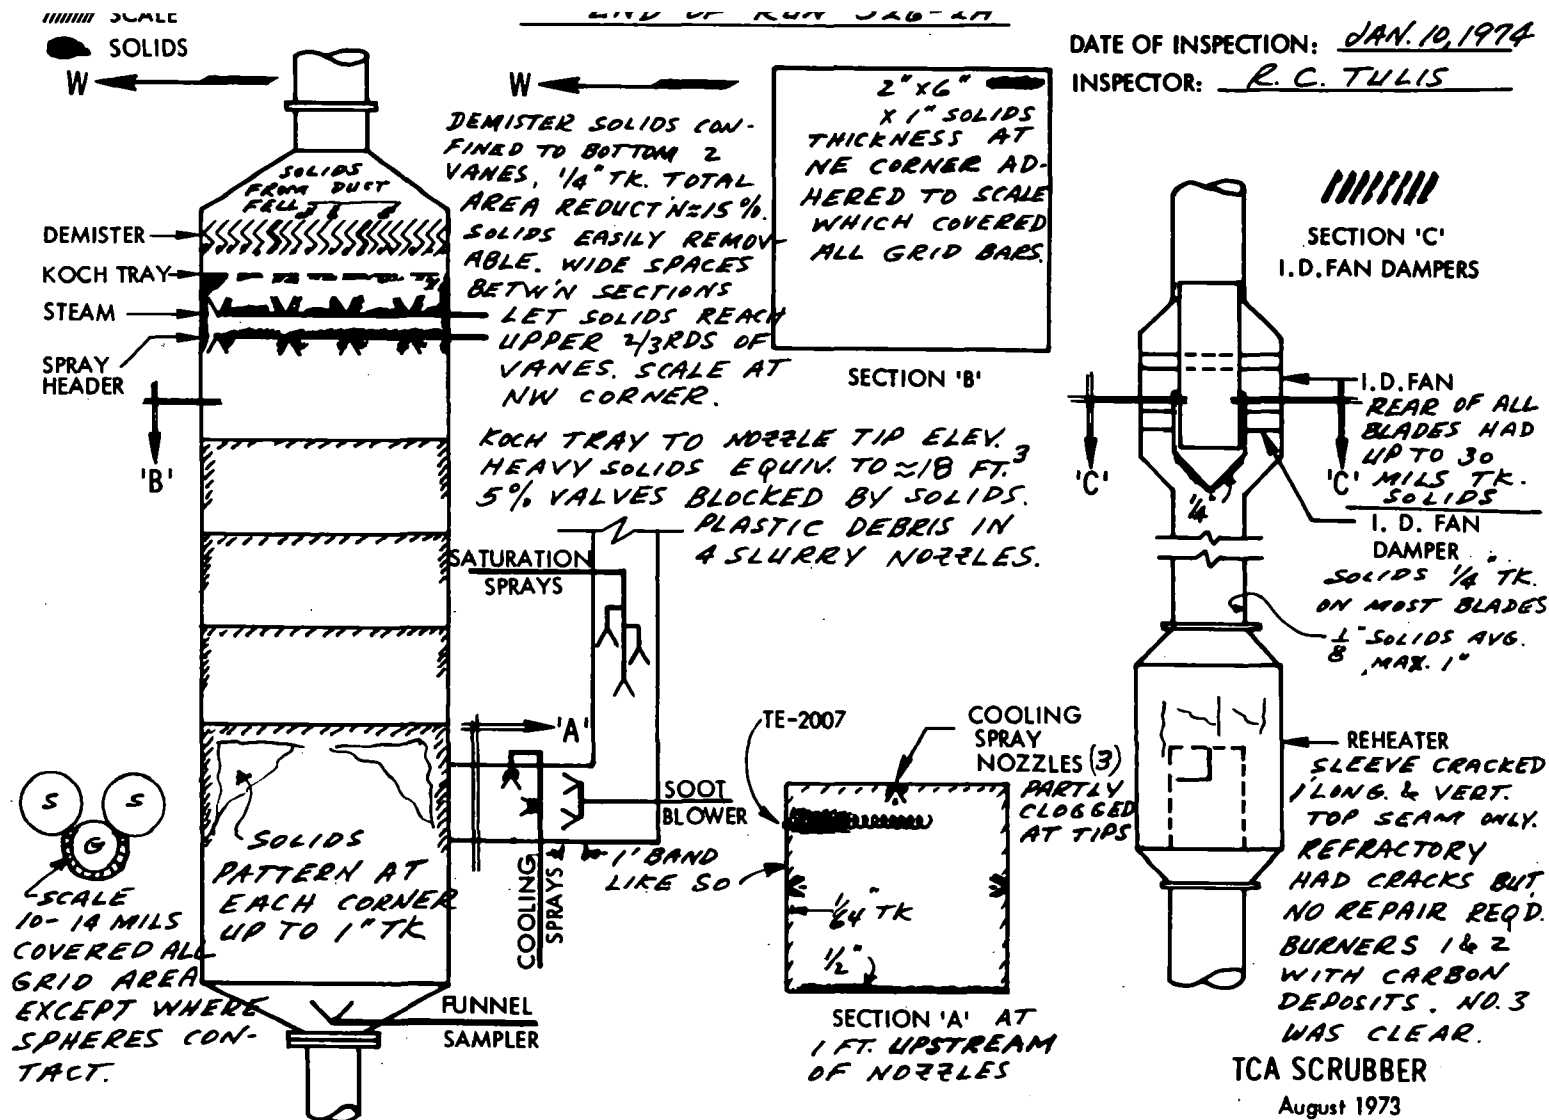
Figure 3-1. TCA Inspection

The general appearance of the scrubber was good. Scattered solids deposits (up to 1 inch) covered the walls of the scrubber below the bottommost bar-grid. About 1/16 inch thick scale was found on the walls below the bottommost grid and on the wall areas not in contact with the spheres. The 4 bar grids were covered with 10-14 mil scale.

Heavy solids deposit covered the inlet slurry spray nozzles and header and adjacent walls between the elevation of the nozzle tips and Koch wash tray. A heavy relatively uniform (about 1 inch thick) solids

layer covered the underside of the wash tray. Approximately 5 percent of the tray valves were covered with solids. All four inlet slurry spray nozzles were partially plugged with debris, primarily with plastic covering from pipe insulation. Demister plugging was confined to the bottom two passes only (1/4 inches thick solids), reducing the free flow area by about 15 percent.

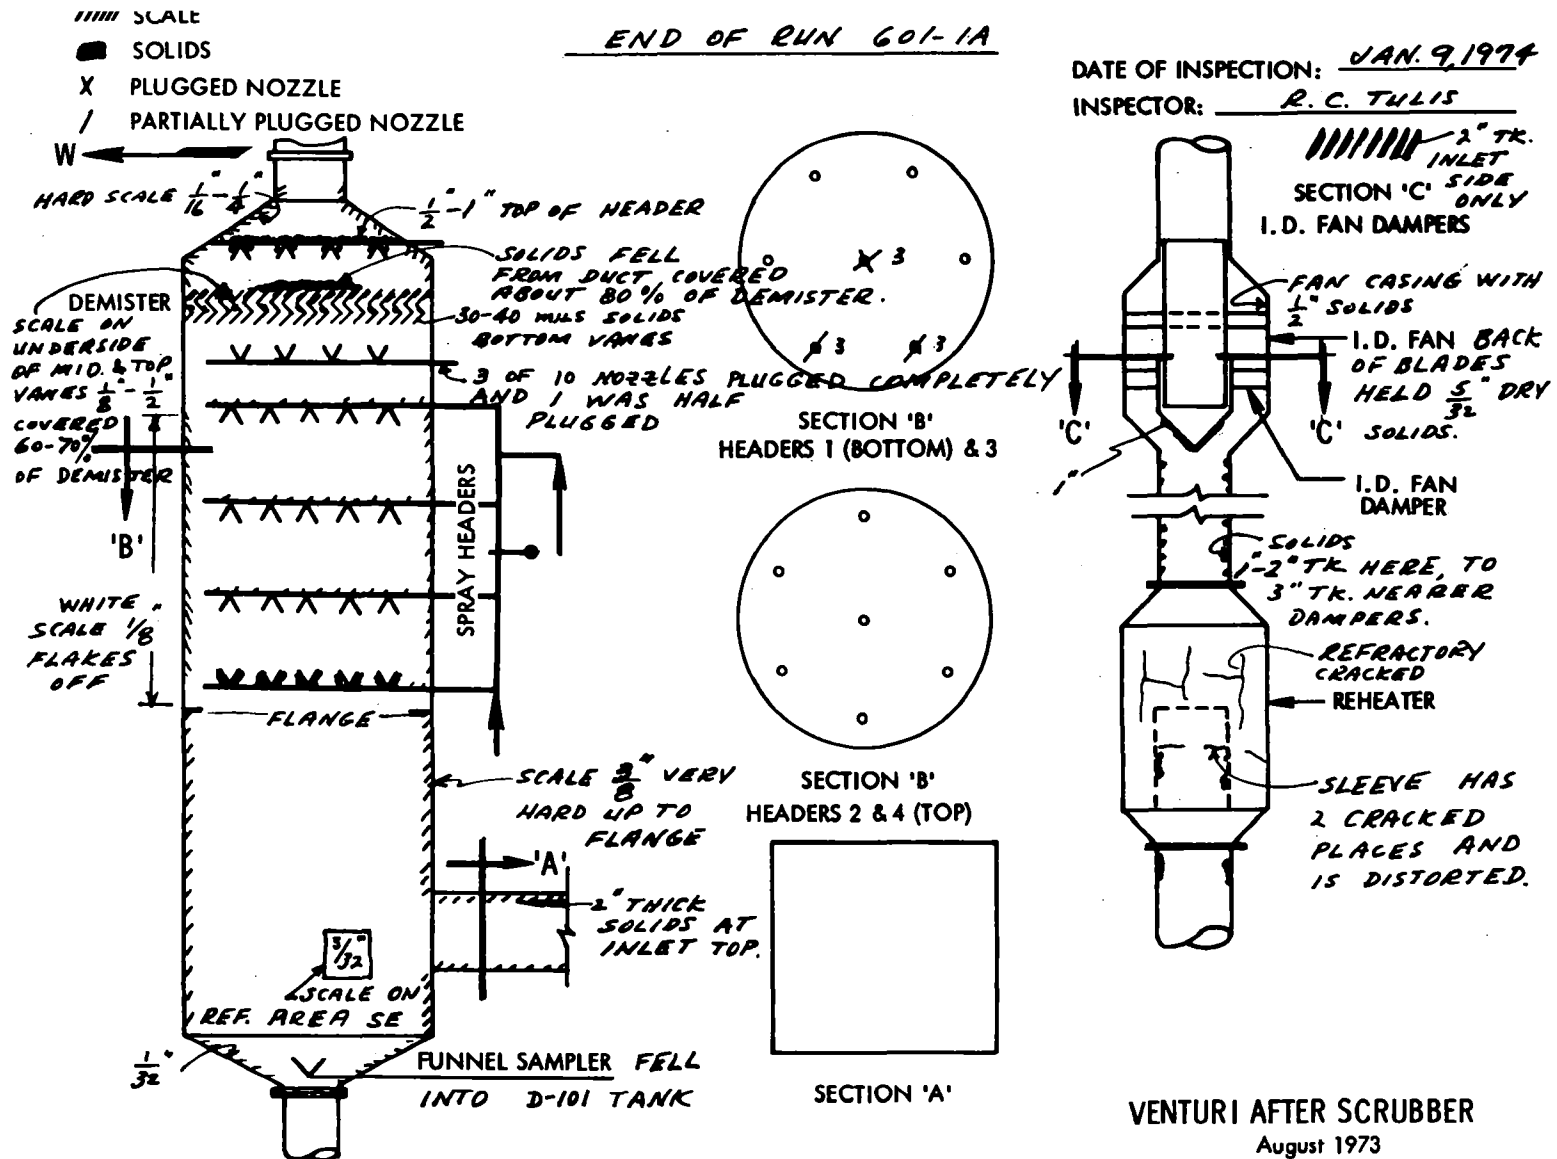
Figure 5-3. Spray Tower Inspection

several of the spray nozzles, especially on the bottom header. Some of the Bete stainless steel ST-48 FCN spiral tip nozzles were found to be significantly eroded after approximately 4300 hours of slurry service; of a total of 28 nozzles, 9 were severely eroded and 15 were considerably worn.
