**- Final Project Report -  
Demonstration and Evaluation of Technologies for  
Determining the Suitability of USTs  
for Upgrading with Cathodic Protection**

**Midwest Research Institute**

**U.S. Environmental Protection Agency  
Office of Research and Development  
National Risk Management Research Laboratory  
2890 Woodbridge Avenue  
Edison, New Jersey 08837-3679**

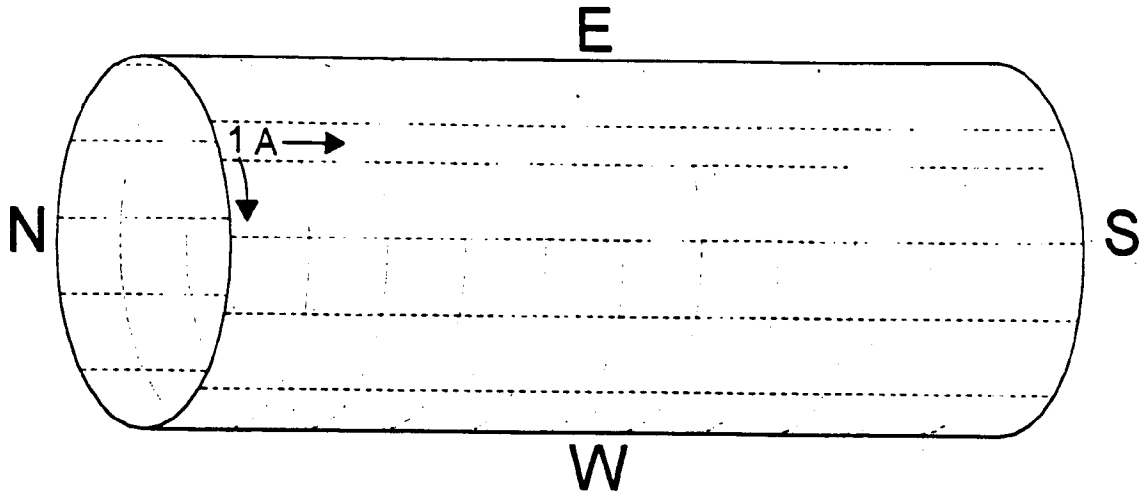
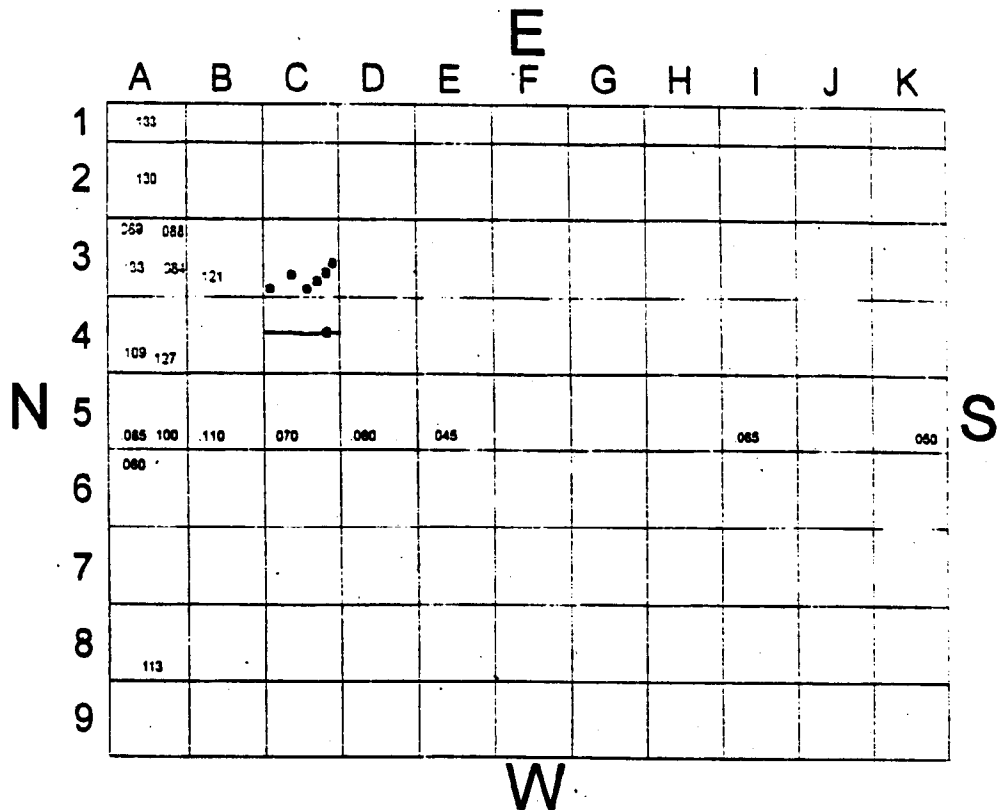
## Tank #19

- Magnetic Flux Inspection
- Internal Corrosion Readings
- Weld
- Holes

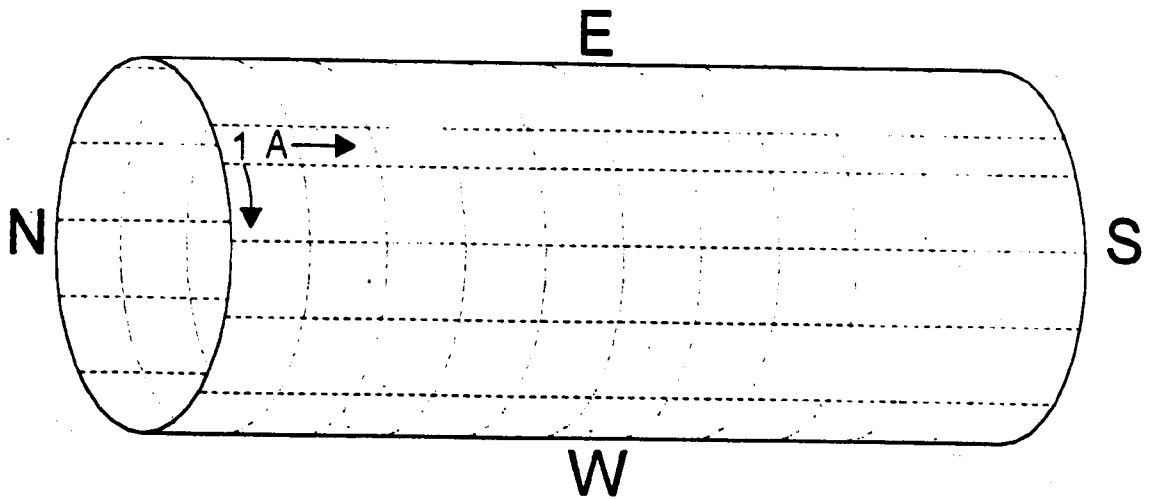
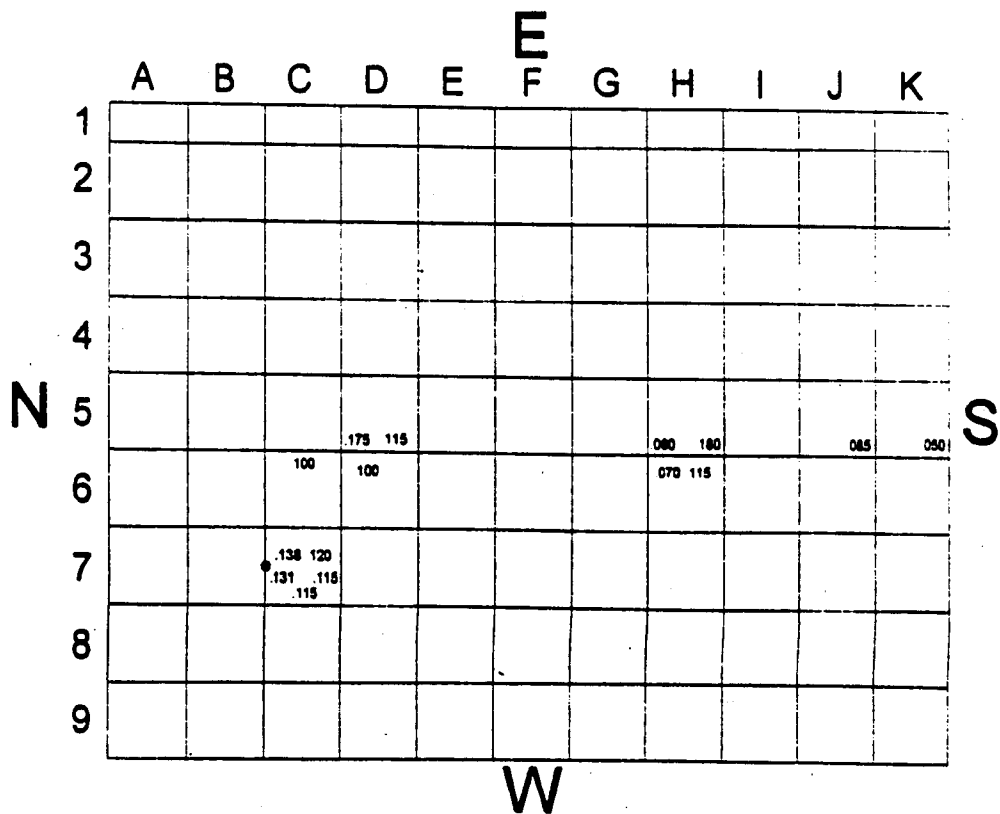
## Tank #20

- Magnetic Flux Inspection
- Internal Corrosion Readings
- Holes

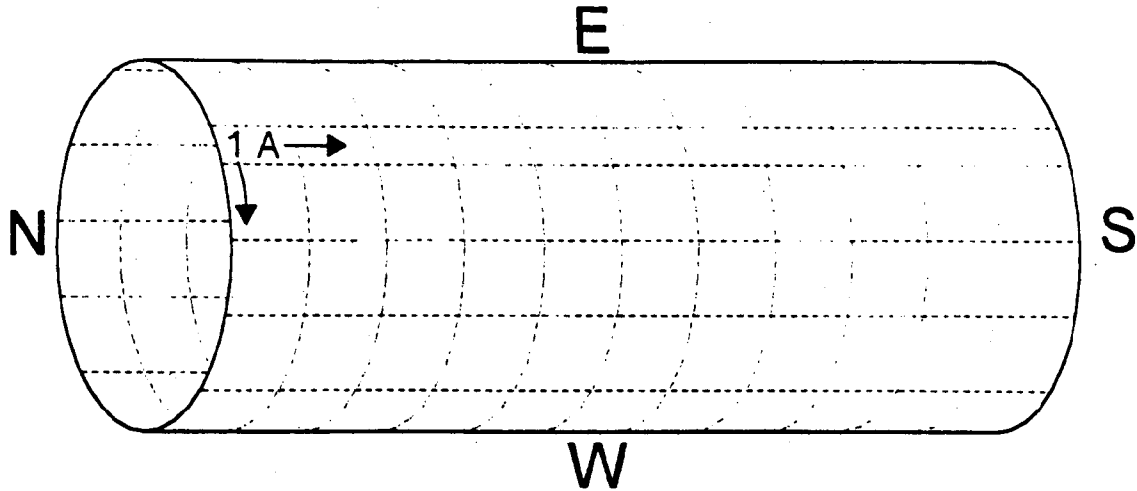
## Tank #25

- ☒ Magnetic Flux Inspection
- ☒ Internal Corrosion Readings
- ☒ 3' x 3' Grid Thickness Readings of less than 85% of the original metal thickness

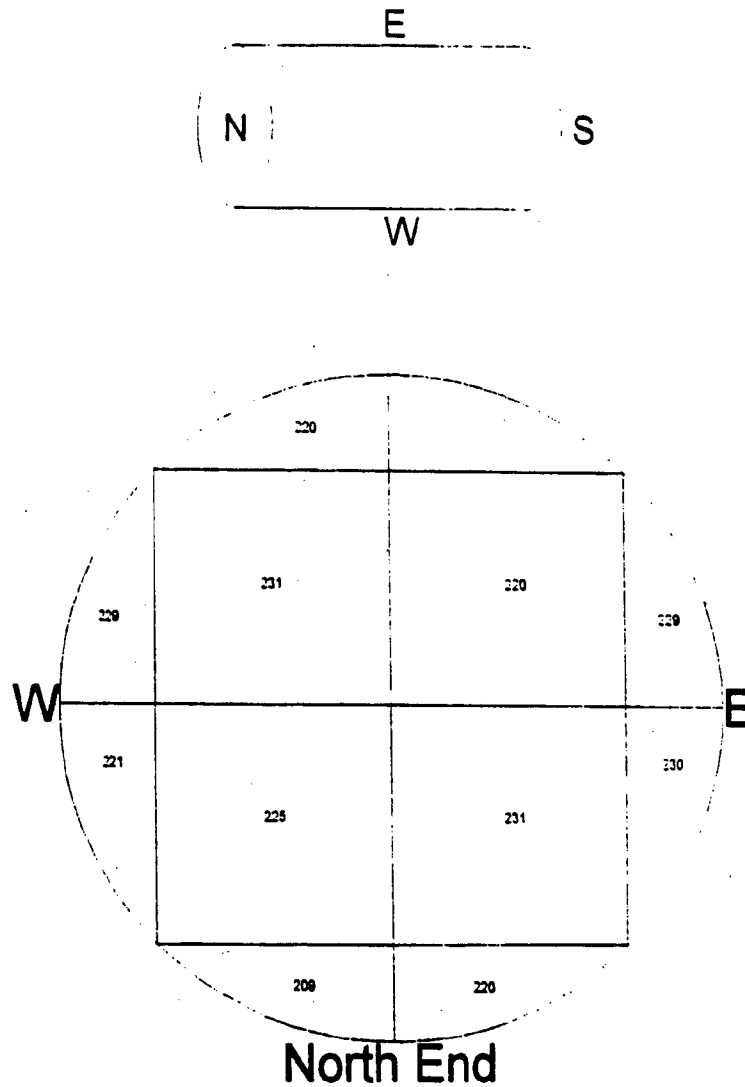
### End Views

■ 3' x 3' Grid Thickness Readings of less than 85% of the original metal thickness
