# Above Ground Gamma Ray Logging of Edgemont, South Dakota and Vicinity

Jack E. Thrall\*  
Joseph M. Hans, Jr.\*  
Vonni Kallemeyn\*\*

February 1980

\*U.S. Environmental Protection Agency  
Office of Radiation Programs  
Las Vegas Facility  
Las Vegas, Nevada 89114

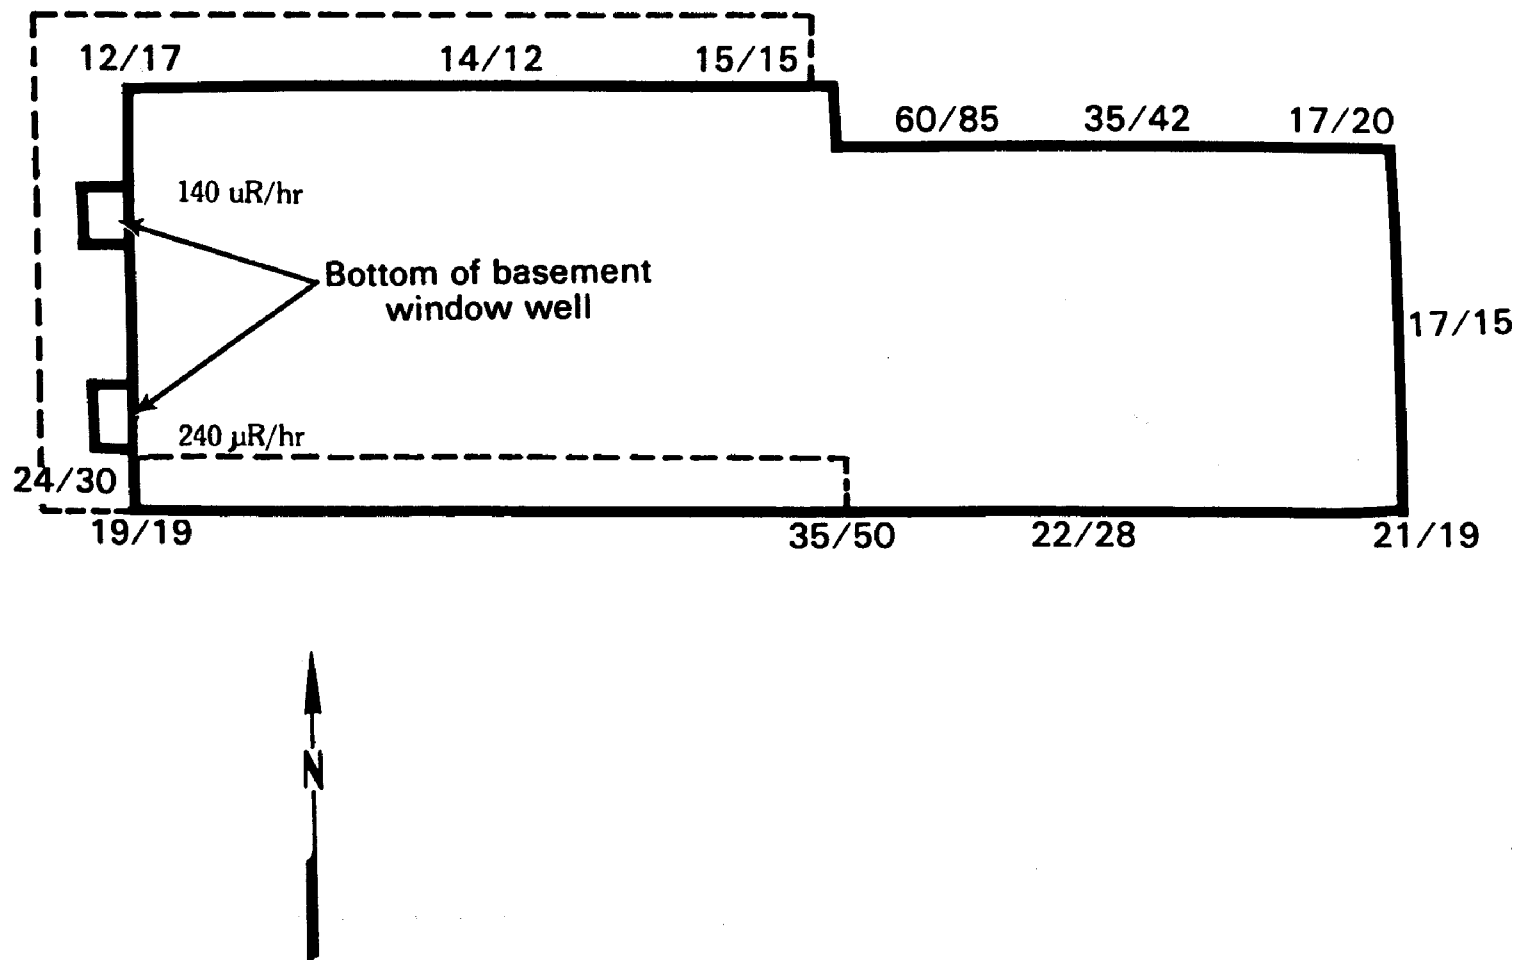
Figure A-2-c. Location 7811-80 - Outside of House

**NOTE: SANDSTONE USED IN FIRE PLACE, YARD AND AROUND HOUSE MEASURED 75  $\mu$ R/hr AT CONTACT.**

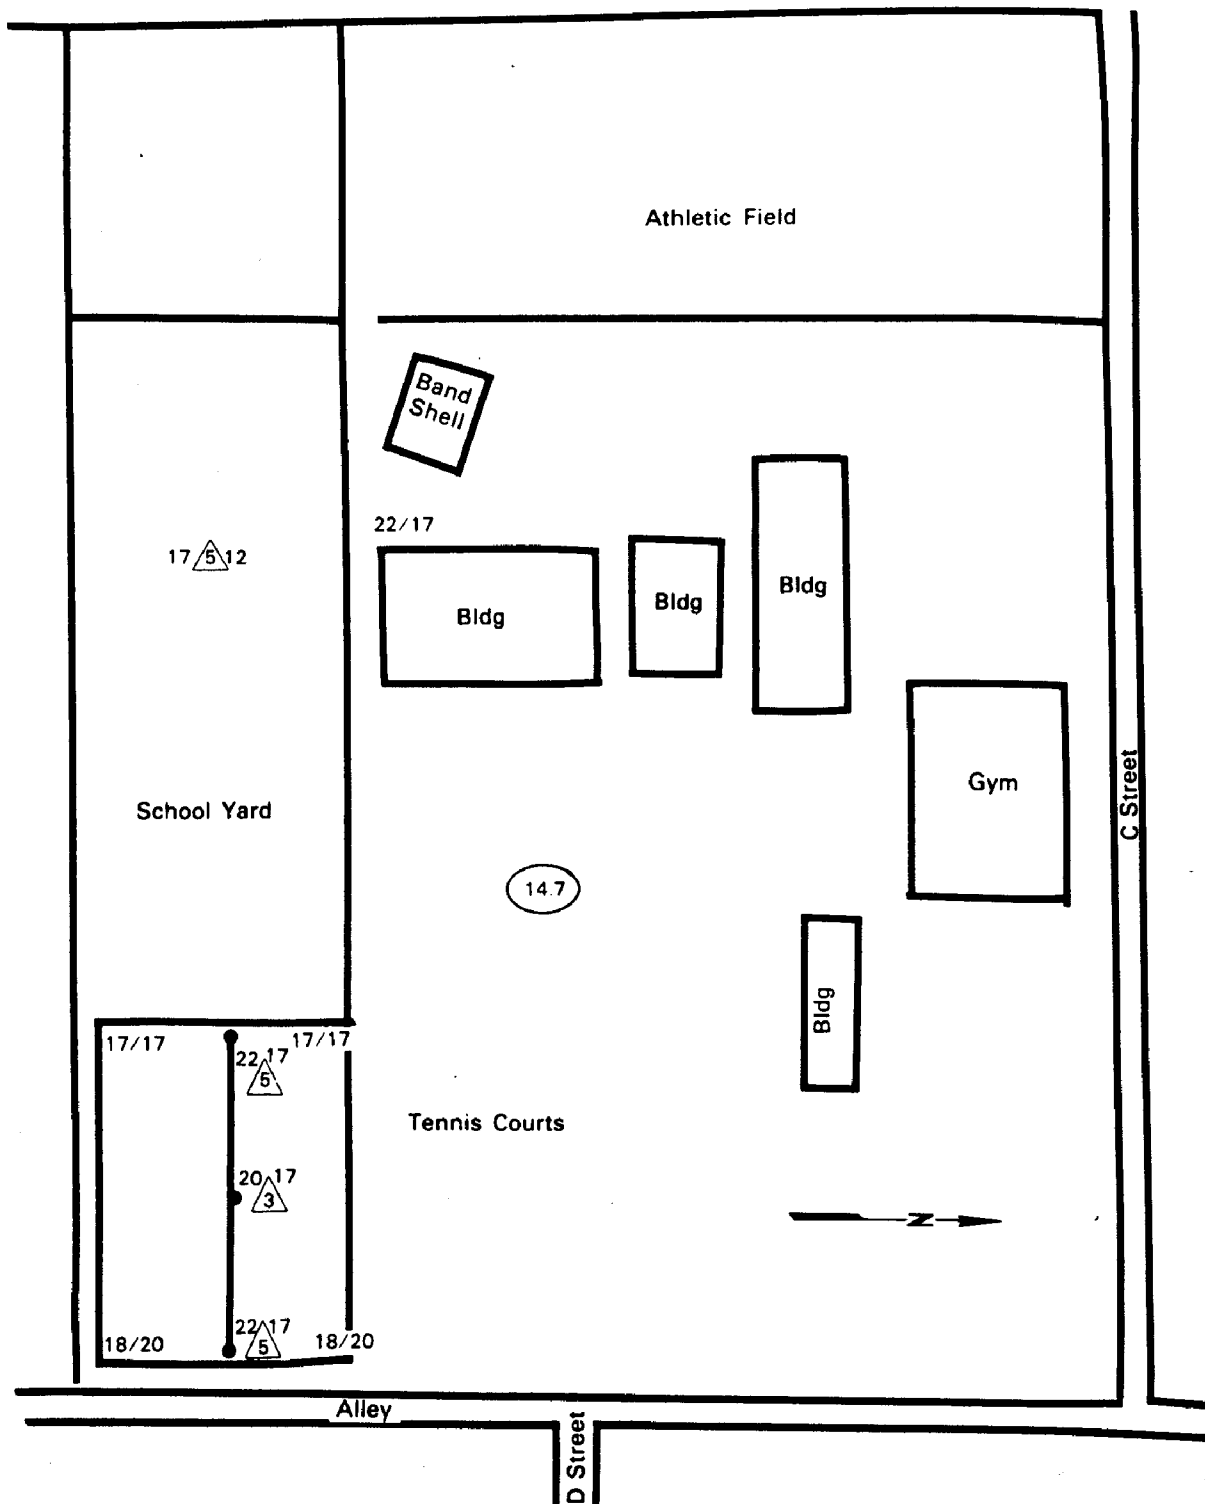
Figure A-5-a. Location 7811-83 & 7811-63 - Edgemont School Area

Locations 2, 4 and 5 above are on the school complex which has suspected mine waste use. Locations 1 and 3 are probably caused by gamma radiation from adjacent anomalies. The cause of elevated gamma exposure rates at locations 6 and 7 is not known.

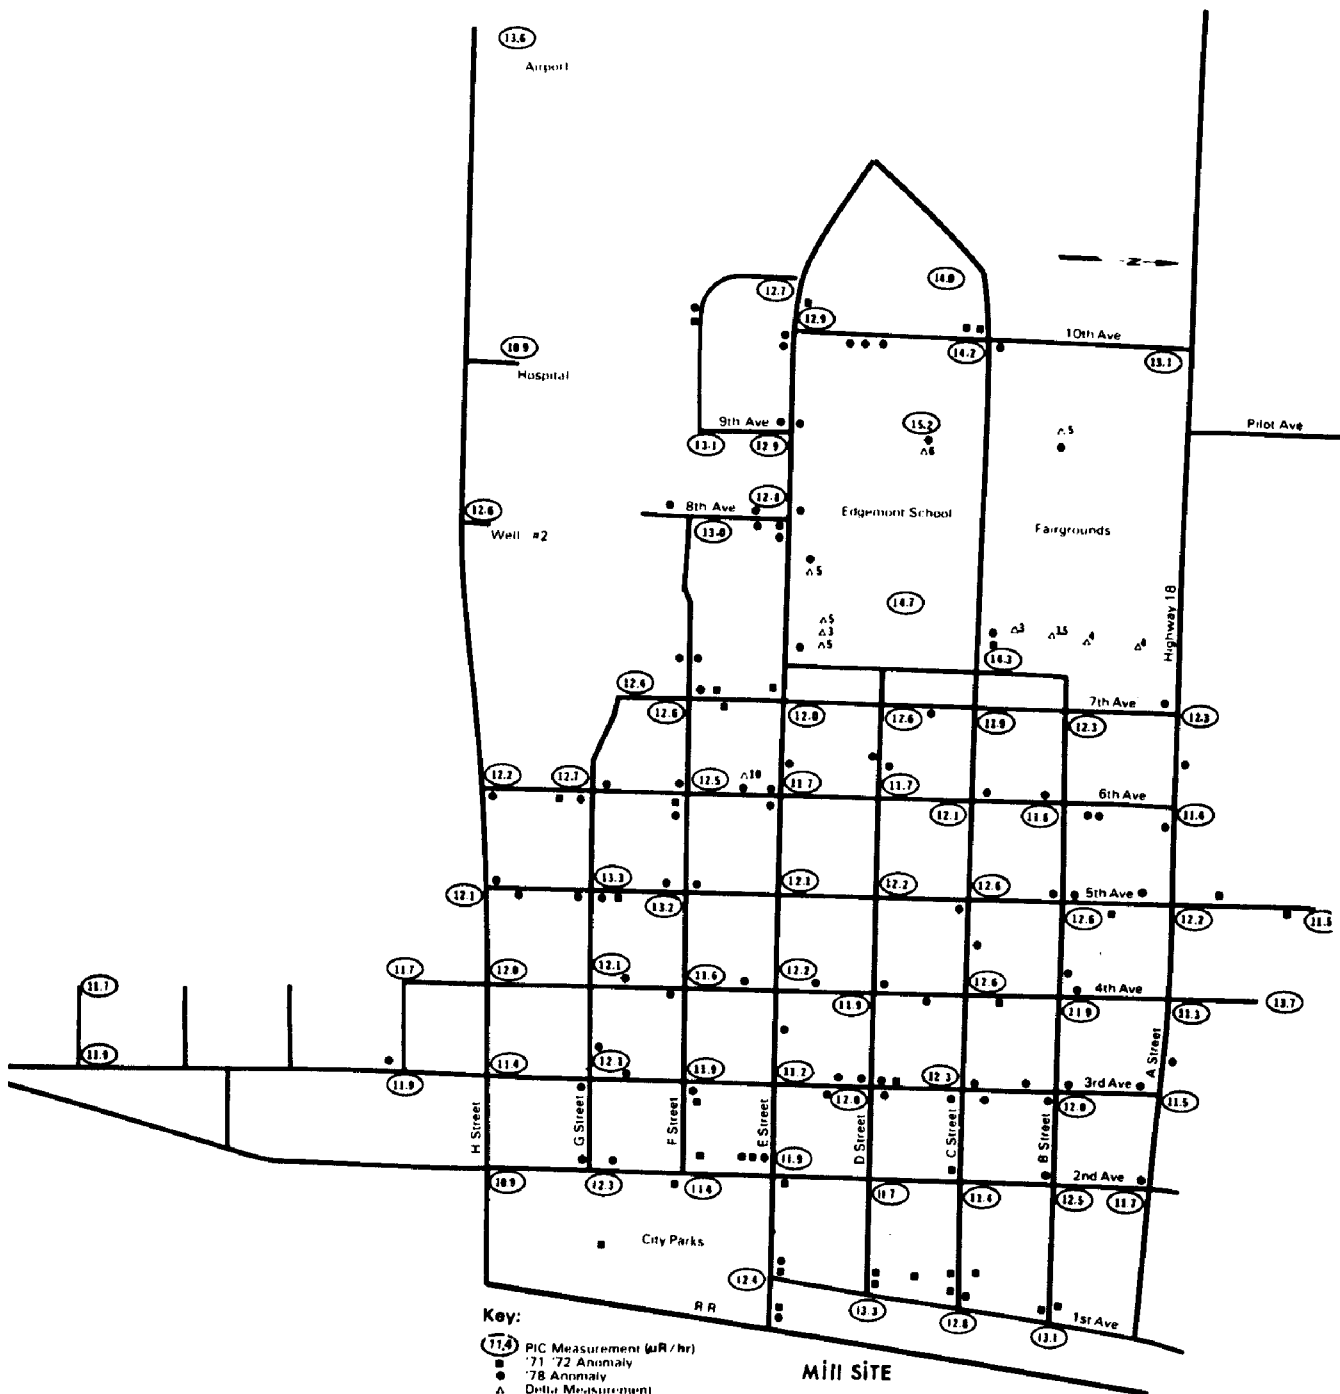
Figure B. Edgemont

These measurements do not imply that Edgemont or Dudley contain no airborne deposition of mill wastes. Large portions of 1st and 2nd Avenues in Edgemont were found to contain wind blown tailings during the 1971-72 survey.
