1978
MOTOR VEHICLE
TAMPERING SURVEY

U.S. Environmental Protection Agency
Mobile Source Enforcement Division
Technical Support Branch

November, 1978

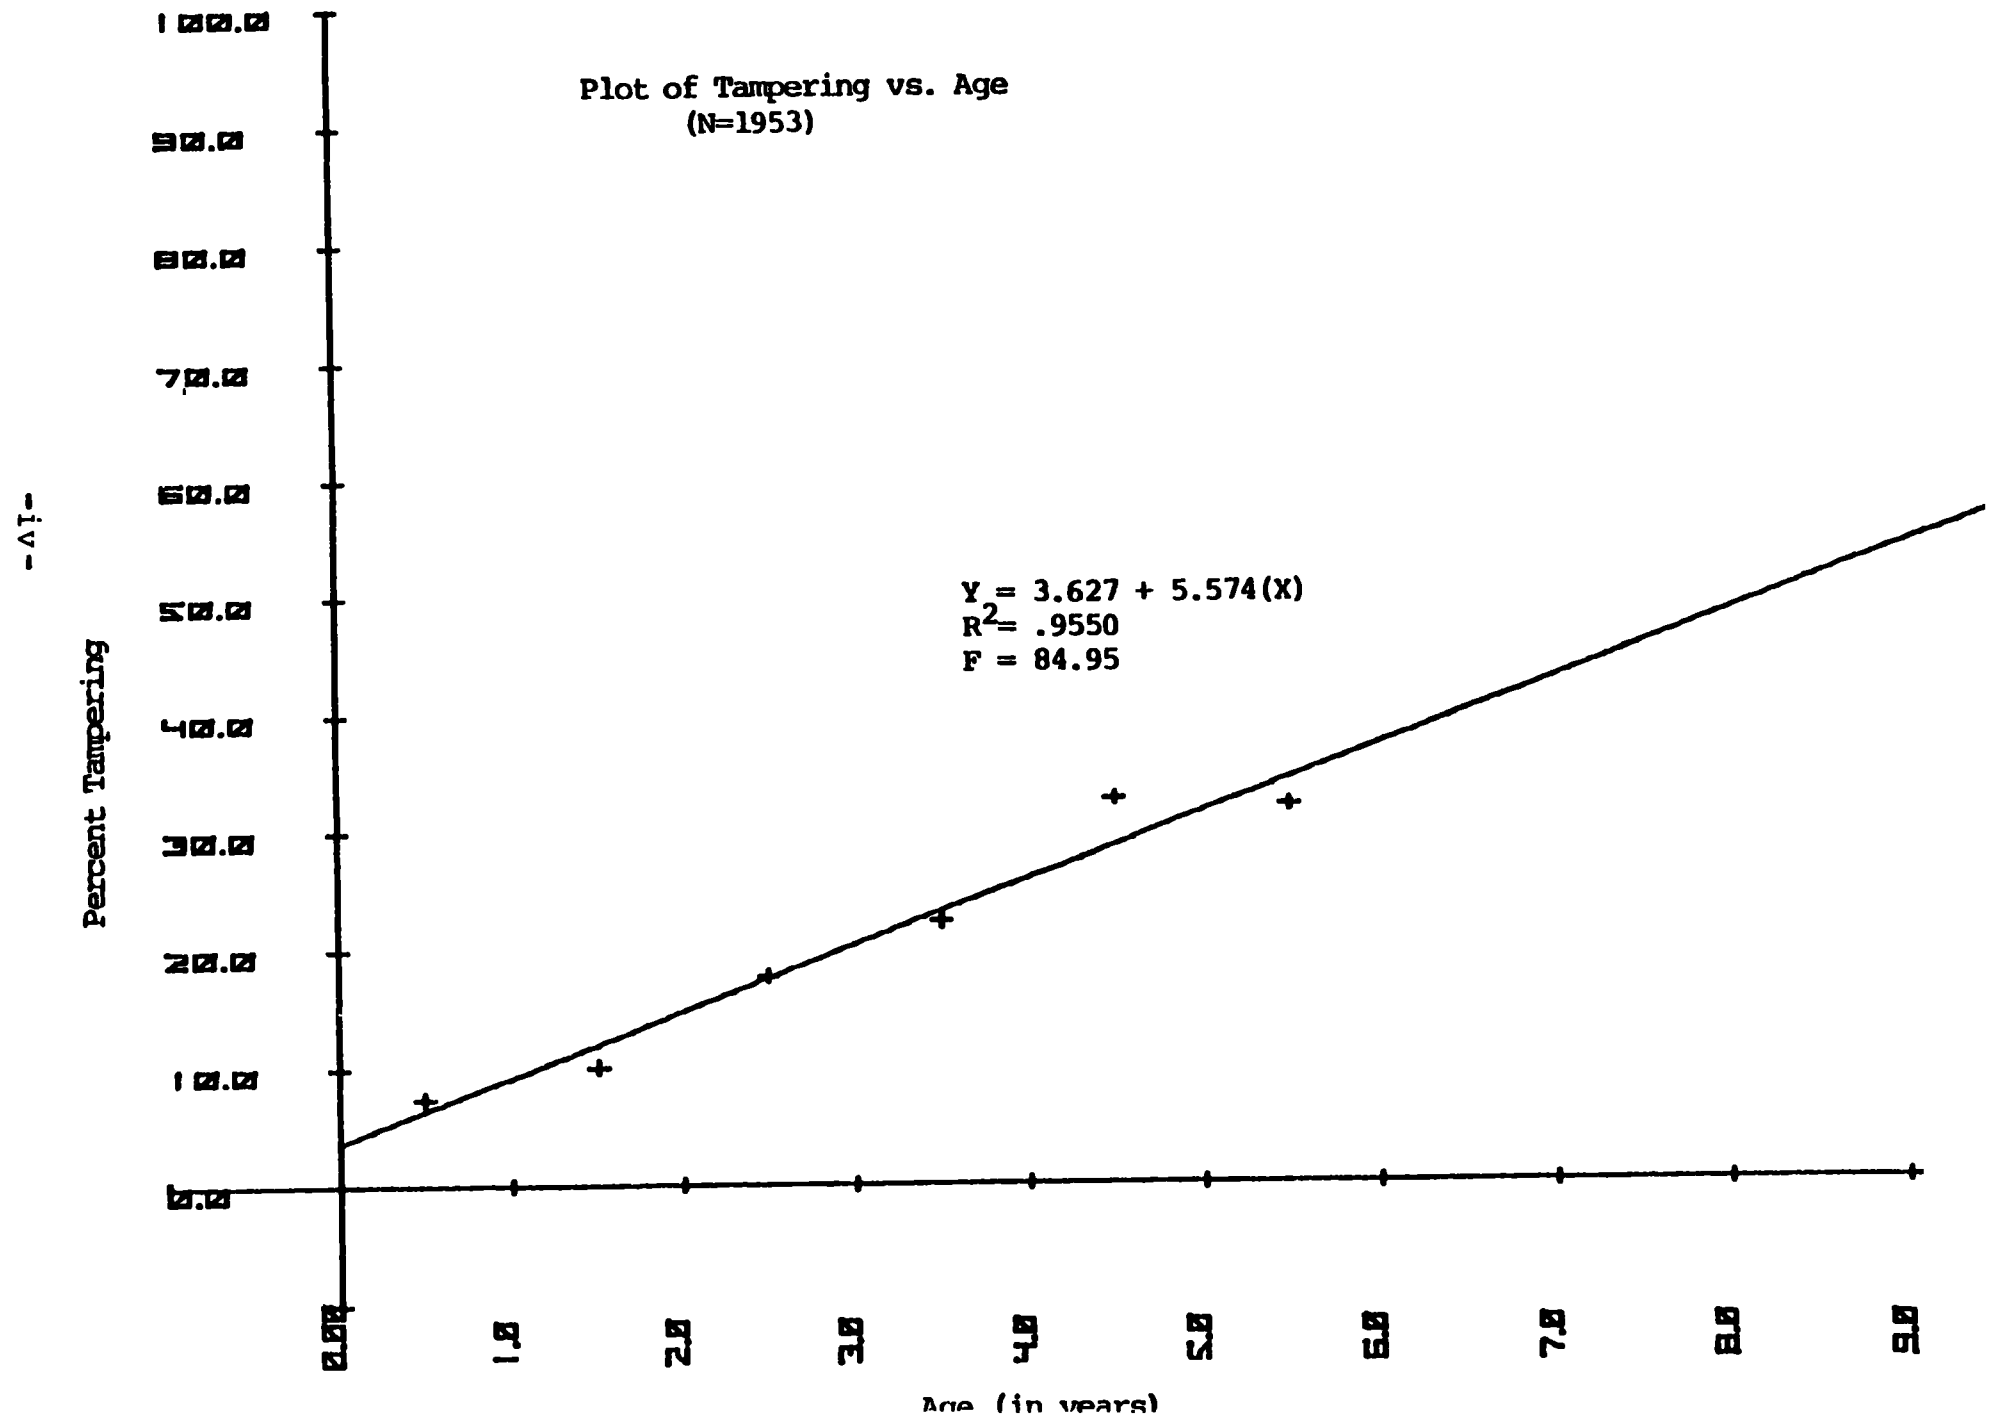
Figure 1

There is a direct relationship between the tampering rate and the age of the vehicle as shown in Figure 1. The projected rate of tampering increases to approximately 50% as the fleet approaches 100,000 miles. The rates of tampering at different sites were all within 5% of the 19% national average.
