**ANALYSIS AND EVALUATION  
OF A RADIOACTIVE WASTE PACKAGE  
RETRIEVED FROM  
THE FARALLON ISLANDS 900-METER DISPOSAL SITE**

**September 1990**

**P. Colombo and M. W. Kendig  
Waste Management R&D Group  
Department of Nuclear Energy  
Brookhaven National Laboratory  
Associated Universities, Inc.  
Upton, New York 11973**

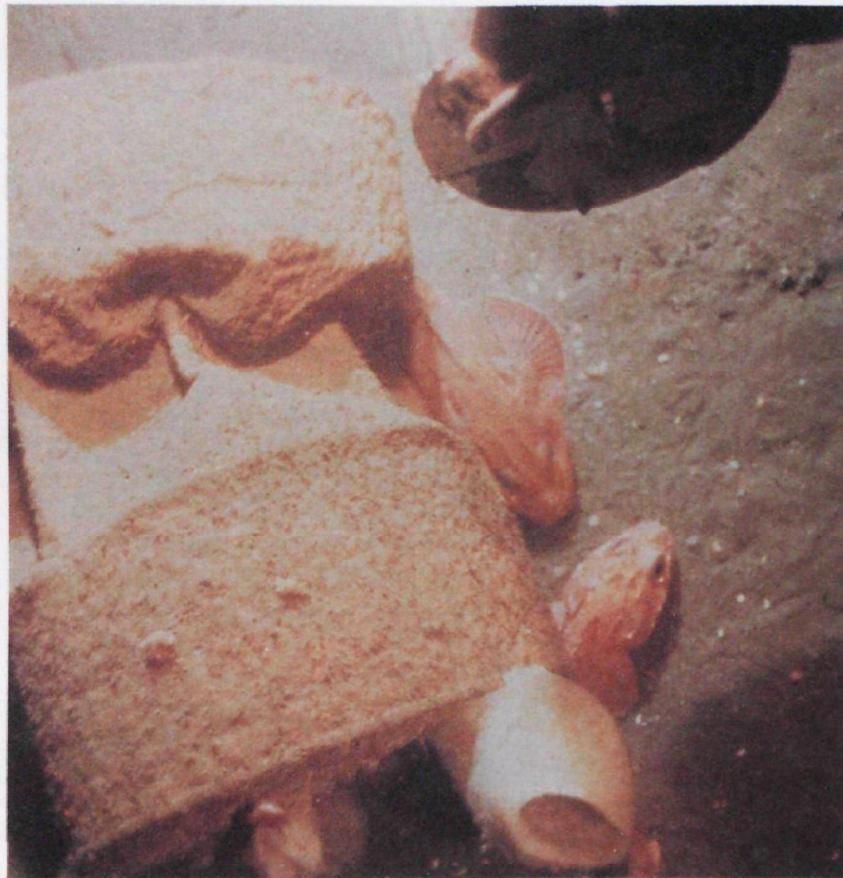
An example of the implosion pattern characteristic of many of the waste packages sighted is shown in Figure 2.5. Hydrostatic crushing at the center of a drum is typical of radioactive waste packages prepared as shown in Figure 1.2, whereby the waste was essentially sandwiched between two plugs of concrete within the container. Invariably the waste consisted of laboratory trash which was insufficiently compacted to remove air voids or lacked the physical strength to resist hydrostatic implosion. Although the center portion of the drum in Figure 2.5 showed severe indentations, it did not appear to be breached. Several thornyhead fish, either Sebastolobus alascanus or Sebastolobus altivelis are seen taking shelter near the side of the drum. The exposed concrete cap establishes a solid anchor site for a number of marine invertebrates such as the white vasiform hexactinellid sponges attached to the exposed concrete end of the package.

Figure 2.5 Waste Package Showing Severe Hydrostatic Implosion

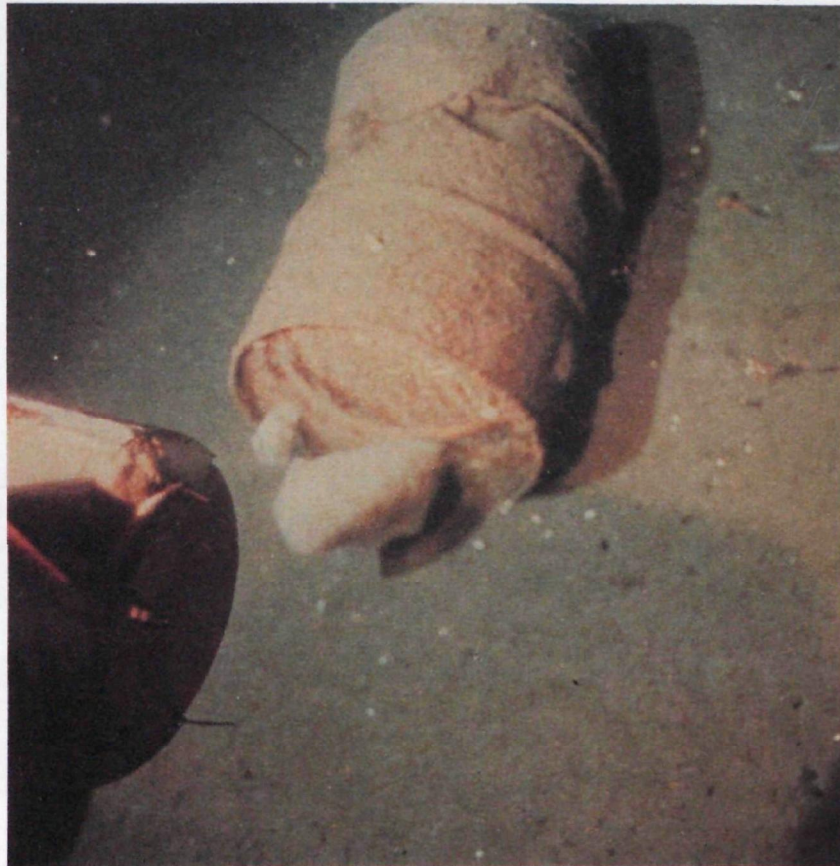
Figure 2.6 shows a waste package with a moderate amount of hydrostatic crushing. A lifting eye, typical of waste packages disposed of at the site between 1951-1953, is evident on the concrete end of the package. Also evident are several sponges attached to the concrete.

Figure 2.6 Waste Package Showing Mild Hydrostatic Implosion

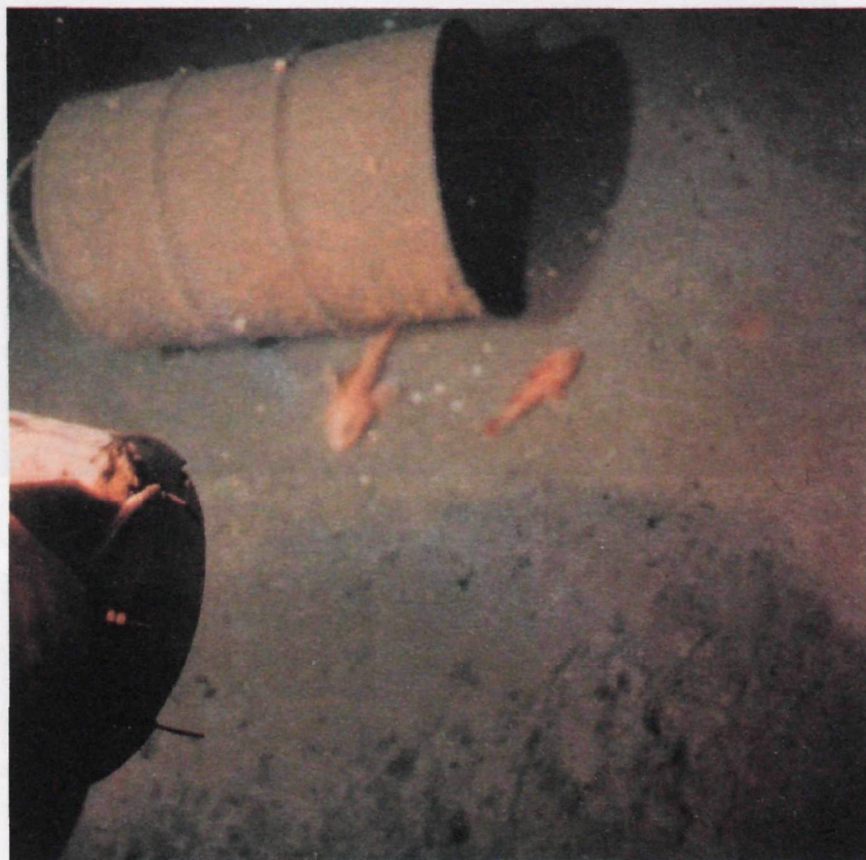
By contrast, Figure 2.7 shows a barrel with no evidence of hydrostatic crushing. A coating of fine, minimally disturbed sediment is prominent on the exterior of the drum. Sediment taken by boxcore in the vicinity of this drum is sandy silt having a mean grain size of approximately 5.6 $\phi$ . At the surface the sediment consists of 28.8 percent sand, 44.8 percent silt and 26.8 percent clay [5]. The photo also indicates the small amount of drum penetration into the sediment with little or no sediment scouring in the vicinity of the drum.

Figure 2.7 Waste Package Showing No Signs of Hydrostatic Implosion

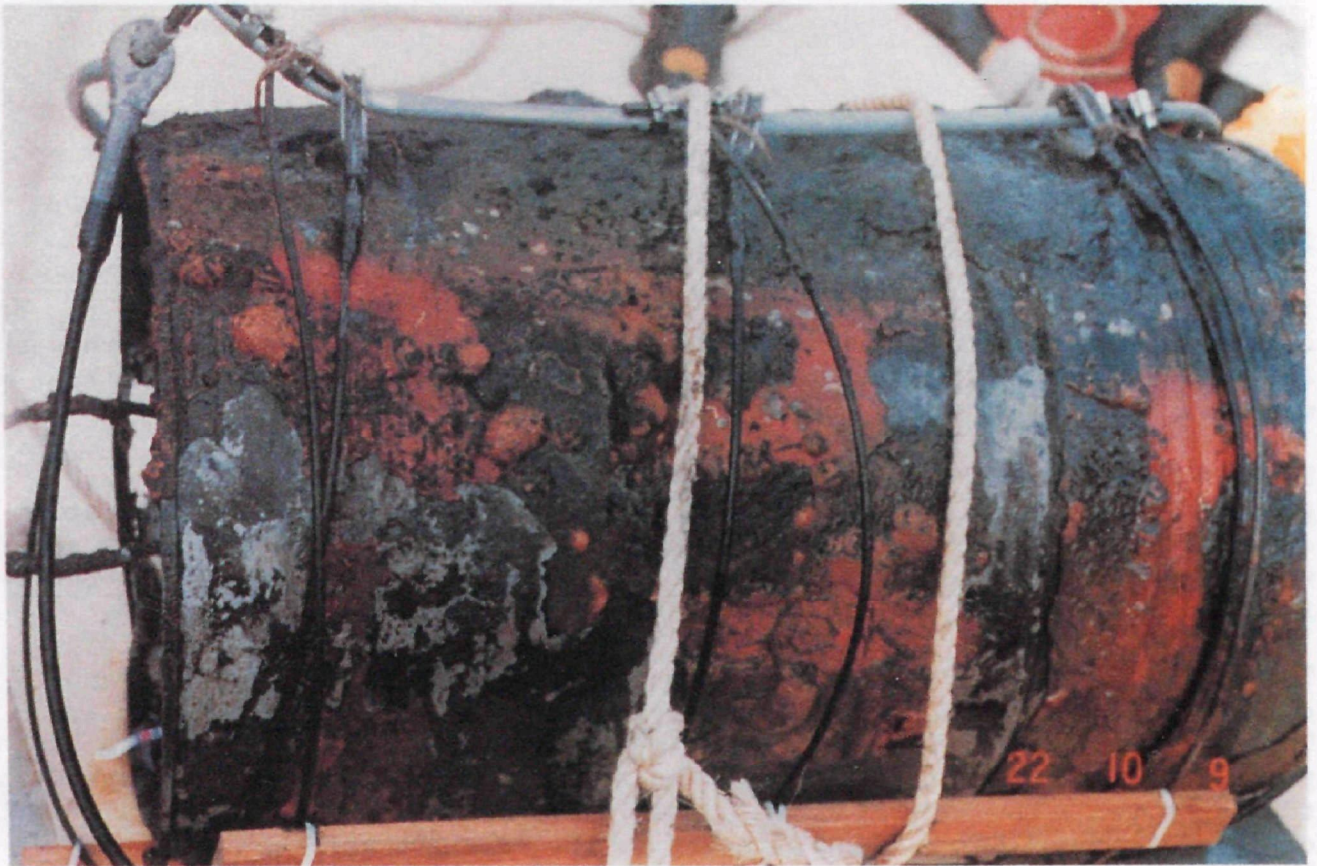
The sea-exposed surface of the container contained corrosion products and scale ranging in color from black to reddish orange, as seen in Figure 2.13. The whitish areas around the rim of the container in Figure 2.13, resemble polychaete (sea worm) tubes. Sea worms appear to be prominent as observed on the concrete surface in Figure 2.14. In addition to the worms, several small or broken sponges can be seen attached to the concrete surface.

In general, the condition of the container appeared to be good considering the duration of exposure in the deep ocean (estimated 21-23 years). The area of heavy corrosion appeared to be on the outer rim of the sediment side of the container. A more detailed description of the types and effects of corrosion on the metal container will be given later in this report.

Figure 2.13 A View of the Corrosion on the Sea Side of the Container

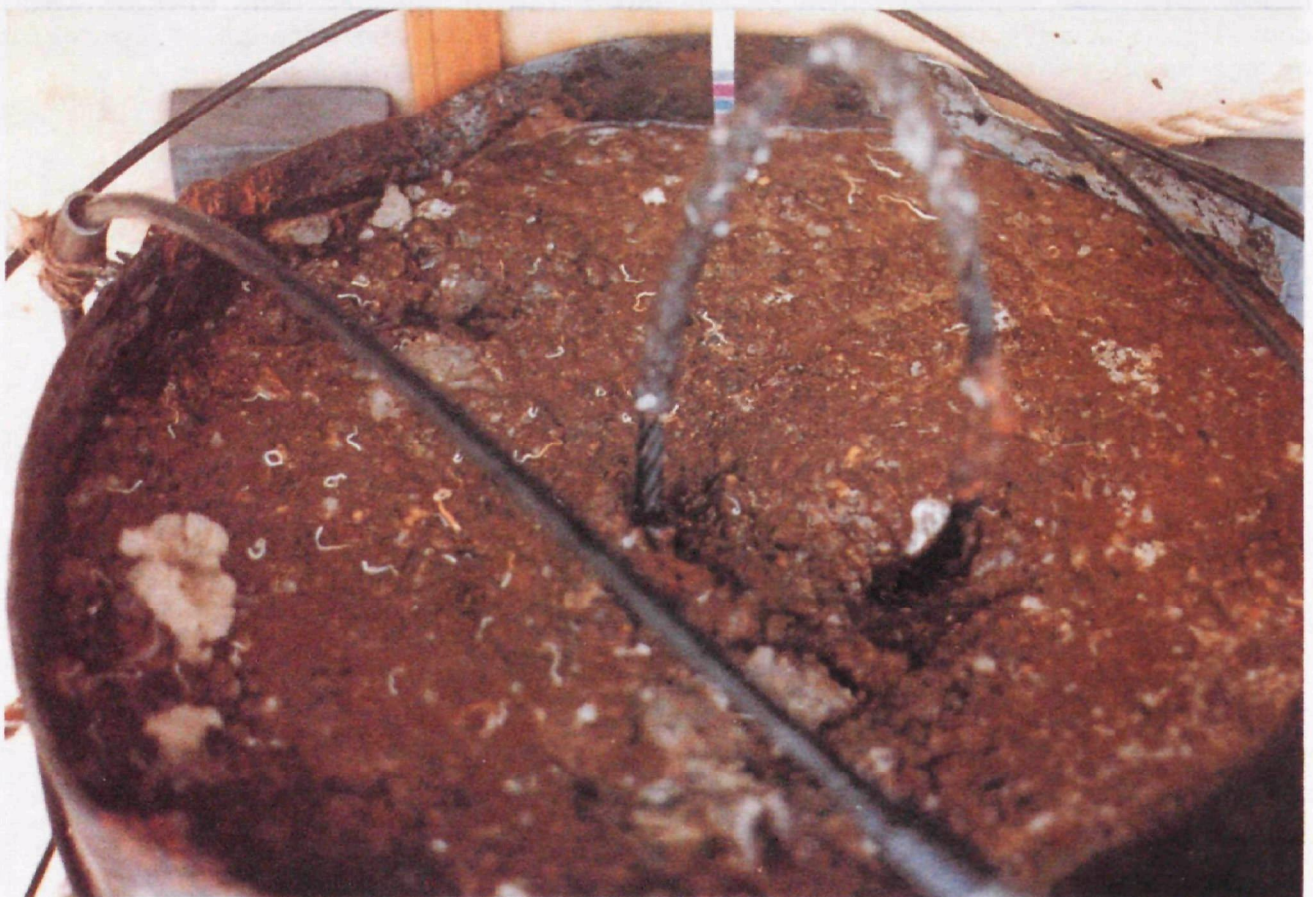
Figure 2.14 Sea Worms Attached to the Concrete Surface of the Waste Form

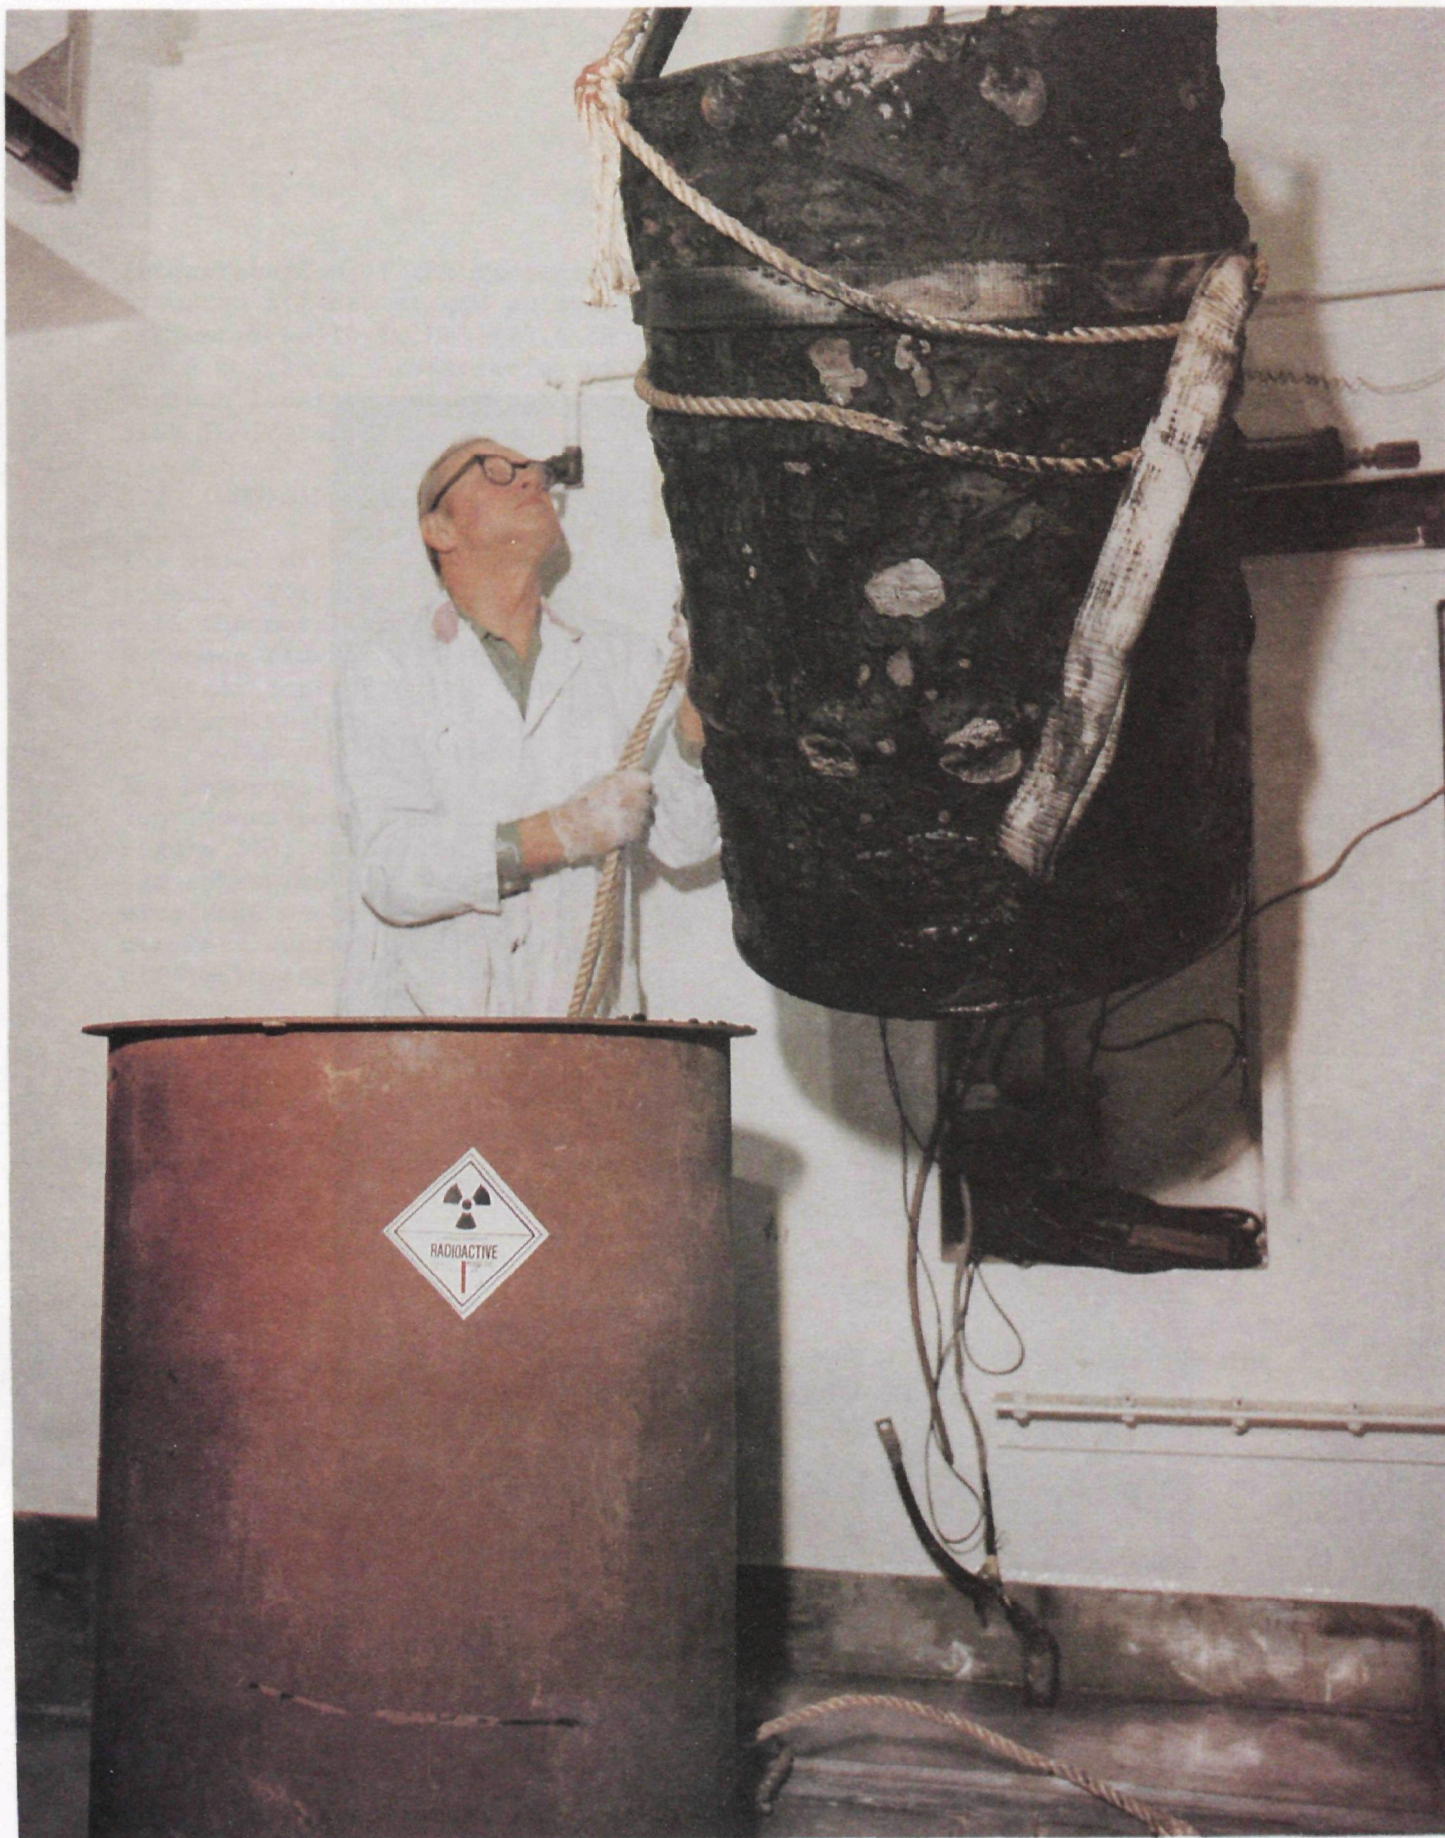
The blackish mud, indicative of anaerobic bottom conditions, remained strongly bonded to the container when it was removed from the sealed storage container, as shown in Figure 3.1. A faint odor of hydrogen sulfide could be detected, typical of anaerobic bottom sediments where sulfate-reducing bacteria are present. This condition is initiated through the formation of ferrous sulphide ( $\text{FeS}$ ) scale on the steel, which is cathodic to the bare metal surface [7,8].

Figure 3.1 Removal of the Waste Package From the Shipping Container

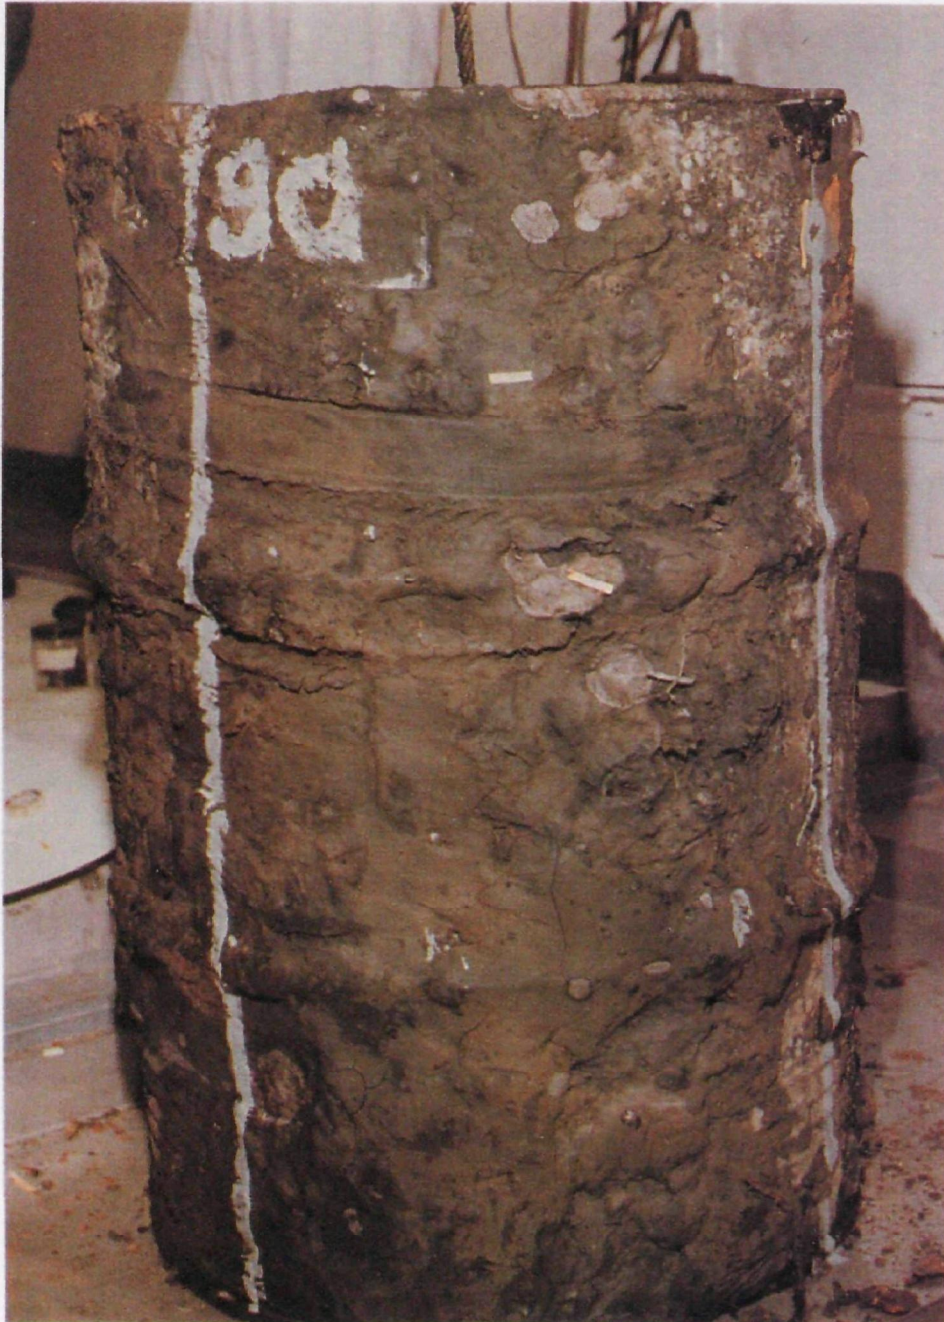
When the waste package was exposed to atmospheric conditions, the blackish coloration immediately began to change to greenish-brown, as shown in Figure 3.2. This can be attributed to oxidation processes, with some metals such as iron, during the transition from anaerobic to aerobic conditions.

Figure 3.2 View of the Sediment Side of the Waste Container

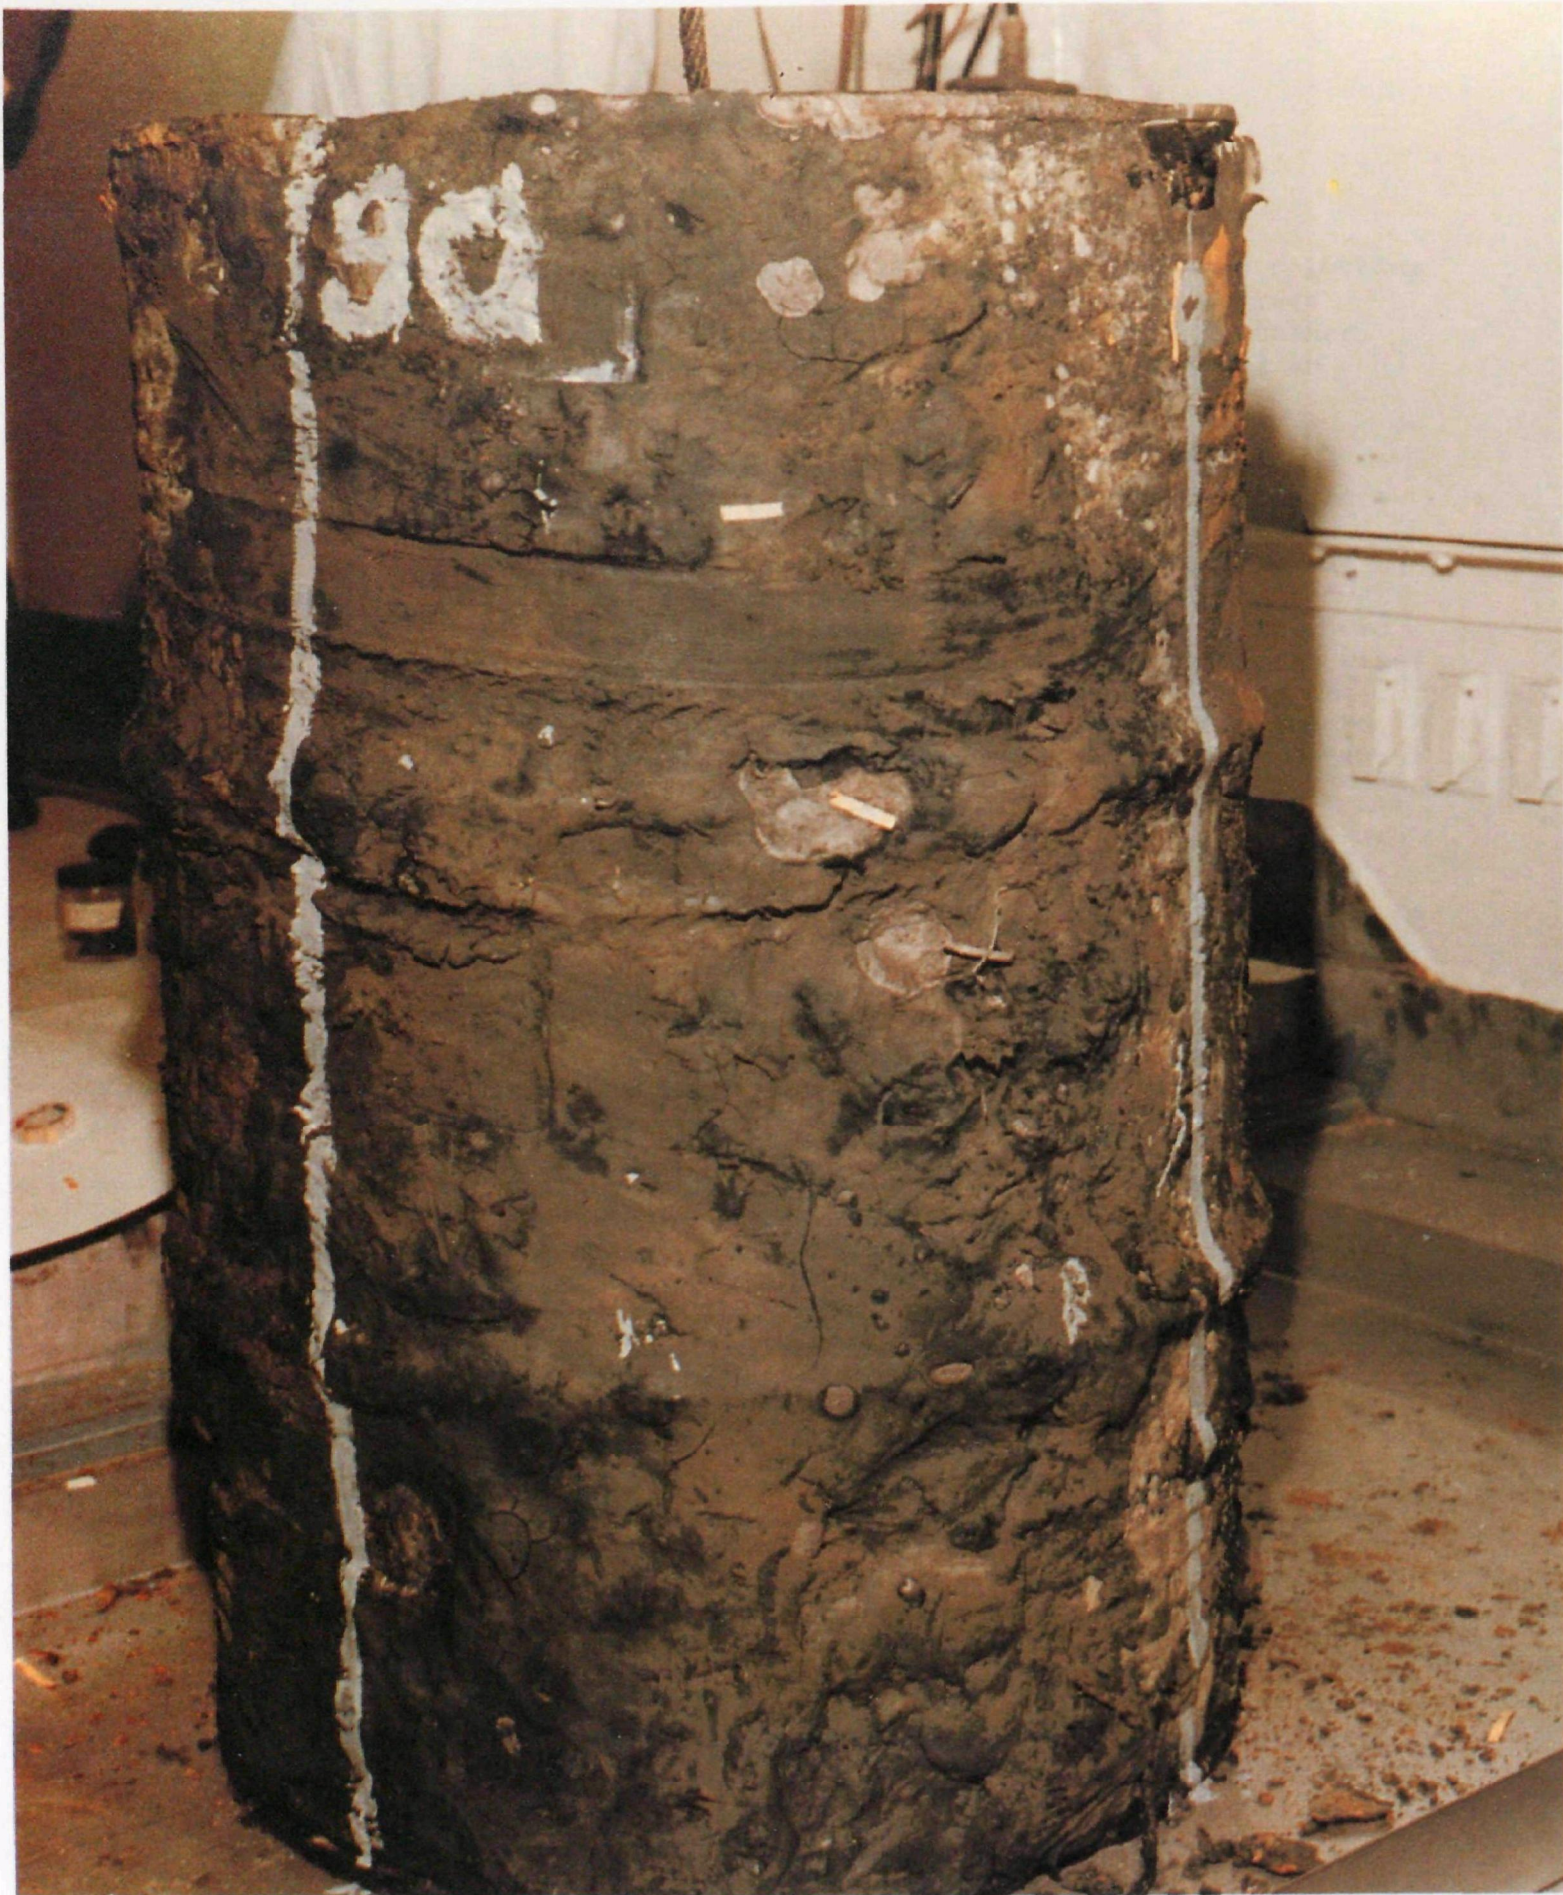
As seen from Figure 4.2, the portion of the container buried in black mud comprises those coordinates between  $\approx 0^\circ$  and  $\approx 135^\circ$  and the sea side comprises regions between  $135^\circ$  and  $360^\circ$ . The sea-exposed surface contains black to orange scale and corrosion products. In addition, many nodular conglomerations of orange to black corrosion products cover the sea side of the container. Figure 4.6 shows some of these regions. Where a nodule was removed an adherent black underscale was observed, characteristic of much of the other regions of the sea side (for example, Figure 4.5). Measurements using pH paper in areas where a nodule was removed indicated values between 8 and 10, corresponding to mild alkalinity. The mud also showed an alkaline pH between 8 to 10.

Figure 4.2 View of Waste Package Showing the Sediment Side ( $0^{\circ}$  -  $90^{\circ}$ )

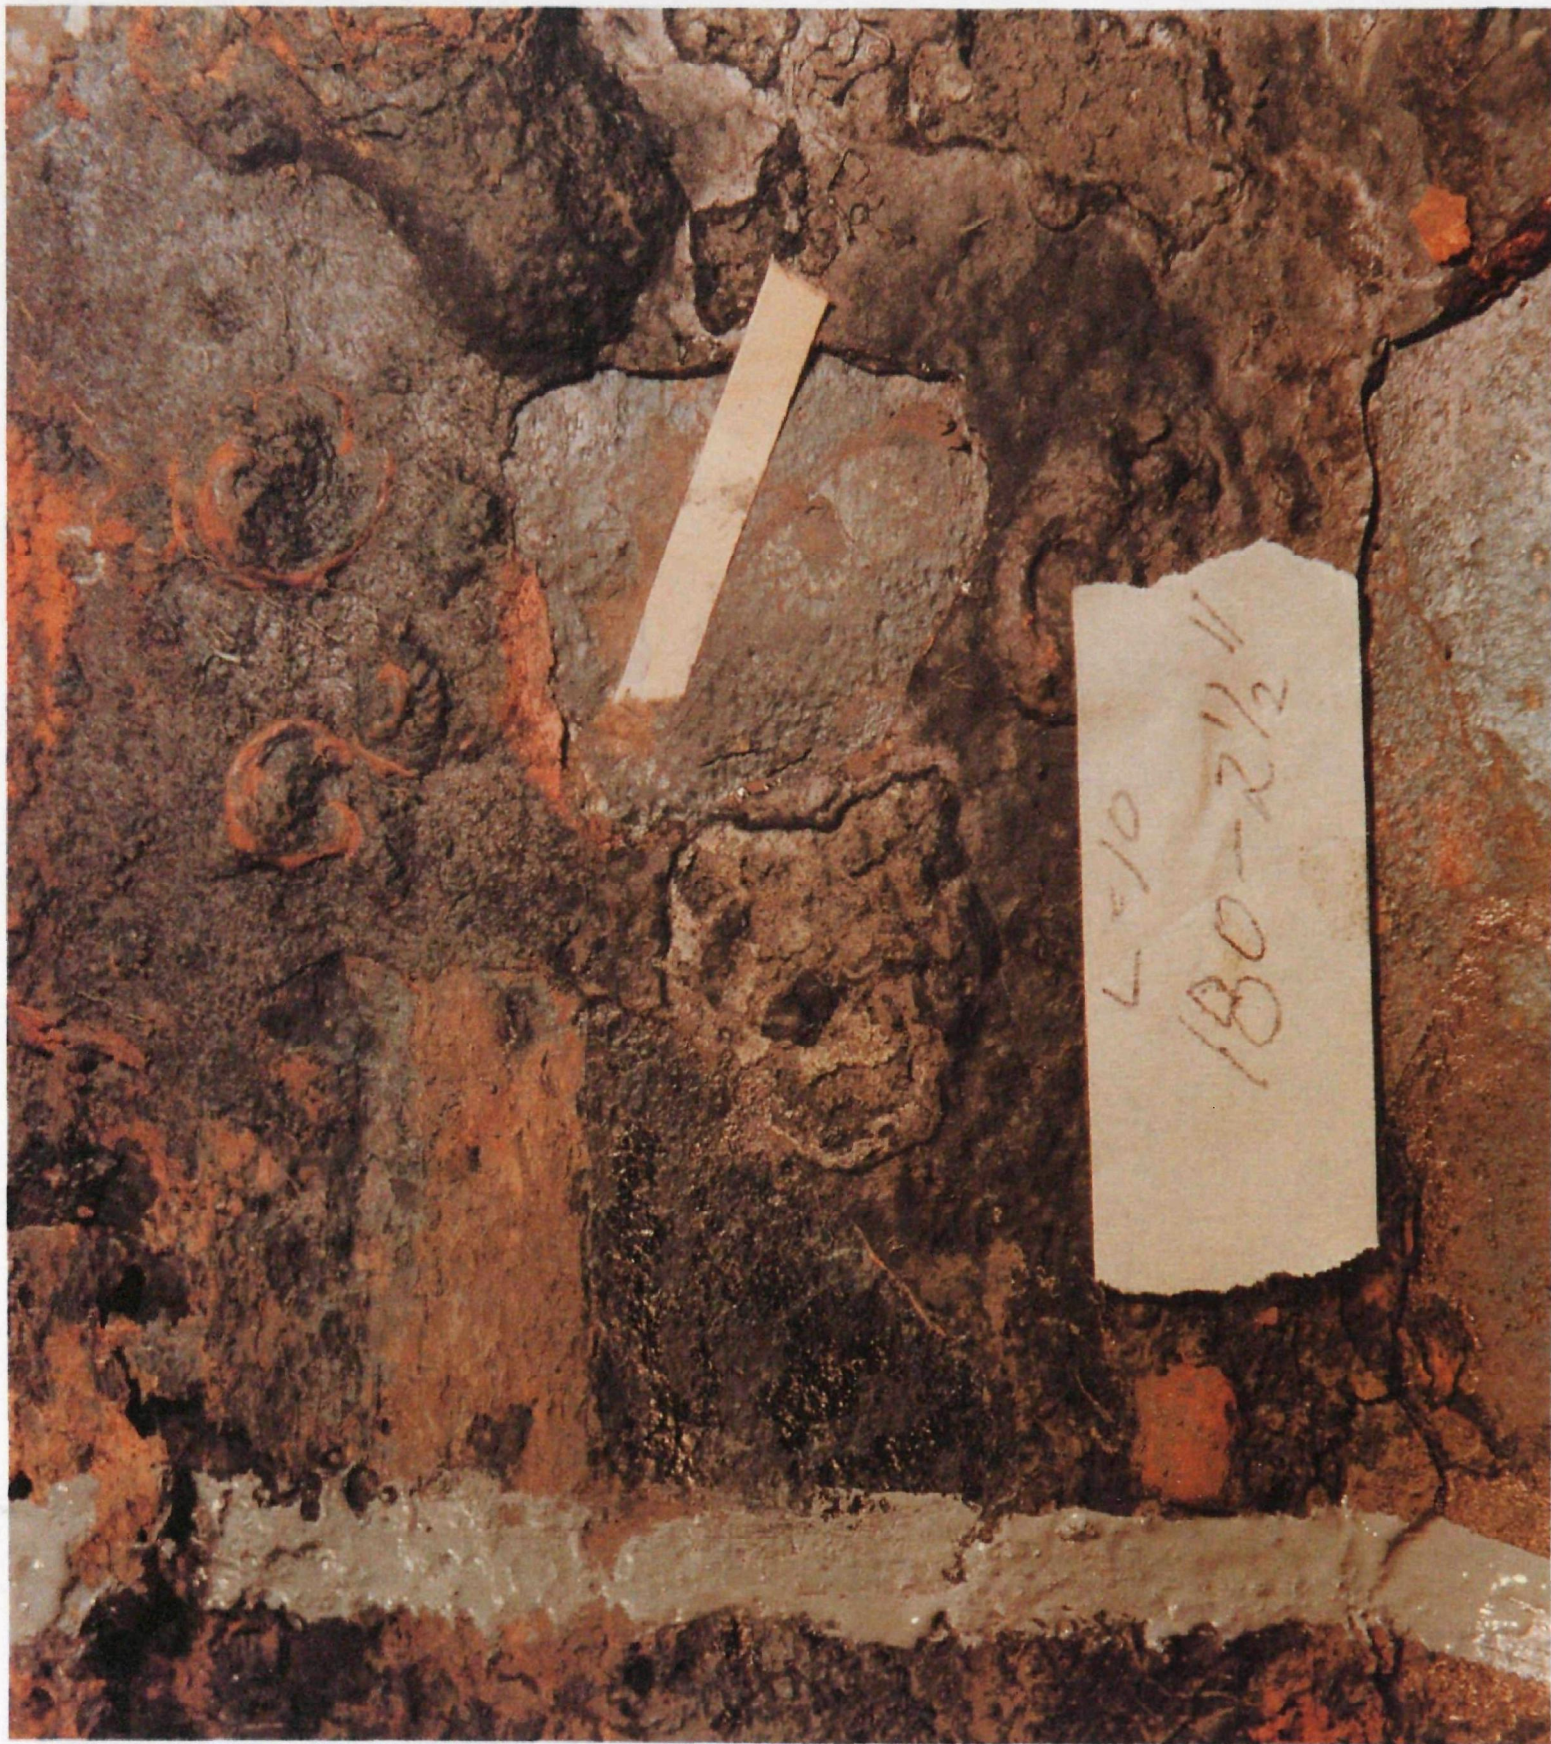
Figure 4.6 Nodule of Corrosion Product on Sea Side

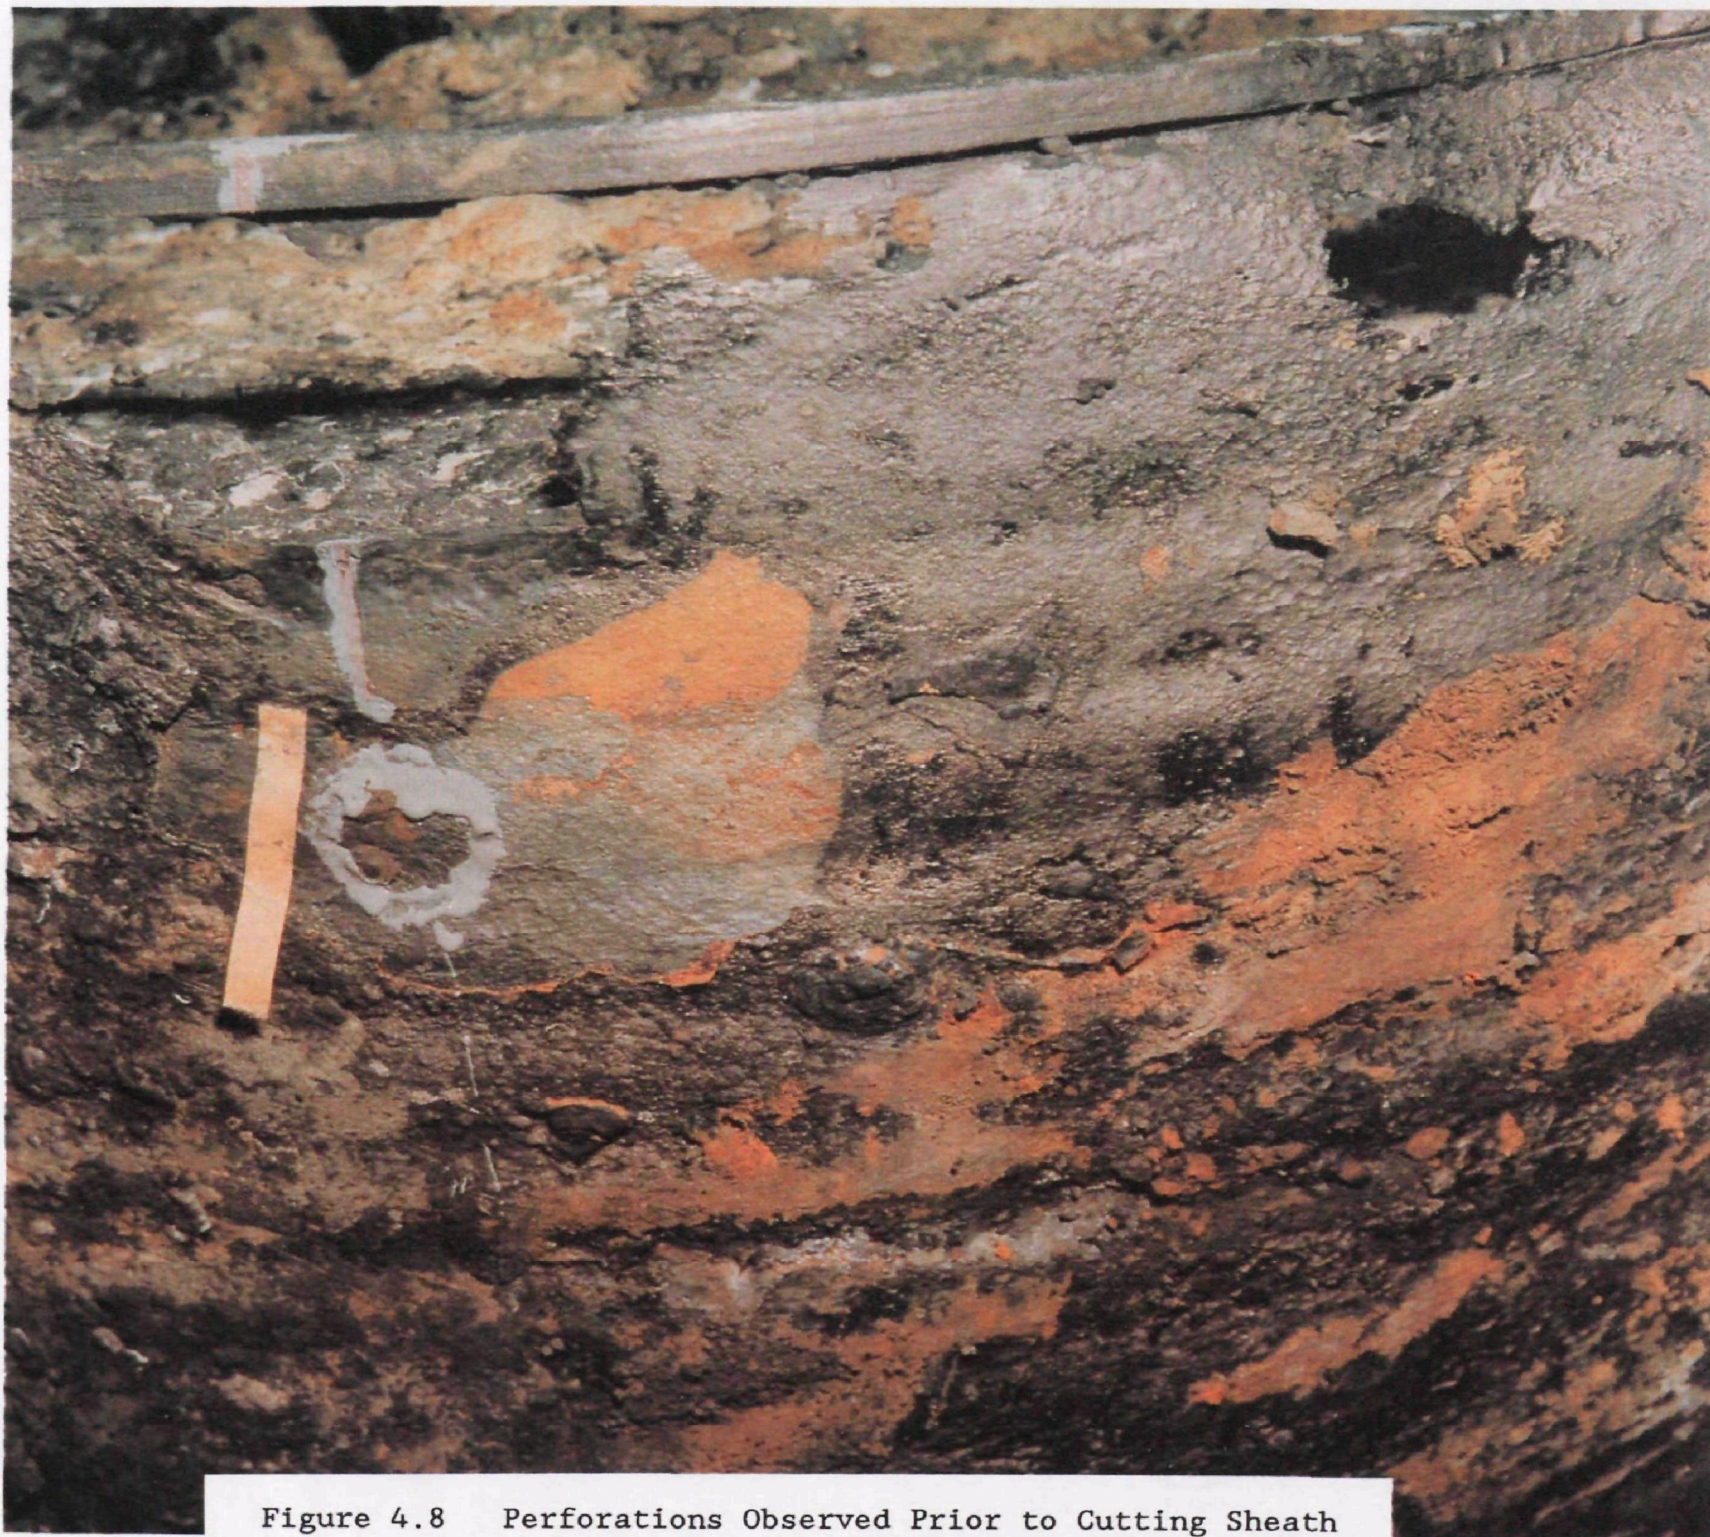
The sheath was cut and 4 inch strips were extracted from the mud side at  $45.8^\circ$  and the sea side at  $255.8^\circ$  (Figure 4.7). Samples from these strips allowed dimensional analysis. Before cutting the container for samples, perforation of the carbon steel sheath at the rim was noted (Figure 4.8) at  $x=0$  and  $\theta=0$ .

Figure 4.8 Perforations Observed Prior to Cutting Sheath

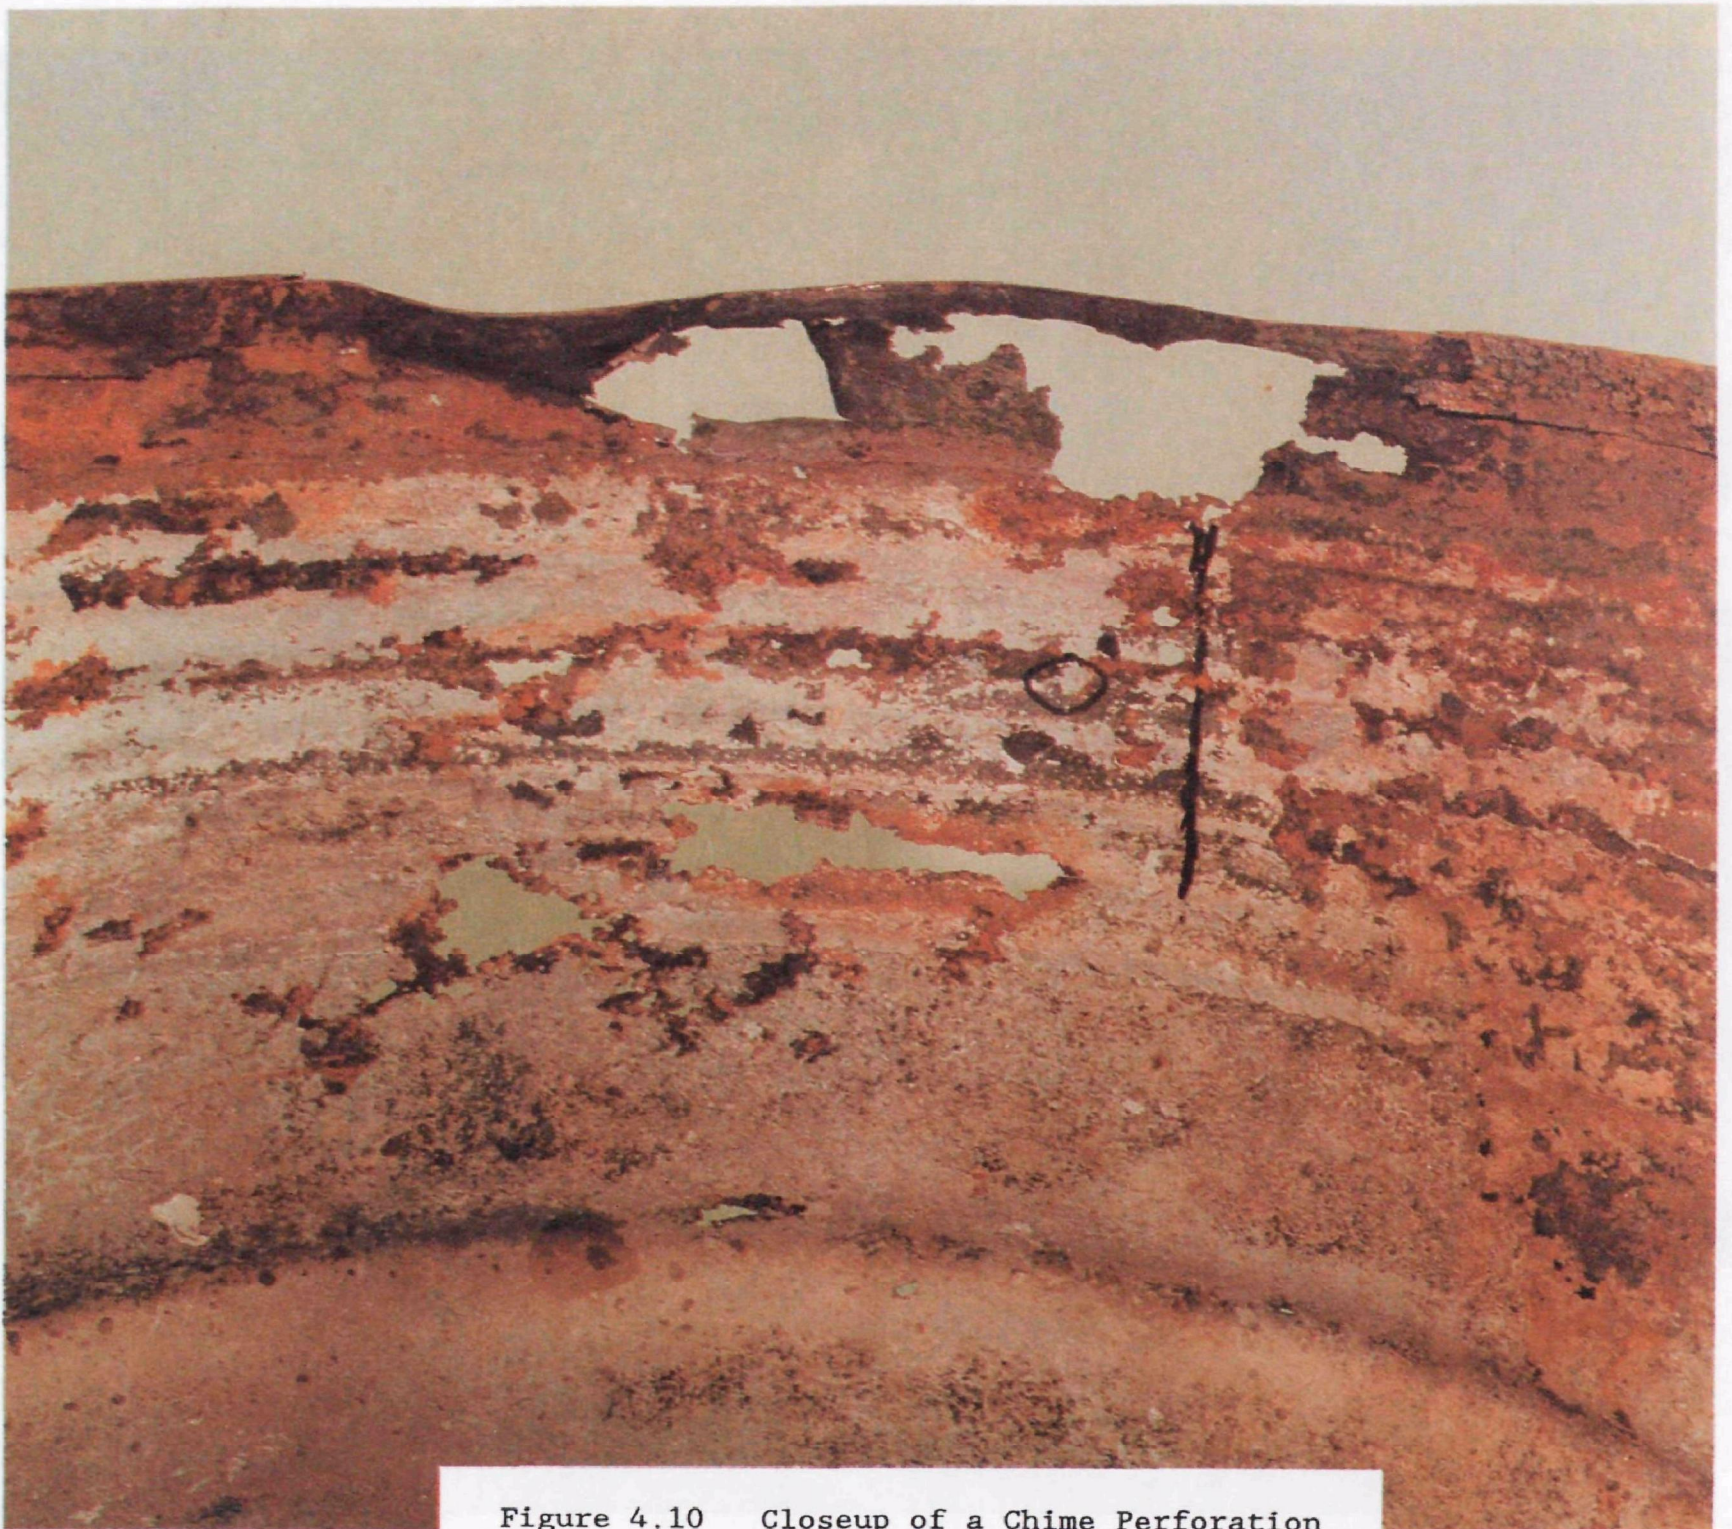
Figure 4.10 Closeup of a Chime Perforation

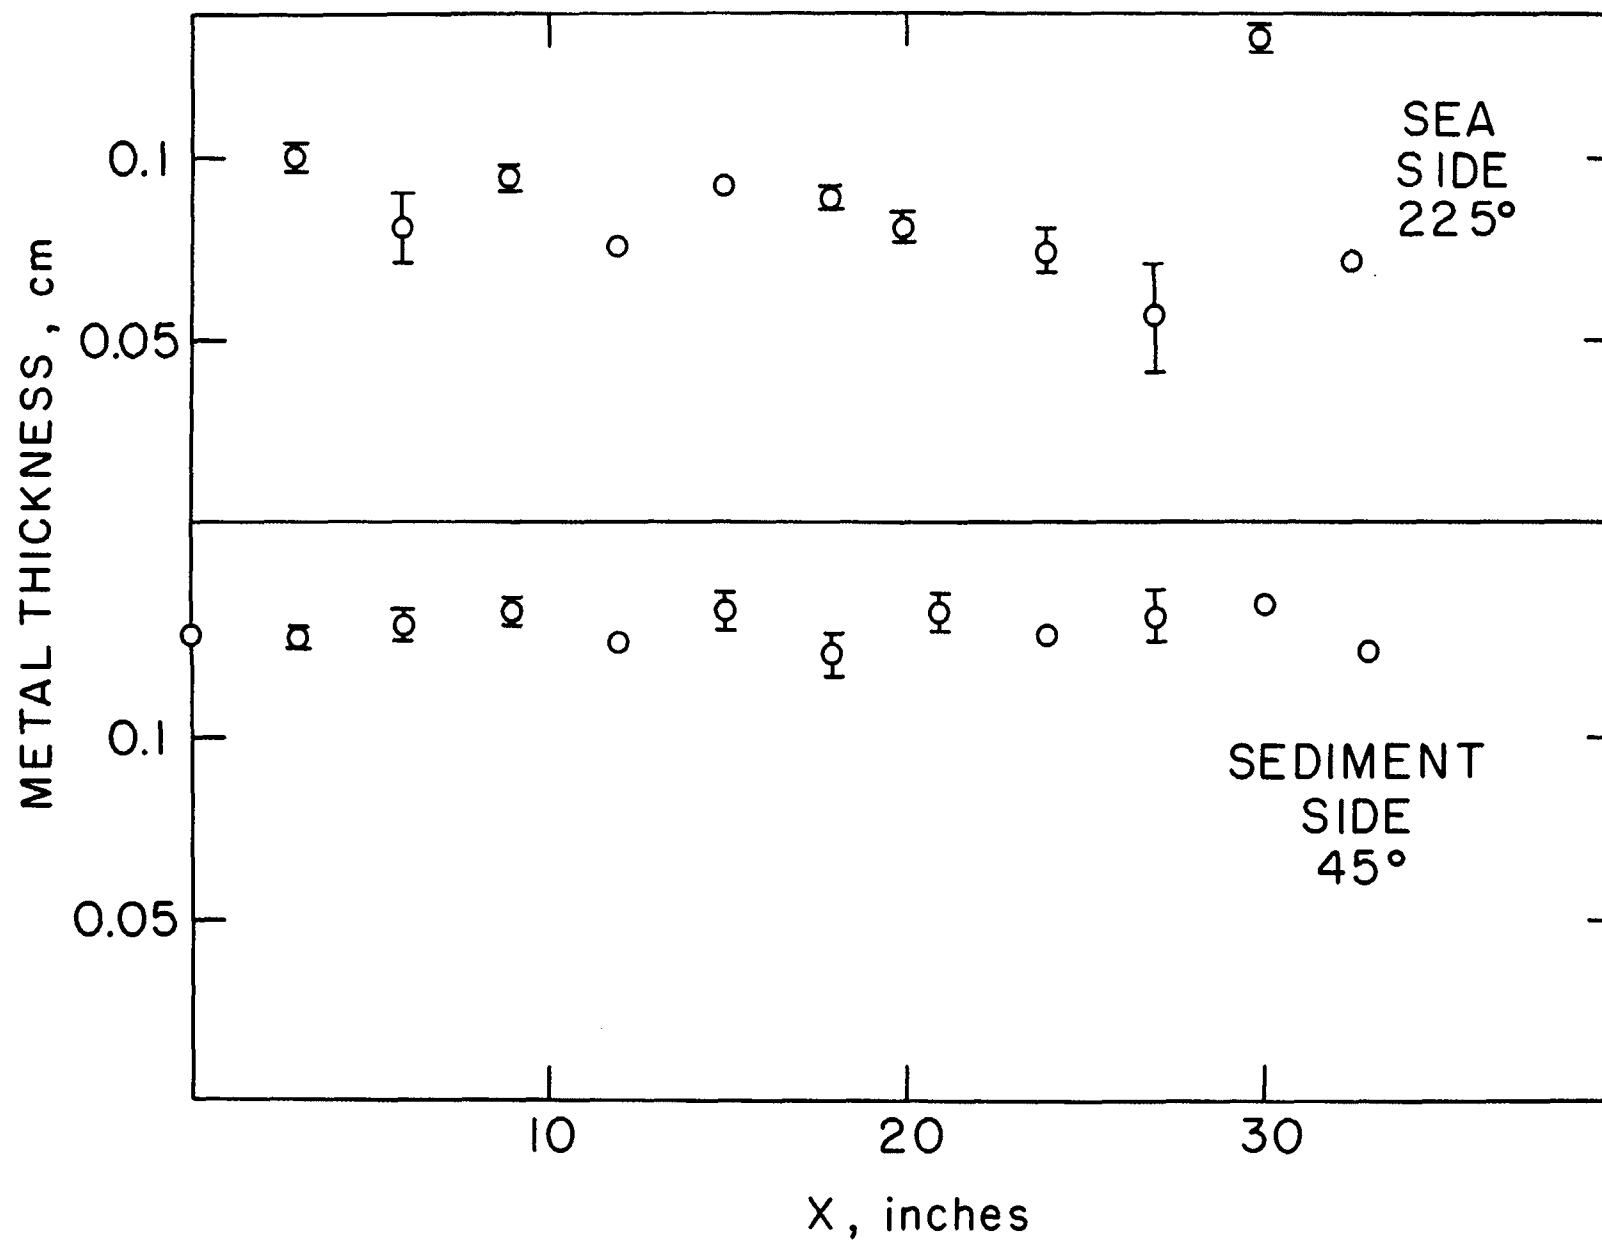
Figure 4.11 shows the results plotted as metal thickness vs.  $x$ , the dimension down the container axis. As can be seen, the sediment apparently inhibits the general corrosion of the container material. The sediment side shows virtually no metal loss while the sea side shows approximately 0.045 cm average metal loss. A precise calculation of the metal loss is made difficult by insufficient knowledge of the initial thickness of the container. A fold in the rim which was presumably not attacked had a metal thickness of 0.12 cm, which was slightly less than the average thickness of the sediment side of the container. This part of the rim, however, may have been reduced somewhat by the forming process. Assuming the sediment side to have not had a significant metal loss, its average dimension may serve as the initial dimension. This average "initial dimension" is  $0.130 \pm .005$  cm. The average dimension loss for the sea side is, therefore,  $0.045 \pm 0.01$  cm.

Figure 4.11 Metal Thickness as a Function of Position
