**ANALYSIS AND EVALUATION  
OF A RADIOACTIVE WASTE PACKAGE  
RETRIEVED FROM  
THE FARALLON ISLANDS 900-METER DISPOSAL SITE**

**September 1990**

**P. Colombo and M. W. Kendig  
Waste Management R&D Group  
Department of Nuclear Energy  
Brookhaven National Laboratory  
Associated Universities, Inc.  
Upton, New York 11973**

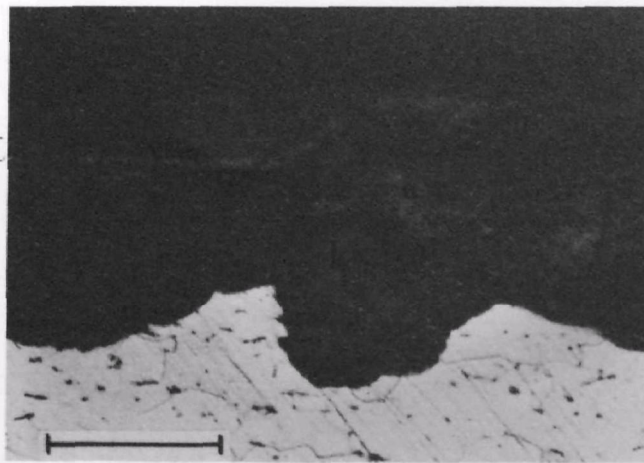
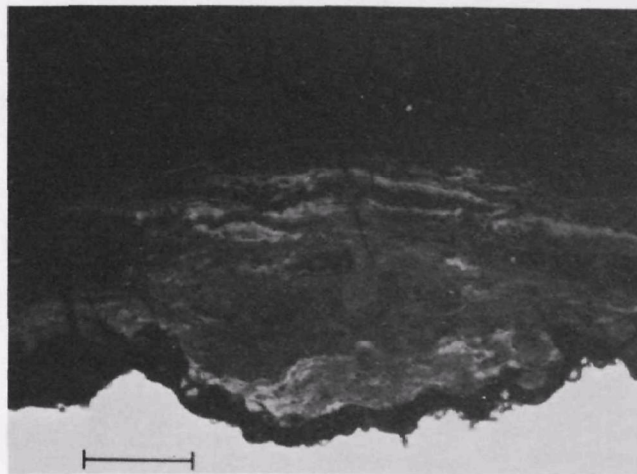
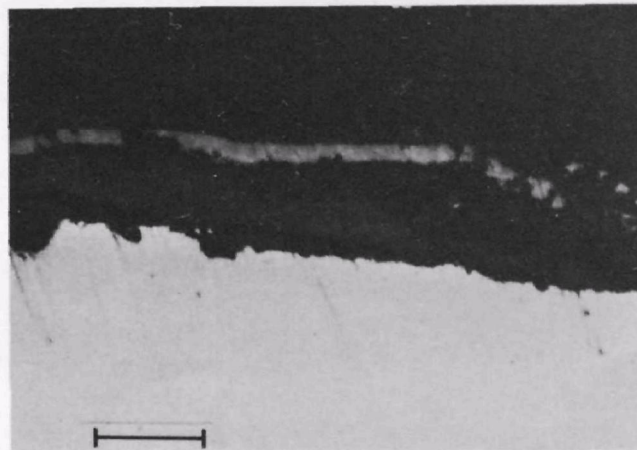
Figure 4.12 shows micrographs of a well-protected surface at coordinates along the  $45^\circ$  axis of the container sheath. The microstructure of the metal shows a grain size of between  $10\text{-}25\mu\text{m}$ . A compact scale typically  $40\text{-}50\mu\text{m}$  thick with pits in the metal containing up to  $250\mu\text{m}$  of scale characterizes the attack on the well-protected sediment side of the container. While the macroscopic corrosion rate measurement could not precisely detect this low rate, the scale thickness can give an estimate of the corrosion rate under the assumptions that the scale represents the entire corrosion product and its density is half of that of the metal. A laminar material on the left of the photo at AB of Figure 4.12 (a) suggests an initial surface scale consistent with the assumption that the entire product formation has remained as scale. Using this argument, an estimated corrosion rate for the sediment buried side falls near 0.0025 mm/yr, assuming a linear scale growth with no induction time. This probably represents an upper limit for the general corrosion on the sediment side since a non-linear parabolic law would seem more realistic because the film appears to be protective. However, at this time it is premature to postulate a corrosion mechanism and corrosion rate. Of course, as described in previous sections, high localized corrosion completely penetrated the

Figure 4.12 Optical Micrograph of Well Protected Specimens Taken from Positions ( $x = 9$  inches,  $\theta = 45$ ), ( $x = 15$  inches,  $\theta = 45$ ) respectively

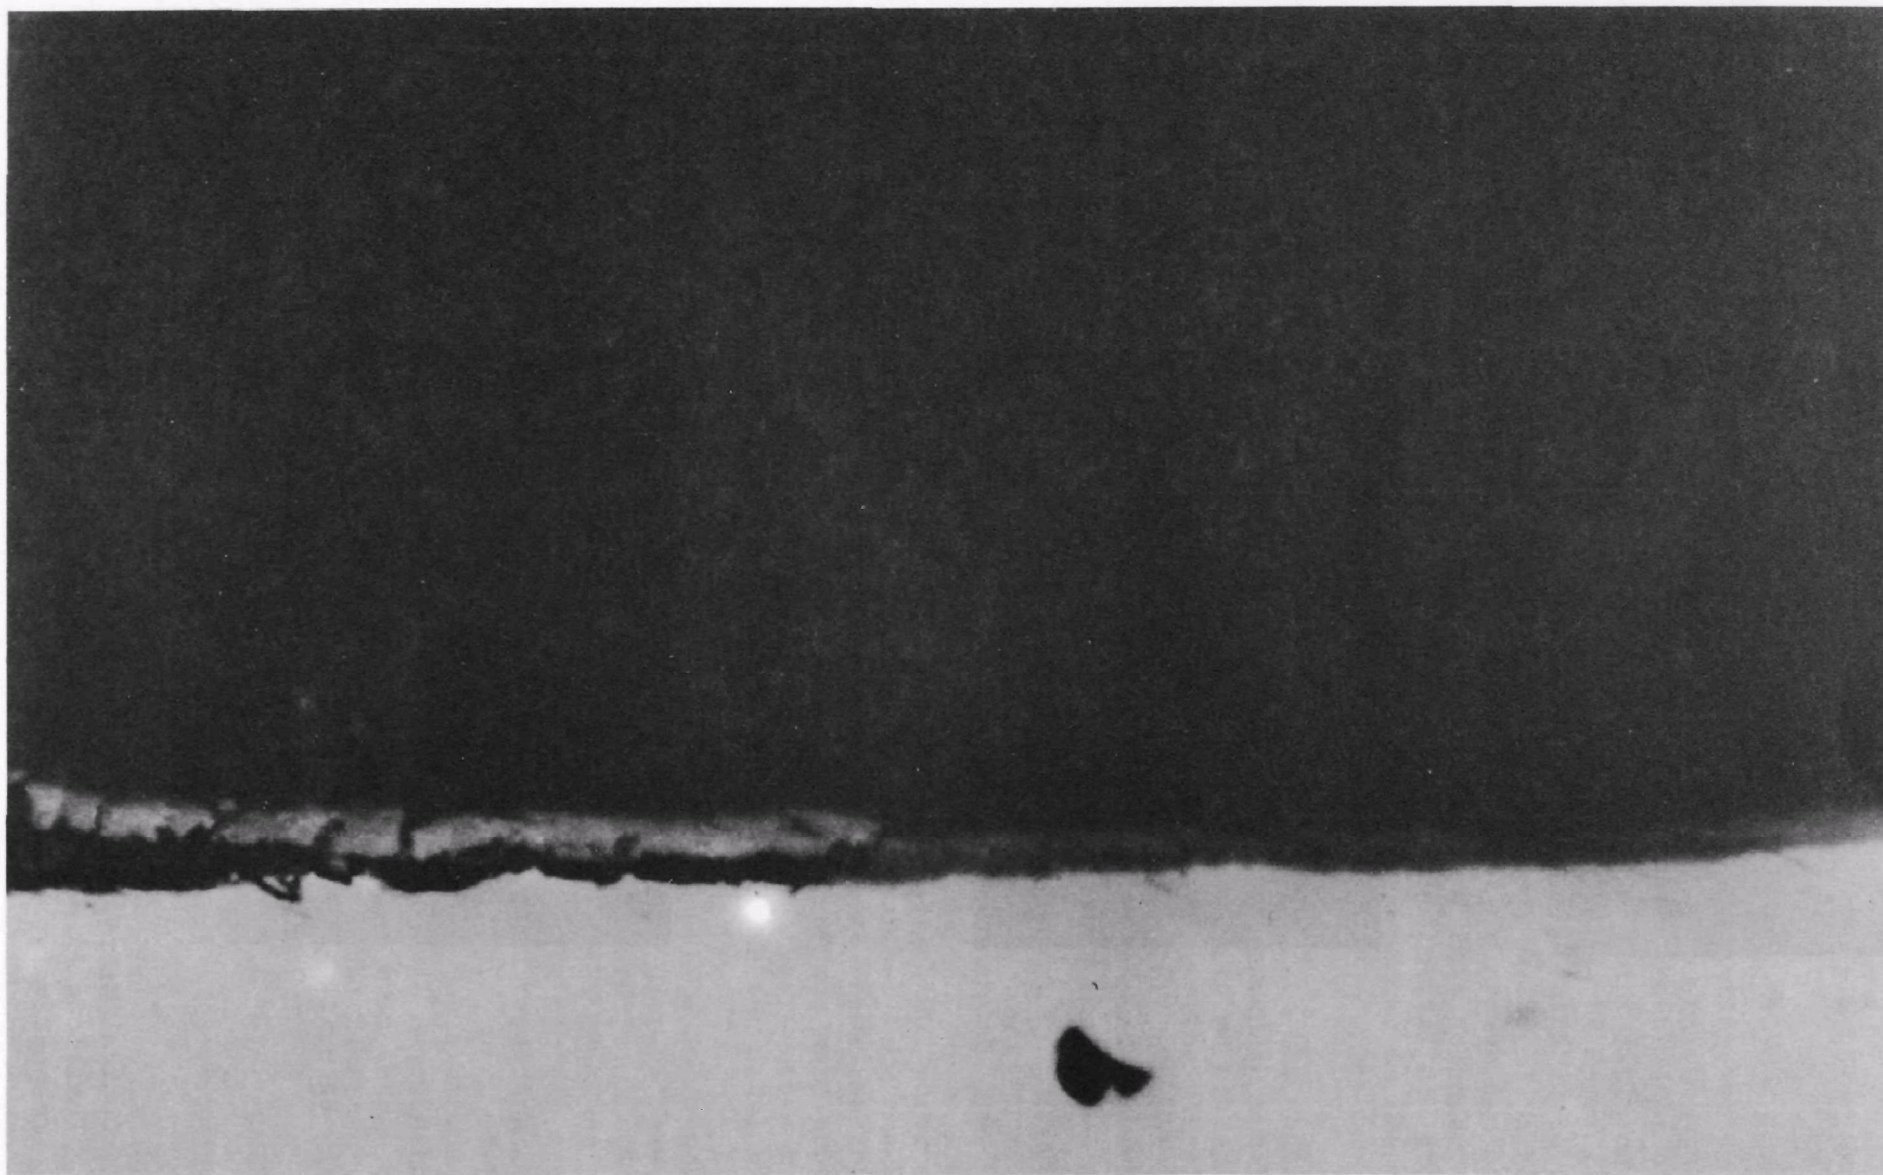
Figure 4.13 Initiation of Corrosion on the Sediment Side of the Container  
( $x=12$  inches,  $\theta = 46^\circ$ )

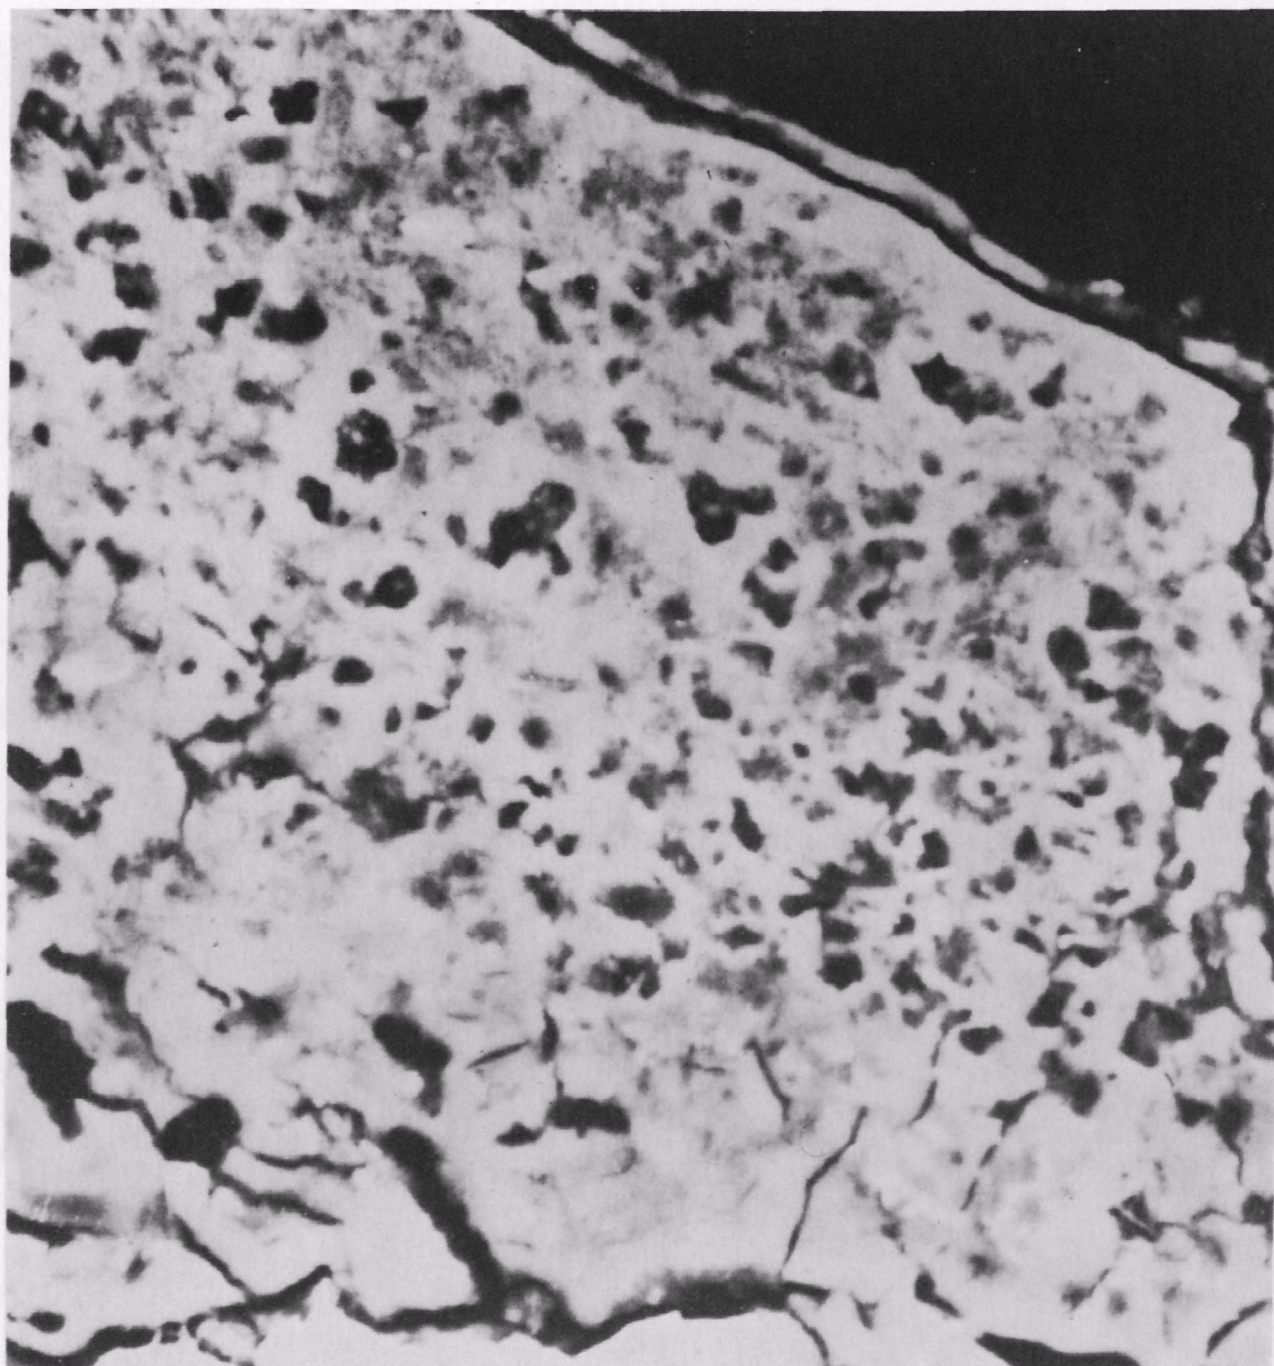
Figure 4.14 Rapid General Corrosion on Sample Taken from X=27 inches,  $\theta = 225^\circ$

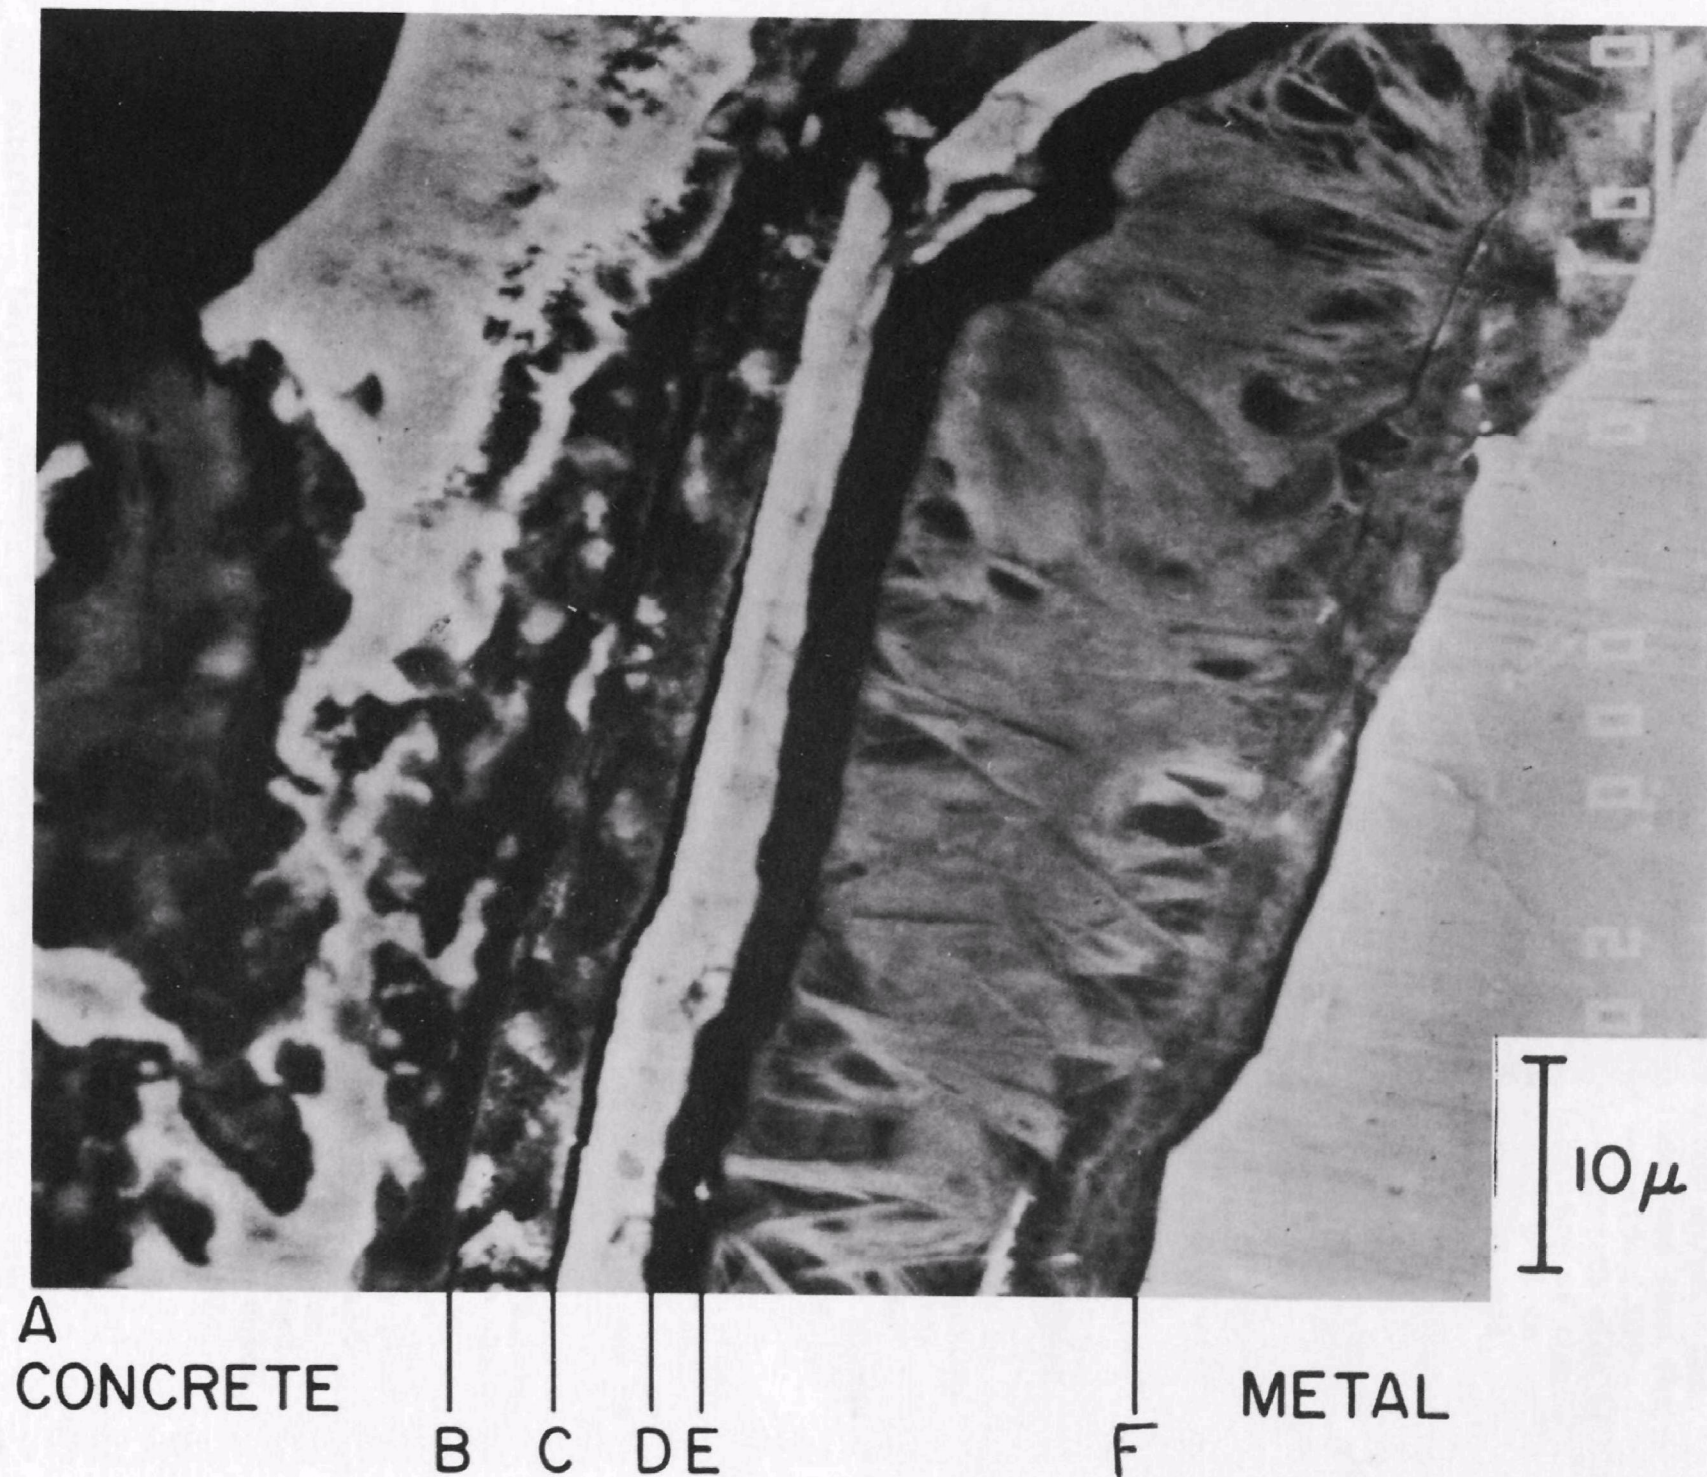
As shown in Figure 4.16, the concrete side of this sample shows a more compact scale formation. Significantly a thick  $20\mu\text{m}$  to  $50\mu\text{m}$  oxide (EF) forms under the initially existent lamina, oxide (CD) and "coating" (BC). The identification of these layers are based on X-ray fluorescence (XRF) evidence provided in Figure 4.17. Here the scales (CD and EF) are shown to contain iron and are assumed to be oxides of iron. Area DE represents a void resulting from delamination. Area AB contains aluminum and is, therefore, part of the concrete waste form, while region BC shows neither iron nor aluminum. Section BC probably represents the remnants of a coating, although no evidence of this "coating" has been found on the remainder of the vessel even though repeated searches were made with the aid of the Brookhaven National Laboratory metallography laboratory. The  $5\mu\text{m}$  thick scale, CD, remains on much of the well-protected portions of the container.

Figure 4.16 Corrosion Scale of Sample (Concrete Side) Taken From x=27 inches,  $\theta = 225^\circ$
