SUMMARY

Since the Mines Development, Inc., uranium mill located at Edgemont, South Dakota, began commercial operation in 1956, the resultant impact of waste management practices on environmental radiation levels has been the subject of several State and Federal studies. The first set of post-operational samples were collected during June, 1957. During the latter part of July, 1957, an intensive in-plant study was conducted to characterize the mill process and liquid effluents. Water quality studies conducted during September, 1966, and July, 1971, showed that process and waste liquors were being lost by seepage from mill ponds and entering surface waters - Cottonwood Creek and the Cheyenne River. Soil and bottom sediment samples collected during the 1971 study confirmed the loss of unstabilized sand tailings to the water environment by wind and water erosion.

The mill was revisited October 3, 1972, to discuss the efforts undertaken by Mines Development, Inc., to abate radiological pollution and to assess the progress achieved in the year following the 1971 Conference. To eliminate seepage from mill ponds, the Company had instituted a program of operating the ponds at lower fluid

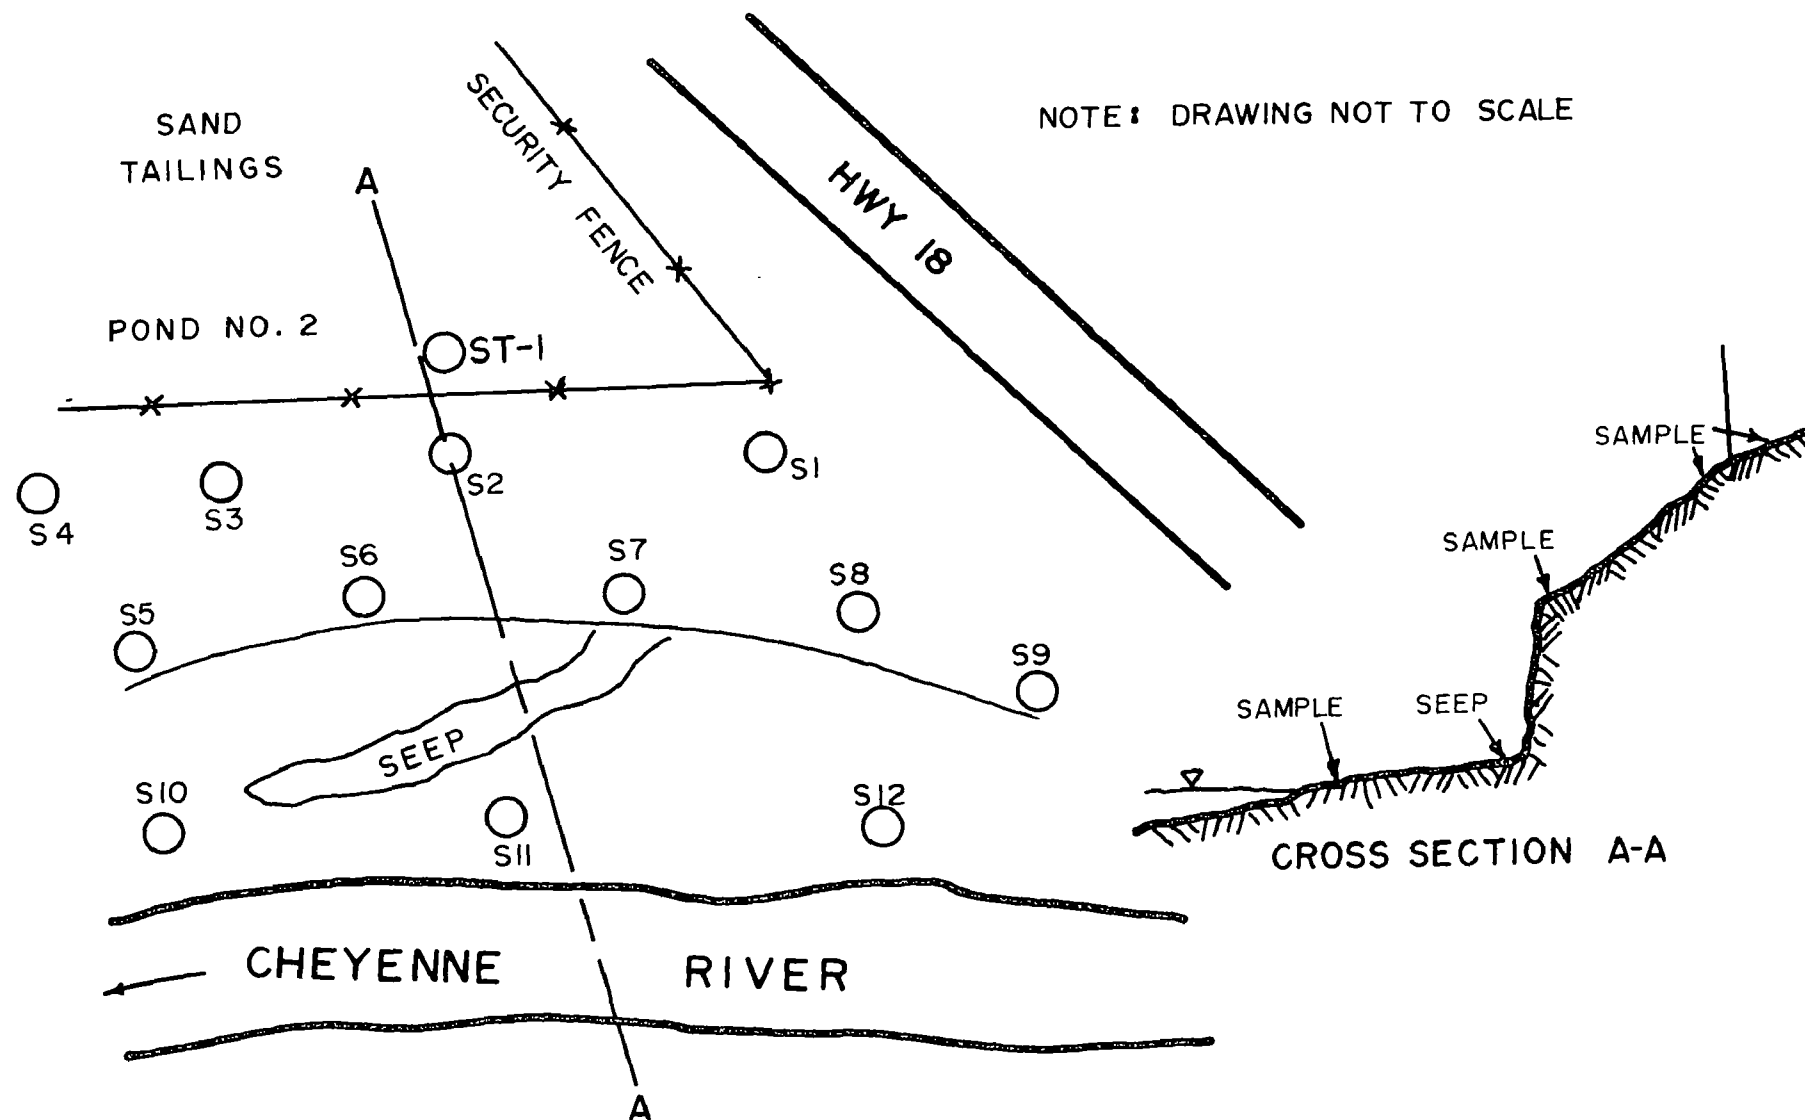
FIGURE IV

The field study eliminated any question regarding the transport of sand tailings from pile No. 1 into Cottonwood Creek by erosive action during periods of high runoff and/or wind action. Such transport was documented by the analysis of bottom sediment samples as well as visual observation of the common boundary between the creek and the tailings pile for a distance of several hundred feet. One small section of this common boundary is shown in Figure IV (photograph taken on October 3, 1972 - low flow condition). Similar documentation was obtained for the loss of sand tailings from the Pond No. 2 storage area. Soil samples collected at thirteen locations on the Cheyenne River bank and the dry stream bed adjacent to Pond No. 2 (Figure V) showed that sand tailings had breached the security fence and were beginning to migrate down the slope. Radium-226 concentrations in samples collected just outside the fence - Stations S1, S2, S3, and S4 - were indicative of sample compositions approaching 25 to 50% sand tailings (Table X). Along the line marking the sharp increase in bank slope - Stations S5, S6, S7, S8, and S9 - background concentrations of radium-226 were found. These data suggested that a loss of solids to the river had and continues to take place, but the magnitude of the loss has not been large. Slightly elevated radium-226 concentrations in the dry stream bed - Stations S11 and S12 - were probably caused by seepage as opposed to sand tailings.

SAND TAILINGS PILE NO. 1 ALONG  
STRETCH OF COTTONWOOD CREEK  
OCTOBER 1972

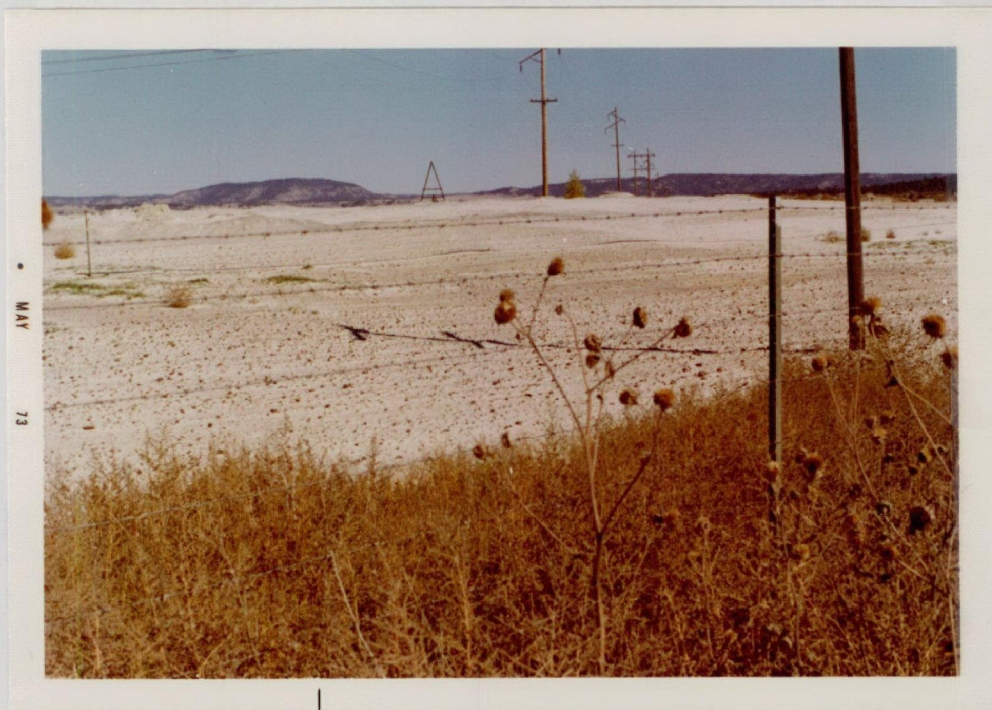
FIGURE VI  
POND NO. 2 SAND TAILINGS  
STORAGE AREA STABILIZATION TEST PLOT  
OCTOBER 1972

From the standpoint of vegetative growth, both test plots were failures. Figure VI shows the growth of the rye grass on the Pond No. 2 test plot. Figure VII shows a sparse growth of only fireweed and sunflowers on the pile No. 1 test plot. As expected without routine watering, there was no germination of grass seed on this plot. Despite the sparsity of growth, the mere fact that fireweed could grow on the "treated" sand tailings is viewed optimistically by plant personnel as indicating that fireweed may provide suitable vegetative cover if the growth period is sufficiently long. As observed by Mr. Hudson, the sparsity of rye and clover growth may have been attributable, at least in part, to the late planting date - late June. However, it seems more likely that the major causative factor was the lack of a good topsoil base and adequate irrigation.

Additional testing of fireweed growth is planned for 1973. The plan calls for leveling additional areas, adding fertilizer at a loading greater than that used for the 1972 test plots, pumping Cheyenne River water into the areas during the spring period of high sediment transport in order to build-up a topsoil base, and encouraging the subsequent growth of native fireweed. It is envisioned that after two to three years, the fireweed could be burned to obtain the mulch required for the establishment of natural grass. The drawbacks to this plan are several:

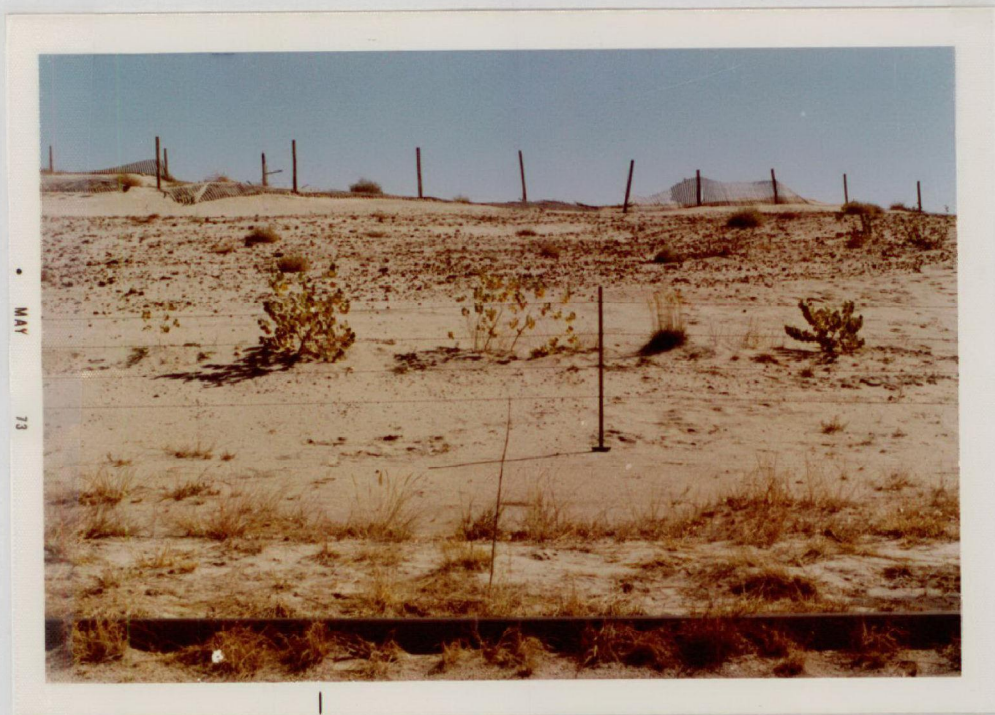
FIGURE VII

SAND TAILINGS PILE NO. 1  
STABILIZATION TEST PLOT  
OCTOBER 1972

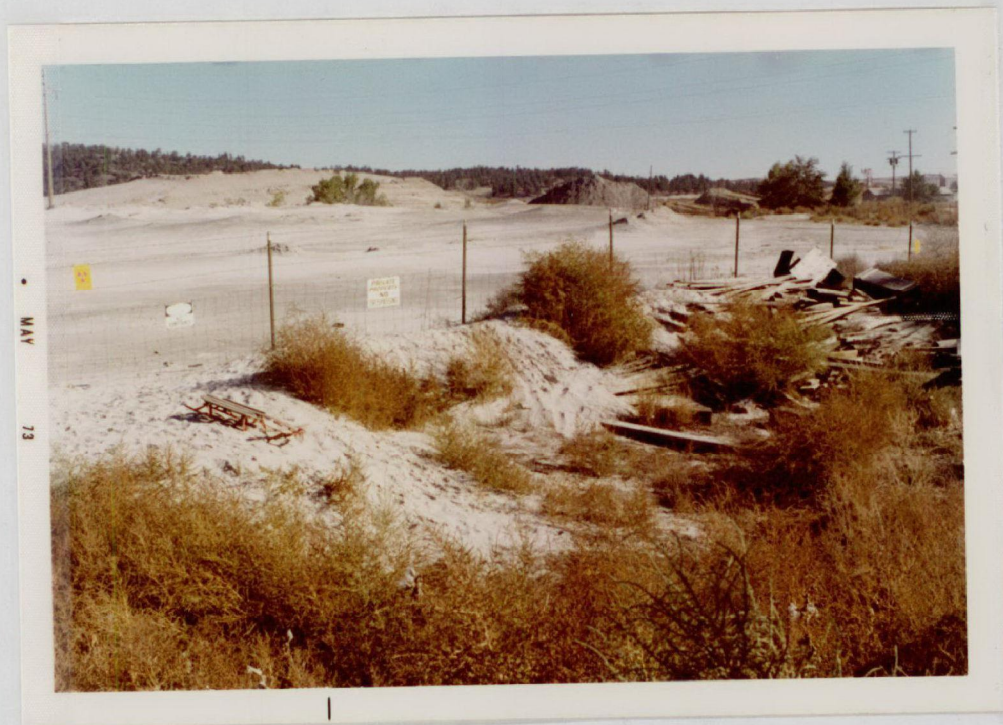
FIGURE VIII

Not only have the sand tailings drifted through the security fence to within a few feet of State Highway 18 (Figure VIII) and onto the river bank, but tailings now form a common boundary with the Martinez family property (Figure IX). The Martinez property immediately adjacent to the tailings storage area is used for a pig pen, chicken coop, and yard for a milk cow. (Small pigs were observed running on the tailings.) A soil sample collected in the chicken area just inside the fence - judged to be predominately sand tailings by visual observation - contained 34 pCi of radium-226 per gram; nearly twenty times natural background. More importantly, significant contamination was found in the soil sample collected in the play yard. The radium-226 content of this sample was 9.2 pCi/gram, or approximately five times the background level. Accordingly, the following control actions are recommended:

VIEW FROM STATE HIGHWAY 18 ACROSS POND  
NO. 2 SAND TAILINGS STORAGE AREA  
OCTOBER 1972

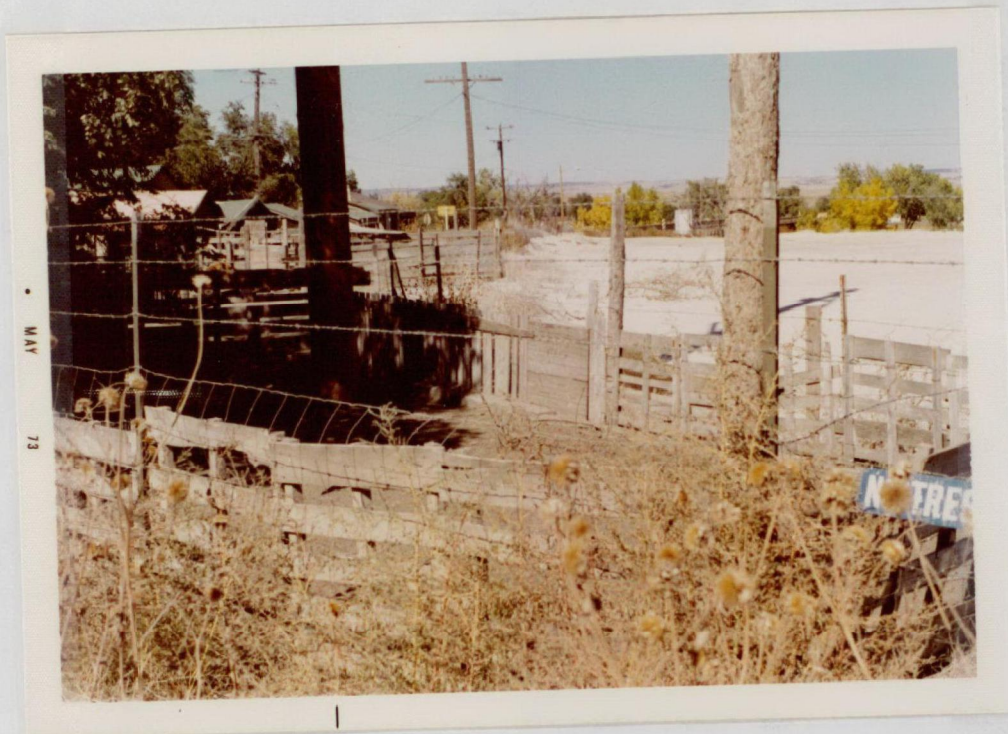
FIGURE IX

VIEW OF MARTINEZ PROPERTY SHOWING ENCROACHMENT  
OF SAND TAILINGS FROM POND NO. 2 AREA  
STATE HIGHWAY 18 IN IMMEDIATE BACKGROUND -  
IDENTIFIED BY YELLOW ROAD SIGN AND BRIDGE  
OCTOBER 1972

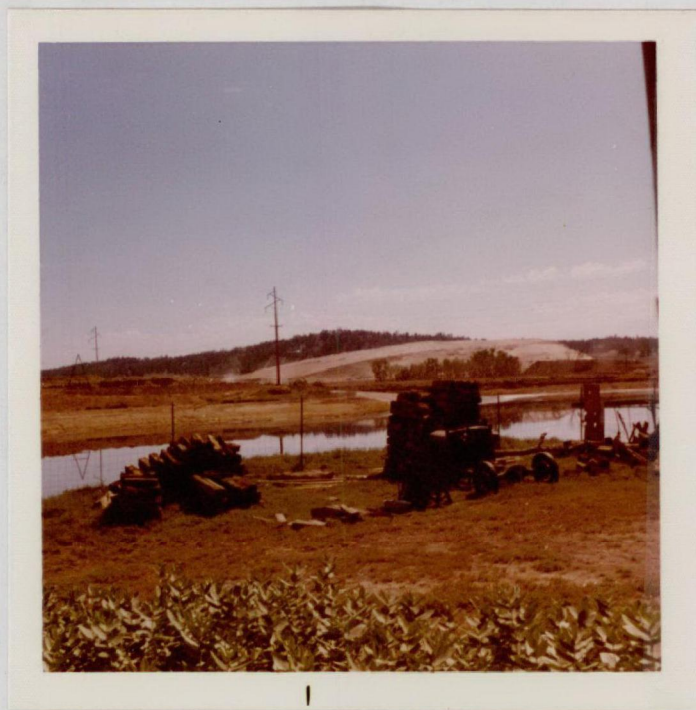
FIGURE X

Some insight to the environmental degradation which has occurred as the result of sand tailings storage in Pond No. 2 can be gained from Figure X which shows largely the same area as Figure VIII. The difference is that the photograph shown in Figure X was taken in September 1966 just after the start of sand tailings input to Pond No. 2.

VIEW FROM STATE HIGHWAY 18  
ACROSS POND NO. 2  
SEPTEMBER 1966
