EPA-600/R-97-135  
November 1997

# **Florida Large Building Study Polk County Administration Building**

## **Final Report**

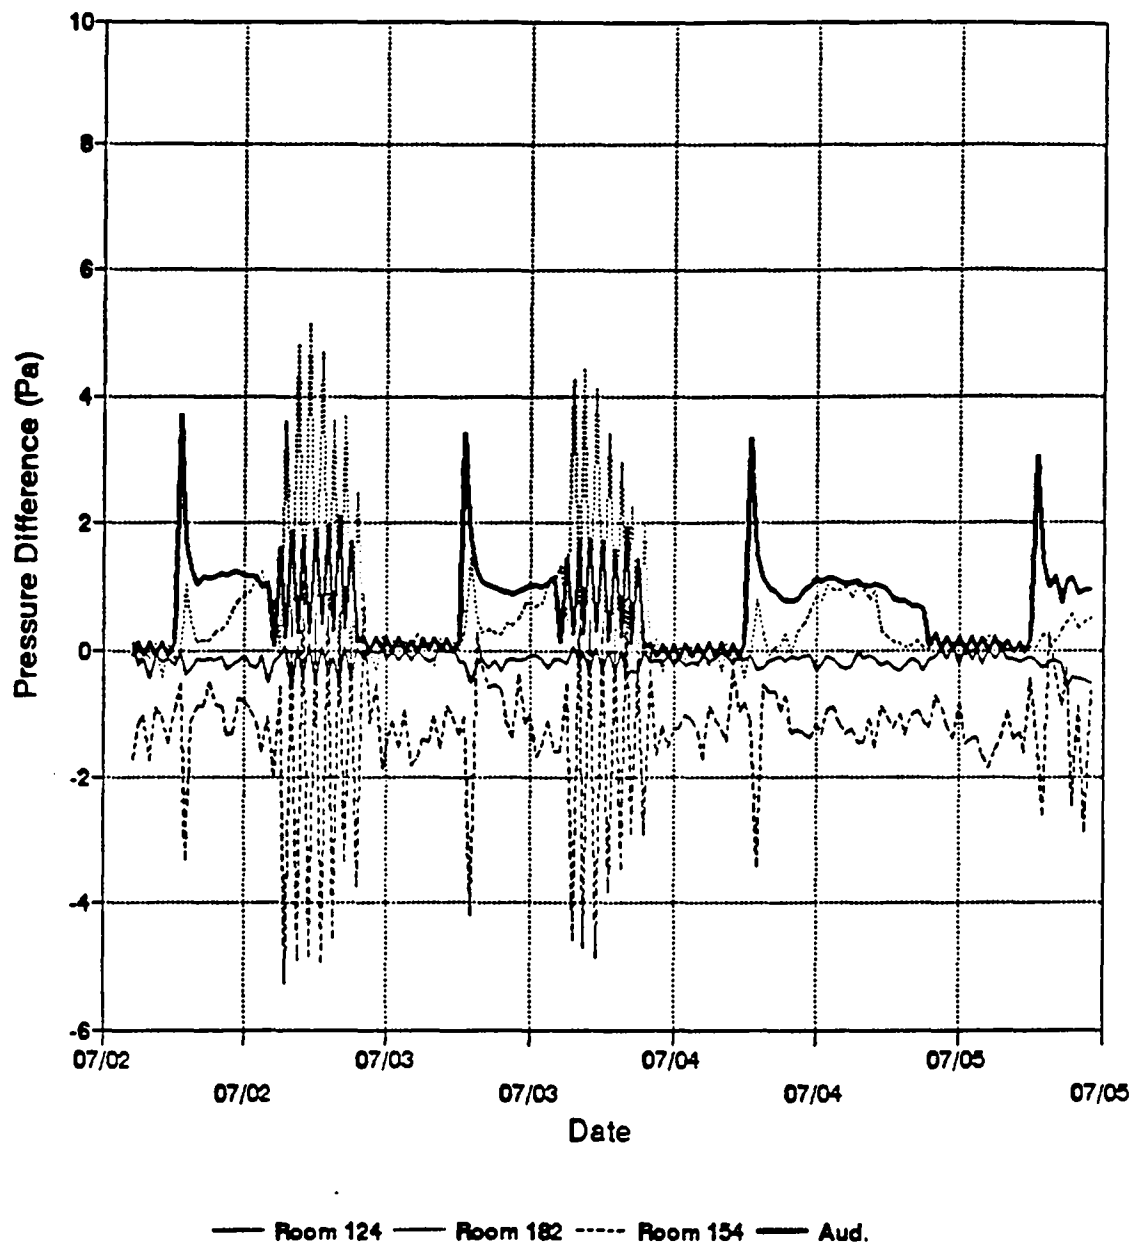
Figure 4. Pressures with respect to atrium of first floor rooms in Polk County Administration Building

Figure 4 shows the trend of pressures in three first floor zones relative to the lobby. As can be seen, during the occupied hours there is an initial pressure surge as the air handlers leave setback mode, followed by a broad peak as cooling load increases the pressure difference between each zone and the lobby increases in magnitude through a maximum, then decreases in the afternoon. For some zones, notably the auditorium, the pressure difference can be 4-8 Pa. This effect is attributable to flow restrictions in the crossover windows in the fire-rated walls separating the first floor zones. Any flow imbalance among the three ground floor AHUs is converted into pressure imbalances at these restrictions. Such pressure imbalances are significant for radon entry in that they can create areas of local depressurization with respect to outdoors (or the subslab soil) even in buildings that are not depressurized overall. Two other mechanisms for local depressurization were also noted. During the setback periods (Modes B and C) fluctuation pressure differences of up to 4 Pa were induced between ground floor zones as alternate air handlers were switched off on the 30 minute duty cycle. These fluctuations are clearly seen in Figure 4 during the weekend Mode C times or the afternoon of July 2 and 3. In contrast, Figure 5 plots the pressure differential across the slab in three of the same rooms. Here the scatter in the data are greater and only two of the five pressure transducers (Rooms 124 and Auditorium) appear to be operational; however, two things are noteworthy. First, the pressure differences across the slab do not show the effects of the zone-to-zone imbalance in the building. The peak-to-peak variations are less than half that occurring within the building, and occur in synchronization with the 12 hour tidal pattern of fluctuations in the barometric pressure rather than the HVAC cycle.

Potentially more serious is the depressurization of the ground floor mechanical rooms due to net return duct leakage. FSEC measured the depressurization of the mechanical rooms for AHU1-3 to be -13.4, -10.6, and -14.6 Pa, respectively, relative to the lobby area for full VAV open conditions. Clearly, any radon drawn into the mechanical rooms will be immediately transferred throughout the ground floor by the HVAC system operation.

- Seal return ductwork in each mechanical room between air handler plenum and mechanical room fire walls to reduce or eliminate mechanical room depressurization and infiltration.

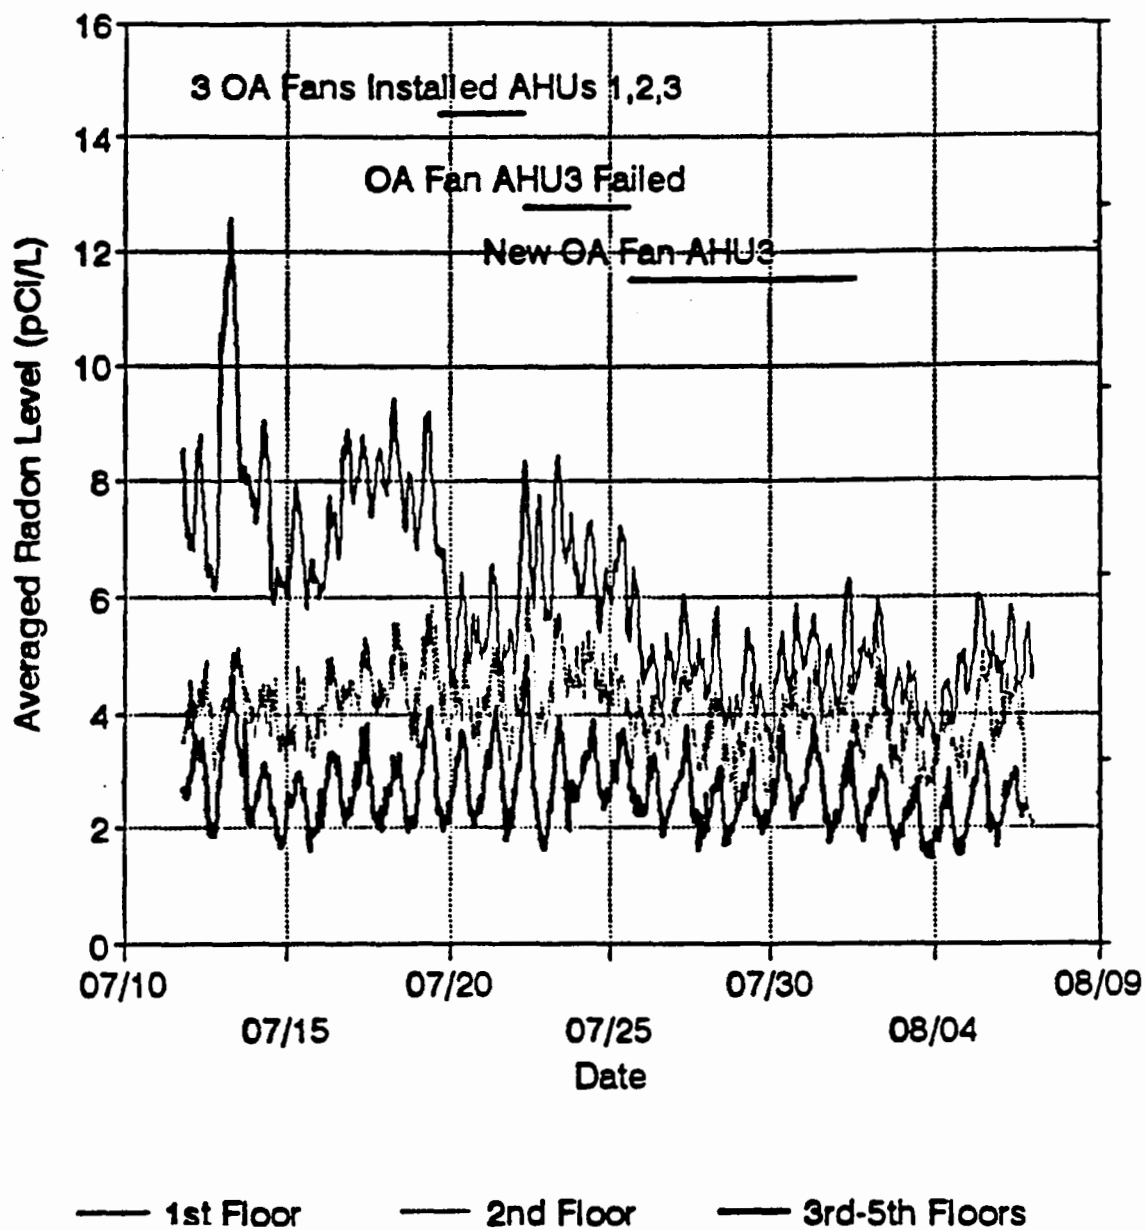
Figure 7. Average radon concentrations in Polk County Administration Building for three configurations of outdoor air fans

The average indoor radon concentrations were not significantly changed by the changes in the Outdoor Air (OA) damper positions in Operating Cycles 1-3. Other measures of ventilation, including tracer gas air exchange measurements and peak CO<sub>2</sub> concentrations, were also unaffected. Apparently, the incremental changes in the low outdoor air flowrate were too small to cause any significant change to building ventilation. During periods of operation of the inline blowers in the OA duct, the indoor radon was reduced by an average of 18% with two fans operational (700 cfm added OA) and 40% with all three fans (1939 cfm) operational.

- Install induced air fans on the outdoor air intake lines of Air Handler Units 1-3 with capacity to deliver, respectively, the design values of 1500, 750, and 1050 cfm outdoor air flowrate in operation. Seal ductwork between fans and outdoor air intakes to insure against infiltration of indoor air. Configure each fan to operate continuously whenever the air handler is operating.

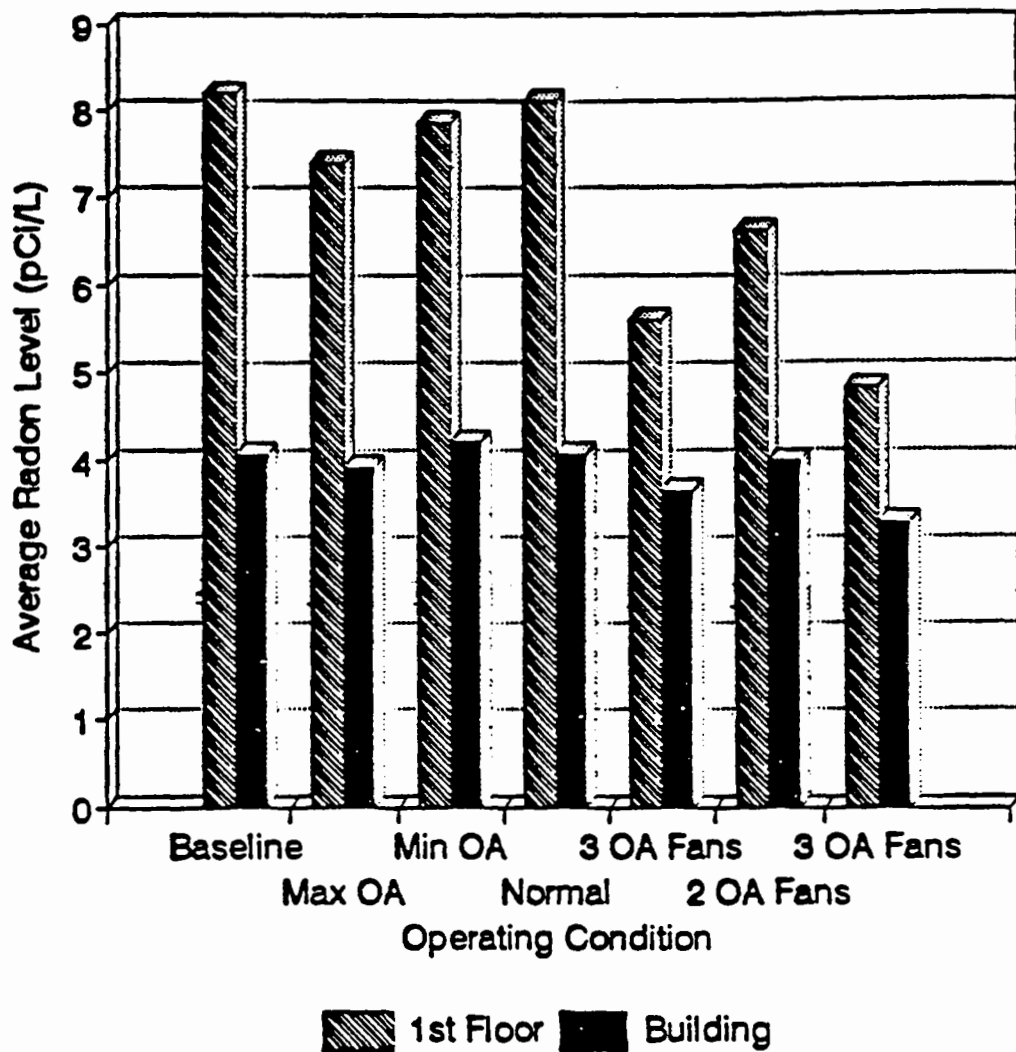
**Figure 8.** Average radon levels on the first floor and the entire building under various operating conditions at the Polk County Administration Building

Radon concentrations in the “as found” condition averaged approximately 8.1 pCi/L on first floor, and 3.1 pCi/L on upper floors, yielding 4.1 pCi/L for the building as a whole. As can be seen in the table, radon concentrations were essentially unaffected by variation in the OA damper settings. As described below, tracer gas measurements of the building air change rate over this period (in the range 0.15-0.25 hr<sup>-1</sup>) also show no significant variation, indicating that the damper settings are largely ineffectual in varying the ventilation rate.

This finding suggests that ventilation in this building is primarily by direct leakage across openings in the building shell and is driven by local pressure differentials

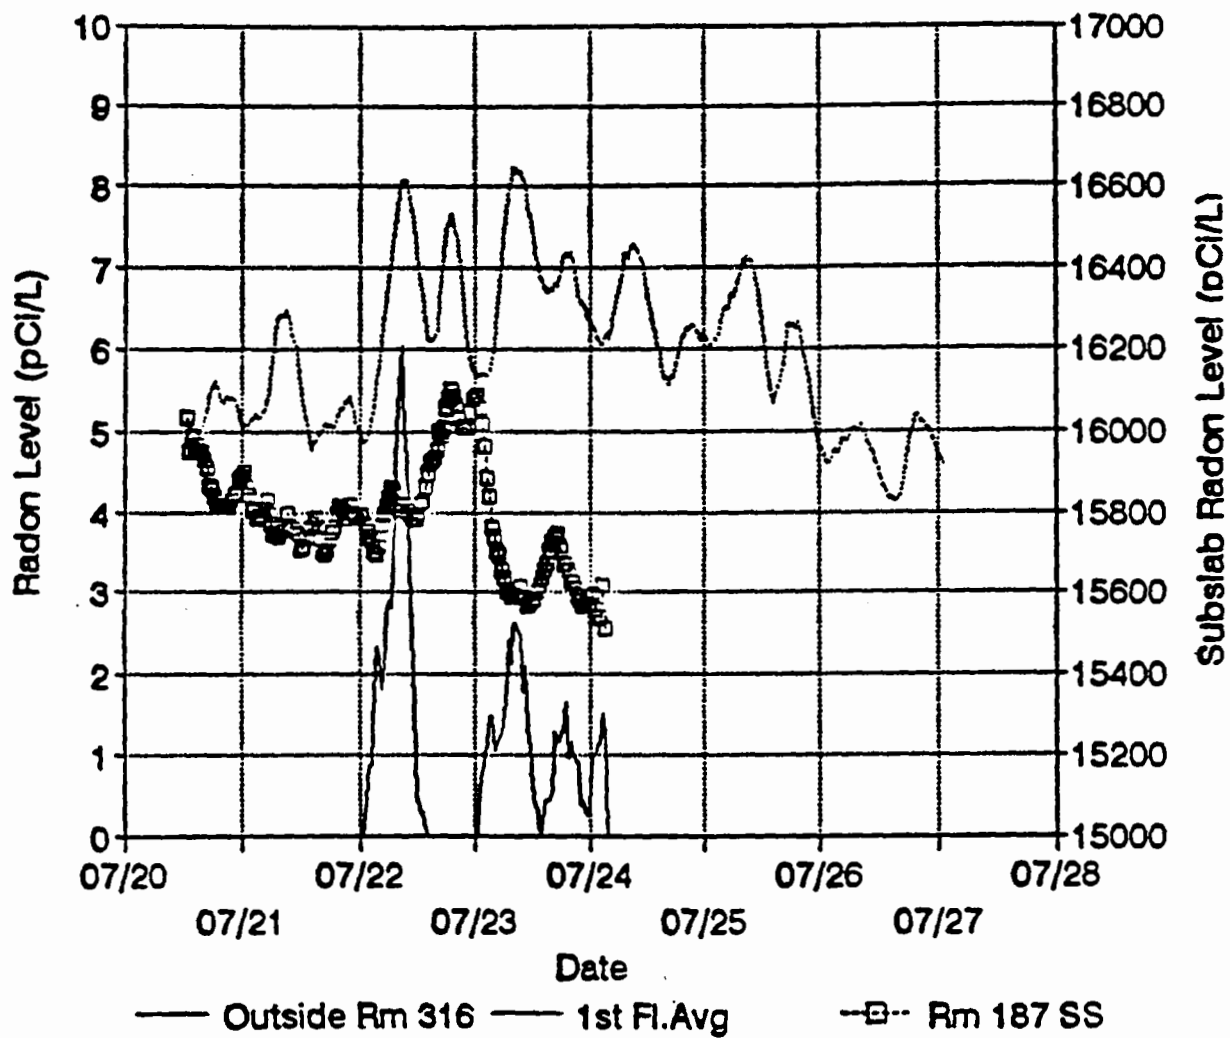
Figure 9. Comparison of radon levels outside the building and under the slab with the average of all first floor monitors at the Polk County Administration Building

Other relevant radon levels are illustrated in Figure 9 where a portion of the average first floor levels is plotted along with the outside and subslab radon levels. The data were taken on a 30 minute time scale but has been averaged over a period of 3 hours to remove fine structure. It is seen in this figure that the outdoor radon levels track quite well with the averaged first floor levels. The subslab radon level has some structure that may or may not be related to building operation. It may also be more closely related to atmospheric conditions. As shown in Table 2 the average outdoor levels were 2.8 pCi/L at the first floor level and about 0.7 pCi/L at the 3rd floor level. The average subslab radon level was 15,878 pCi/L.

In an attempt to identify major radon entry routes into the building, a continuous radon monitor was placed in the maintenance pit at the bottom of the elevator shaft. The results are shown in Figure 10 where the radon levels in the shaft are plotted along with the averaged first floor levels. These measurements were carried out during more-or-less normal operating conditions of the building. The average level in the elevator shaft was about 4.4 pCi/L which is less than 50% of the level measured on the first floor over the same period. It can safely be concluded that the elevator shaft is not a major source of the building radon, if it is a source at all. One reason to question the elevator shaft as a major entry route is because the construction of the shaft is such that cracks and openings are minimized. The radon in the shaft probably originates from the building interior itself. Similar measurements in the telephone room and electrical room in the first floor shows radon levels comparable to the surrounding NE zone. On the other hand, inspection of the first four columns of Table 2 and the figures of Appendix B indicates that all three mechanical rooms (138, 123, and 187) have average radon concentrations above the averages of other rooms in the zones they serve for most of the study period. These results are highly suggestive that the highly depressurized

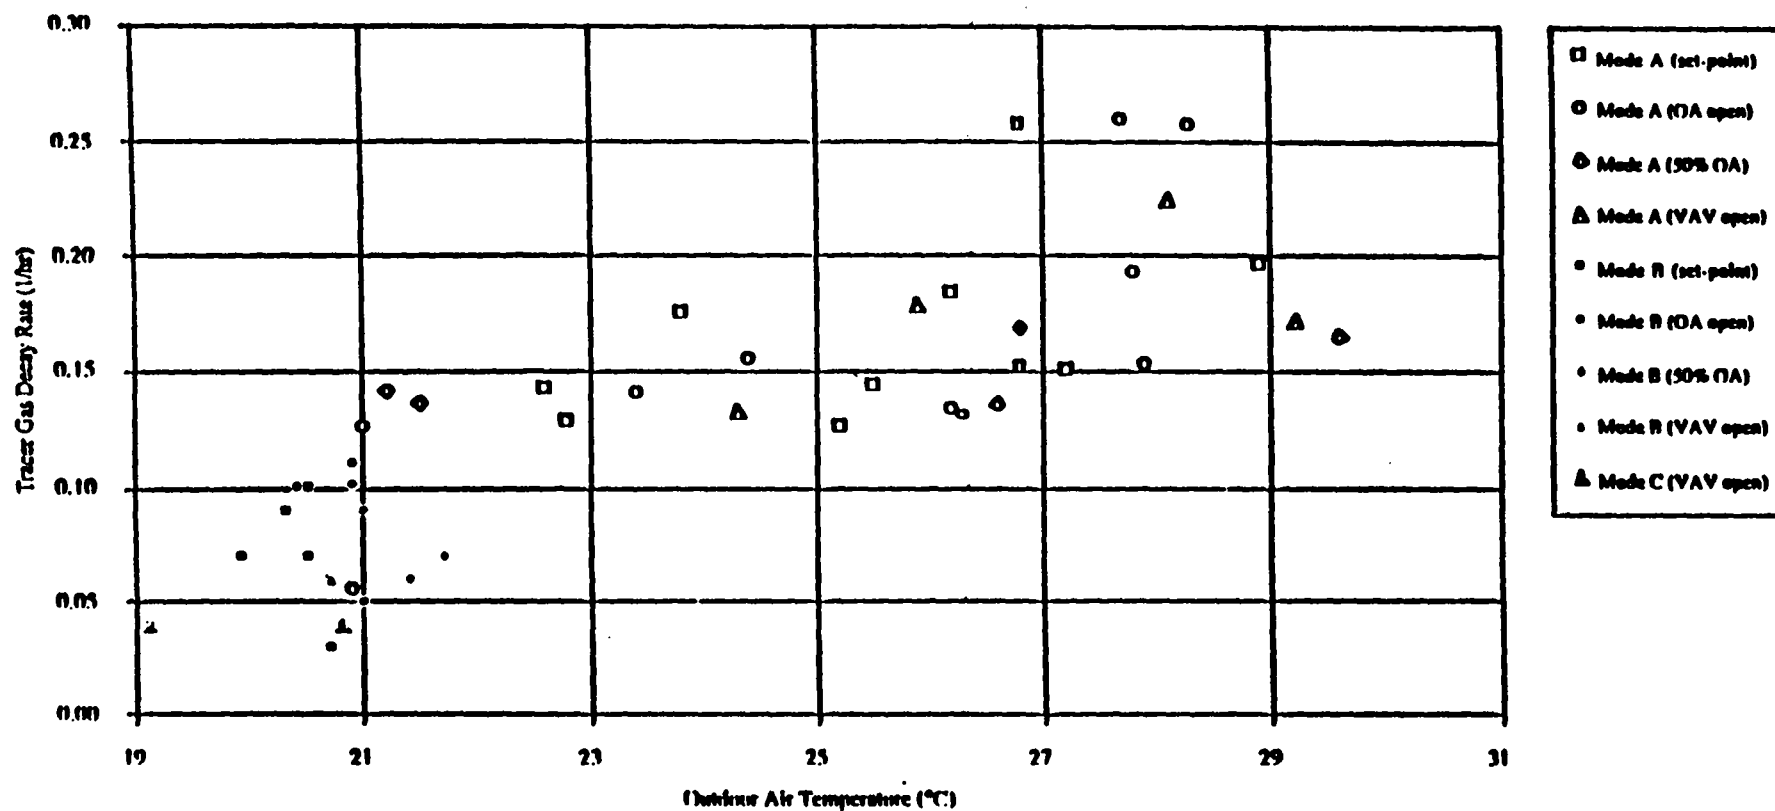
Figure 11. Whole building air change rates measured by NIST using SF<sub>6</sub> tracer gas in the Polk County Administration Building.

As seen in Figure 11, the estimated building air change rate varied from about 0.05 air changes per hour (ach) to about 0.25 ach with the lower values occurring during the unoccupied modes of operation B and C, which is also when outdoor air temperatures were at their lowest. Higher air change rates occurred at higher outdoor temperatures. This increase may be caused by increased supply airflow rates in

response to increased thermal loads, which may have in turn increased the rate of outdoor air intake and pressure-induced infiltration. Based on the building volume of approximately 60,000 m<sup>3</sup> and the maximum and minimum whole building air change rates, the air change rate is between 830 L/s (1,760 cfm) and 4,200 L/s (8,900 cfm) or between 2.8 L/s (5.9 cfm) per person and 14 L/s (30 cfm) per person based on a building occupancy of 300 people.
