PHYSICAL DAMAGE FORMATION ON AUTOMOTIVE FINISHES DUE TO ACIDIC REAGENT EXPOSURE

**Douglas White, Raymond Fornes
Richard Gilbert, J. Alexander Speer**
North Carolina State University
Box 8202
Raleigh, North Carolina 27695-8202

John Spence
United State Environmental Protection Agency
Atmospheric Research and Exposure Assessment Laboratory
Research Triangle Park, North Carolina 27711

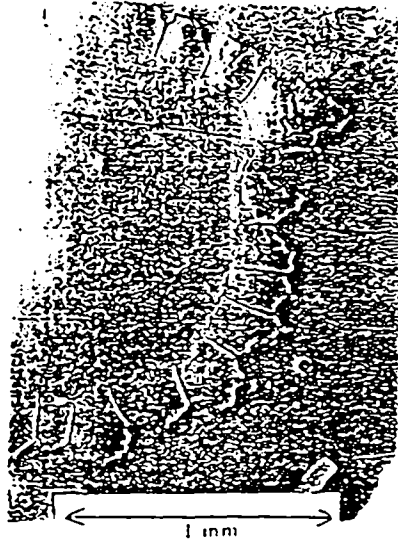
Ring shaped blistering damage was observed on all the paint surfaces. Figure 1 is of a paint surface with a clear coat having an hydroxyl containing acrylic resin crosslinked with diisocyanates and melamine formaldehyde. The clear coat appears to be separating into layers, and fracturing of the ring can be observed. This is a result of the dew being absorbed into the paint coating followed by the dew reacting with the paint surface. As the dew reacts with the clear coat, the elasticity of the paint coating decreases resulting in splitting of the surface. The ring shaped form of the damage suggests a free energy minimization process favoring a concentration of the damaging reagent at the edge of the evaporating drop. This process will be discussed in a separate section of this paper.

Figure 1 Chamber Dew #7 Damage - Paint #2
50 Minute Exposure at 54°C

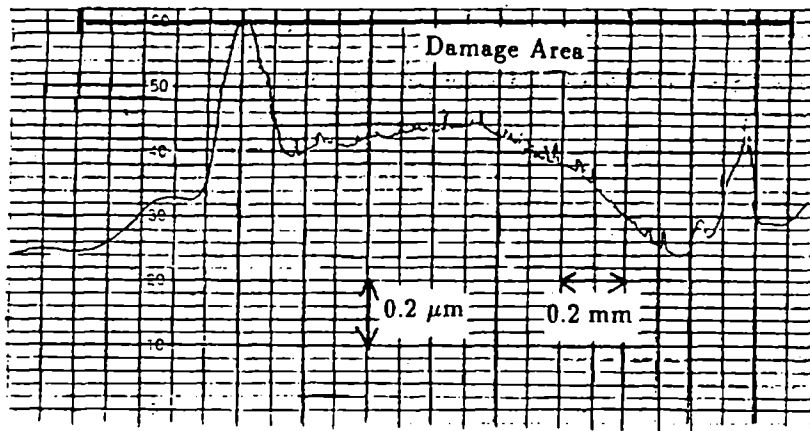
with a clear coat having an acrylic resin containing hydroxyl groups and crosslinked with diisocyanates. A crater shaped blister was formed with wall heights up to 0.6 micrometers.

Figure 3 Profile of Chamber Dew #7 Damage - Paint #4
50 Minute Exposure at 54 C

Results from inspection of the profilometer analysis and photomicrographs of the exposed paints indicate that the damage areas are not necessarily etches as would be expected from acid attack. What seems to be occurring is instead a separation of the clear coat into layers. The acidic dews at elevated temperatures generally form an uplifted crater on the paints. The center of the crater is approximately the same height as the rest of the paint. However, the sides of the crater are higher than the rest of the paint.
