CASE STUDIES OF
RADON REDUCTION RESEARCH
IN 13 SCHOOL BUILDINGS

PB94-130010
4. TITLE AND SUBTITLE Case Studies of Radon Reduction Research in 13 School Buildings	5. REPORT DATE December 1993

6. PERFORMING ORGANIZATION CODE	
7. AUTHOR(S) Bobby E. Pyle and Ashley D. Williamson	8. PERFORMING ORGANIZATION REPORT NO. SRI ENV-92-766-7400.10	
9. PERFORMING ORGANIZATION NAME AND ADDRESS Southern Research Institute P. O. Box 55305 Birmingham, Alabama 35255-5305	10. PROGRAM ELEMENT NO.

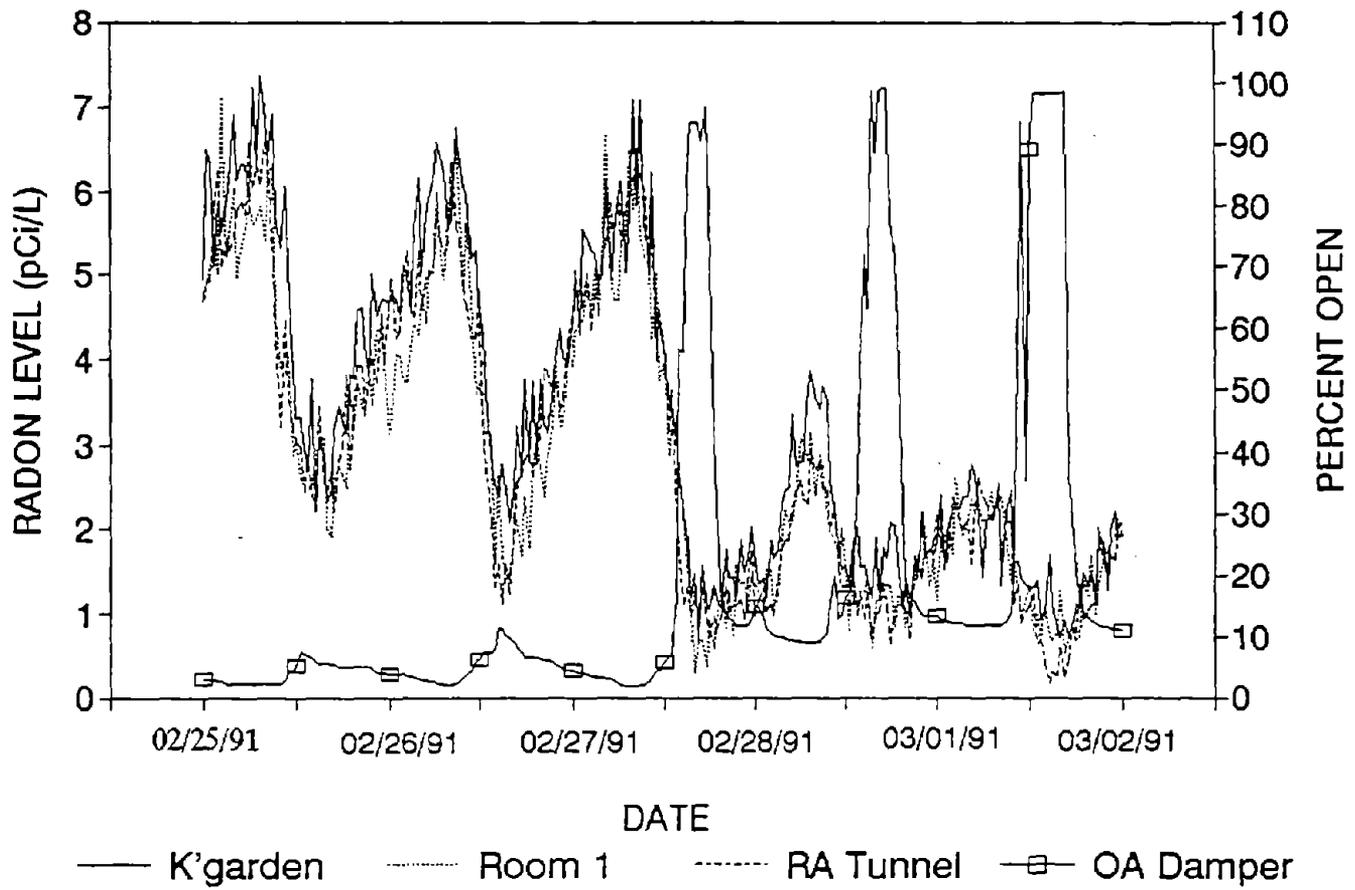
Figure 4.1.9. Effects of opening OA damper upon radon levels at Barton Elementary.

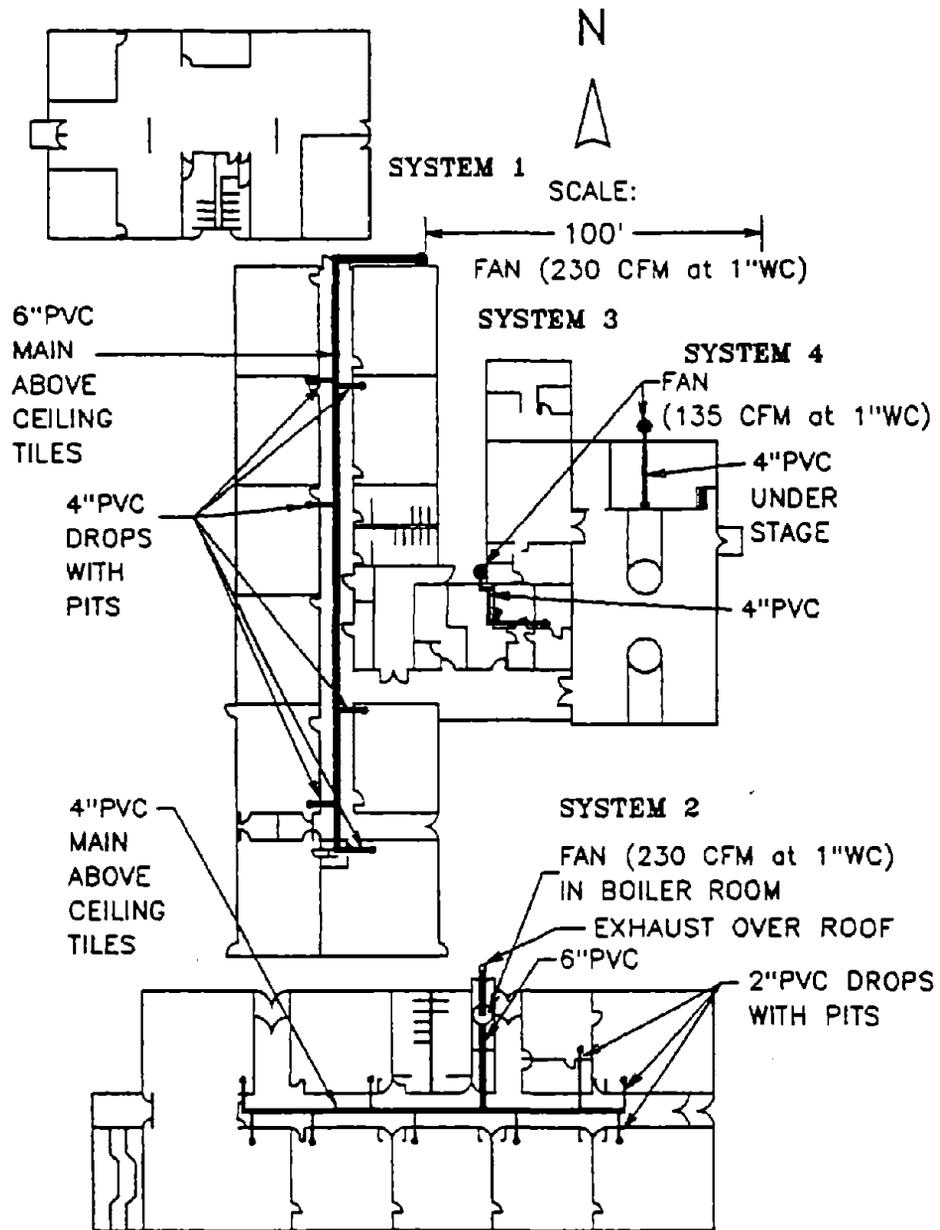
Figure 4.2.10. Proposed mitigation systems for Platteville Elementary School.

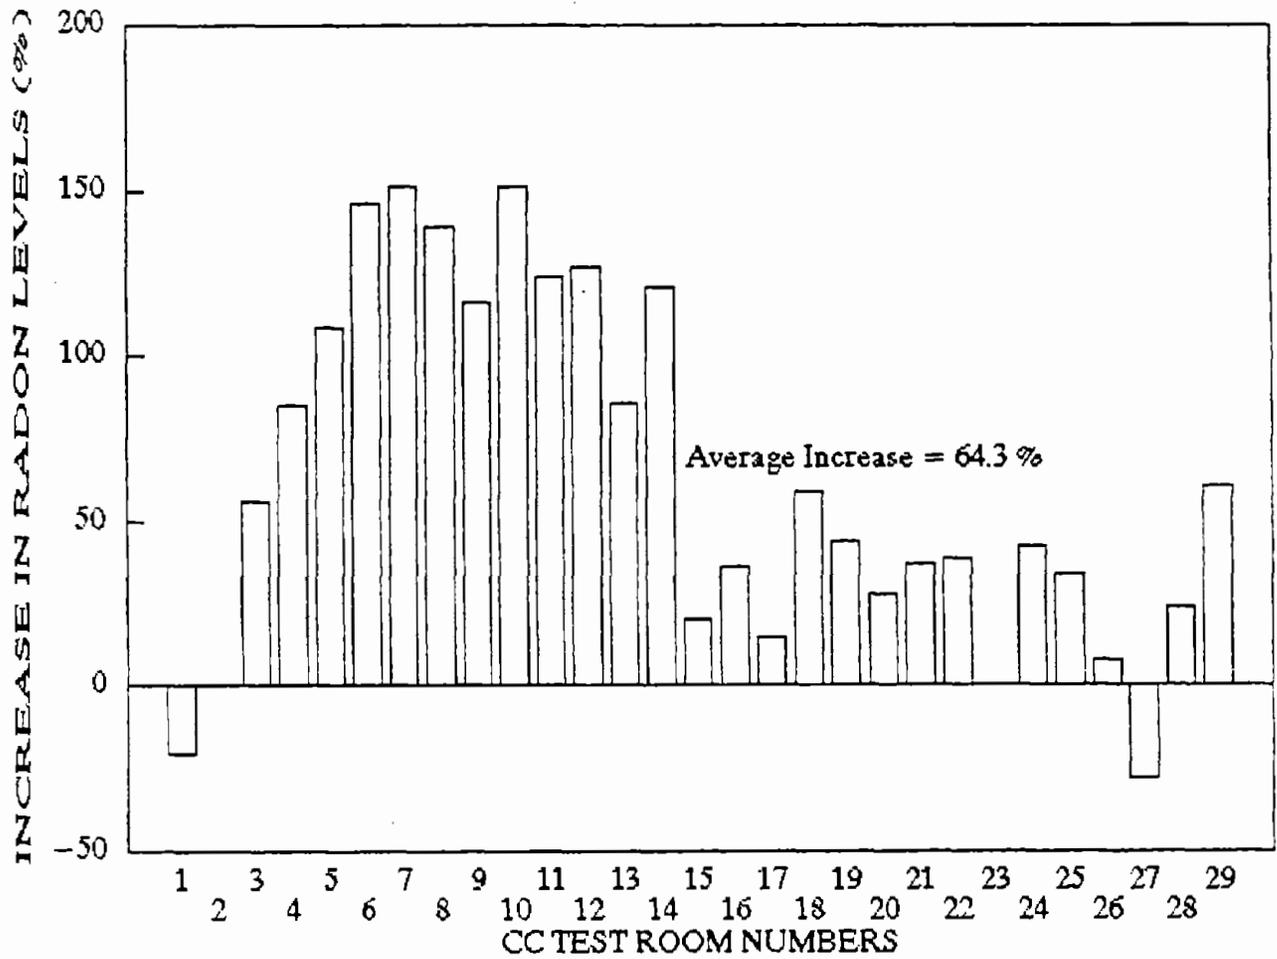
Figure 4.2.14. Changes in the radon levels when the HVACs on versus when off at Platteville Elementary, Platteville, CO.

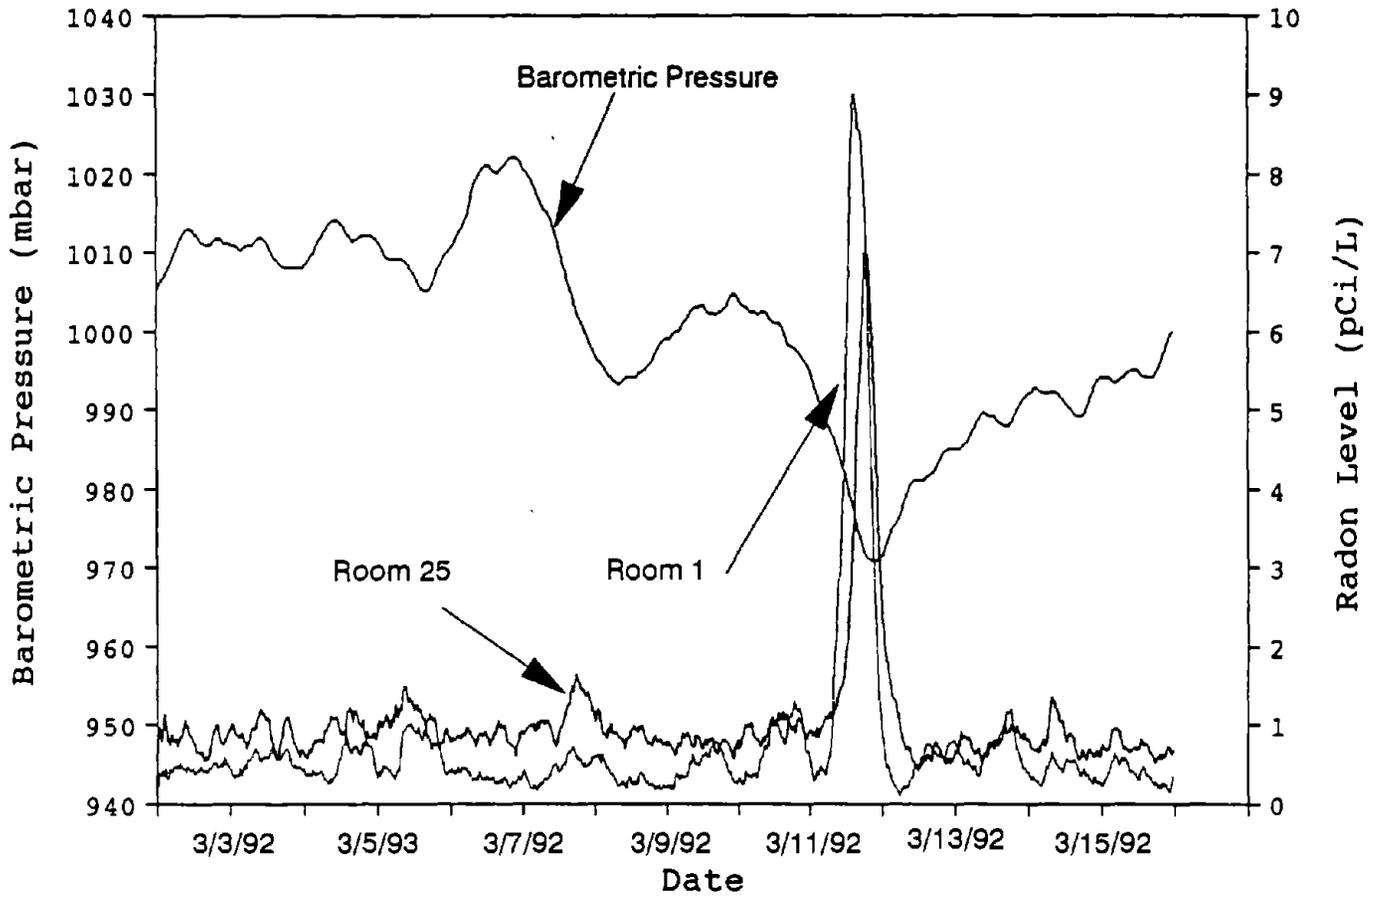
Figure 5.2.2. Correlation of radon level increases with changes in barometric pressure at Russell Elementary School, Gray, ME.

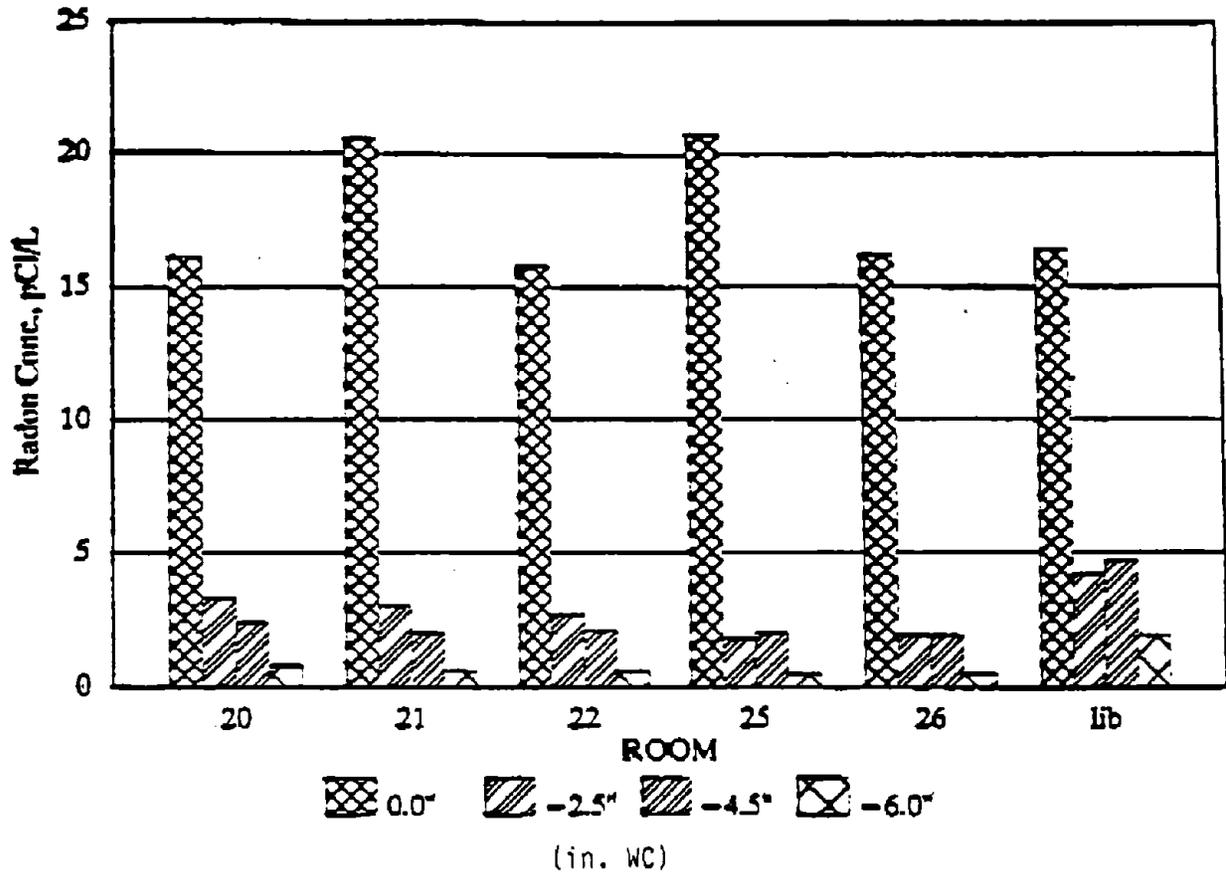
Figure 5.2.3. ASD performance, for center wing of Russell Elementary.

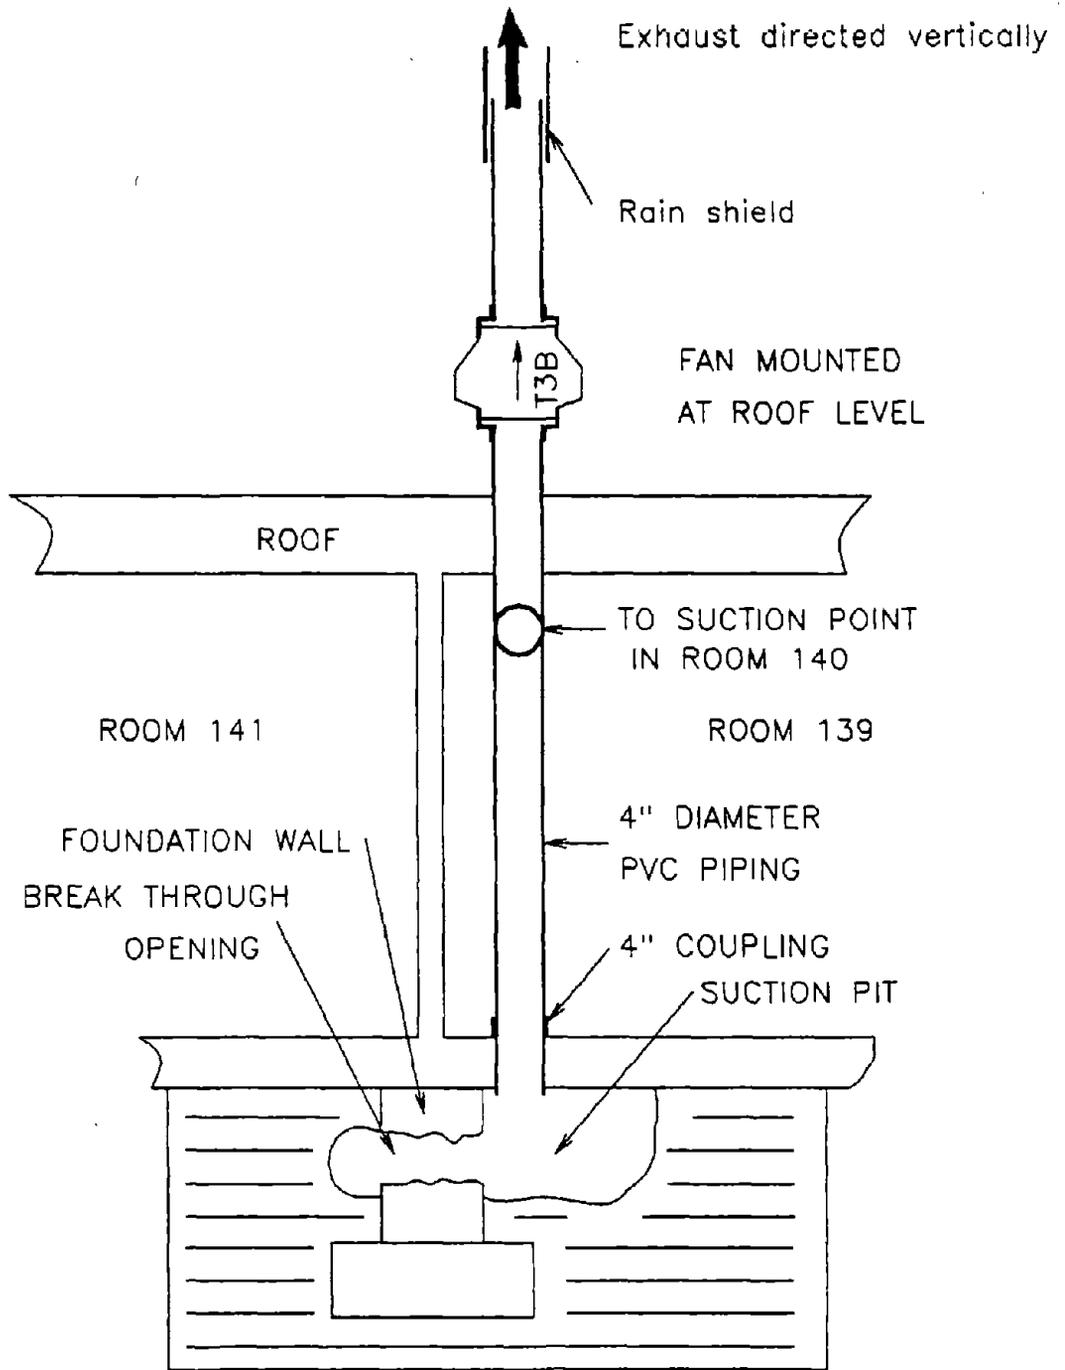
Figure 10.1.9. Cross-section view of the suction points proposed for Lidgerwood Elementary School (the same design should be used in Rooms 128 and 129).
