# NONPOINT SOURCE PROGRAM SUCCESS STORY

## New Hampshire

### Project Improves Water Quality and Saves Eroding Farmland

EPA 841-F-06-003E  
June 2006

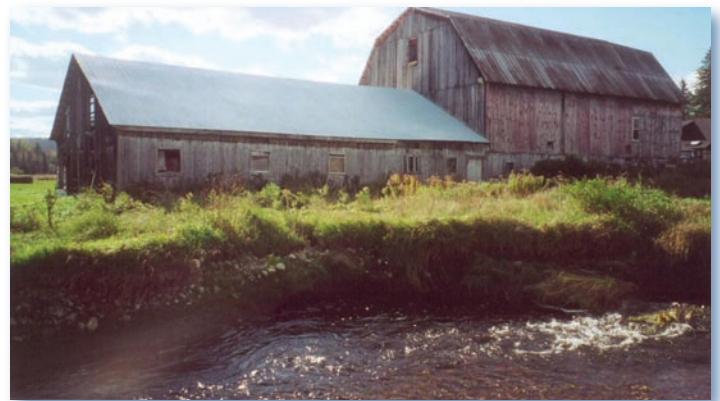
Bog Brook is in the Connecticut River Basin, near the town of Stratford in northern New Hampshire. Much of the area is in agricultural use. Decades ago, riparian vegetation was removed along the streambank, presumably to increase the amount of arable land. The absence of deep-rooted shrubs made the bank vulnerable to erosion. The once meandering stream channel became marked by a sharper bend as the bank eroded. This change in stream channel geometry caused erosion to accelerate even further. The eroding stream channel eventually threatened a barn and septic system on private property, prompting a need for action.

Analysis of aerial photographs showed that the stream channel had eroded laterally up to 35 feet between 1999 and 2003, consuming 4,000-square feet of land. This translated to 120 tons of sediment—approximately the amount needed to fill 9 dump trucks—entering the stream each year to worsen water quality and smother fish habitat. Had this been allowed to continue, the stream likely would have cut a new channel into valuable farmland, sending several thousand tons of additional sediment downstream.

Bog Brook before restoration. Removing riparian vegetation facilitated channel erosion, which ultimately threatened the barn.

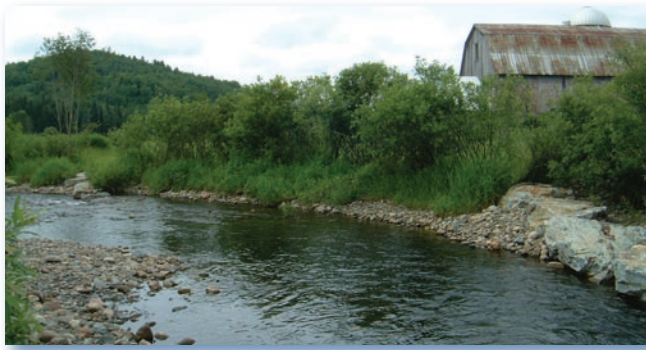
Bog Brook after restoration. The project saved the barn and stopped several thousand tons of sediment from smothering fish habitat.

One year after construction, the relocated stream reach had become more narrow and deeper—a positive trend indicative of channel stability. The vegetation along the bank was found to be well-established and firmly rooted.

- Increase the meander radius, or curvature of the bend in the stream, to reduce stress on the eroding bank
- Increase the channel slope to improve the stream's ability to transport sediment
- Plant a vegetated buffer of deep-rooted shrubs along the streambank to help hold sediments in place

Construction occurred in May 2004. Using an excavator, a small bulldozer, and several dump trucks, project leaders realigned the stream channel, filled in the former channel, and planted riparian vegetation along the streambank.
