**ASBESTOS EXPOSURE ASSESSMENT IN BUILDINGS**

**INSPECTION MANUAL**

**Revised: October 1982**

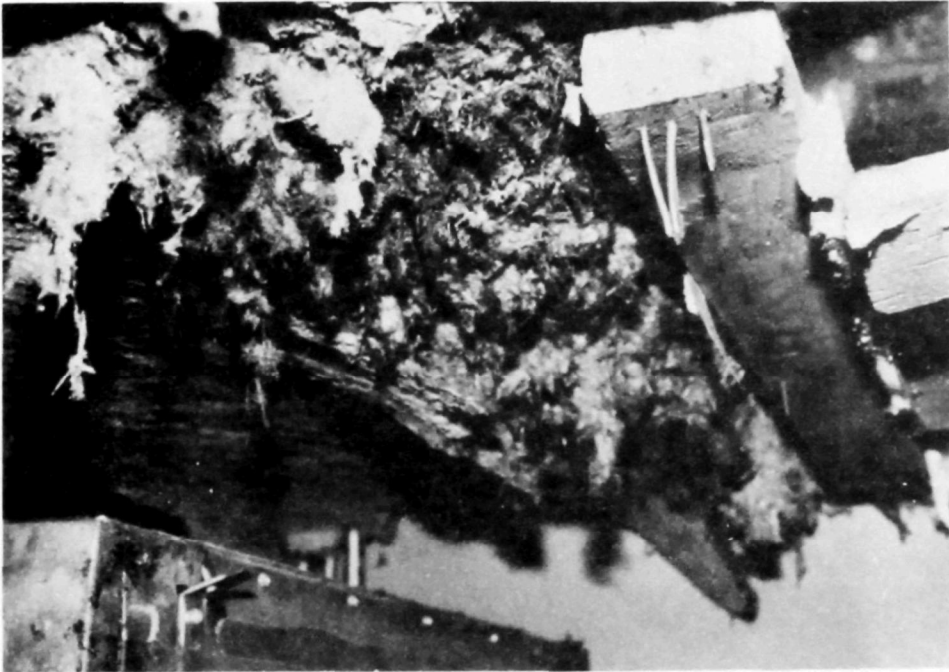
Severely deteriorated and damaged asbestos-containing ceiling insulation. Note the material is composed entirely of fibers.

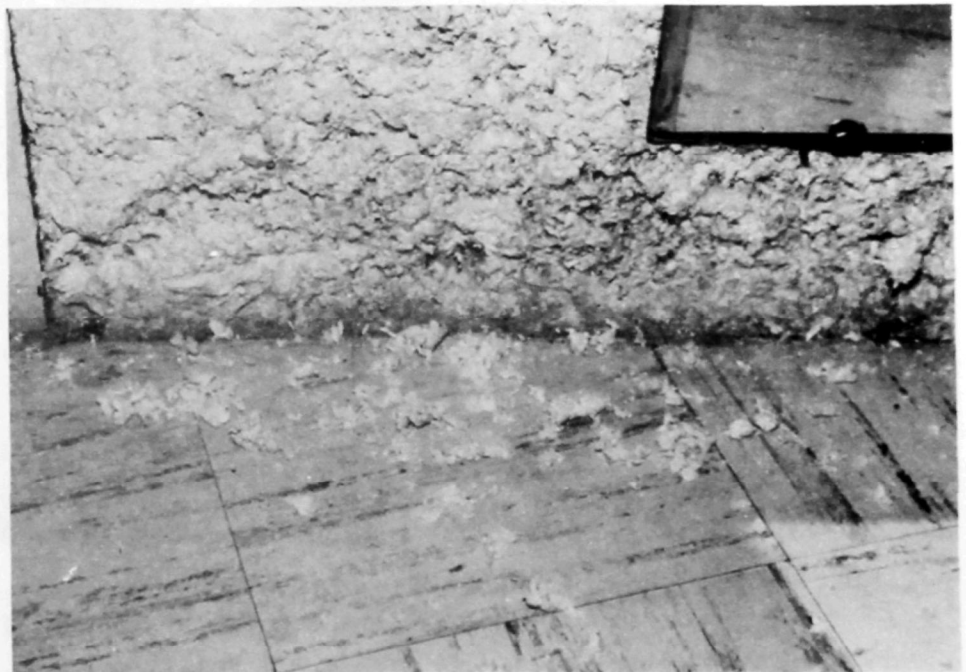
Asbestos-containing wall insulation deteriorated and falling to the floor.

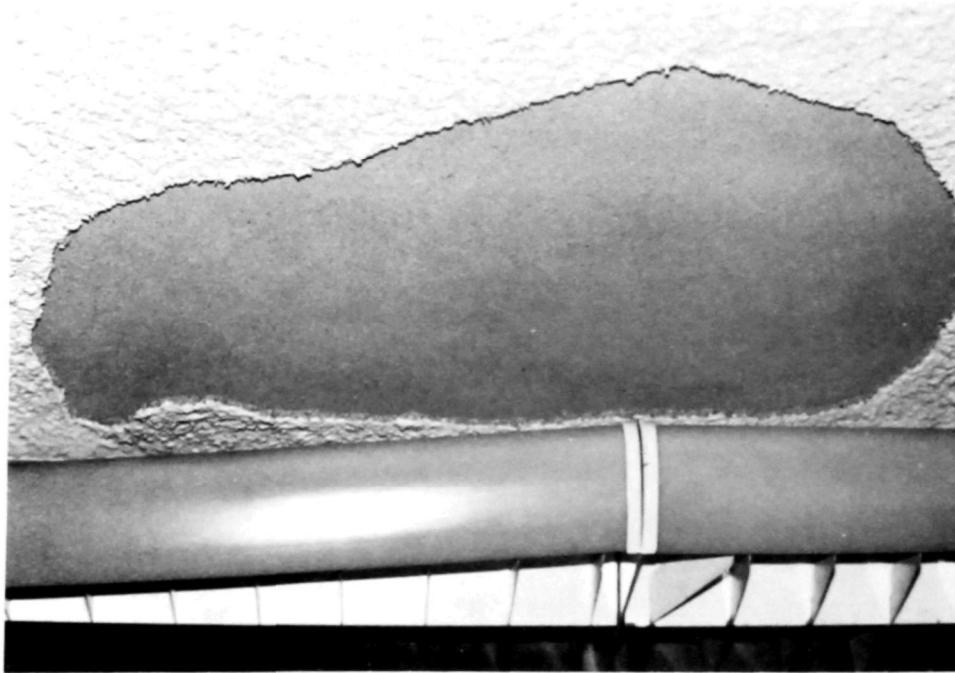
Large pieces of granular/cementitious, asbestos-containing acoustical plaster have separated from the ceiling and fallen to the floor.

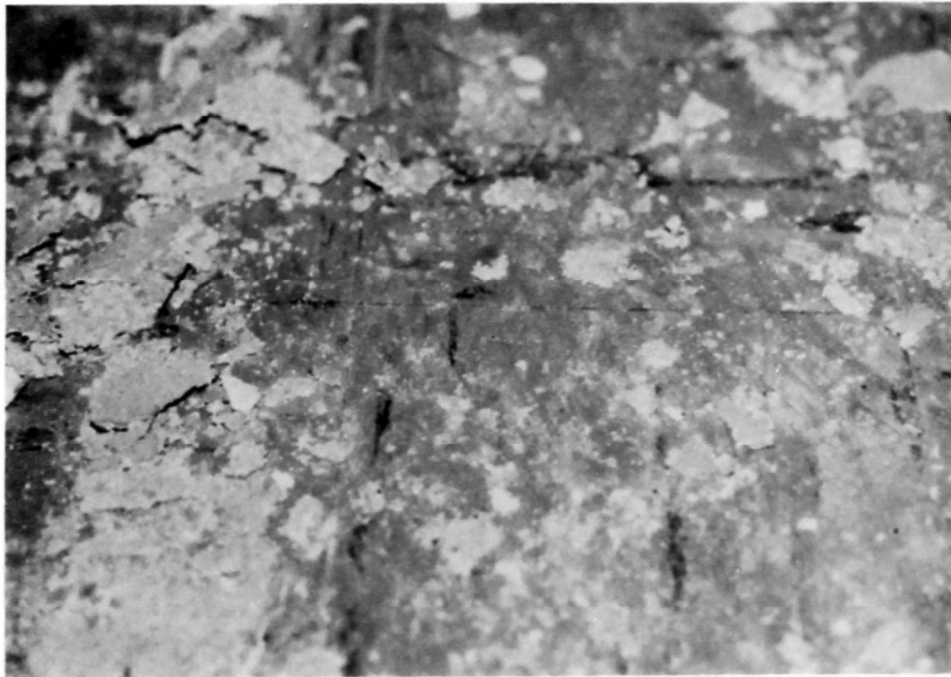
Pieces of asbestos-containing, acoustical plaster lying on the floor and being pulverized by foot traffic.

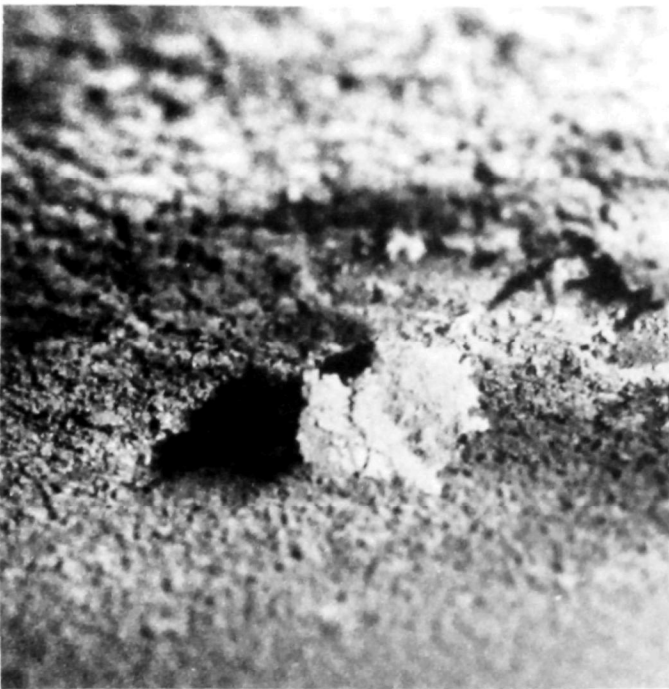
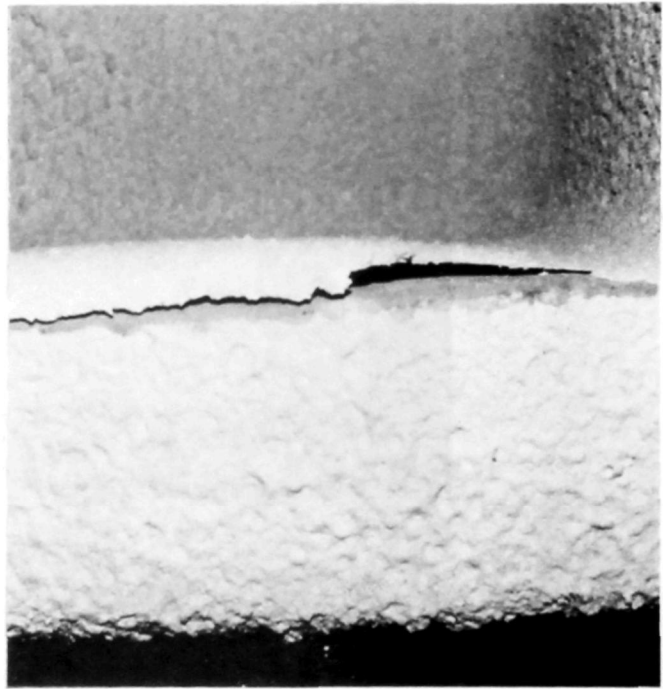
Water has destroyed the bond between the acoustical plaster and the substrate. Note delamination of ceiling coating.

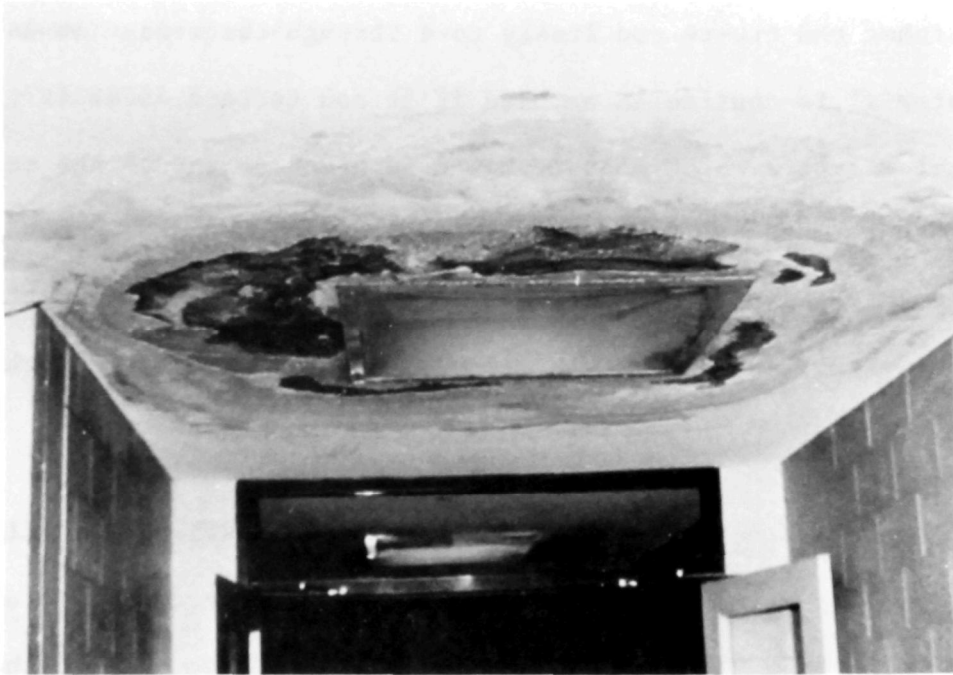
Water damage particularly severe around sky lights.

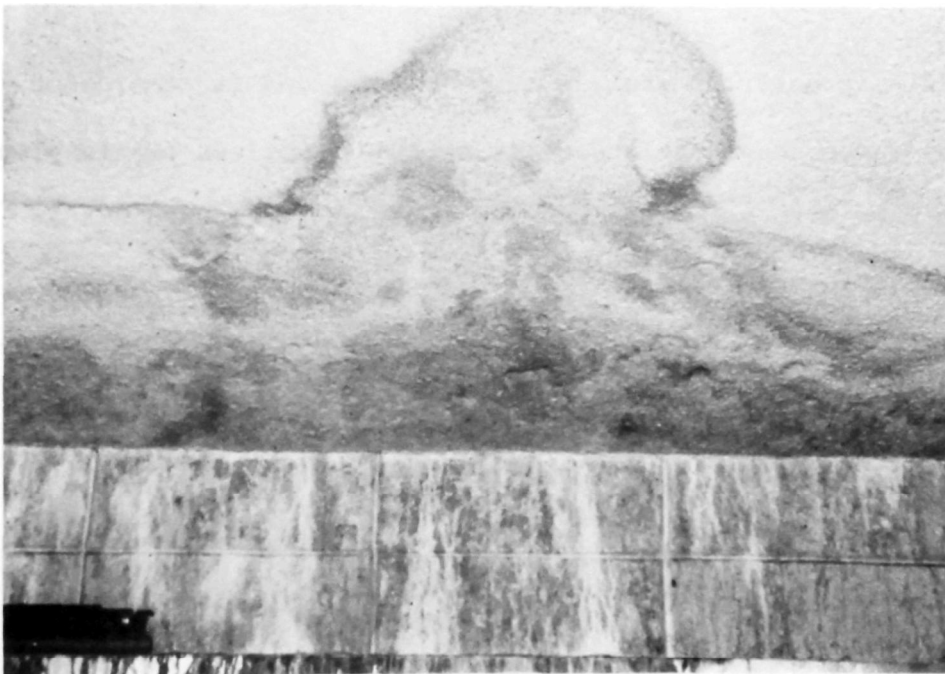
Water has leached asbestos fibers from the acoustical plaster ceiling, carried these fibers down the wall and evaporated leaving a deposit of asbestos fibers on the wall.

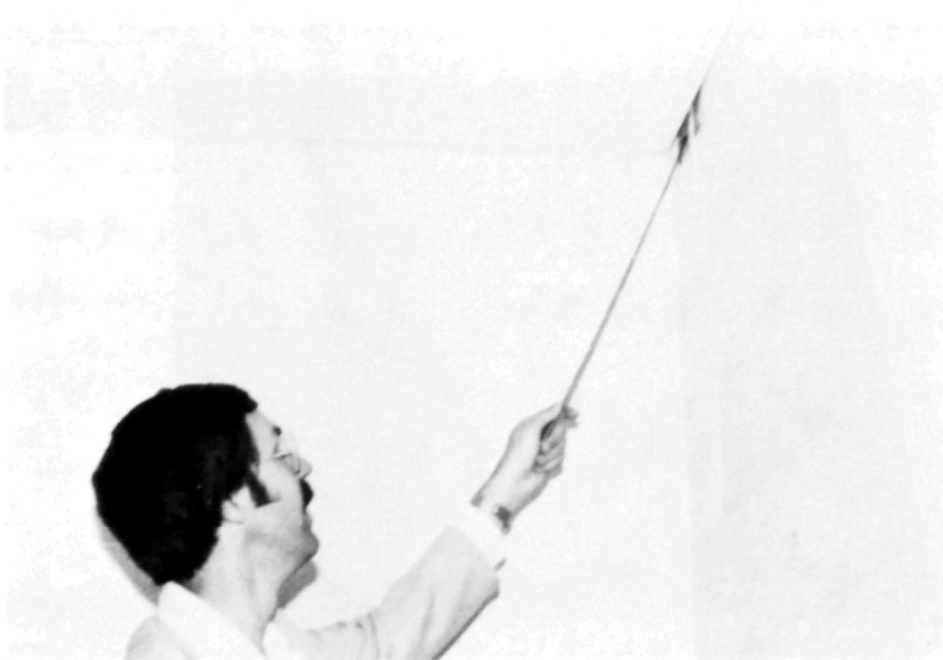
Space between  
suspended ceiling  
panels and wall.  
Asbestos-containing  
insulation above  
suspended ceiling.

Light difuser panel  
missing from sus-  
pended ceiling.  
Light recessed into  
asbestos-containing  
insulation.

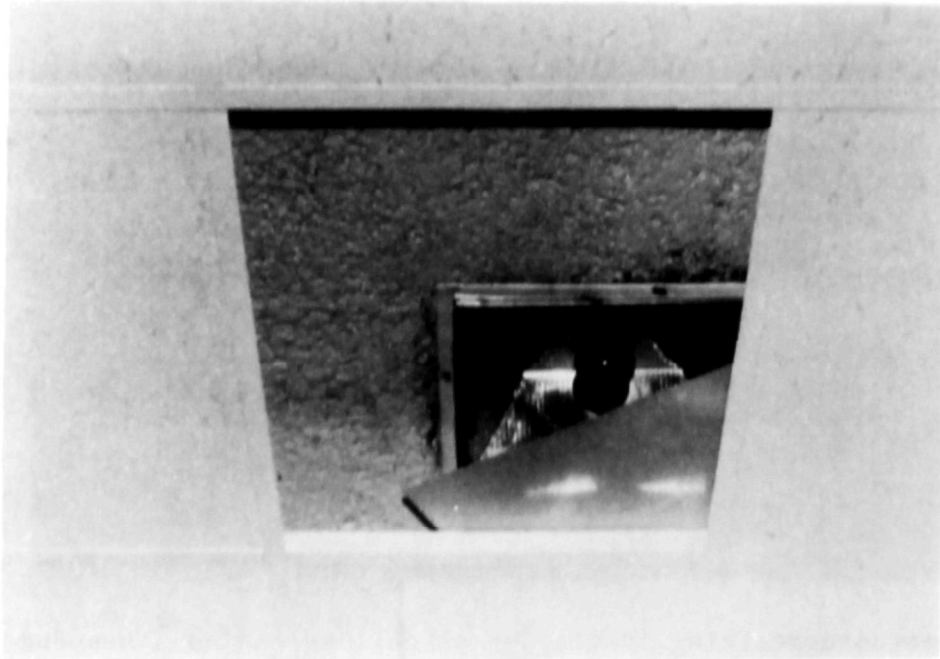
Light fixture recessed into asbestos-containing insulation. Space above suspended ceiling rarely entered, only for maintenance activities such as changing light bulbs.

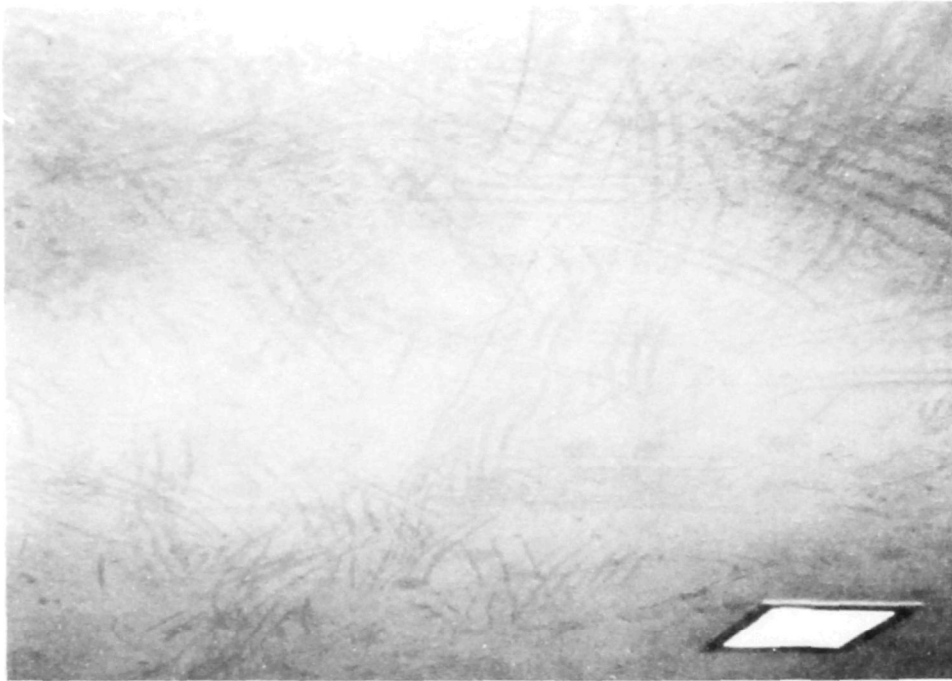
Look for evidence of contact and damage such as finger marks in acoustical plaster ceilings.

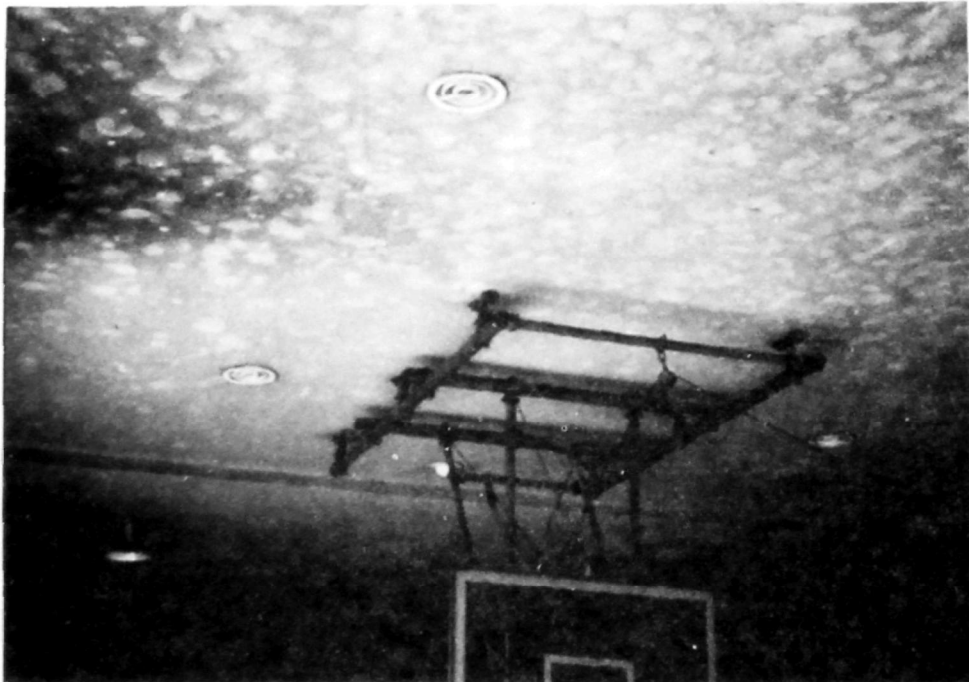
Although some ceilings may be more than 18 feet high, evidence of ball impact damage is observable on the ceiling.

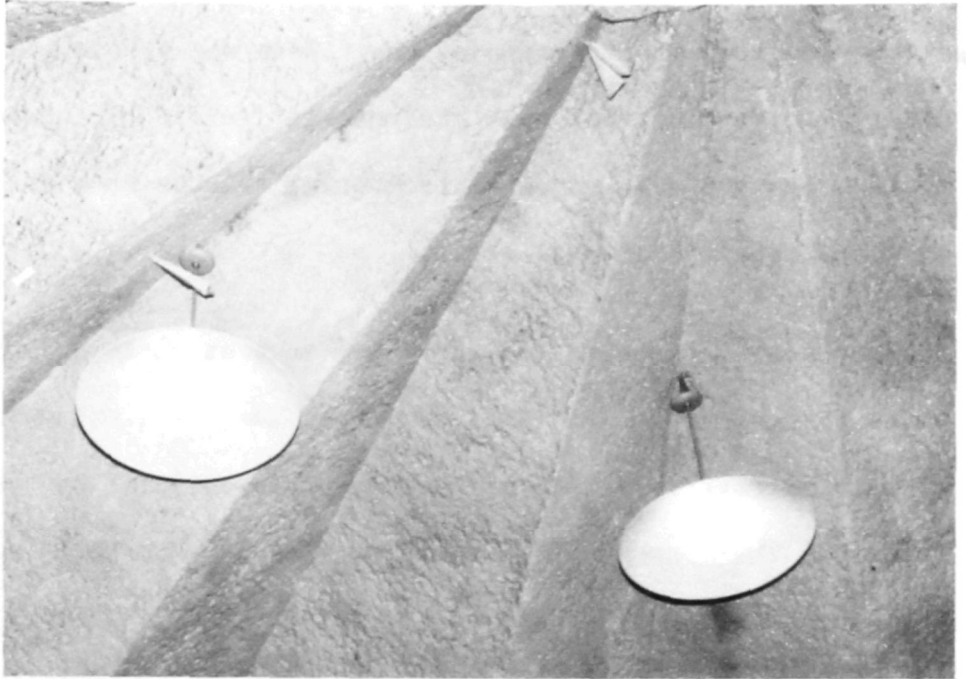
Although some asbestos-containing ceiling insulation may be out of the reach of building occupants, a ceiling is still considered highly accessible if items have been thrown at it. In many cases such items remain embedded in the insulation, as the paper airplanes in the photograph.

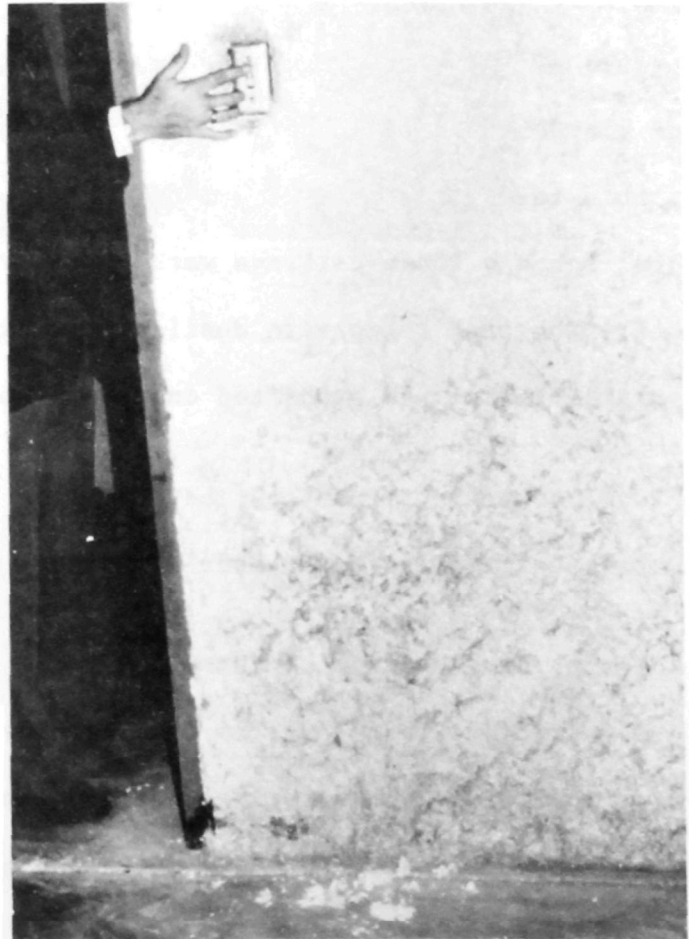
Another example of highly accessible, asbestos-containing insulation is wall coatings. Normal activities such as flipping a light switch can result in knocking pieces of the wall insulation to the floor.

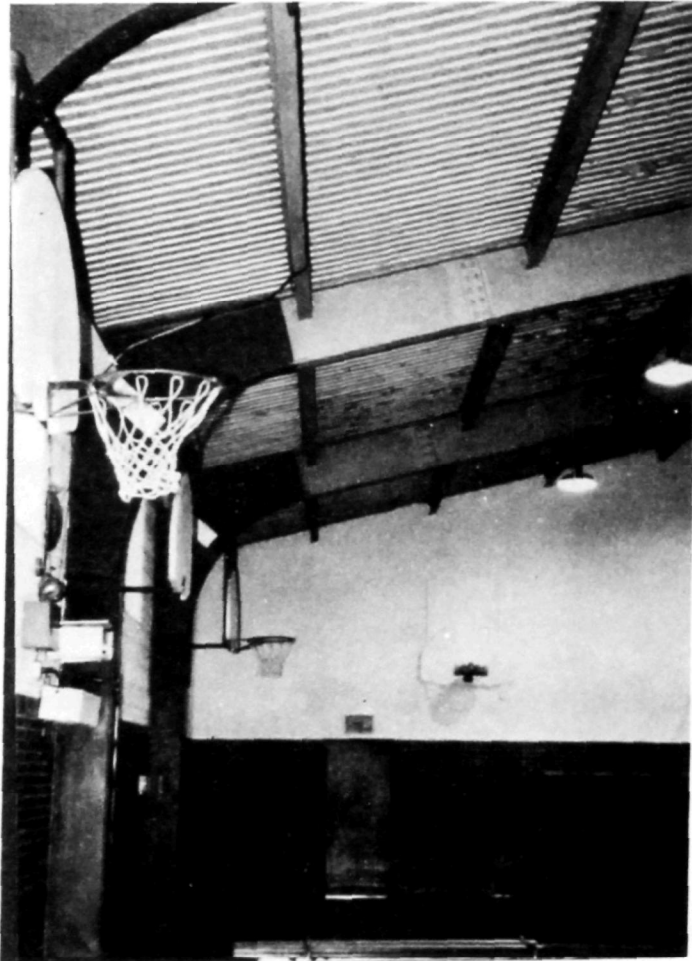
Gymnasiums are high activity level areas and ceiling damage is usually evident.

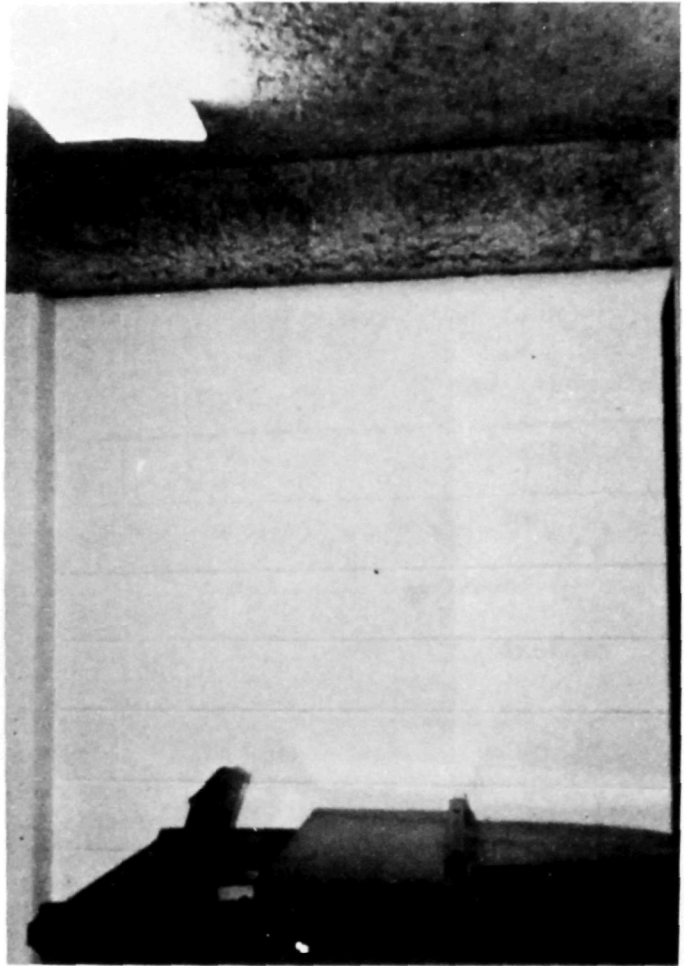
Although the activity level of the room occupants may be low, sound waves generated by the musical instruments may vibrate the asbestos-containing insulation and result in fiber release.

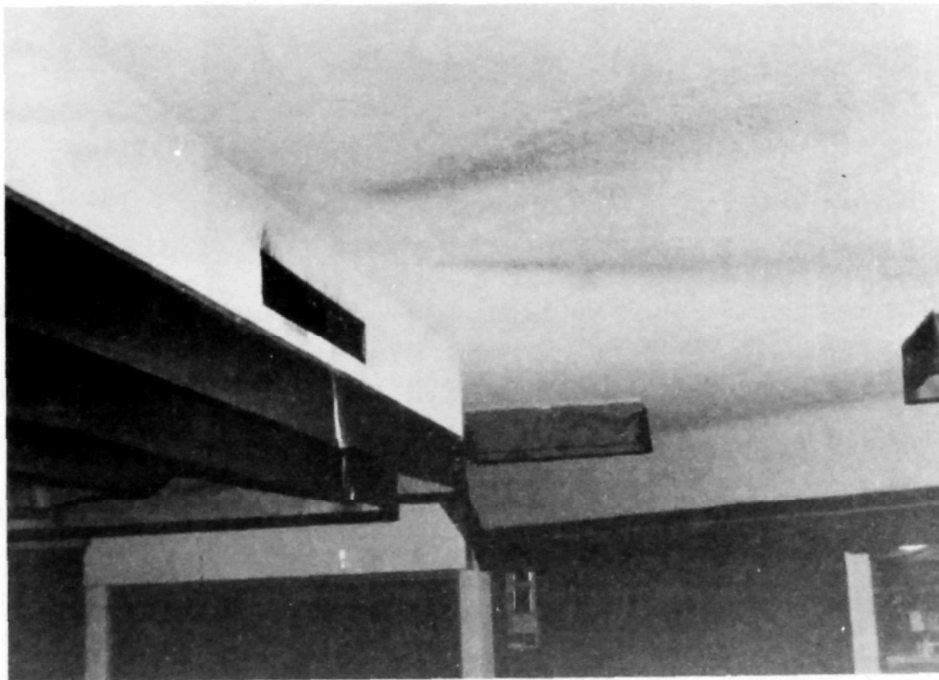
Look for air erosion patterns in the ceiling or wall coating.

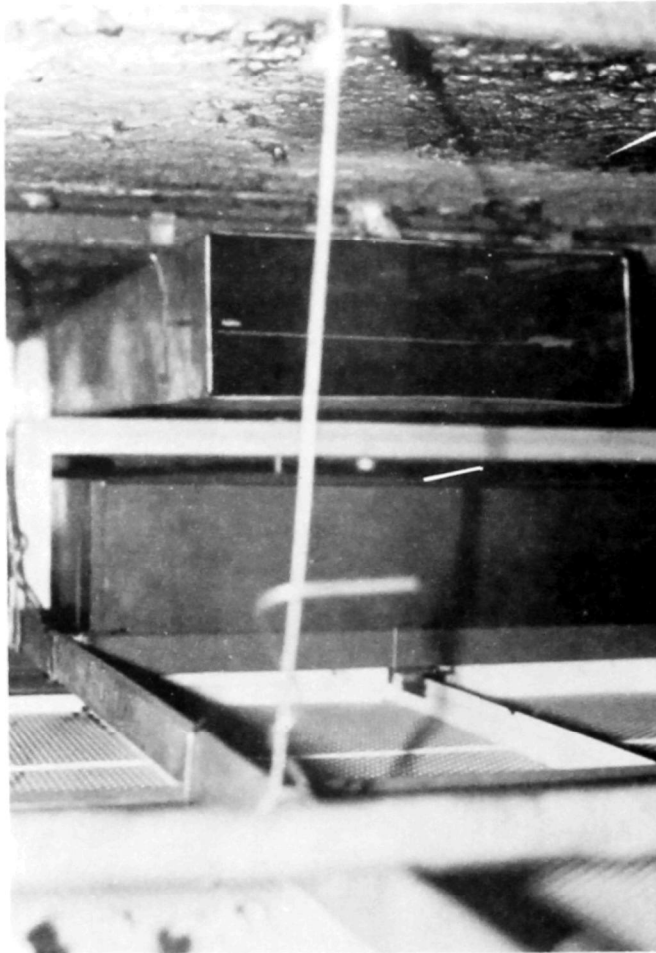
← Erosion Pattern in  
Asbestos Ceiling  
Insulation.

← Open End Air Duct

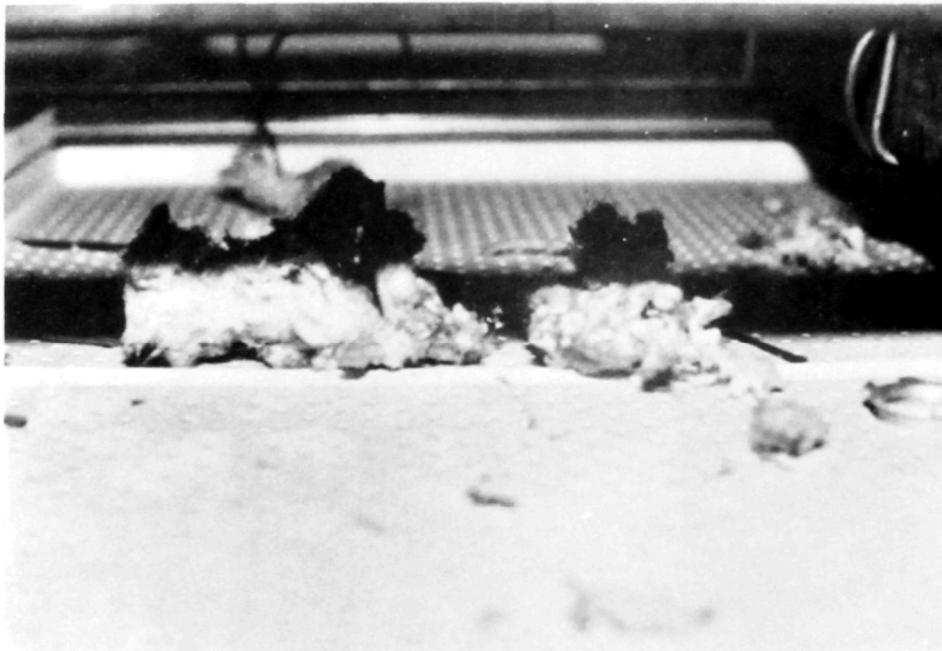
Insulation debris  
on ceiling tiles →

Air Plenum Space Above Suspended Tile Ceiling

← Asbestos-Containing  
insulation debris

← Perforated Metal  
Ceiling Tiles (Note  
numerous 1/8 inch  
holes in tiles)

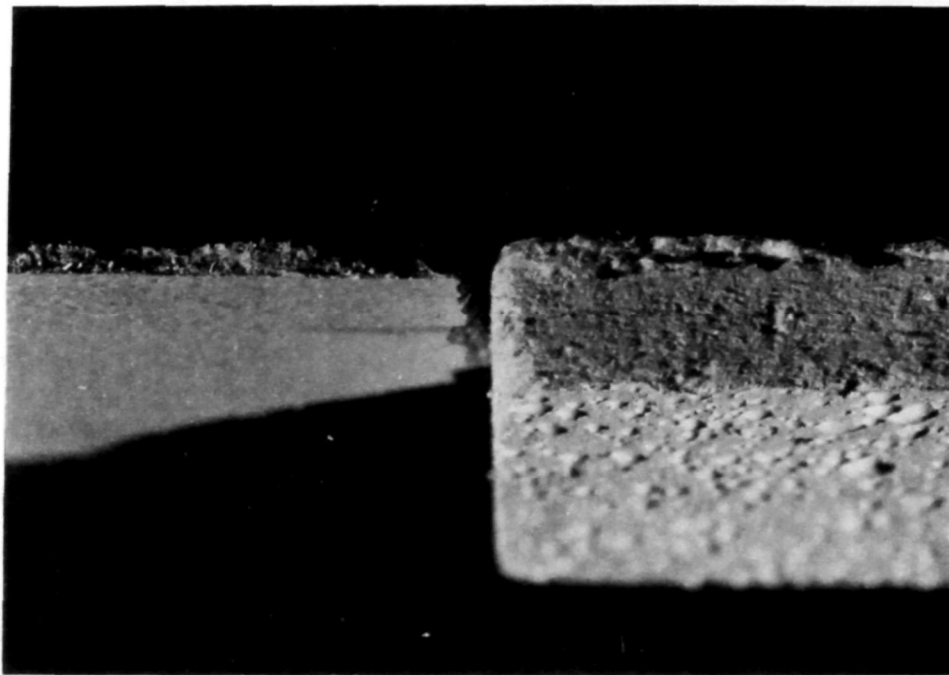
↑  
Asbestos-containing,  
1/8 inch thick, sus-  
pended ceiling tile.  
(End view of broken  
tile, note fibers.)

↑  
Non-asbestos, 1/2 inch thick,  
suspended ceiling panel.  
(End view)
