A STUDY OF COASTAL WATER QUALITY IN THE
VICINITY OF SAN JUAN, PUERTO RICO, JANUARY
13-31, 1971

Environmental Protection Agency
Water Quality Office
Southeast Water Laboratory
Technical Services Program
Athens, Georgia

February 1971

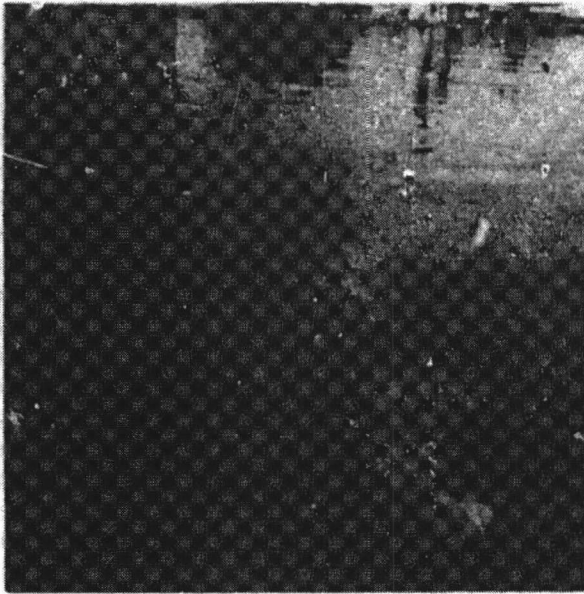
- 1) Oily discharge entering Condado Lagoon from Miramar side on January 13, 1971.
- 2) An oil slick 15 feet by 200 feet observed in San Juan Bay near the Army Terminal on January 13, 1971. Also floating and settleable solids and a brown film over half the upper bay on same date.
- 3) January 18, 1971--an oil slick, tons of floating debris, and a brown scum extending from Puerto Nuevo Channel to Point Cataño in upper San Juan Bay.

January 13, 1971
An Oil Slick 15'x200' in the
Vicinity of the Army Terminal Area

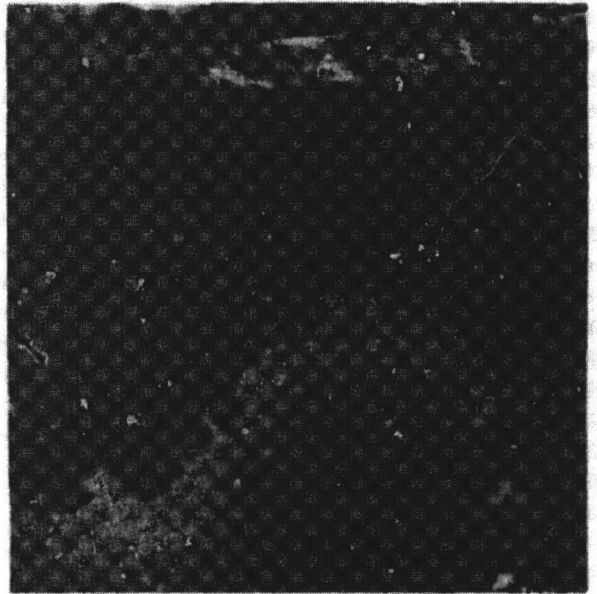
January 22, 1971
Oil in the Mosquito Control Canal
75' Before Mixing in San Juan Bay

Wastes from the Gulf Caribbean refinery are discharged into the mosquito control canal which enters San Juan Bay near Cataño (see Figure 1). Zero dissolved oxygen conditions were found at the mouth of the canal. Large quantities of oil also enter the bay from the canal.
