## Surface Infiltration Rates of Permeable Surfaces: Six Month Update (November 2009 through April 2010)

U.S. Environmental Protection Agency  
National Risk Management Research Laboratory  
Water Supply and Water Resources Division  
2890 Woodbridge Ave (MS 104)  
Edison, NJ 08837

This document outlines the methods and results of the surface infiltration monitoring of the permeable parking surfaces during the first six months of operation.

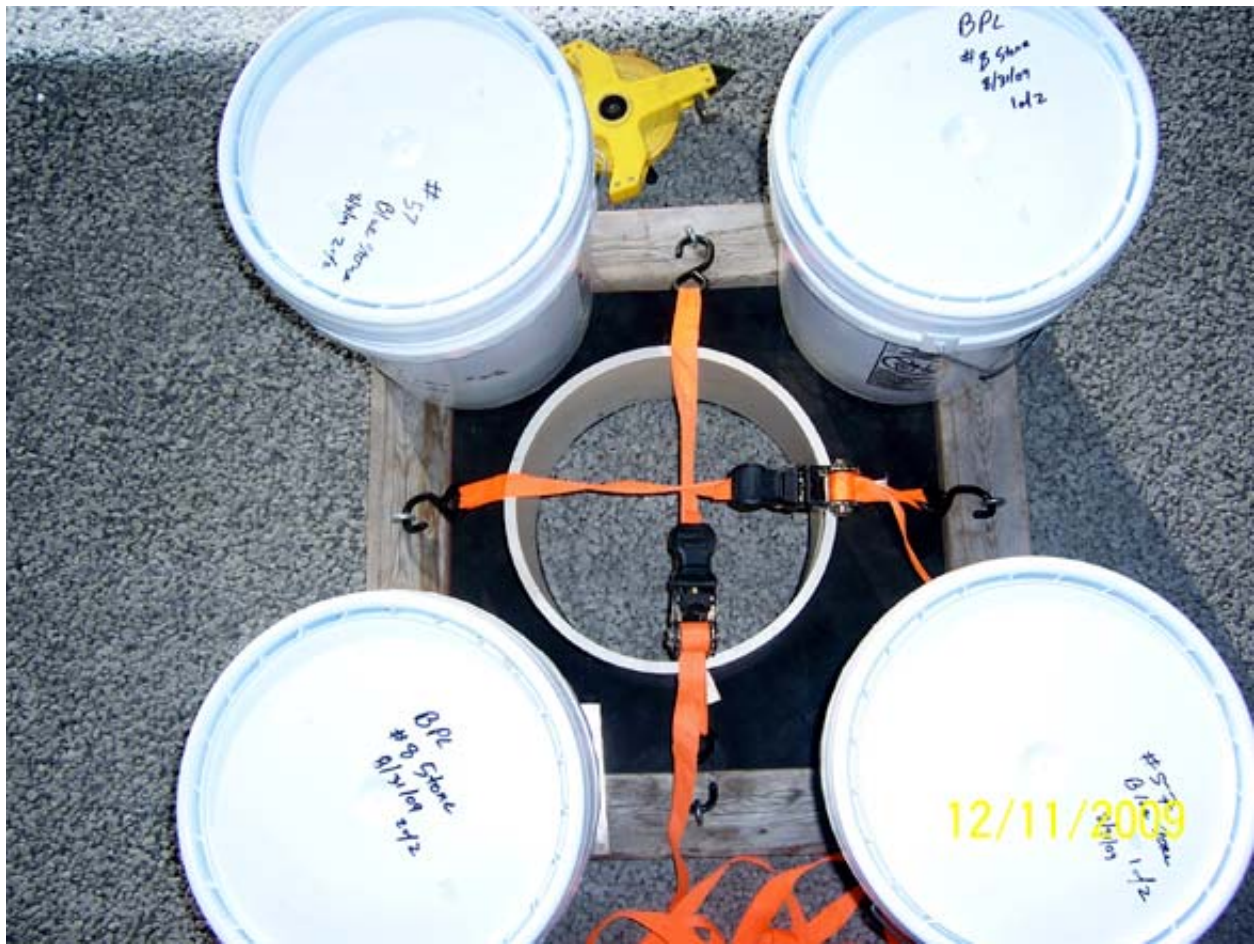
Figure 1. The weight of the 5-gallon buckets of stone applied to the PVC compresses the Neoprene sheeting to form a leak-free seal with the parking surface. Collectively the buckets weigh 150 to 200 kg.

Infiltration measurements were made following a modified version of the ASTM method C1701 (ASTM 2009). Although the method was developed specifically for porous concrete, this testing applies the same method to all three permeable surfaces. The sole modification was the sealing method between the 12-inch diameter PVC cylinder and the surface. The pipe used in this testing is 15 cm high with parallel black lines drawn 10 and 15 mm from the pipe bottom. This work substitutes ½-inch thick Neoprene sheeting compressed with applied weight (See Figure 1) for the plumbers' putty seal described in the ASTM method. The Neoprene sheeting is trimmed to align with the inside circumference of the pipe. The wooden frame holds 5-gallon buckets filled with stone. Tie-down straps spanning the PVC cylinder support the frame slightly above the parking lot surface. The weight of the buckets on the pipe compresses the Neoprene sheet to form a gasket with minimal leakage. When used on the pavers, additional Neoprene strips placed in the gaps between the individual paver blocks dam the openings. Similar sealing mechanisms have been used successfully by others (e.g., Bäckström and Bergström 2000; Bean 2007; Houle 2008).

After positioning the pipe and applying the weight, 3.60 kg of water is poured into the area isolated by the cylinder while keeping the water level between the two lines drawn on the interior during the pouring. The pipe is oriented so that the lines are at the lower (southern) side. The time required for the water to drain, called the prewet time, is measured and recorded. The time begins when the water first impacts the permeable surface and stops when water is no longer visible on the surface.

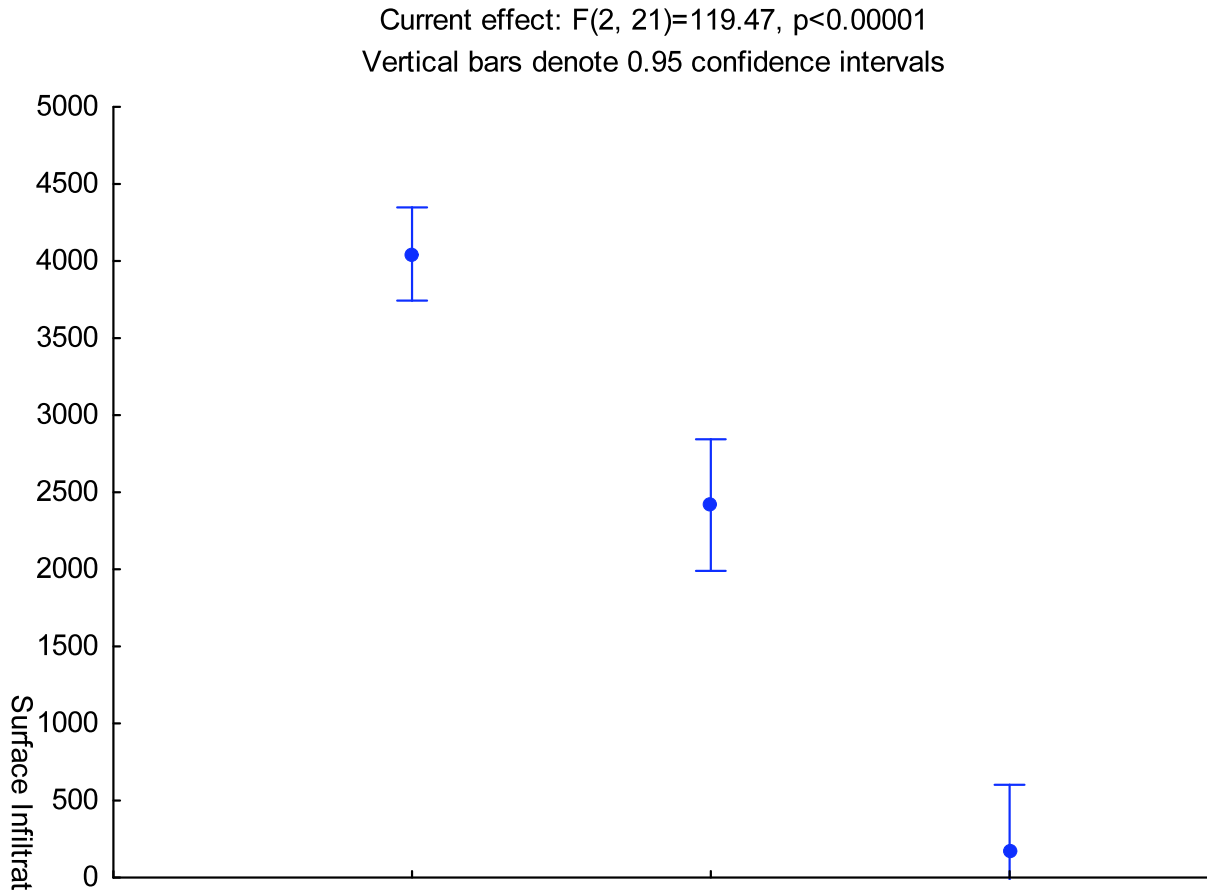
Figure 3 The ANOVA shows differences in the infiltration rate of the three surface materials. This analysis pools the porous concrete measurements across both rows.

The first hypothesis tests whether the surface infiltration rates vary from surface to surface. The ANOVA groups the two porous concrete rows into a single category and shows that the surface infiltration rates are significantly different ( $F(2, 21)=119.5$ ,  $p<<0.001$ ). The trend (observed unweighted means) is from porous concrete (4000 cm/hr) to pavers (2,400 cm/hr) to porous asphalt (200 cm/hr). Figure 3 shows the results for the three surfaces.

The data are highly variable with relative standard deviations usually exceeding 10% of the mean value. The confidence interval for the mean infiltration rate made on a given surface in a given month average 700 cm/hr and range from 480 to 900 cm/hr. This is partially attributable to the high infiltration rates making the measurement difficult to execute. Pouring 18 kg of water into the 12-inch diameter pipe while trying to maintain the water depth between the markings 5 mm apart in the pipe is awkward. The high variability will make it difficult to detect meaningful change. For example, the confidence interval for the porous asphalt does not exclude zero so, if current uncertainty levels continue, even complete blockage will not be statistically different from the current readings (see Figure 3 and Figure 5).

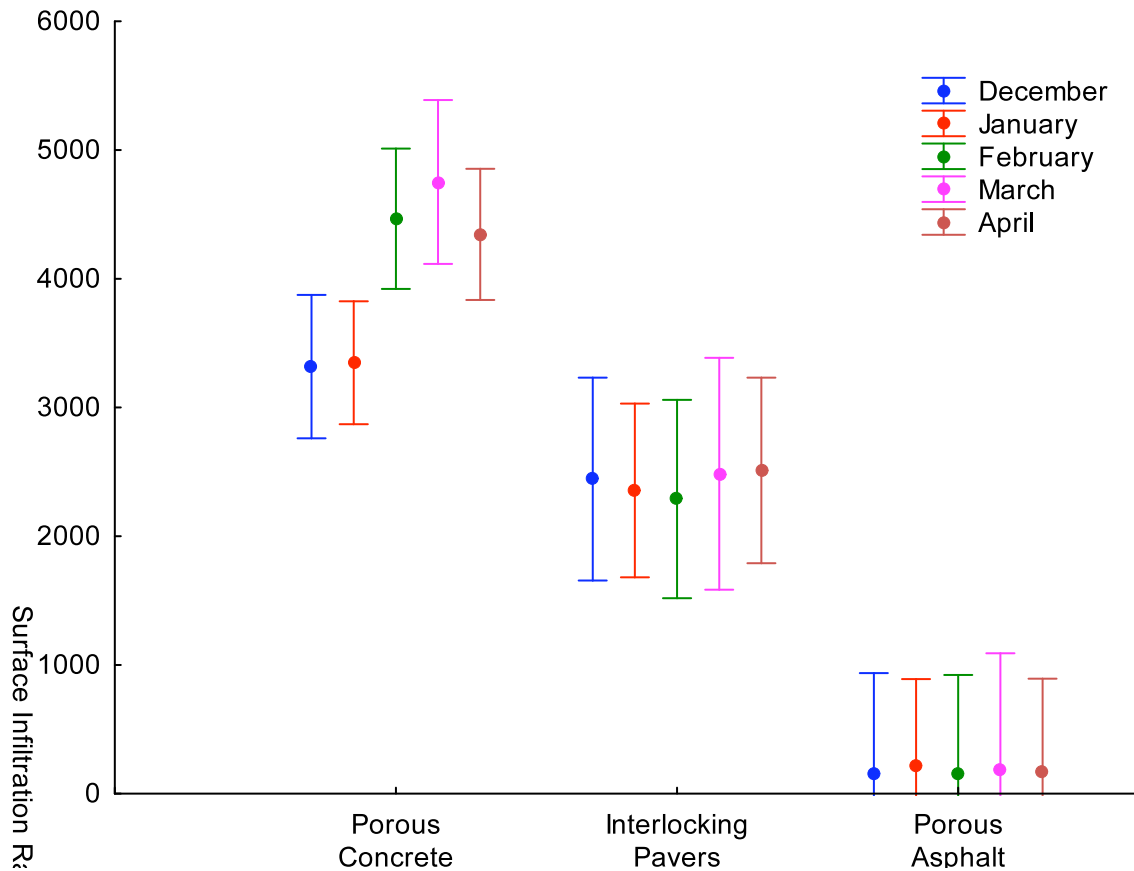
Figure 5. The monthly measured surface infiltration rate of each surface is shown above. This analysis pools the measurements from both rows of porous concrete. There is no change in the measured infiltration rates of the interlocking pavers or porous asphalt, but the infiltration rates of the porous concrete increase.

The measurements show no significant changes in the infiltration rate of the porous asphalt or the pavers during the monitored period. The porous concrete, however, shows a more surprising trend. The infiltration rates measured from February through April are larger than the December and January measurements. Figure 5 shows the monthly mean infiltration rate for each permeable surface.

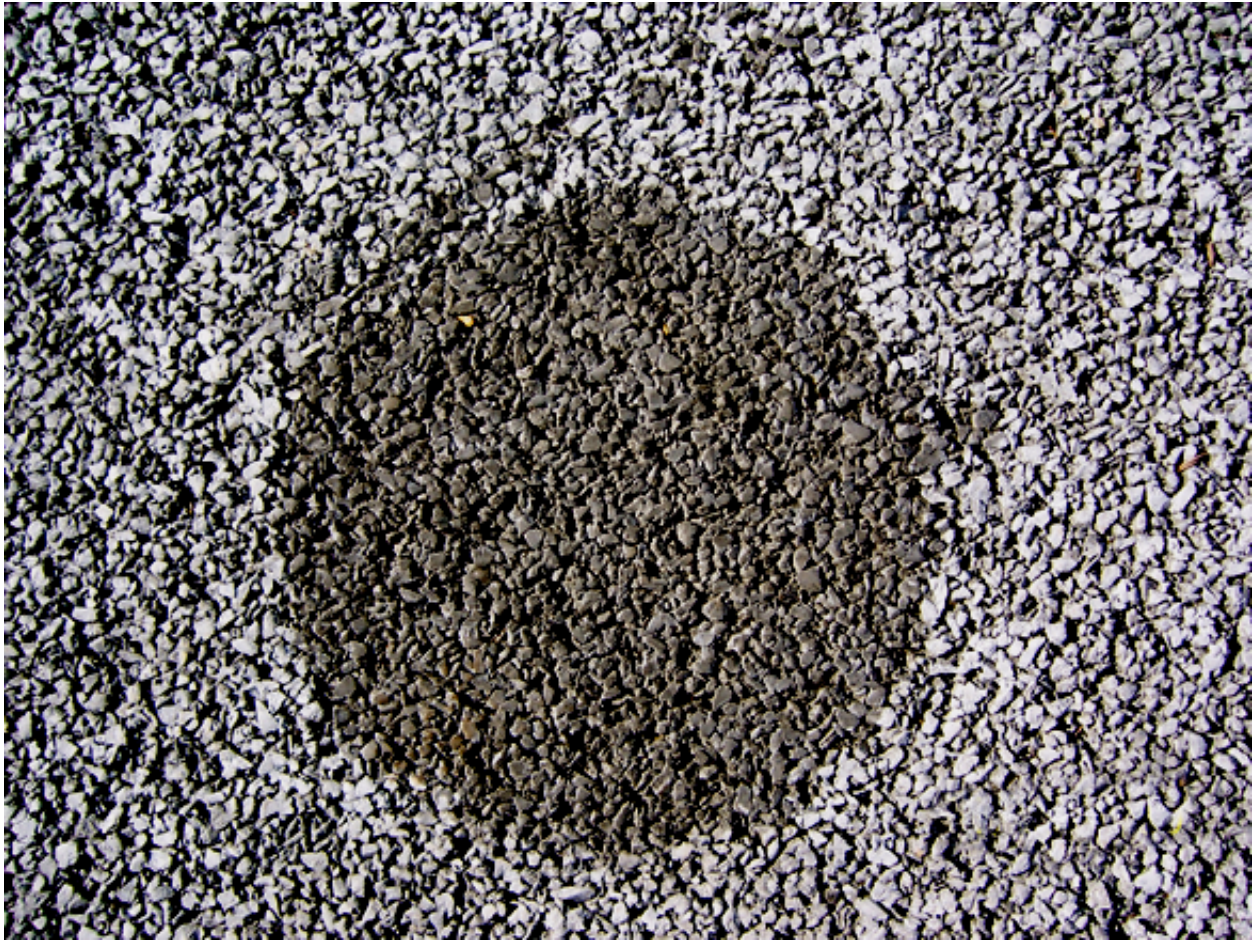
**Figure 6.** The wetted area after removing the test apparatus shows the limited leakage through the seal formed by the compressed Neoprene sheeting.

The compressed Neoprene sheet forms an effective seal that prevents leaks between the pipe and the parking surface. Minimal leakage was observed on the porous asphalt and nearly no leakage was observed on either the pavers or the porous concrete (see Figure 6).
