# Pilot Study of an Innovative Biological Treatment Process for the Removal of Ammonia from a Small Drinking Water System

**Summary Report:**

**Pilot Study of an Innovative Biological Treatment Process for the  
Removal of Ammonia from a Small Drinking Water System**

September 2012

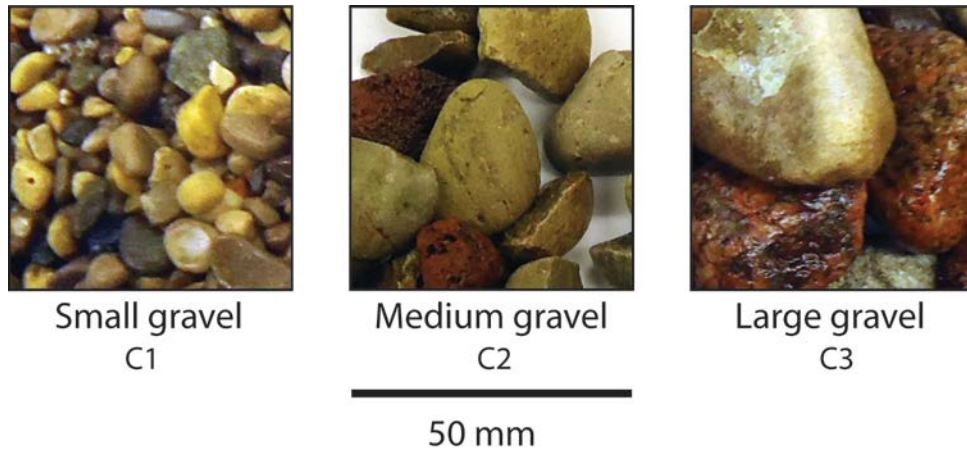
**Figure 3.** Three gravels used in the contactors of the piloted biological ammonia removal treatment technology system

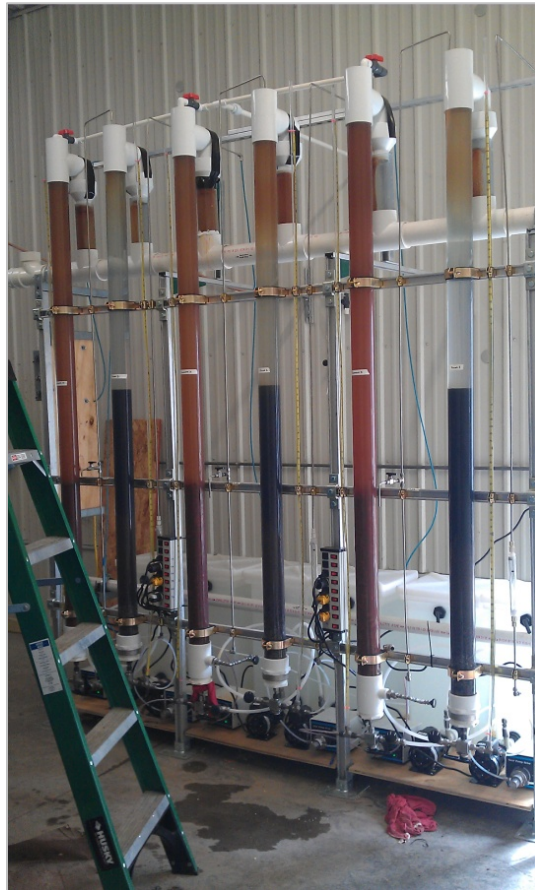
**Figure 4.** Pilot biological water treatment system for ammonia removal at the Iowa study site.

The pilot system (Figure 4) was operated on a continuous basis (24 hours per day, 7 days per week) with the exception of a few instances where pumps were replaced or other maintenance actions occurred (<24 hours downtime or the system was intentionally shut down to evaluate the impact of doing so) for over extended periods of time. Raw water from the small community's existing well and drinking water was not chlorinated or treated in any way prior to supplying the pilot system. Treated water and excess filter backwash water was routed to the on-site sanitary sewer.

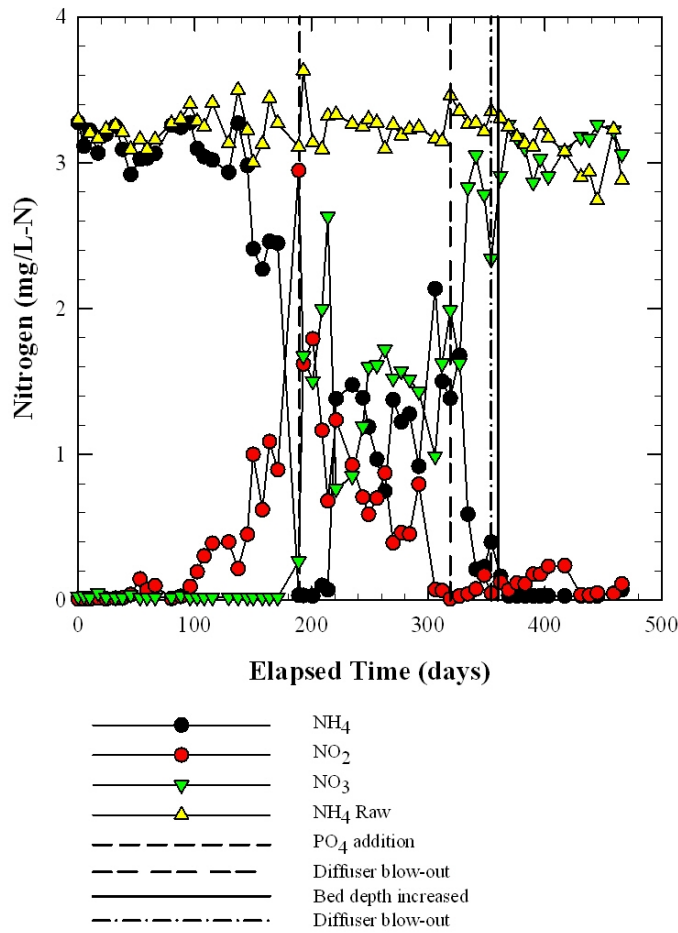
**Figure 5.** Nitrogen content of treated water from Contactor 1.

*Contactor 1/Filter 1.* Contactor 1 was operated for approximately 55 days before nitrite levels started to increase suggesting the initiation of the biological nitrification process within the contactor (Figure 5). The increase was brief, however, and nitrite only reached 0.2 mg N/L before the level suddenly dropped back to non-detectable (<0.01 mg N/L) (Figure 5). It was discovered that at 63 days, the pilot system inadvertently received chlorinated water as a result of inadequate or failed backflow prevention measures ahead of the pilot system, the extent and time-frame to which was uncertain. The presence of chlorine presumably halted biological activity in the contactor and, as a result, was attributed to the decrease of nitrite generation. Proper backflow prevention was installed immediately after the event.

Following plumbing modifications to address backflow issues, nitrite levels began to increase again by 95 days (Figure 5). Nitrite steadily increased to a peak of 0.4 mg N/L by 140 days. A similar decrease in ammonia through the contactor over the same time period was observed. No nitrate was produced in the contactor during this time.

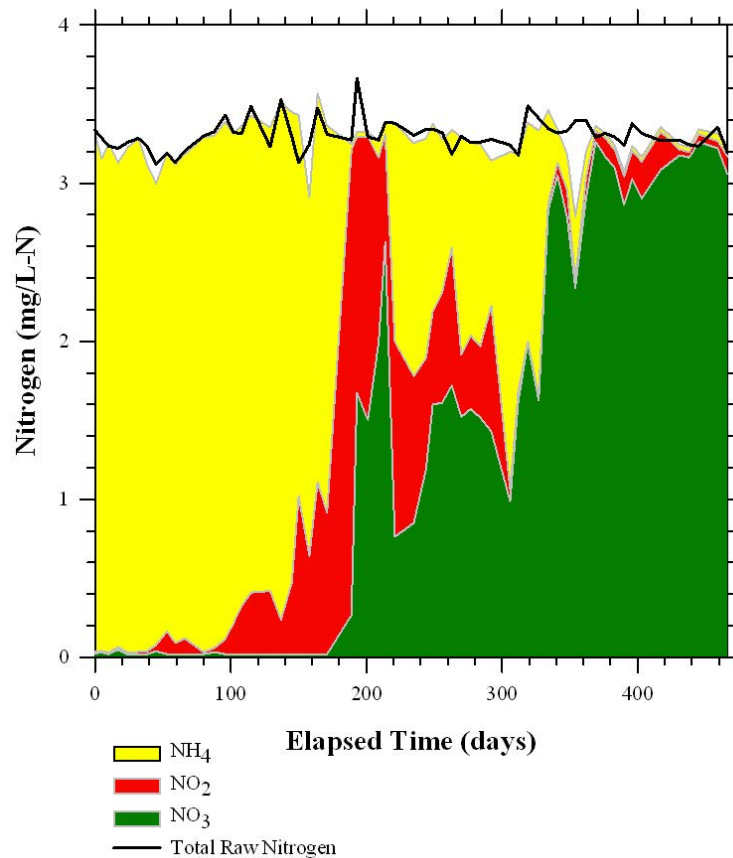
**Figure 7.** Contactor 1 nitrogen mass balance between influent and effluent.

Clearly, the filter improved overall water quality by polishing contactor effluent. Most notably, comparison between Figures 7 and 9c indicate the degree to which nitrate formation was enhanced in the filter effluent (more green shaded area).

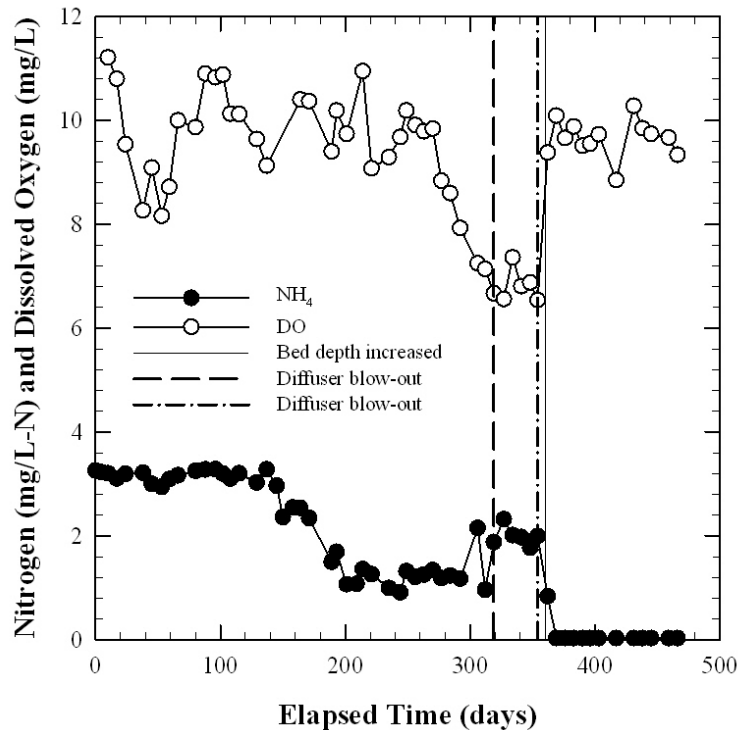
Figure 12. Contactor 2 effluent ammonia and DO.

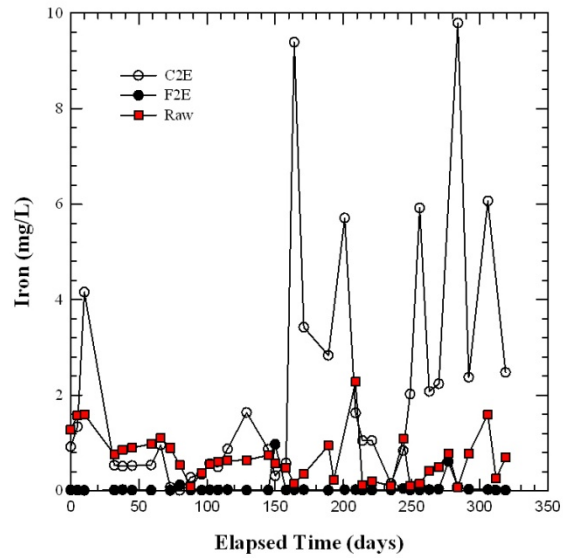
Figure 15. Iron in raw water and treated water through Contactor 2 and Filter 2.

Iron removal through the filters was not impacted by filter loading rates (Figures 14 and 15). Filters were operated between 0.5 gpm/ft<sup>2</sup> (1.2 m/hr) and 2.2 gpm/ft<sup>2</sup> (5.4 m/hr). Filter flowrates had to be lower than contactor flowrate due to limitations in pilot design. At the completion of the study, Filter 1 was operated at a loading rate of approximately 2 gpm/ft<sup>2</sup> (4.9 m/hr).

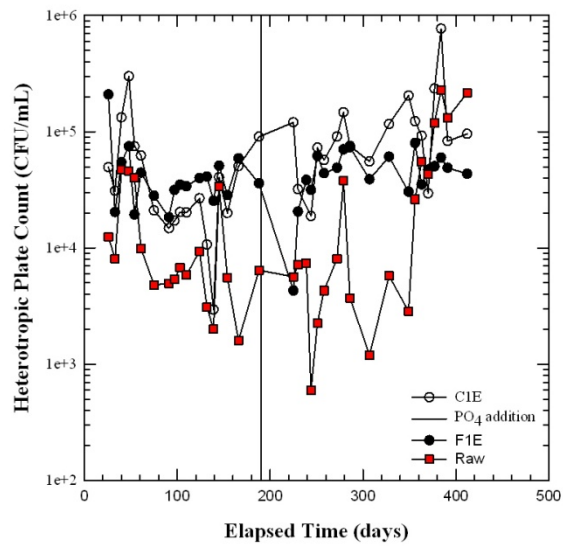
Figure 18. Heterotrophic plate counts (HPCs) in raw, Contactor 1 effluent and Filter 1 effluent.
