EPA/600/R-14/195 | September 2014 | www.epa.gov/ord

# Engineering Technical Support Center Annual Report Fiscal Year 2013

# Technical Support and Innovative Research for Contaminated Sites

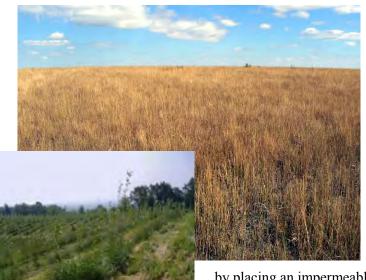
Figure 9: Examples of Evapotranspiration Covers

by placing an impermeable sediment cap over a landfill or other contaminated site, then placing a layer of topsoil selectively seeded with native grasses, shrubs and trees that will grow on the surface. Figure 9 provides examples of successfully installed evapotranspiration covers.

An <u>evapotranspiration (ET) cover</u> uses plants and soil to capture rainfall to later return it to the atmosphere by evaporation and transpiration, which limits the amount of moisture reaching the contaminated area. Although ET covers are used more extensively for landfill applications, another potential use is to attenuate or remediate volatile contaminants present in low concentrations at Brownfields or other legacy contaminated sites. Therefore, if designed properly, this method can provide both a remediation and restoration solution in one effort. An ET cover starts

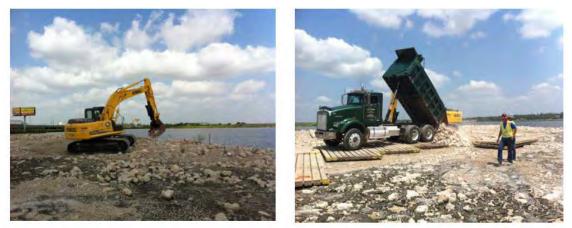
Figure 30: Repair activities to the armor cap at the San Jacinto Waste Pit Superfund Site in 2012.

To prevent surface water infiltration and human/benthic contact on the site, EPA installed temporary caps to stabilize the waste pits in 2010 until the remedial investigation and feasibility studies were carried out. In 2012, pore water sampling within the surface of the caps found the caps successfully contained the contaminated material. In July 2012 some erosion of the armor rock was seen on the west side of one of the caps. The underlying geotextile was intact, and there was no visible exposure of the waste material in the waste pits. Maintenance of the cap consisted of placing new armor rock material that is denser than the material originally specified for this area. The repair work was performed in August, 2012 (Fig. 30). ETSC provided support to the region in the form of comments/input on the Superfund cleanup plan

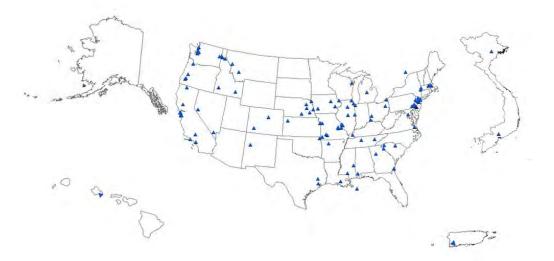
In FY 2013, the ETSC received 189 unique technical support requests (see Figure 37). One-hundred fifteen of those requests fulfilled Superfund related issues (74% of total sites serviced), and 66% of those Superfund sites were listed on the National Priority List. The ETSC also serviced 24 RCRA, two Brownfields and three international sites, including two sites in Vietnam and one in Canada. In 2013, the ETSC also provided support to sites located in Alaska, Hawaii and Puerto Rico.

Figure 37: Map of ETSC FY2013 Technical Support Requests including sites in Vietnam, Canada, Alaska, Puerto Rico, and Hawaii.
