**Engineering Design and Operation Report:**  
**Biological Treatment Process for the Removal of Ammonia from a**  
**Small Drinking Water System in Iowa: Pilot to Full-Scale**

**Darren A. Lytle, Dan Williams, Christy Muhlen, Maily Pham, Keith Kelty**

U.S. Environmental Protection Agency,  
Office of Research and Development  
National Risk Management Research Laboratory  
Water Supply and Water Resources Division  
26 W ML King Drive  
Cincinnati, Ohio 45268, United States

September 2014

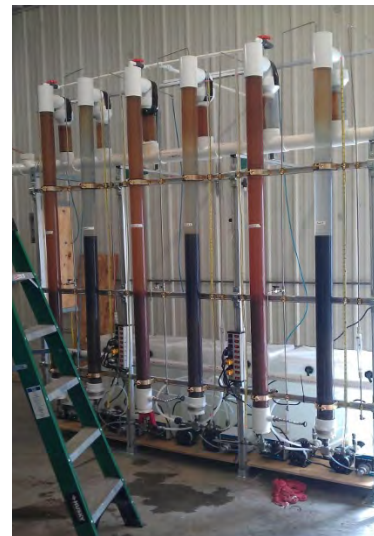
**Figure 3.** Pilot biological water treatment system for ammonia removal at the Palo, Iowa study site.

The pilot system was designed and built by EPA staff, and installed in March 2011 (Figure 3). In a collaborative effort, EPA and Palo staff coordinated system operation and maintenance, as well as water sample collection and analysis. The system consisted of a column making use of an aeration contactor approach (1.4 to 10 mg-N/L) followed by a granular filter in series. Saturated oxygen levels were maintained throughout the contactor and minimal backwashing was needed. This pilot system was operated on a continuous basis (24 hours per day, 7 days per week) with the exception of a few instances where pumps were replaced or maintenance actions occurred (Lytle et al., 2012). After 360 days of running, a second contactor was placed in the series to study the effect of doubling the bed depth.

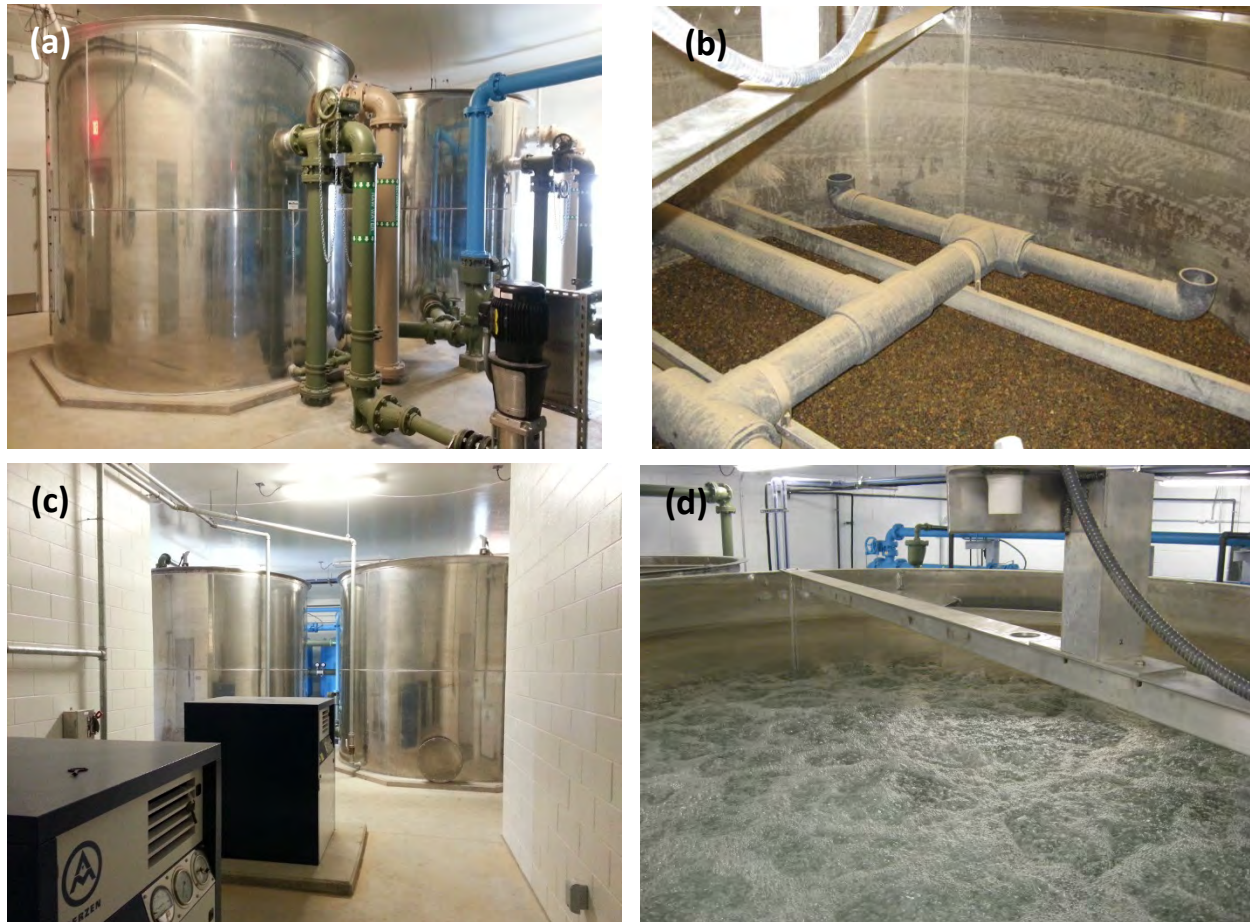
**Figure 6.** Photographs of (a) aeration contactors, (b) contactor media and piping, (c) aeration contactors and air blowers, and (d) aerated contactor surface.

**2.3.1 Aeration Contactor Design.** The treatment plant used two cylindrical aluminum up-flow aeration contactors (Figure 6a) (designated as contactor 1 and 2) configured in parallel. Each contactor was 10.5 ft (3.2 m) in diameter and 10 ft (3.05 m) high, and filled with 45 inches (114 cm) of gravel with effective size of  $\frac{1}{4}$  inch (0.65 cm). Air was delivered to the bottom of the contactor at a rate of  $1.5 \text{ cfm/ft}^2$  ( $0.40 \text{ m}^3/\text{m}^2$ ) through a network of non-clogging, horizontally-slotted plastic distributors (Figure 6b) using a Delta rotary positive displacement blower unit (Figure 6c). Each contactor has a dedicated blower, however, both blowers can direct air flow into one contactor during the backwash process to increase air, scour the media and dislodge any trapped sediment or loose biomass.

Raw water was pumped into the bottom of the contactor at a rate of  $2.2 \text{ gpm/ft}^2$  ( $5.6 \text{ m}^3/\text{hr}$ ), although under normal operation water is pumped at a rate of  $1.7 \text{ gpm/ft}^2$  ( $4.3 \text{ m}^3/\text{hr}$ ) so that water flow is upward and co-current with the air flow. This configuration differed from the pilot (counter-current operation), but was thought to reduce any likelihood of flow restrictions or blockages through the contactor. Similar pilot studies performed elsewhere in Iowa at the time of design showed no difference in performance between counter- and co-current contactor operations (Lytle, et al., 2014a). Contactors can be backwashed with raw water if necessary at a rate of  $15 \text{ gpm/ft}^2$  ( $0.63 \text{ m}^3/\text{min}$ ) for 7 minutes. This backwash condition will not expand the bed but remove loosely attached particles and biofilm from the

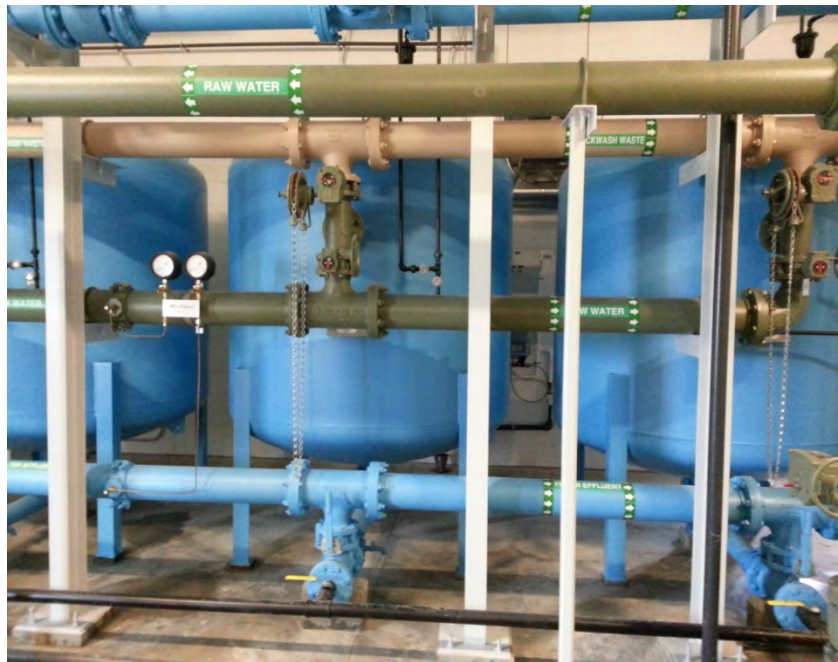
**Figure 7.** Photograph of pressure filters.

**2.3.3 Filter Design.** The treatment plant used three parallel 100 gpm (378 L/min) dual media steel pressurized tanks (100 psig) (689.5 kPa) (designated as filters 1, 2, and 3) and operated at a loading rate of 2.2 gpm/ft<sup>2</sup> (5.6 m/hr). The filter design differed from the pilot in that the pilot filters were operated under gravity feed. Pressurized filters are commonly used in the region to remove iron and, although not evaluated for ammonia removal, were not anticipated to be detrimental. The filters were designed to be biologically active, and provide additional ammonia and nitrite oxidation should the contactors not sufficiently address the ammonia load from the raw water. Each filter was 6 feet, 6 inches (198 cm) in diameter and 5 feet (152 cm) high, and contained 20 inches (51 cm) of anthracite (0.04 inch [0.1 cm] effective size) over 10 inches (25 cm) of sand (0.018 inch [0.046 cm] effective size) (Figure 7).

The filter backwash design rate is 17 gpm/ft<sup>2</sup> (0.72 m/min) to achieve 50% filter bed expansion for 15 minutes. The frequency of backwash was established during full-scale operation to only be once per three weeks such that only one filter was backwashed per week. Filters were backwashed with finished chlorinated water. Filters were backwashed with non-chlorinated water in the pilot to avoid destroying the nitrifying biofilm. The backwash procedure in the full-scale system will be examined to identify

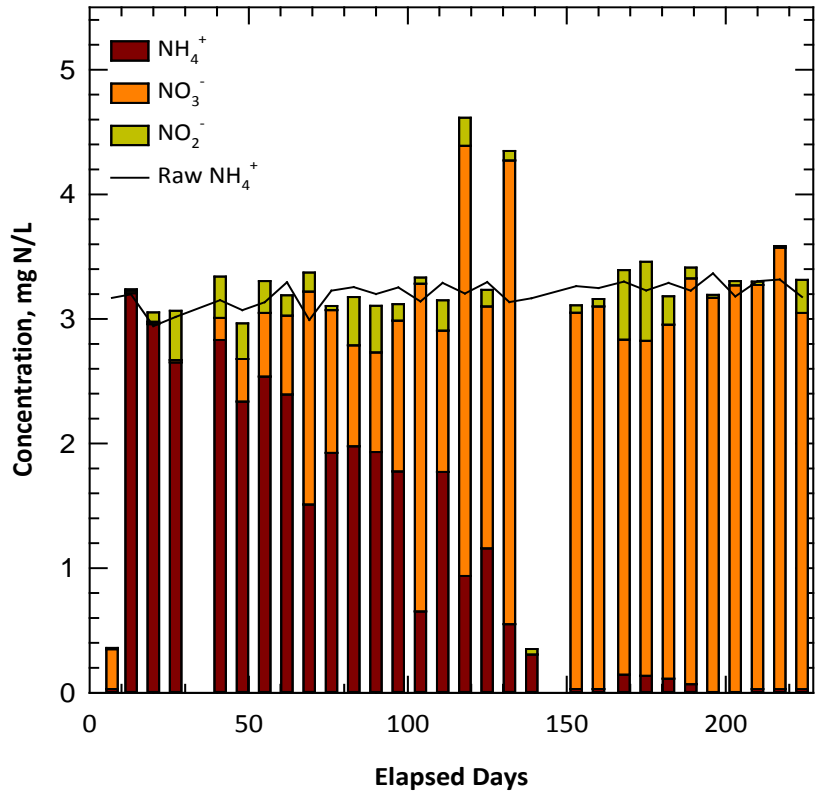
In general, the patterns and progression of nitrification in the filters paralleled the contactors (Figures 12 to 14). Additional oxidation of the ammonia and nitrite from the contactors was observed. Ammonia levels in all filters gradually decreased with time up to approximately 138 days. After 138 days, ammonia levels in all filters dropped to very low levels for the remainder of the data collection period. Nitrite on a few rare occasions reached as high as 0.7 mg N/L, but typically were very low. The filters improved overall water quality by polishing contactor effluent. The finished water ammonia, nitrite and nitrate values paralleled the filters and reflected the combination of all three (Figure 15). Nitrite levels in the plant finished water never approached the drinking standard of 1 mg N/L.

**Figure 12.** Nitrogen balance in filter 1 effluent (ammonia failed quality check on day 34 and nitrate failed on day 139).

**Figure 13.** Nitrogen balance in filter 2 effluent (ammonia failed quality check on day 34 and nitrate failed on day 139).

**Figure 14.** Nitrogen balance in filter 3 effluent (ammonia failed quality check on day 34 and nitrate failed on day 139).
