# **National Database Structure for Life Cycle Performance Assessment of Water and Wastewater Rehabilitation Technologies (Retrospective Evaluation)**

**Erez Allouche, Ph.D., P.E., Shaurav Alam, Ph.D.,  
and Ray Sterling, Ph.D., P.E.**  
Trenchless Technology Center at Louisiana Tech University

**Contract No. EP-C-11-038  
Task Order No. 1**

**U.S. Environmental Protection Agency  
Urban Watershed Branch  
National Risk Management Research Laboratory  
Water Supply and Water Resources Division  
Edison, NJ 08837**

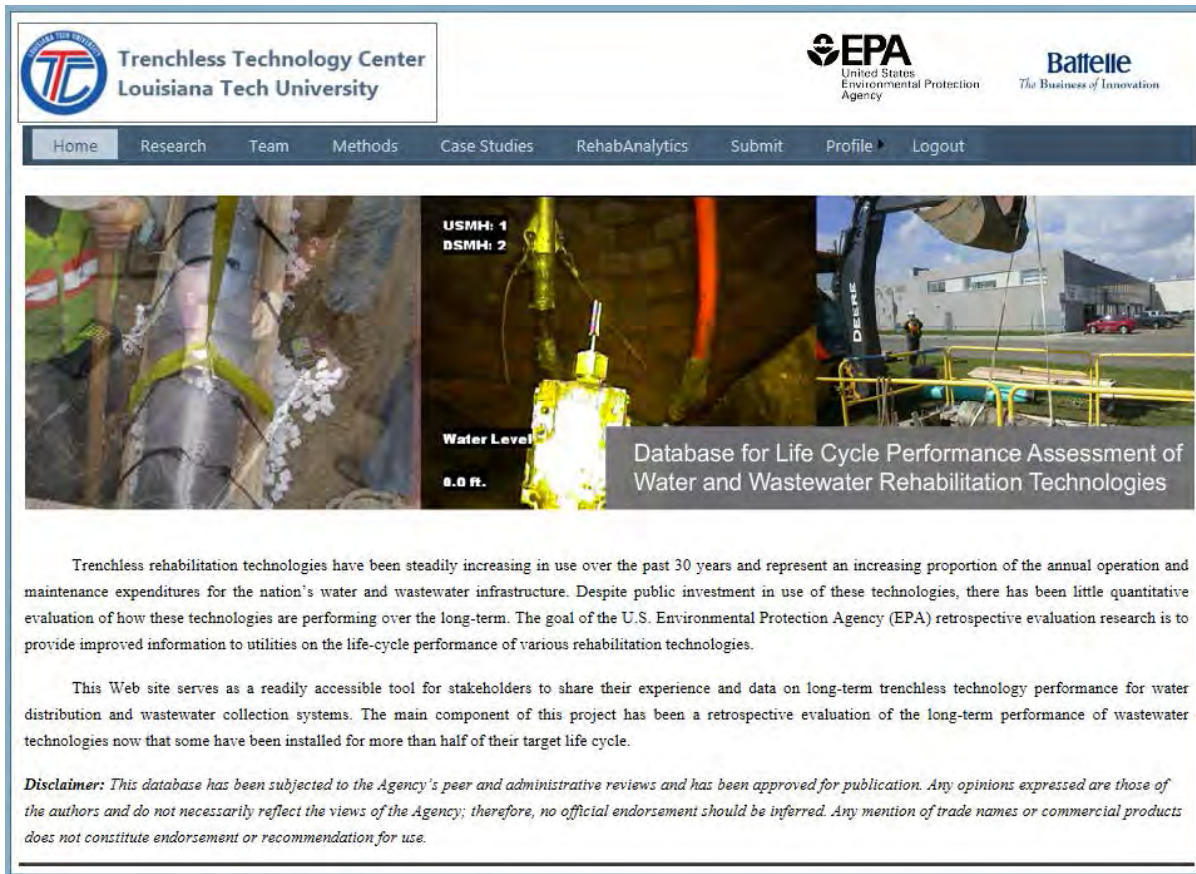
**Figure 2-1. Home Page of the Database Web Site**

After successful login, the user will be directed to the home page where a brief description of the project is given. As shown in Figure 2-1, the Web site housing the database consists of the following Web pages:

- Home Page,
- Research Page,
- Team Page,
- Methods Page,
- Case Studies Page,
- RehabAnalytics,
- Submit, and
- Account Profile/Login.

Under the *Research* Web page, the overall research objectives for the retrospective study are explained, along with information about the database. The participants on the research team from Battelle Memorial Institute and the TTC, Louisiana Tech University are presented under the *Team* Web page, along with acknowledgments of the participating cities.

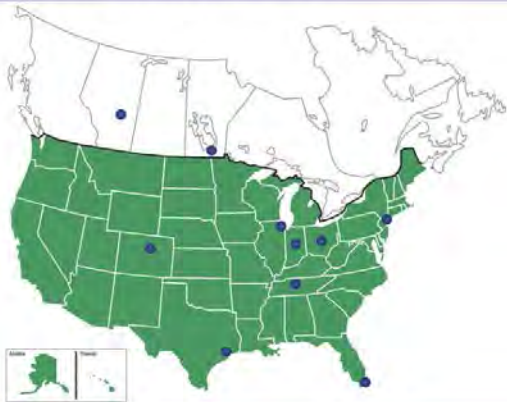
## Figure 2-3. Retrospective Case Studies Included in the Database

Retrospective evaluation specimens were collected from different physical locations across North America. In the *Case Studies* tab, access to information and data about the rehabilitation case studies is provided (see Figure 2-3). The data related to each sample were labelled following the naming scheme “Name of the City – Diameter of the Host Pipe – Year of Installation.” For example, NYC-15-1989 stands for the test results for the CIPP liner sample installed in a 15-in. diameter sewer line in 1989 from New York City. From this Web page, the user can select a rehabilitation method and download the testing data into a Microsoft® Excel format for review and analysis. The user can select a specific case study to review or select to download all of the data for a particular rehabilitation method. The data downloaded are all of the available raw data.

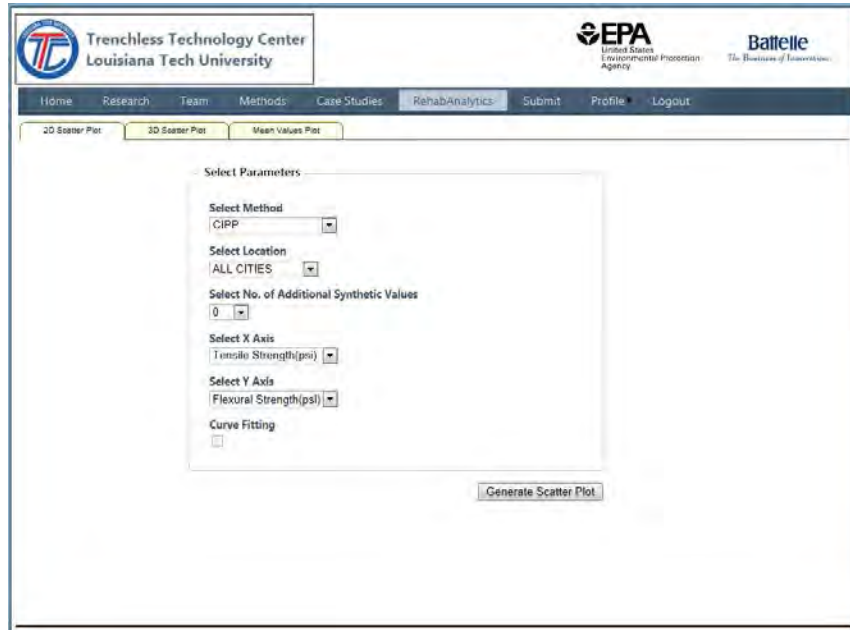
**Figure 2-7. RehabAnalytics Generation of Synthesized Values in the Database**

Within *RehabAnalytics*, the user can then decide whether or not to utilize this statistical approach by selecting “0,” “50,” “100,” or “500” for the number of synthetic values to be generated (see Figure 2-7). For each set of synthetic values generated, the positions of the unpaired values within the distribution of the data are randomly selected. The “0” mentioned in the dropdown box (see Figure 2-7) indicates that no synthetic values are generated and only “paired” values are plotted. A comparison of “0” synthetic value and “100” synthetic values for HOU-21-1996 is shown in Figure 2-8. Both plots indicate the increasing trend of flexural strength when compared to the tensile strength. It is expected that this synthetic data addition process yields more understandable and consistent visualization of the data in the database, but the user also has the option to download the raw data and use this to create their own plots from the database.

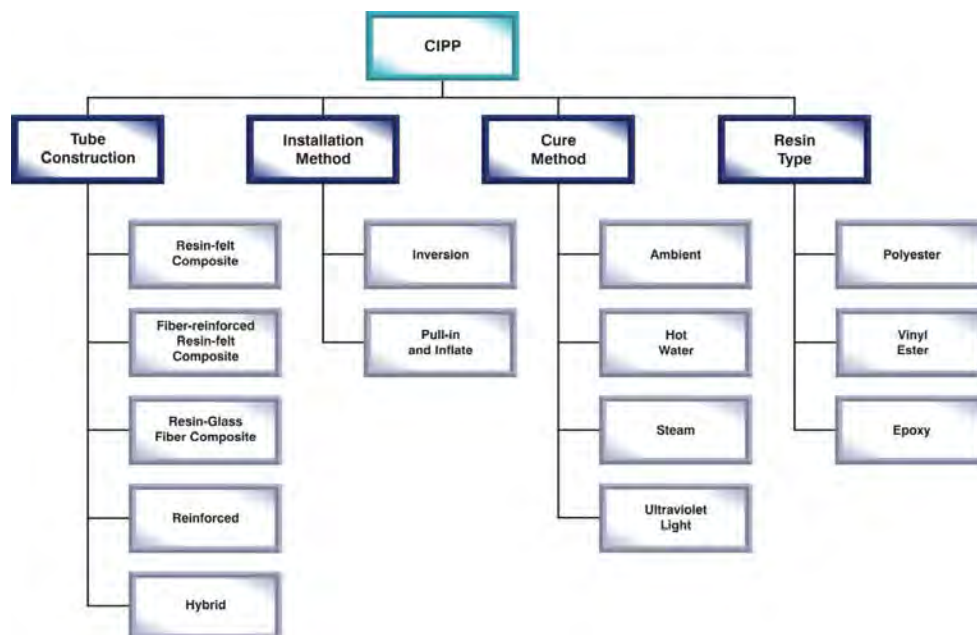
Figure 3-1. Summary of Common CIPP Technologies

CIPP lining involves the impregnation of a liner fabric with a resin either in a factory setting or on site. The saturated fabric contained within one or more sealing layers is then introduced into the host pipe that is to be rehabilitated. Once the liner is in place, it is cured using either heat or ultraviolet (UV) light, depending on the formulation of the resin used. The resulting cured liner provides a close-fit, high-strength lining to the host pipe and is typically designed to extend the life of the host pipe by a minimum of 50 years. Figure 3-1 highlights the main variants in CIPP technologies available today based on tube construction, method of installation, curing method, and type of resin.

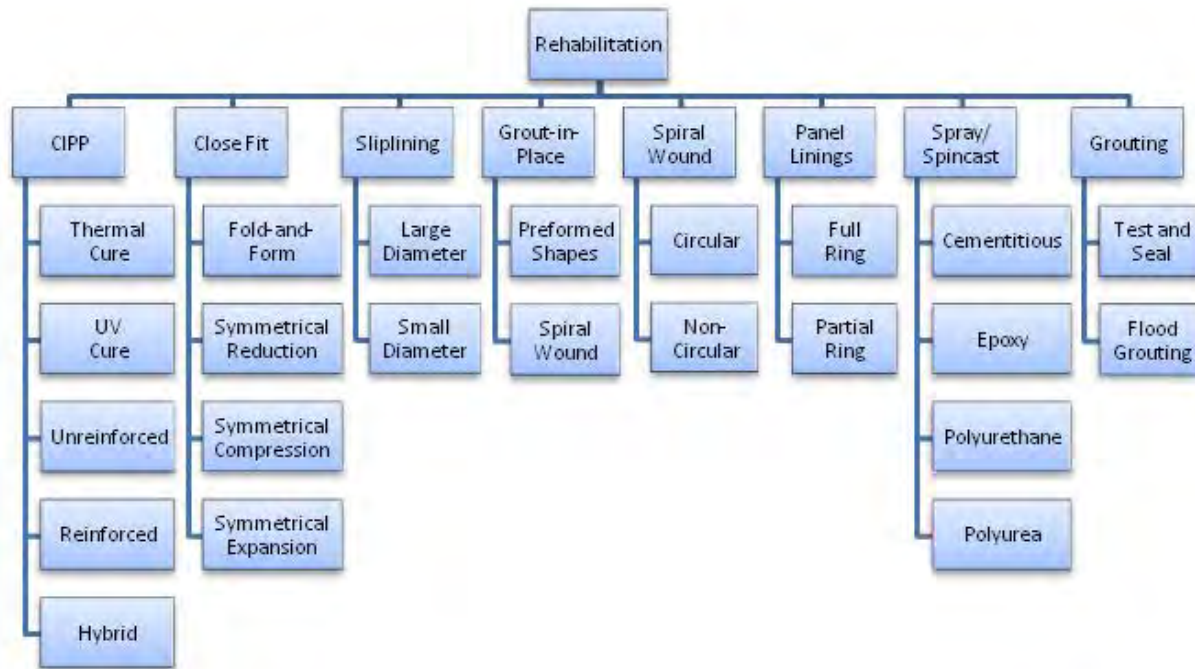
**Figure 3-3. Summary of Trenchless Sewer Rehabilitation Technologies**

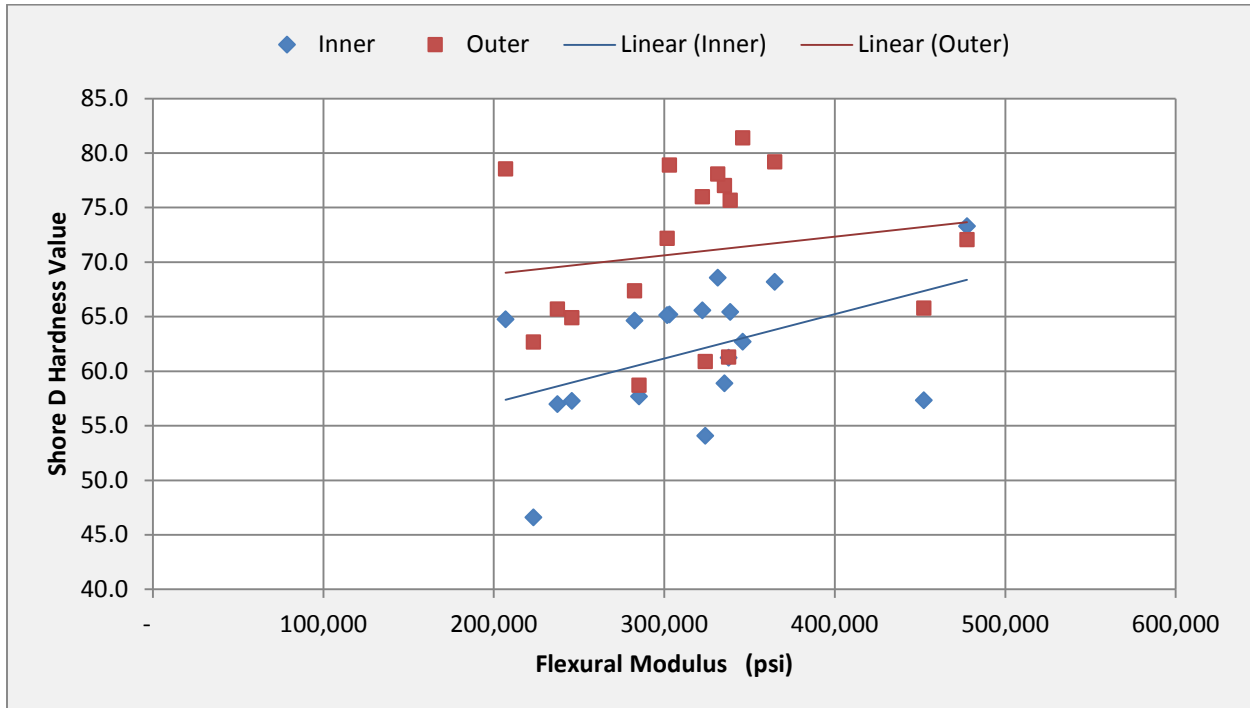
**Figure 5-10. Shore D Hardness versus Flexural Modulus**

There is a significant amount of scatter in the data, particularly for the outer surface hardness results ( $R^2$  equal to 0.03 compared to 0.21 for the inner hardness). Linear trend lines have been shown in the graph, but it should be noted that the axis for the hardness value starts at 40 rather than 0. This accentuates the apparent relationship of hardness to flexural modulus. There is, however, an observable overall trend of higher surface hardness with increased flexural modulus and this is physically reasonable.

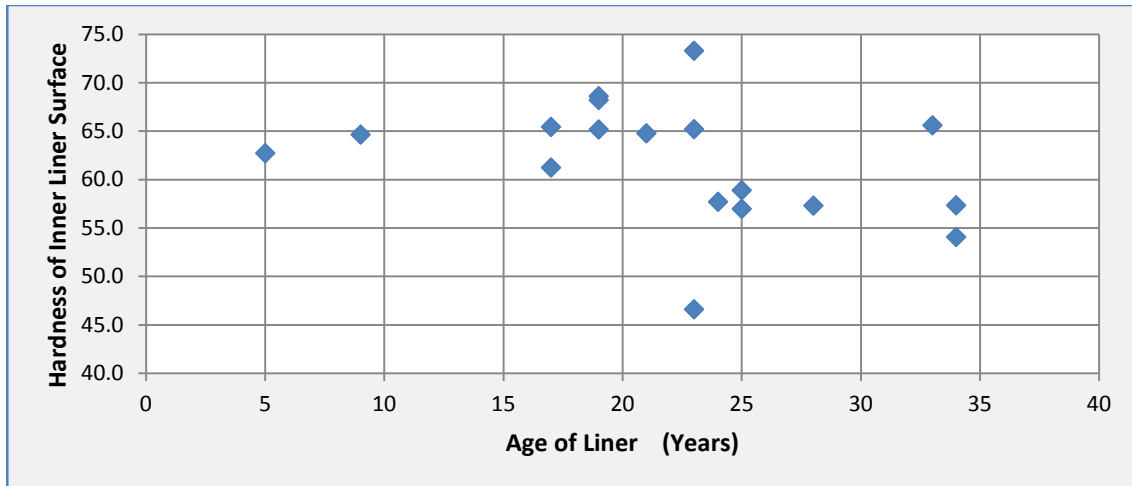
**Figure 5-11. Shore D Hardness of Inner Liner Surface versus Age of Liner**

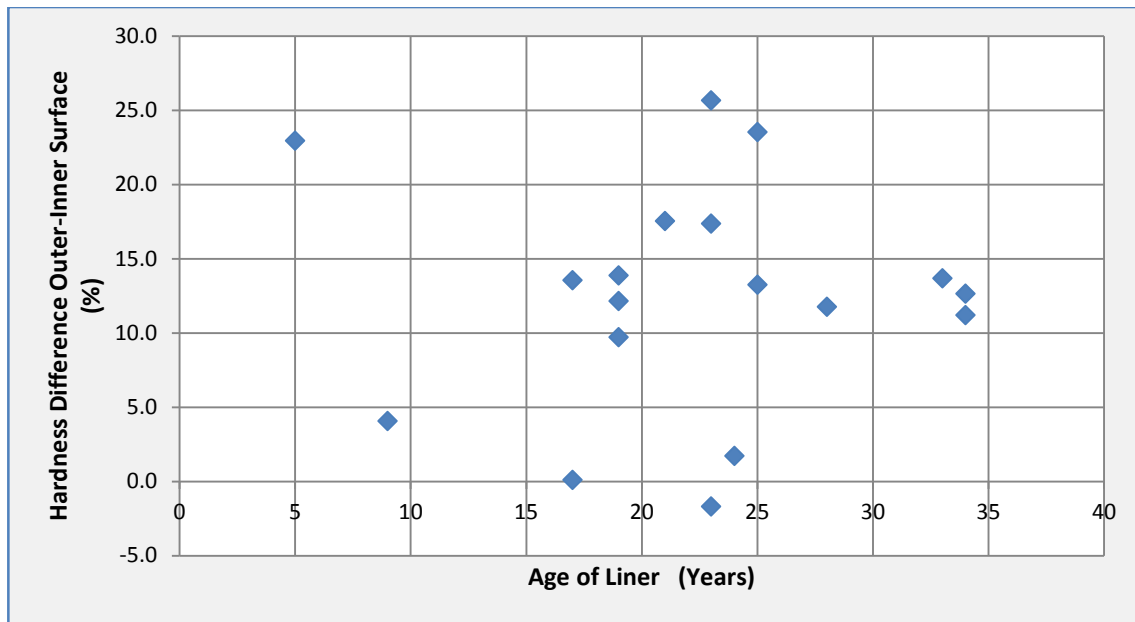
**Figure 5-12. Hardness Difference Outer-Inner Liner Surface versus Age of Liner**

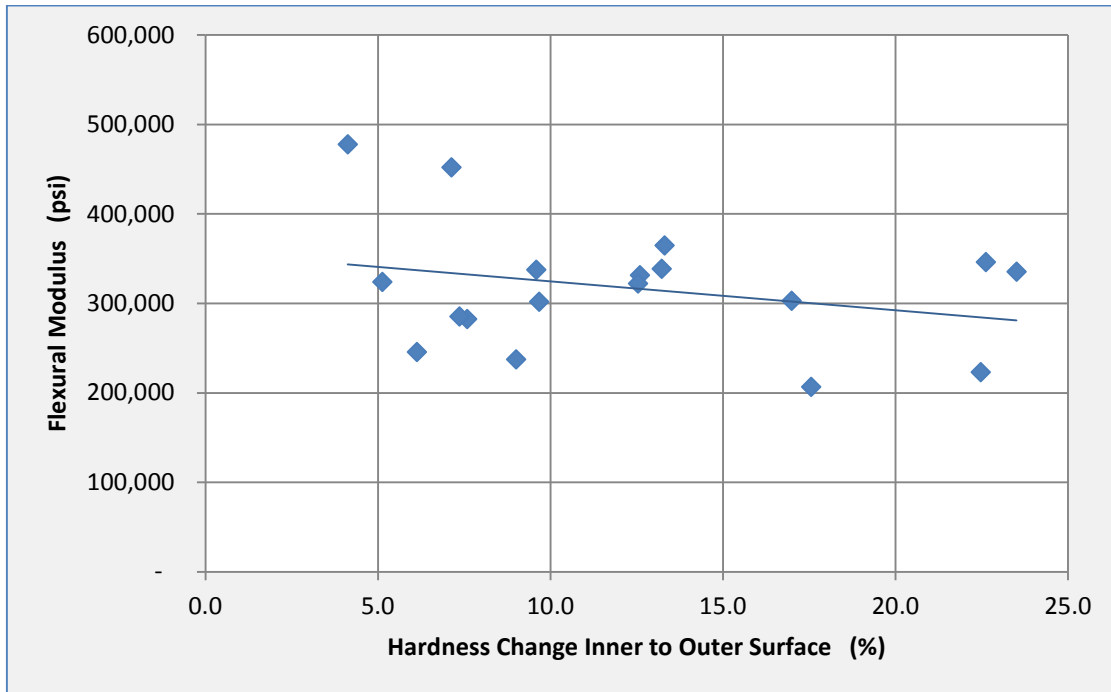
**Figure 5-13. Flexural Modulus versus Variation in Surface Hardness**

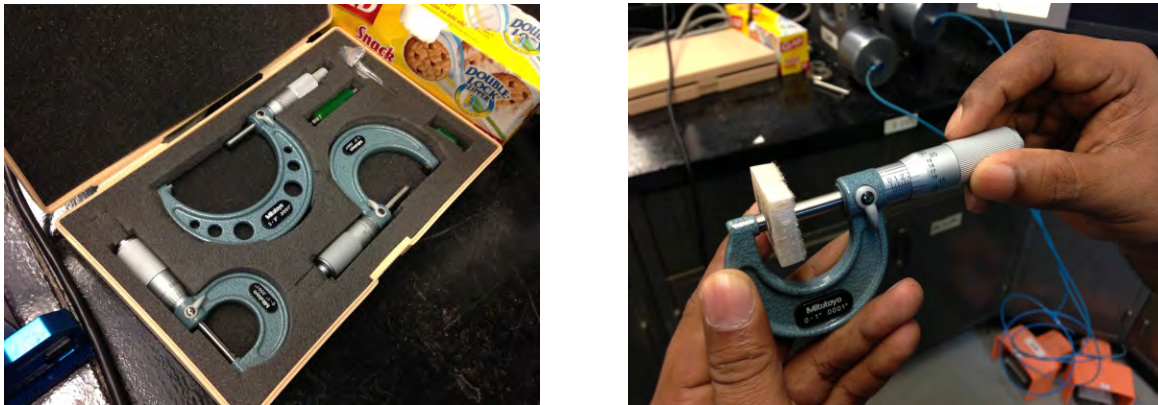
**Sample Thickness Measurement.** In ASTM D2122, specimens were cut into 1 in. × 1 in. squares and the thickness was measured using a micrometer with a resolution of  $\pm 0.0025$  mm (see Figure A-1).

**Figure A-1. Micrometer Set (left) and Measurement of Thickness Using a Micrometer (right)**

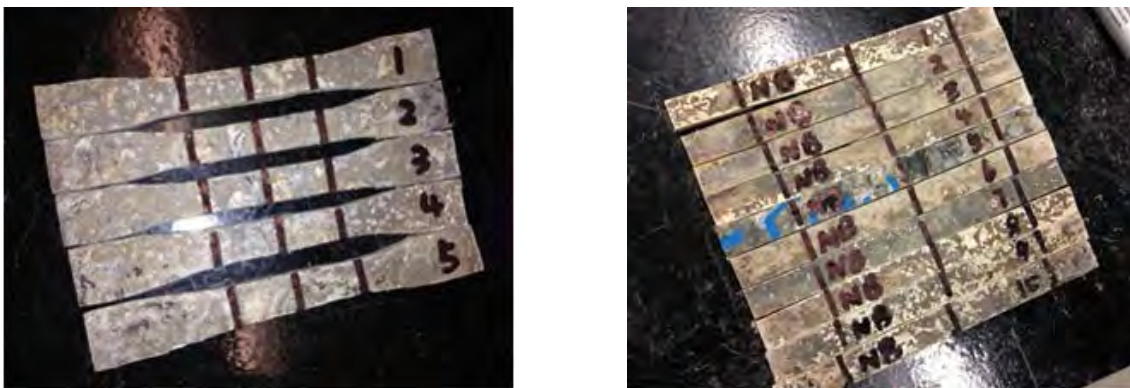
**Flexure and Tensile Testing.** Flexure (ASTM D790) and tensile (ASTM D638) tests were performed using a 2.2 Kip capacity universal testing machine. No slippage was ensured by employing the pneumatic grips during the tensile test. The samples were prepared according to the relevant standard (see Figure A-2) and later tested using the universal testing machine (see Figure A-3). It should be noted that, for the tensile testing, the extensometer used had a range of up to 2 in. elongation and hence the tensile tests were stopped if the specimen extension reached this value.

**Figure A-2. ASTM D638 Specimens (left) and ASTM D790 Specimens (right)**

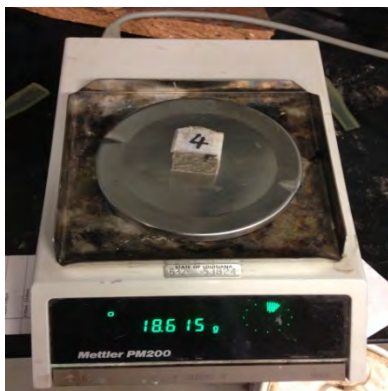
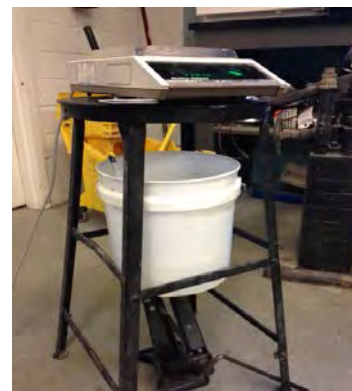
**Figure A-4. Weight Measured in Air (left) and in Water (right)**

**Apparent Specific Gravity.** Apparent specific gravity was measured following ASTM D792. Specimens of 1 in.  $\times$  1 in. size were cut from the CIPP liner/panel. The weight of each specimen was measured first in air and later in water. A sinker was used to ensure submersion of the test sample (see Figure A-4). The water temperature also was read to allow the appropriate water density to be used.

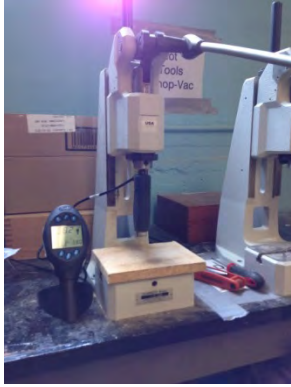
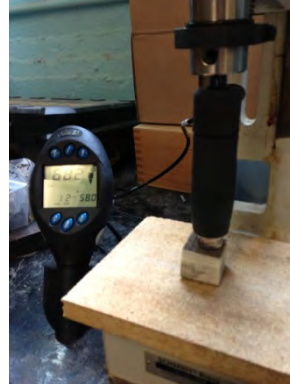
**Figure A-5. Hardness Test Instrument (left) and Hardness Test on a Specimen (right)**

**Durometer (Shore Type D) Hardness.** Durometer (Shore Type D) hardness (ASTM D2240) was used to determine the hardness of the liner samples (see Figure A-5). Samples (1 in.  $\times$  1 in.) were cut from the retrieved CIPP liner with a band saw. The Shore D hardness scale utilizes a weight of 10 lb (4,536 g). The tip diameter and angle are 0.1 mm and 35°, respectively. Readings were taken on the inner and outer surfaces of the liner specimens.

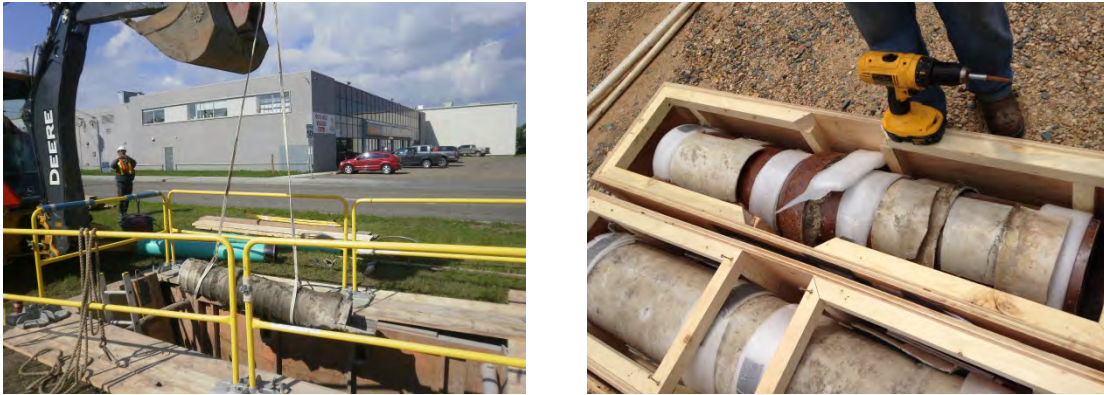
**Figure B-1. Edmonton 1: Retrieval of the Sample (left) and Received Sample (right)**

The retrieval process and the retrieved sample are shown in Figure B-1. The specimens were received at the TTC South Campus Lab Facility on July 23, 2013.

**B.1.2.1 Visual Inspection.** The sample was found to be in excellent condition. The polyurea coating was still present and the thickness was uniform around the circumference.

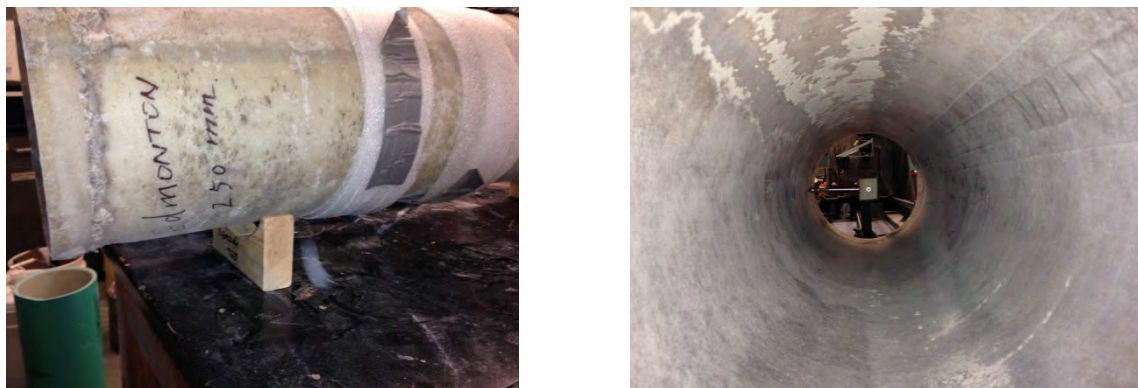
The liner was placed on a wooden saddle, clamped with the platform, and careful measurements were taken to ensure that the liner center was aligned with the measuring device. Next, the profile plotter was aligned with the center of the CIPP liner tube. Continuous readings were taken around the circumference of three cross-sections spaced 8 in. apart and averaged. The liner was found to be approximately circular with reference to its center (see Figure B-4). The ovality of the liner was found to vary from 2.70% to 4.30%.

**Figure B-3. Profile Plotter Setup (left) and Ovality Measurement (right)**

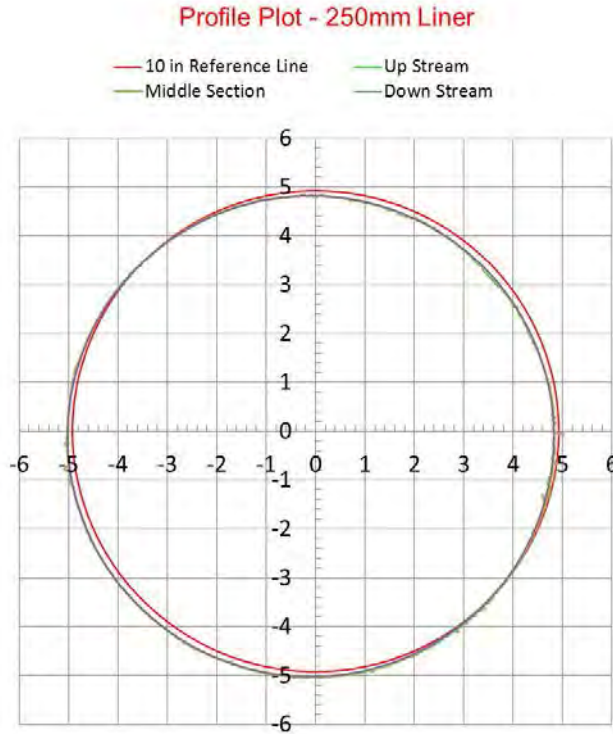
**Figure B-4. Edmonton 1: Ovality of the Liner at Up Stream, Middle and Down Stream Sections**

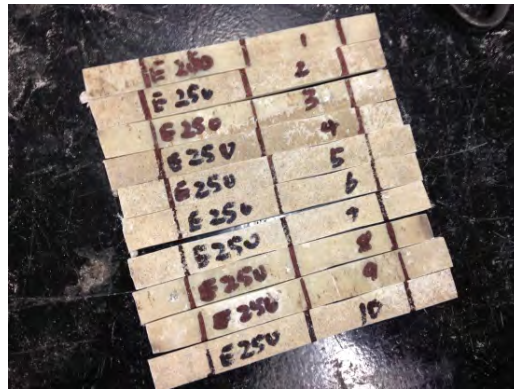
**Figure B-10. Five Specimens (left) and 10 More Specimens (right) for Flexural Testing**

**B.1.2.8 Flexural Test (ASTM D790).** A total of 15 specimens were prepared for ASTM D790 flexure tests. The prepared specimens and test setup are shown in Figures B-10 and B-11.

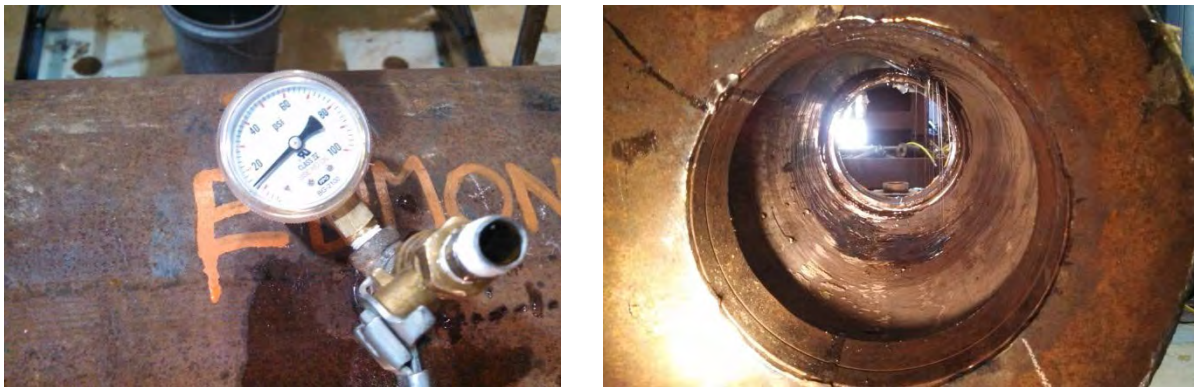
The liner collapsed under the supply line water pressure at around 12 psi before the N<sub>2</sub> was released to the accumulator (see Figure B-14). This is equivalent to over 27 ft of water head above the pipe.

**Figure B-14. Edmonton 1: Short-Term Buckling Test Setup**

**B.1.2.10 Short-Term Buckling Test.** For the short-term buckling test, a 30 in. long piece of full circumference was cut from the sample and housed inside a 12-in. diameter steel tube 30 in. in length. The larger diameter of the steel tube ensured accommodation of any ovality and local curvature of the liner. Two 3/8 in. threaded holes were made on the opposite sides of the steel tube and quick connectors were fixed to the pipe through the holes to allow attachment of the pressure system. Two specially designed, open-ended steel caps were fabricated to keep a uniform 1-in. annular space between the inner wall of the pipe and the outer wall of the liner and these end caps were then sealed. Effective sealing of the annulus under elevated internal annular pressure was essential during the test while the interior of the liner was frequently accessed for observation of liner deformation. The large annular gap for the buckling test makes the buckling test very conservative compared to a liner tightly fitted within the host pipe in the field. However, the test sections also are known to be too short to eliminate end effects (not conservative) because the host pipe configuration and overall testing program did not permit a pipe section with a length of four to six times diameter (32 to 48 in.) to be used.

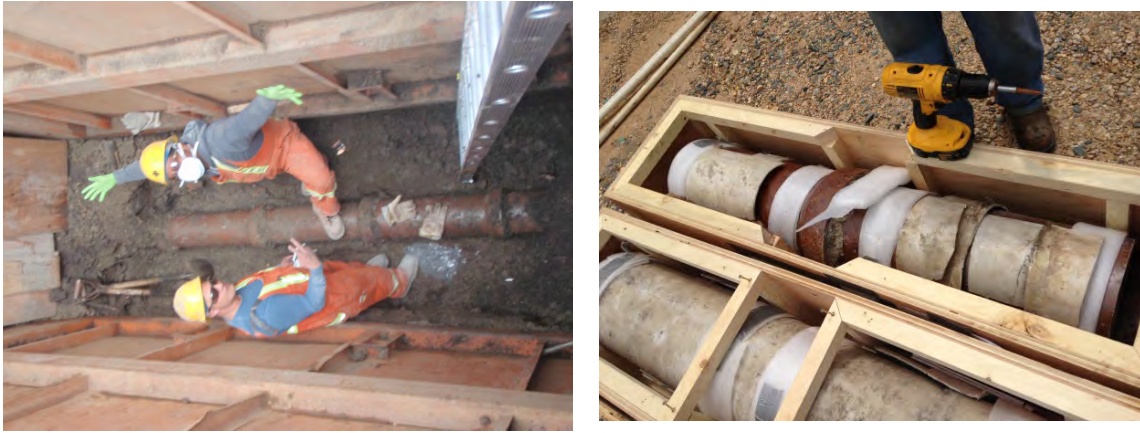
**Figure B-15. Edmonton 2: Retrieval of the Sample (left) and Received Sample (right)**

The retrieval process and the retrieved sample are shown in Figure B-15. The sample was received at the TTC South Campus Facility on July 23, 2013.

**B.1.3.1 Visual Inspection.** The sample was found to be in excellent condition. The polyurea coating (handling layer) was still in place and the thickness of the liner was uniform around the circumference.

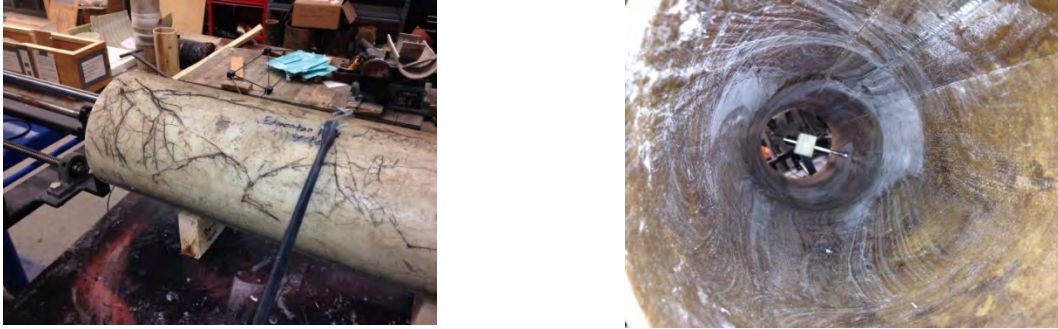
**Figure B-16. Edmonton 2: Profile Plotter Setup (left) and Measurement of Ovality (right)**

**B.1.3.4 Ovality.** A profile plotter (see Figure B-16) was used to map any deformation inside the liner. The system features a LVDT connected to a motor-gear system that rotates around the inner circumference of the liner. An encoder system provides position information regarding the location around the pipe at which the data are collected.

The liner was placed on a wooden saddle, clamped with the platform, and careful measurements were taken to ensure that the liner center was aligned with the measuring device. Next, the profile plotter was aligned with the center of the CIPP liner tube. Continuous readings were taken around the circumference of three cross-sections spaced 12 in. apart and averaged. The liner was found to be approximately circular with reference to its center (see Figure B-17). The ovality of the liner was found to vary from 4.50% to 5.75%.

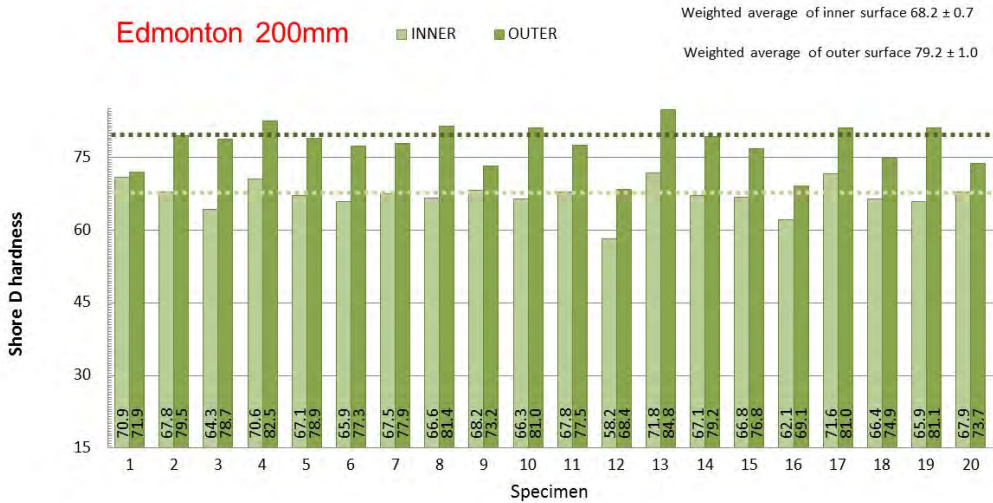
**B.1.3.9 Surface Hardness.** A Shore Type D durometer (ASTM D2240) was used to determine the hardness of the liner samples. Samples (1 in. × 1 in.) were cut from the retrieved CIPP liner with a band saw. A total of 400 readings were taken on the inner and outer surfaces of the liner specimens. The average recorded hardness values are shown in Figure B-22. The hardness of the surface exposed to the flow (inner surface) was found to be only slightly lower than that of the protected (outer) surface, suggesting little, if any, softening or erosion of the resin on the inner surface of the tube during its service life. Differences may also be expected due to the initial presence of the sealing layer on the internal surface.

**Figure B-22. Edmonton 2: Shore D Hardness Readings from Inner and Outer Surfaces**

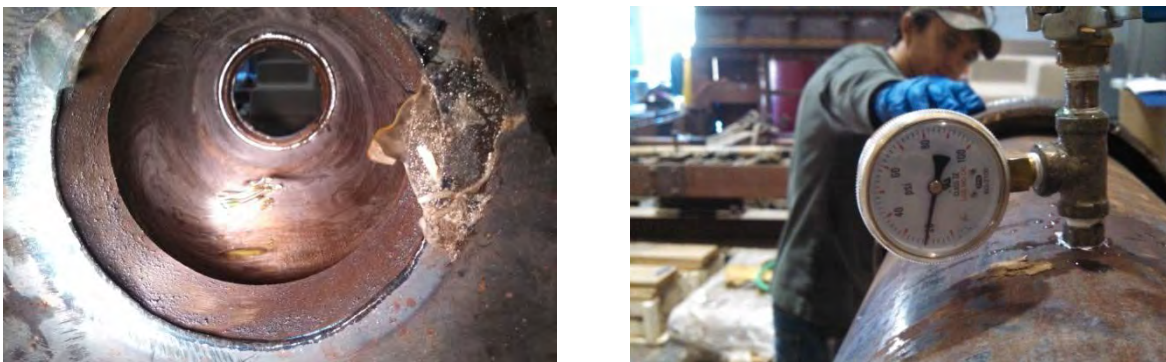
**Figure B-23. Edmonton 2: Short-Term Buckling Test Setup**

**B.1.3.10 Short-Term Buckling Test.** For the short-term buckling test, a 30 in. long piece of full circumference was cut from the sample and housed inside a 10 in. diameter steel tube 30 in. in length with a similar test configuration to that described for the Edmonton 10 in. (250 mm) sample.

Provision was made to apply a high pressure using the TTC’s EPAD but the liner collapsed under the supply line water pressure at around 20 psi before the N<sub>2</sub> was released to the accumulator (see Figure B-23). This pressure is equivalent to approximately a 46 ft head of water above the pipe.

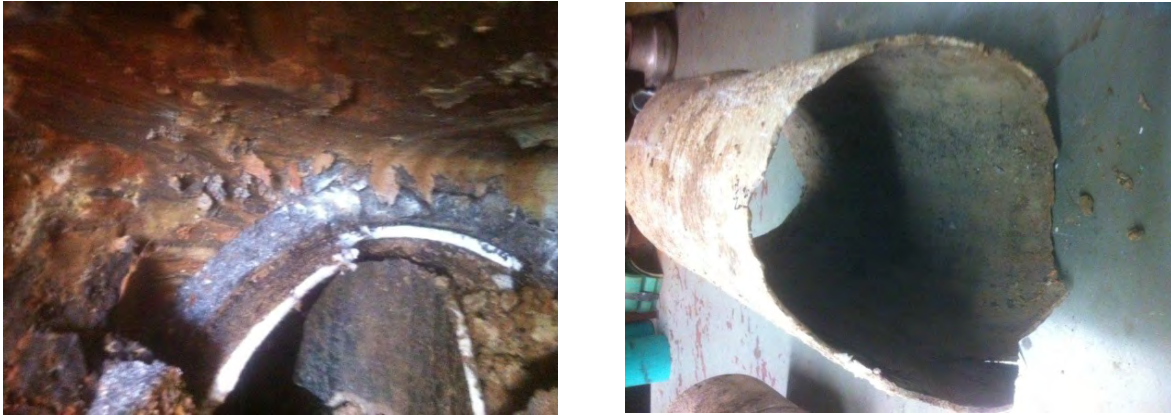
**Figure B-24. Houston 1: Retrieval of the Sample (left) and Received Sample (right)**

**B.2.1.1 Visual Inspection.** In the field, the sample was observed to be brittle and uneven with visible fibers, but it was not clear to what extent this was observed due to the sample removal process from the host pipe. When received at the TTC, the sample was found to be in good condition relative to the other CIPP samples retrieved. As indicated below, the test results were in the normal range.

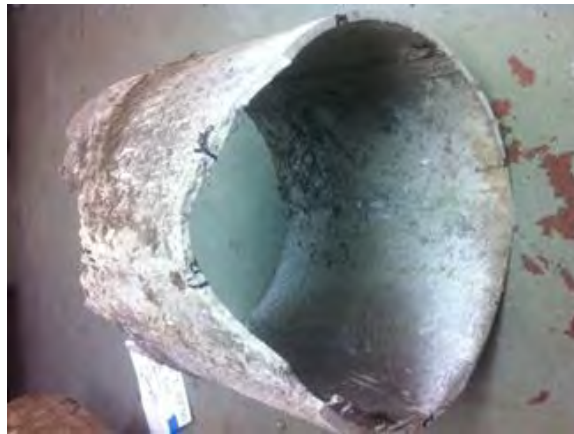
**Figure B-31. Houston 2: Received 18 in. CIPP Sample**

**B.2.2.1 Visual Inspection.** In the field, the sample was observed to be brittle and uneven with visible fibers, but it was not clear to what extent this was observed due to the sample removal process from the host pipe. When received at the TTC, the sample was found to be in good condition relative to the other CIPP samples retrieved. As indicated below, the test results were in the normal range.

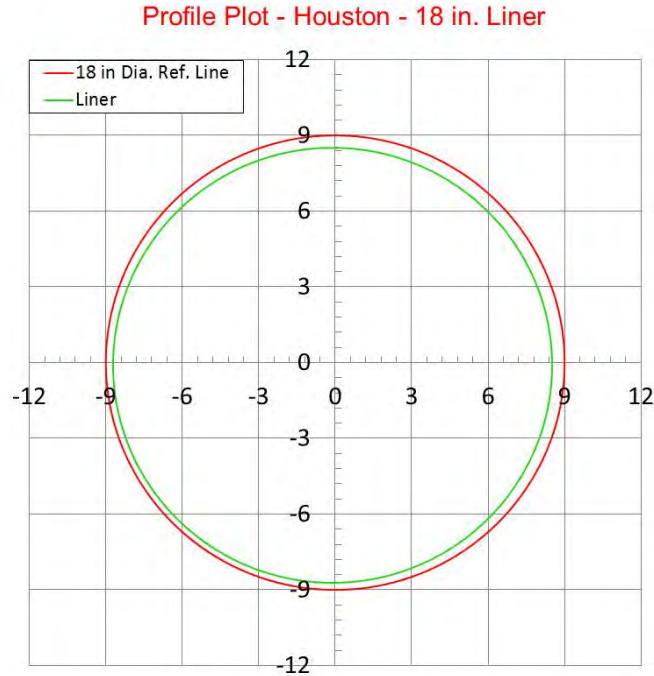
**B.2.2.4 Ovality.** A profile plotter was used to accurately map any deformation inside the liner. The system features a LVDT connected to a motor-gear system that rotates around the inner circumference of the liner. An encoder system provides position information regarding the location around the pipe at which the data are taken. The liner was found to be approximately circular with reference to its center (see Figure B-32). The ovality of the liner was found to be around 1.7%.

**Figure B-32. Houston 2: Ovality of the Liner**

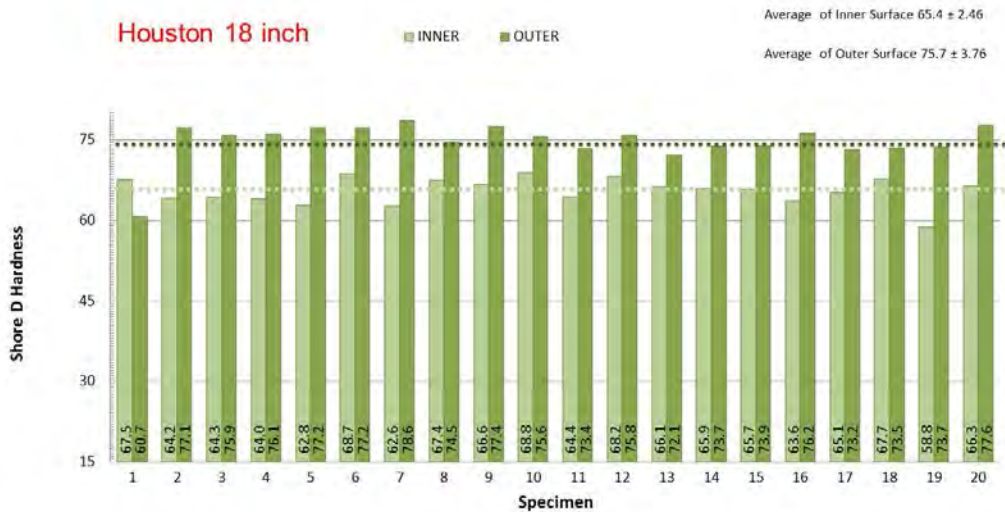
**B.2.2.9 Surface Hardness.** A Shore Type D durometer (ASTM D2240) was used to determine the hardness of the liner samples. A total of 400 readings were taken on the inner and outer surfaces of the liner specimens. The average recorded hardness values are shown in Figure B-37. The hardness of the surface exposed to the flow (inner surface) was found to be only slightly lower than that of the protected (outer) surface, suggesting little, if any, softening or erosion of the resin on the inner surface of the tube during its service life. Differences may also be expected due to the initial presence of the sealing layer on the internal surface.

**Figure B-37. Houston 2: Shore D Hardness Readings from Inner and Outer Surfaces**

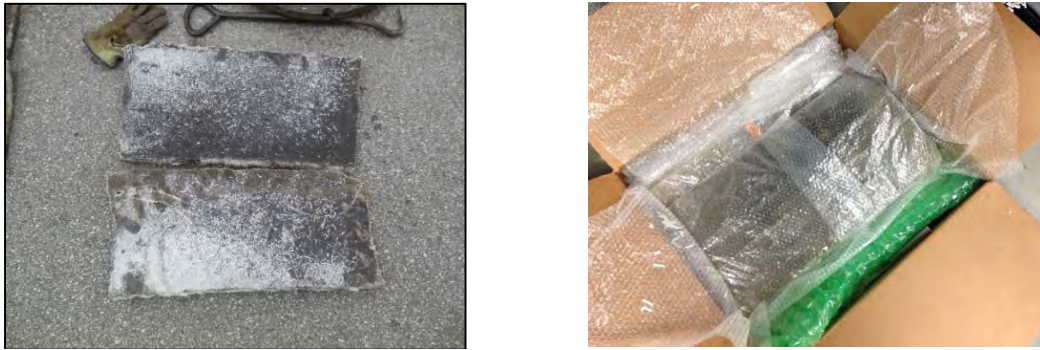
**Figure B-38. Indianapolis: Retrieval of the Sample (left) and Received Sample (right)**

**B.3.1.1 Visual Inspection.** The two panels received were in good condition (see Figure B-39).

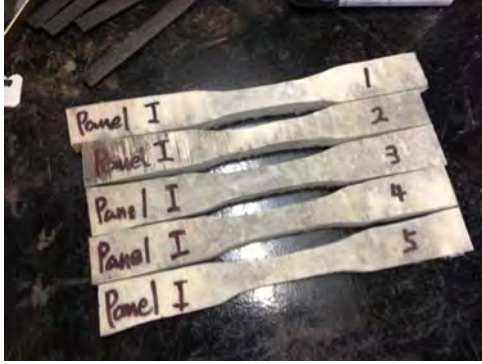
**Figure B-44. Indianapolis: Five Panel 1 Specimens (left) and Five Panel 2 Specimens (right) Prepared for Tensile Testing**

**B.3.1.7 Tensile Test (ASTM D638).** Specimens, as described in ASTM D638, were cut from the retrieved CIPP liner using a table saw and a band saw. Due to the high thickness value of the sample, the Type III specimen dimensions from the standard were used. Tensile specimens were machined to 0.55 in. to meet the limit provided by ASTM D638 (see Figure B-44). The tensile test setup is shown in Figure B-45.

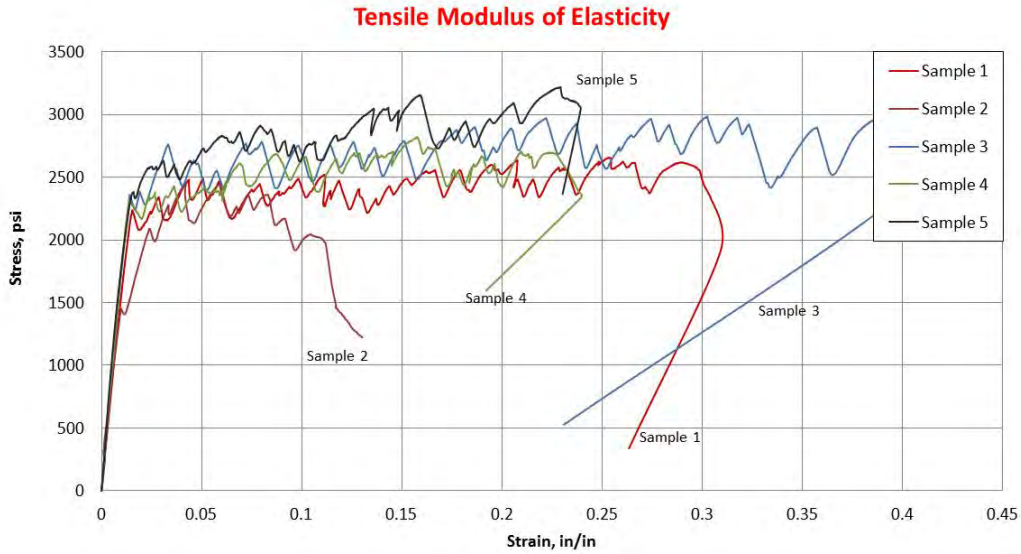
Figure B-46. Indianapolis: Stress – Strain Curves from Tensile Testing of Panel 1

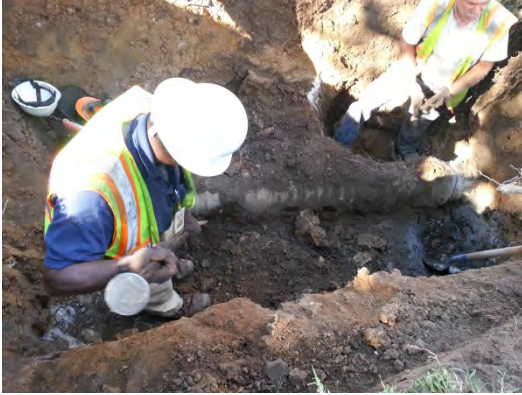
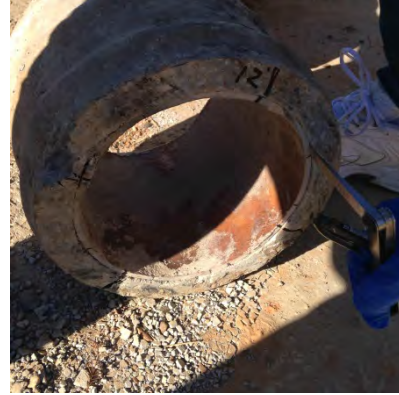
**Figure B-52. Nashville 1: Retrieval of the Sample (left) and Measuring Annular Gap on the Received Sample (right)**

**B.4.1.1 Visual Inspection.** The sample was found to be in excellent condition and closely fit inside the host pipe.

**B.4.1.2 Annular Gap.** The annular gap was measured using a feeler gauge. Eight readings were taken of the annular gap on the remaining host pipe and are shown in Table B-26.

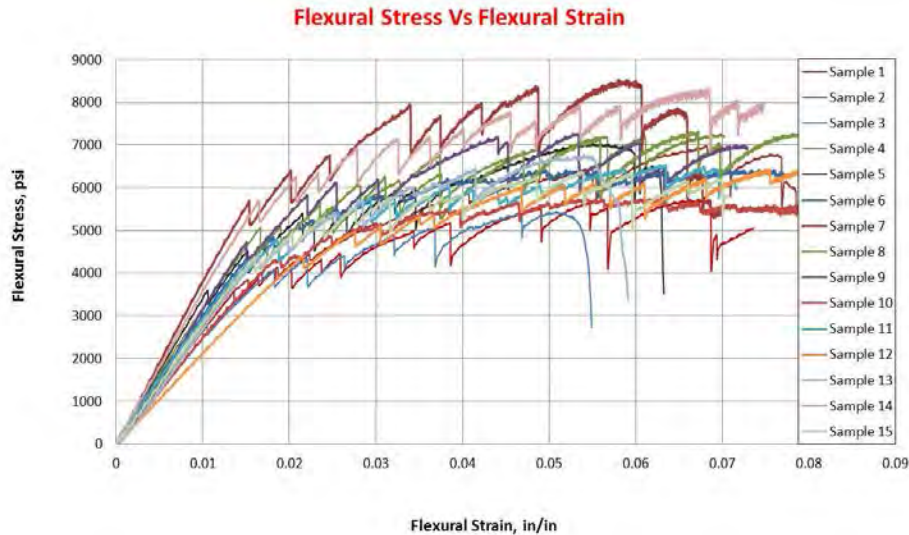
**Figure B-57. Nashville 1: Stress – Strain Curves from Flexural Testing**

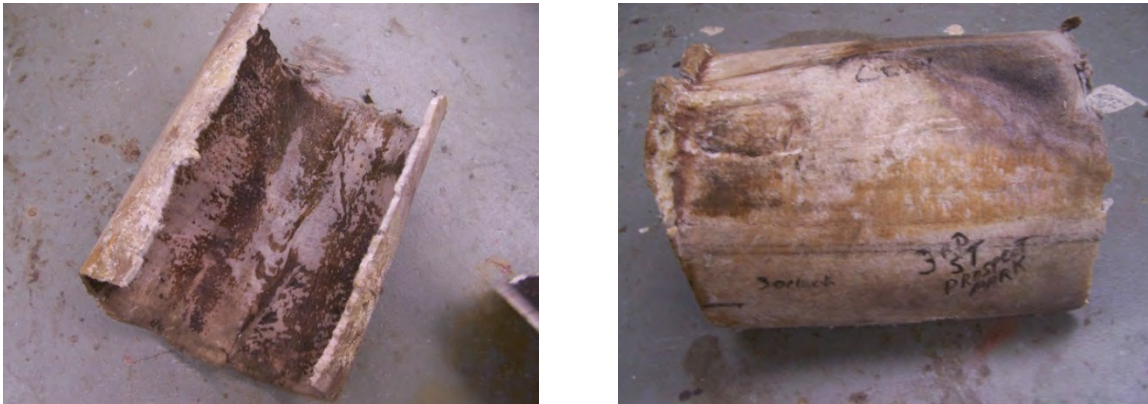
**Figure B-66. New York 1: Defective Sample Retrieved from 3rd Street**

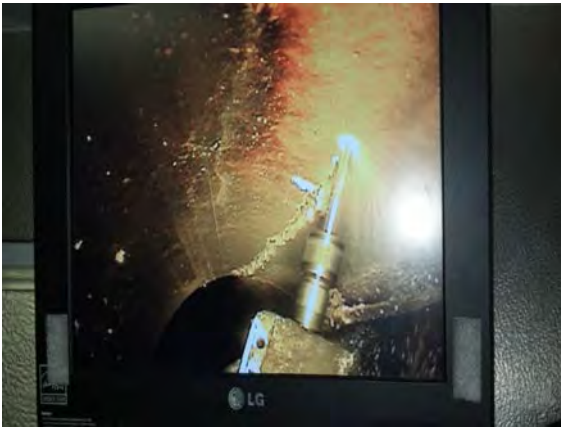
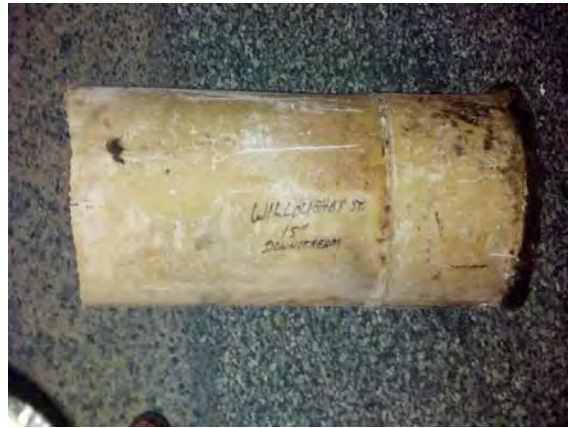
**Figure B-67. New York 2: Retrieval of the Sample (left) and Retrieved Sample in the Field (right)**

**B.5.2.2 Annular Gap.** The liner was observed to be tight to the invert of the pipe (below the 9:00 o'clock to 3:00 o'clock positions) with no annular gap. However, a small annular gap (around 0.007 in. [0.18 mm]) was measured in the field from the 9:00 o'clock to the 3:00 o'clock positions.

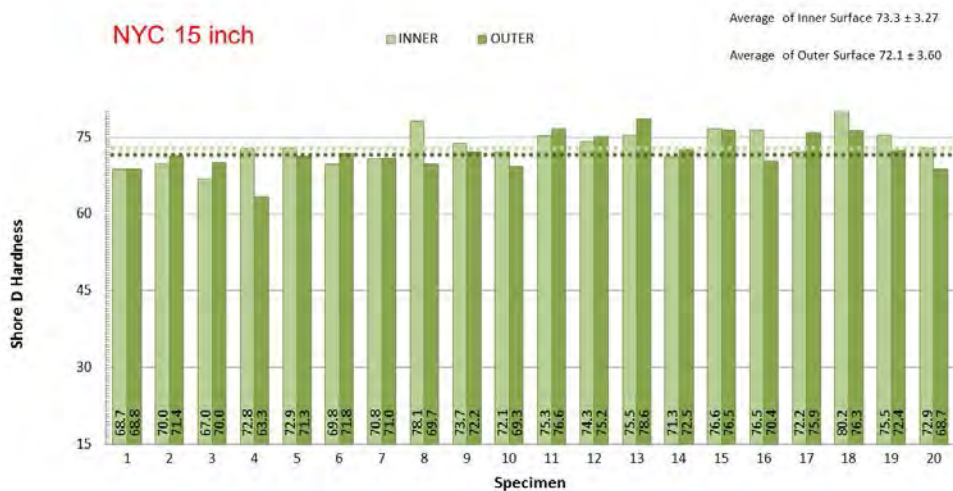
**Figure B-73. New York 2: Shore D Hardness Readings for the Liner’s Inner and Outer Surfaces**

**B.5.2.8 Surface Hardness.** A Shore Type D durometer (ASTM D2240) was used to determine the hardness of the liner samples. Samples (1 in. × 1 in.) were cut from the retrieved CIPP liner with a band saw. A total of 400 readings were taken on the inner and outer surfaces of the liner specimens. The average recorded hardness values are shown in Figure B-73. The hardness of the surface exposed to the flow (inner surface) was found to be slightly higher than that of the protected (outer) surface, suggesting little, if any, softening or erosion of the resin on the inner surface of the tube during its service life. Note that the inner surface of the liner is the resin beneath the original sealing layer which had eroded or degraded away.

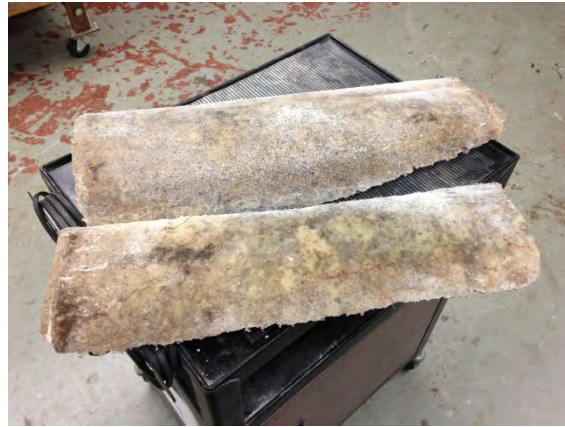
Figure B-74. New York 3: Retrieval of the Sample (left) and Retrieved Sample (right)

**B.5.3.3 Environmental Service Conditions.** No soil samples were collected because of sample removal through the manhole.

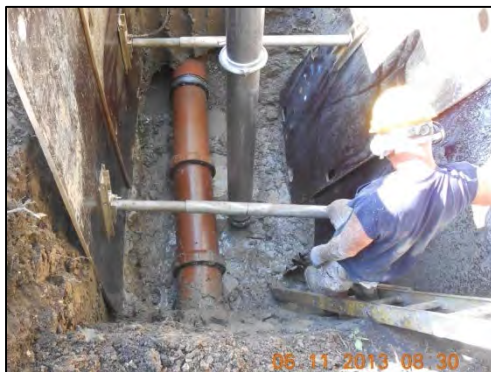
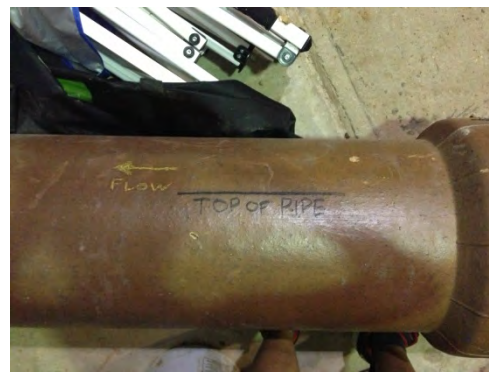
**Figure B-81. Northbrook: Retrieval of the Sample (left) and Received Sample (right)**

**B.6.1.1 Visual Inspection.** The sample was in good condition, with the exception of an approximately 0.5 in. annular gap at the 5 o'clock position of the liner.

**B.6.1.2 Annular Gap.** The south end of the section of pipe removed was where a subsequent point repair had been made, so that the south end of the sample had been connected to the replaced segment with a coupling. The remnants of the connection were left intact and no measurements were made. The north end is the upstream location. Eight readings were taken on the liner within the sample removed (at the north end) and again on the adjacent host pipe that remained in place (see Table B-45).

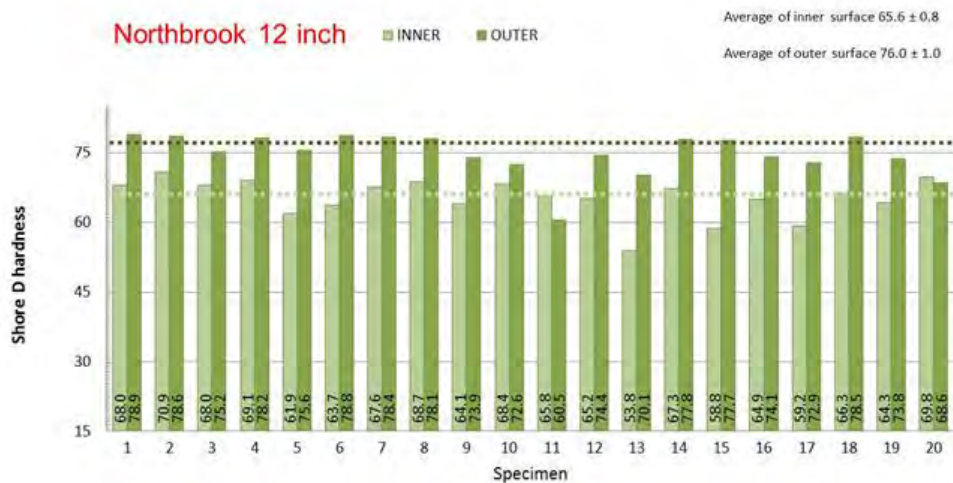
**Figure B-87. Northbrook: Shore D Hardness Readings from Inner and Outer Surfaces**

**B.6.1.9 Surface Hardness.** A Shore Type D durometer (ASTM D2240) was used to determine the hardness of the liner samples. Samples (1 in. × 1 in.) were cut from the retrieved CIPP liner with a band saw. A total of 400 readings were taken on the inner and outer surfaces of the liner specimens. The average recorded hardness values are shown in Figure B-87. The hardness of the surface exposed to the flow (inner surface) was found to be only slightly lower than that of the protected (outer) surface, suggesting little, if any, softening or erosion of the resin on the inner surface of the tube during its service life. Differences may also be expected due to the initial presence of the sealing layer on the internal surface.
