# **National Database Structure for Life Cycle Performance Assessment of Water and Wastewater Rehabilitation Technologies (Retrospective Evaluation)**

**Erez Allouche, Ph.D., P.E., Shaurav Alam, Ph.D.,  
and Ray Sterling, Ph.D., P.E.**  
Trenchless Technology Center at Louisiana Tech University

**Contract No. EP-C-11-038  
Task Order No. 1**

**U.S. Environmental Protection Agency  
Urban Watershed Branch  
National Risk Management Research Laboratory  
Water Supply and Water Resources Division  
Edison, NJ 08837**

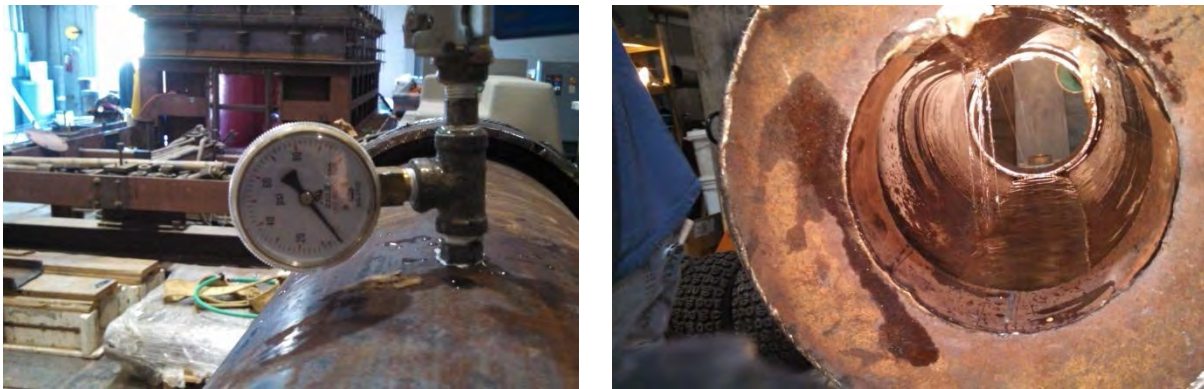
**Figure B-88. Northbrook: Short-Term Buckling Test**

**B.6.1.10 Short-Term Buckling Test.** For the short-term buckling test, a 30 in. long piece of full circumference was cut from the sample and housed inside a 14-in. diameter steel tube 30 in. in length. The larger diameter of the steel tube ensured accommodation of any ovality and local curvature of the liner. The large annular gap for the buckling test makes the test very conservative compared to a liner tightly fitted within the host pipe in the field. However, the test sections also are known to be too short to eliminate end effects (not conservative) because the host pipe configuration and overall testing program did not permit a pipe section with a length of four to six times diameter (32 to 48 in.) to be used.

Provision was made to apply a high pressure using the TTC’s EPAD. However, the liner collapsed at a supply line water pressure of approximately 5 psi before the N<sub>2</sub> was released to the accumulator (see Figure B-88). The liner collapsed at close to the 11 o’clock position in the test setup which mapped to the 5 o’clock position in the liner’s original field location.

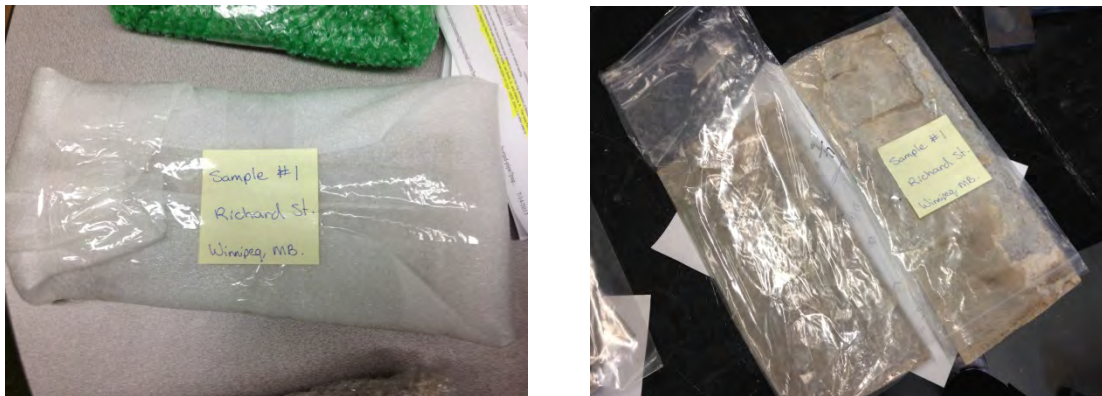
**Figure B-89. Winnipeg 1: Received Sample**

The sample (see Figure B-89) was received at the TTC South Campus Facility on August 2, 2013.

**B.7.1.1 Visual Inspection.** The sample as received at the TTC was found to be in excellent condition.

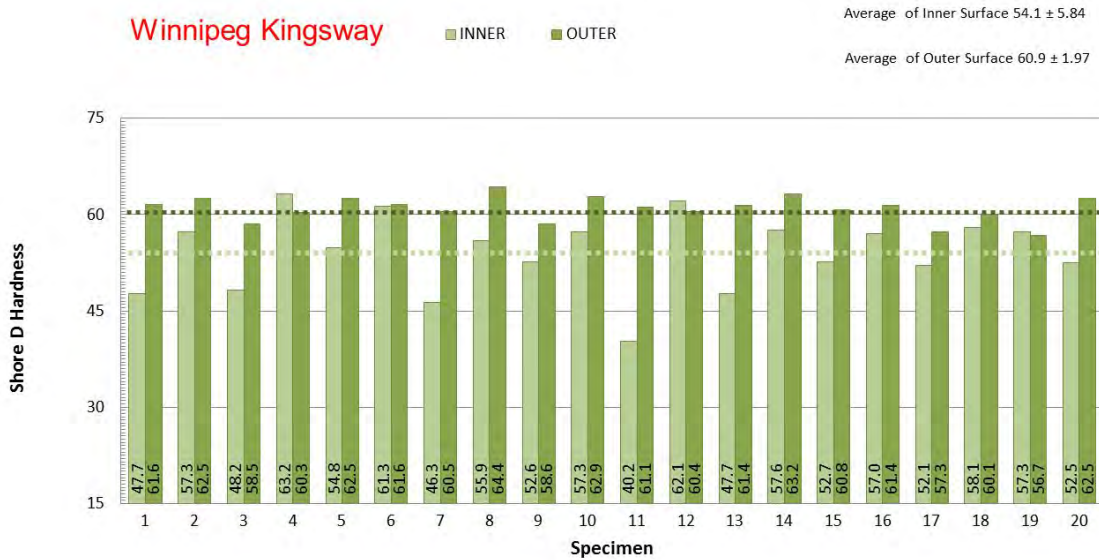
**Figure B-96. Winnipeg 2: Shore D Hardness Readings from Inner and Outer Surfaces**

**B.7.2.8 Surface Hardness.** A Shore Type D durometer (ASTM D2240) was used to determine the hardness of the liner samples. A total of 400 readings were taken on the inner and outer surfaces of the liner specimens. The average recorded hardness values are shown in Figure B-96. The hardness of the surface exposed to the flow (inner surface) was found to be only slightly lower than that of the protected (outer) surface, suggesting little, if any, softening or erosion of the resin on the inner surface of the tube during its service life. Differences may also be expected due to the initial presence or any continuing presence of the sealing layer on the internal surface.

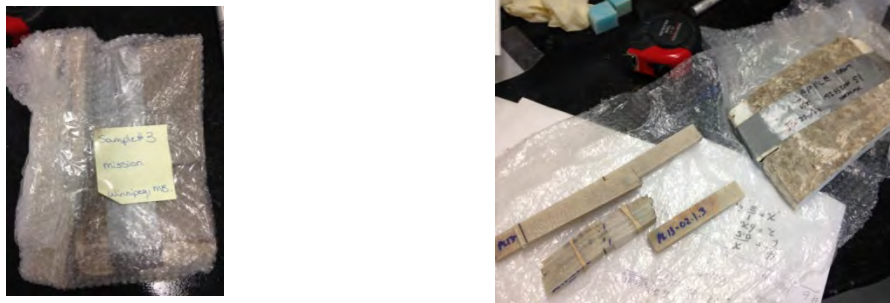
**Figure B-97. Winnipeg 3: Received Sample**

The sample (Figure B-97) was received at the TTC south campus facility on August 2, 2013.

**B.7.3.1 Visual Inspection.** The sample as received at the TTC was found to be in excellent condition.

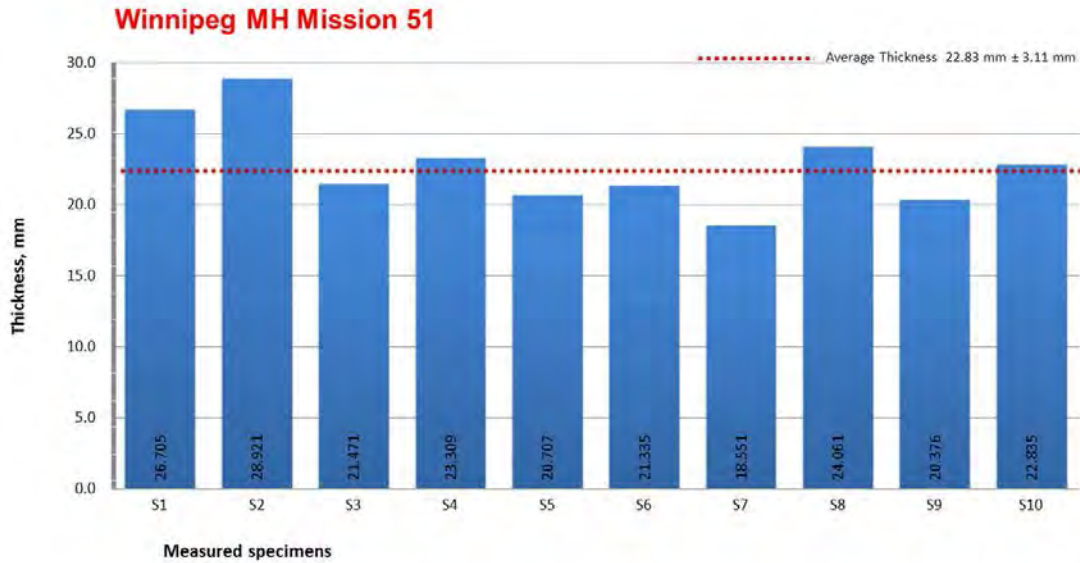
Figure B-98. Winnipeg 3: Average Thickness of the Sample

**B.7.3.4 Thickness.** A total of 60 readings were taken on 10 1 in. × 1 in. samples cut from different locations of the specimen. The thickness was measured randomly using a micrometer with a resolution of  $\pm 0.0025$  mm. The average thickness was found to be  $22.83 \text{ mm} \pm 3.11 \text{ mm}$  as shown in Figure B-98. The design thickness was not available.

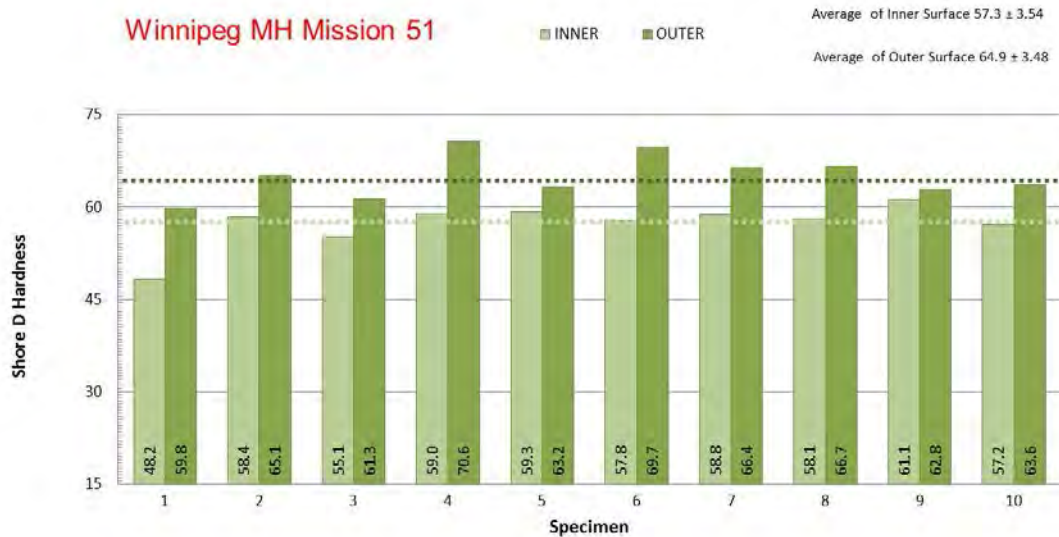
**Figure B-100. Winnipeg 3: Shore D Hardness Readings from Inner and Outer Surfaces**

**B.7.3.8 Surface Hardness.** A Shore Type D durometer (ASTM D2240) was used to determine the hardness of the liner samples. A total of 200 readings were taken on the inner and outer surfaces of the liner specimens. The average recorded hardness values are shown in Figure B-100. The hardness of the surface exposed to the flow (inner surface) was found to be only slightly lower than that of the protected (outer) surface, suggesting little, if any, softening or erosion of the resin on the inner surface of the tube during its service life. Differences may also be expected due to the initial presence or any continuing presence of the sealing layer on the internal surface.

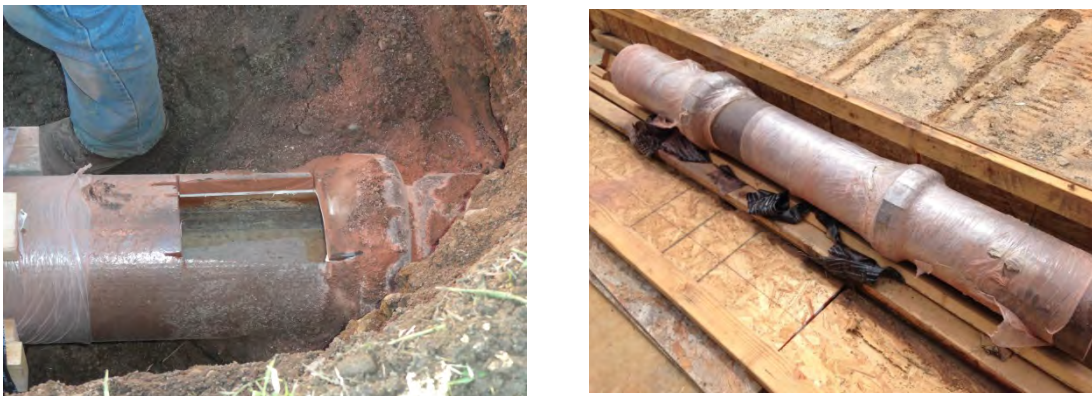
**Figure C-1. Denver Ringsby Ct.: PVC Liner and Host Pipe during Retrieval (left) and at the Laboratory (right)**

**C.1.1.1 Visual Inspection.** The PVC sample was retrieved with the host pipe and both were in good condition. The liner fitted the host pipe closely around most of the circumference. The thickness was consistent. No soil accumulation was retained on the sample when it arrived at the TTC laboratory. The retrieved sample in the field and in the laboratory is shown in Figure C-1.

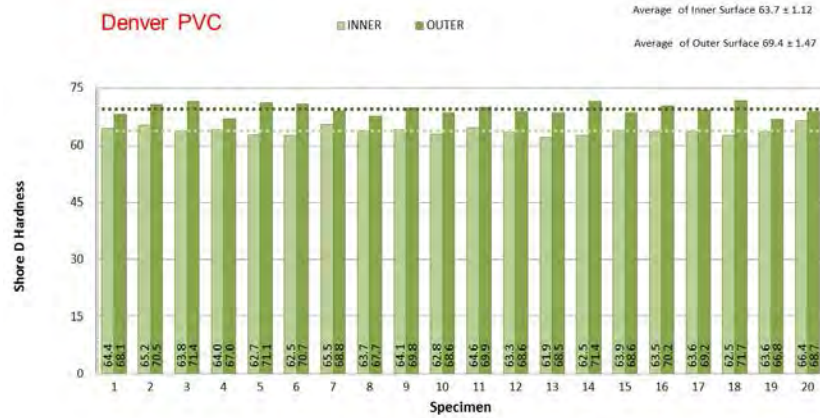
**Figure C-7. Denver Ringsby Ct.: Shore D Hardness Readings for the Liner’s Inner and Outer Surfaces**

**C.1.1.9 Surface Hardness.** A Shore Type D durometer (ASTM D2240) was used to determine the hardness of the liner samples. Samples (1 in. × 1 in.) were cut from the retrieved PVC liner with a band saw. A total of 400 readings were taken on the inner and outer surfaces of the liner specimens. The average recorded hardness values are shown in Figure C-7. The hardness of the surface exposed to the flow (inner surface) was found to be slightly lower than that of the protected (outer) surface.

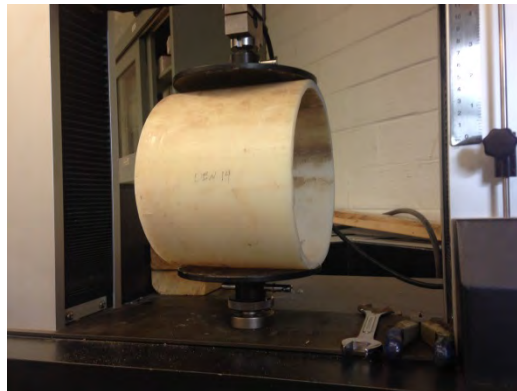
**Figure C-8. Denver Rigsby Ct.: Parallel Plate Test**

**C.1.1.10 Pipe Stiffness.** Pipe stiffness was measured using the Universal Testing Machine (UTM) equipped with parallel plates according to ASTM D2412. Three 6 in. long specimens were cut from the liner using a table saw and positioned between the plates; the load was applied at 0.50 in./min (see Figure C-8).

According to ASTM D2412, the deformation of the pipe was limited to 5% of the inside diameter and the test results are presented in Table C-6. The average value was found to be 19.75 lbf/in./in.

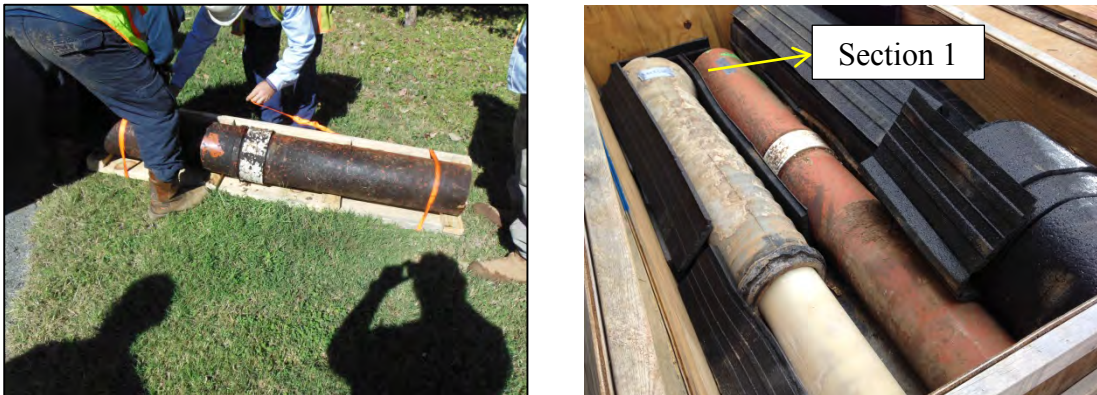
**Figure C-9. Nashville Elaine Dr.: Images of the PVC Liner Section after Retrieval (left) and Samples Received at the TTC Lab (right)**

**C.1.2.1 Visual Inspection.** The PVC sample received along with the host pipe was in good condition. The thickness of the sample was found to be inconsistent with significant variation observed between the maximum and minimum thickness. The retrieved samples in the field and as received at the TTC laboratory are shown in Figure C-9.

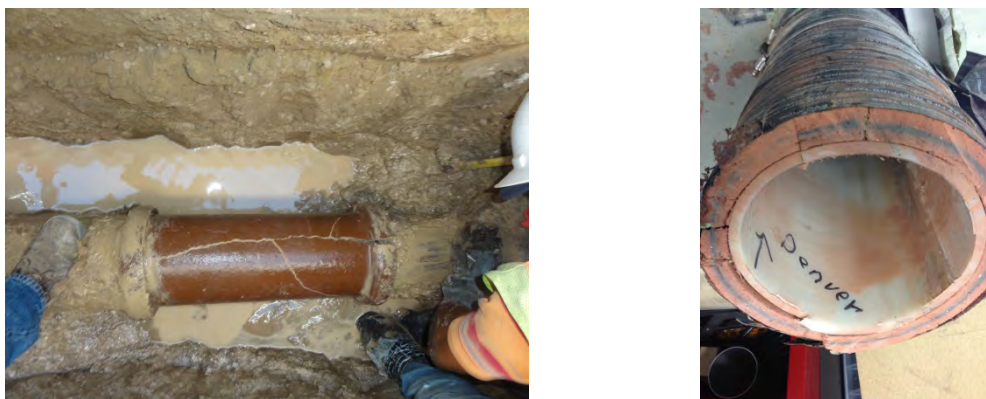
**Figure C-16. Denver Irving St.: Images of the HDPE Liner Section during Retrieval (left) and in the TTC Laboratory (right)**

**C.2.1.1 Visual Inspection.** The HDPE sample was retrieved along with the host pipe which was badly cracked. The reasons for the cracking could not be determined. The main possibilities were that the pipe was cracked prior to its relining in 1998 or that the pipe was cracked by the internal pressure used to re-round the HDPE liner during its installation. There was no soil remaining on the samples when received at the TTC laboratory. The retrieved samples are shown in the field and as received at the TTC laboratory in Figure C-16.

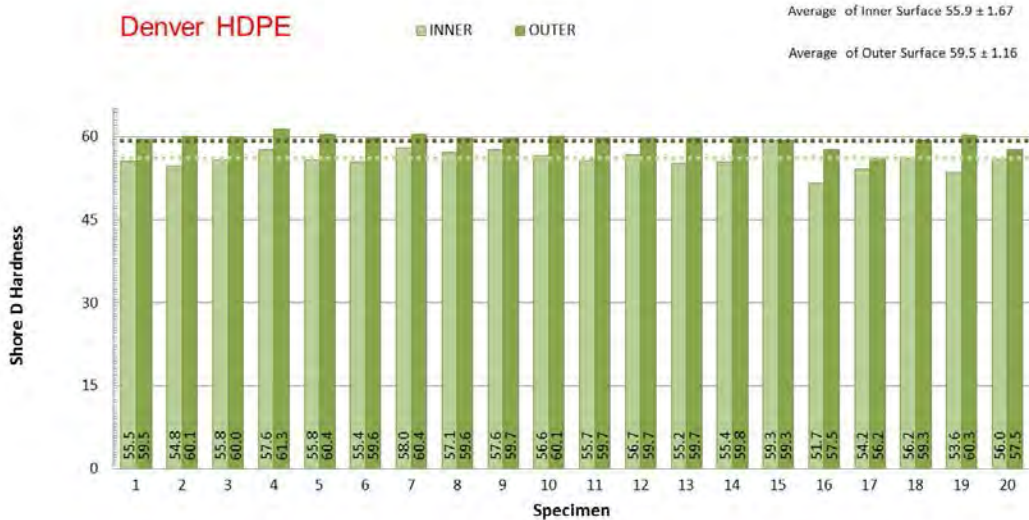
**Figure C-22. Denver Irving St.: Shore D Hardness Readings for the Liner’s Inner and Outer Surfaces**

**C.2.1.9 Surface Hardness.** A Shore Type D durometer (ASTM D2240) was used to determine the hardness of the liner samples. Samples (1 in. × 1 in.) were cut from the retrieved HDPE liner with a band saw. A total of 400 readings were taken on the inner and outer surfaces of the liner specimens. The average recorded hardness values are shown in Figure C-22. The hardness of the surface exposed to the flow (inner surface) was found to be slightly lower than that of the protected (outer) surface.

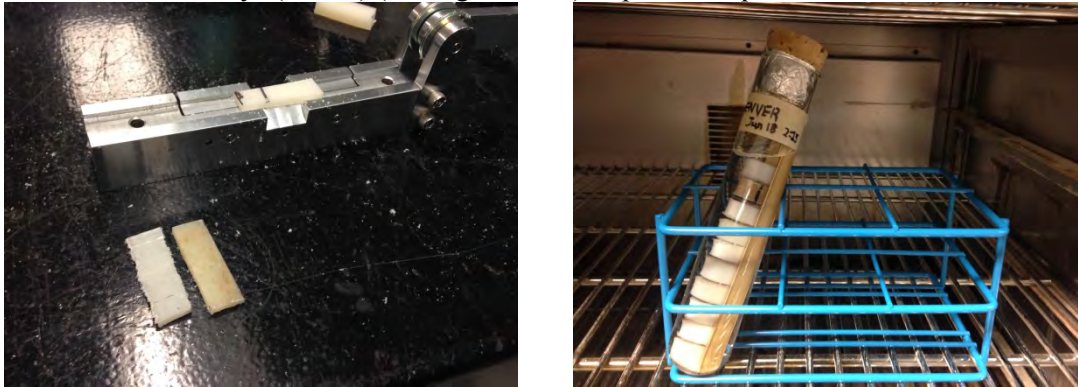
**Figure C-23. Preparation of Test Specimen (left) and Specimens Inside the Oven (right)**

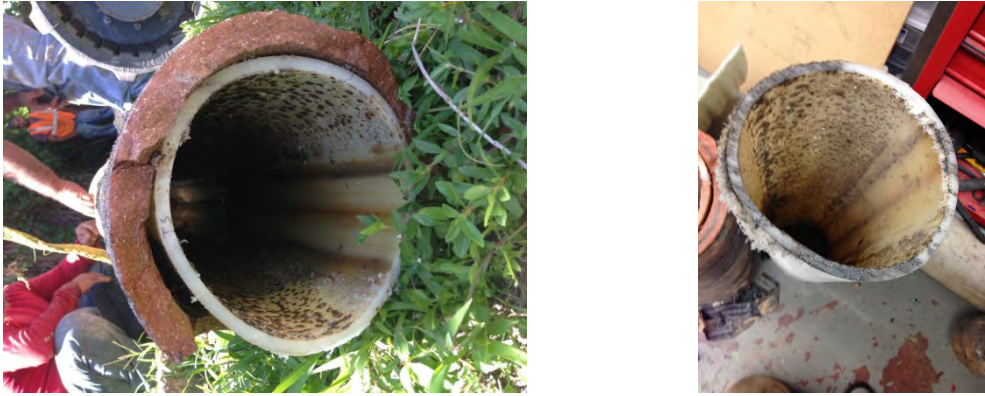
**Figure C-25. Miami 114th St.: Images of the HDPE Liner Section in the Field (Left) and Prior to Testing (Right)**

**C.2.2.1 Visual Inspection.** The HDPE sample was found in good condition. No cracks were visible on the pipe. There was no remaining soil accumulation on the samples when received at the TTC laboratory. The retrieved samples are shown in Figure C-25 in the field and prior to testing.

**C.2.2.2 Annular Gap.** Annular gaps were measured at the site after the sample was exhumed and were recorded as 0.50 in. (12.7 mm) at the 12:00 position and 1 in. (25 mm) at the 1:30 position. However, the cracking and distortion of the host pipe that can be seen in Figure C-25 indicate that the measured values may not be meaningful. The sample was received at TTC without any host pipe attached to it and therefore, no annular readings were recorded.

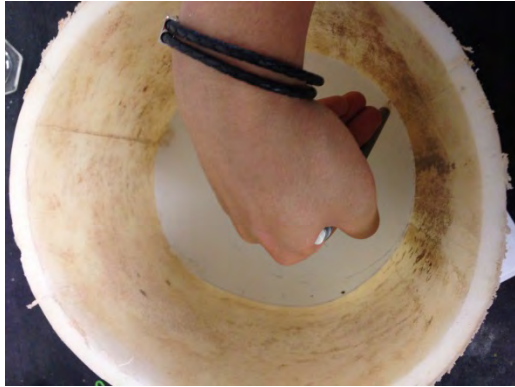
Figure C-26. Miami 114th St.: Tracing the Liner Shape (Left) and Ovality of the Liner (Right)

**C.2.2.4 Ovality.** The sample's ovality was measured using software as described in Section C.1.1.4. The maximum diameter measured ovality was 6.66%, while ovality was 5.82% when calculated based on the minimum diameter. The higher ovality value was used as the representative value. The tracing of the inner circumference of the liner and the resulting diameter measurements are shown in Figure C-26. The detailed ovality calculation is shown in Table C-19.

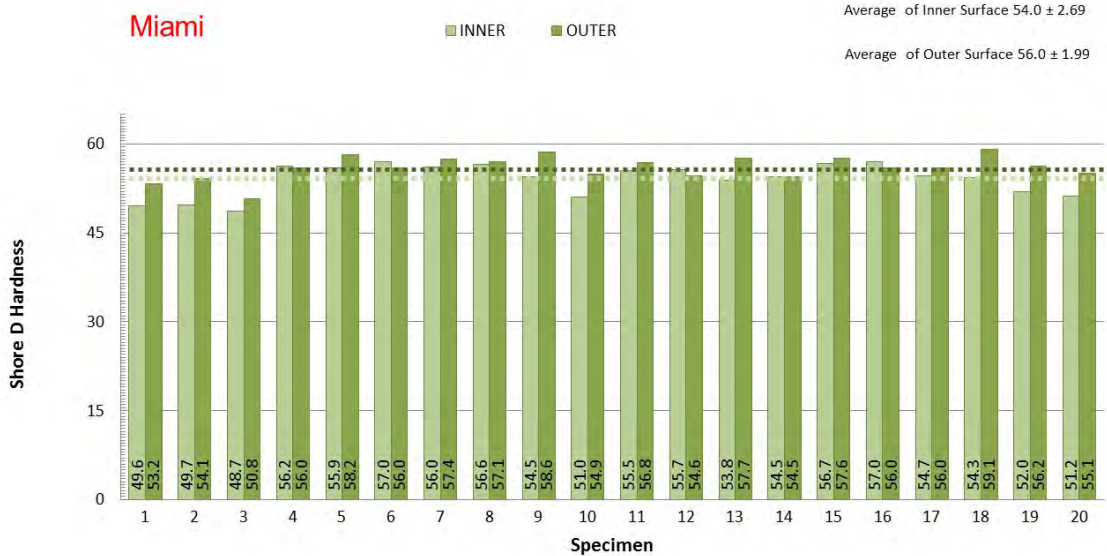
**Figure C-31. Miami 114th St.: Shore D Hardness Readings for the Liner’s Inner and Outer Surfaces**

**C.2.2.9 Surface Hardness.** A Shore Type D durometer (ASTM D2240) was used to determine the hardness of the liner samples. Samples (1 in. × 1 in.) were cut from the retrieved polyethylene liner with a band saw. A total of 400 readings were taken on the inner and outer surfaces of the liner specimens. The average recorded hardness values are shown in Figure C-31. The hardness of the surface exposed to the flow (inner surface) was found to be slightly lower than that of the protected (outer) surface.

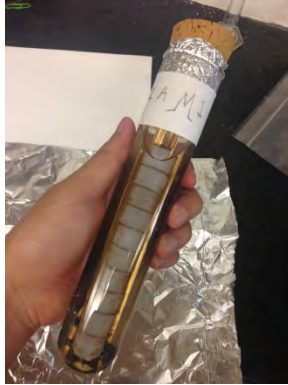
**Figure C-32. Specimens inside the Reagent**

**C.2.2.11 ESCR Testing.** Ten specimens each 1.5 in. long, 0.5 in. wide and 0.0775 in. thick were cut from the liner following the condition “C” mentioned in ASTM D1693. This low thickness was achieved by placing the specimen on a belt sander. A notch of 0.015 in. was grooved in the middle of the specimen using a specific pressing tool. Next, all specimens were bent and slid into a holder. Later, the holder with all of the specimens was submerged in the reagent (Igepal CO-630) in a test tube (see Figure C-32) and the test tube was kept in an oven at 212°F for 8 days (192 hr) as per the requirement from ASTM D3350.

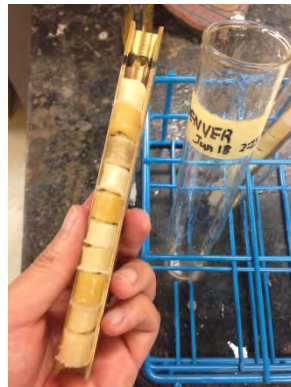
**Figure C-33. Specimens after the Test**

Following the test period, the specimens were taken out of the test tube and checked for any cracks visible by the naked eye. No cracks were found and the sample passed the limitation of maximum failure percent of 20% as per ASTM D3350 (see Figure C-33).

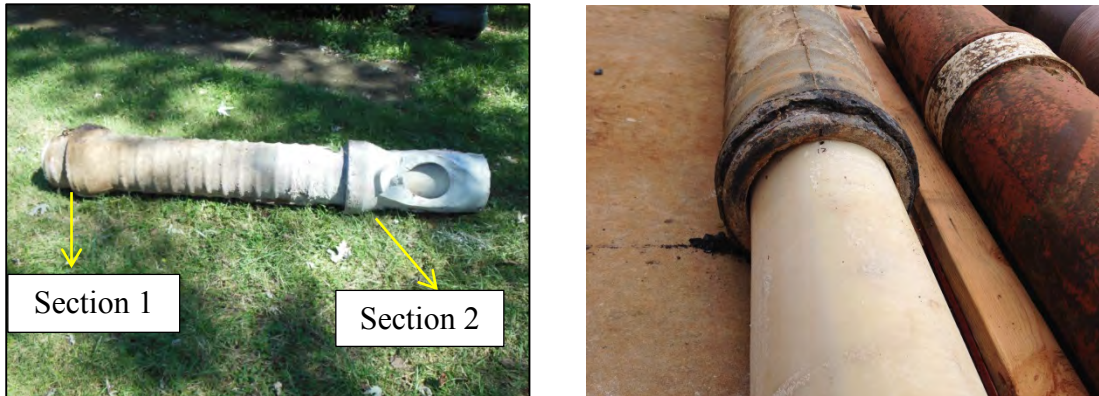
**Figure C-34. Nashville Danby Dr.: Images of the HDPE Liner Section after Retrieval (left) and Taken in the TTC Laboratory (right)**

**C.2.3.1 Visual Inspection.** The HDPE sample with the host pipe was found in good condition. The retrieved sample is shown in Figure C-34.

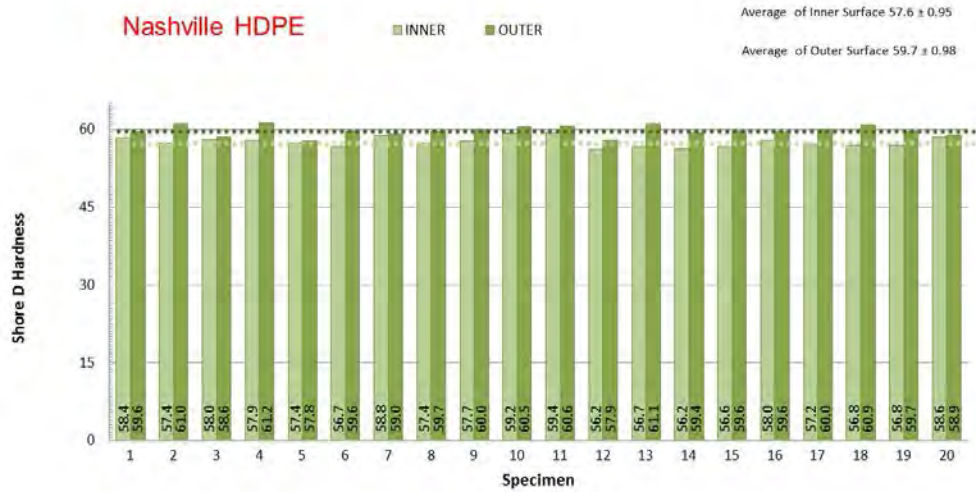
**Figure C-40. Nashville Danby Dr.: Shore D Hardness Readings for the Liner’s Inner and Outer Surfaces**

**C.2.3.9 Surface Hardness.** A Shore Type D durometer (ASTM D2240) was used to determine the hardness of the liner samples. Samples (1 in. × 1 in.) were cut from the retrieved HDPE liner with a band saw. A total of 400 readings were taken on the inner and outer surfaces of the liner specimens. The average recorded hardness values are shown in Figure C-40. The hardness of the surface exposed to the flow (inner surface) was found to be slightly lower than that of the protected (outer) surface.

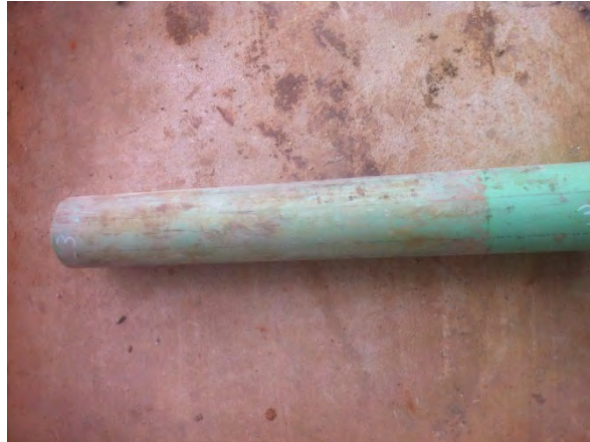
**Figure C-43. Houston Greiner Dr.: Image of the PE Liner Section at the TTC Laboratory**

**C.3.1.1 Visual Inspection.** The polyethylene sample came in good condition and the thickness was constant along the length and circumference of the sample. The sample as received at the TTC laboratory is shown in Figure C-43.

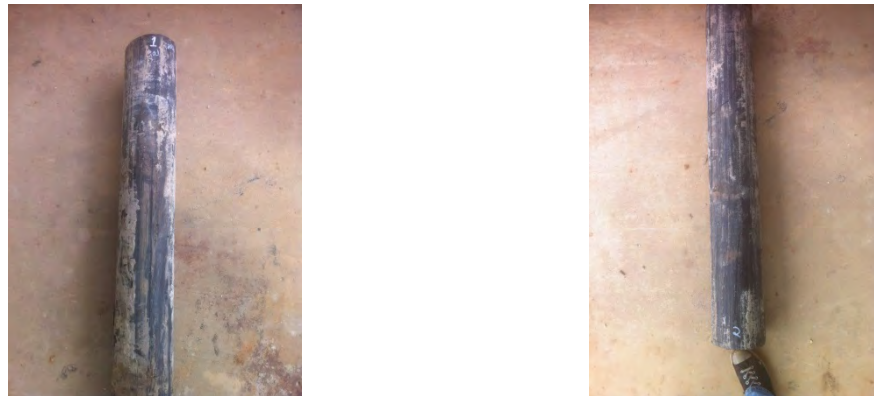
**Figure C-50. Houston – Norton Dr.: Images of the Black Polyethylene Slipliner Section Prior to Testing**

**C.3.2.1 Visual Inspection.** The black polyethylene slipline sample was found in good condition. No cracks were visible on the pipe. There was no evidence of soil accumulation on the samples when received at the TTC laboratory. The retrieved sample is shown in Figure C-50.

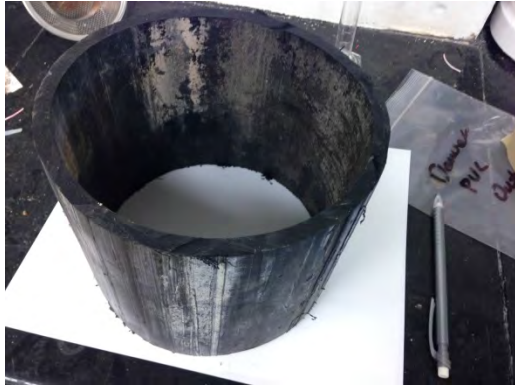
**Figure C-51. Houston – Norton Dr.: Ovality of the Liner**

**C.3.2.4 Ovality.** The sample's ovality was measured using software as described in Section C.1.1.4. The pipe ready for tracing and the resulting diameter measurements are shown in Figure C-51. The detailed ovality calculation is shown in Table C-35. Based on the maximum diameter measured, the ovality was 2.83%, while the ovality was 3.33% when calculated based on the minimum diameter. The higher ovality value was used as the representative value.

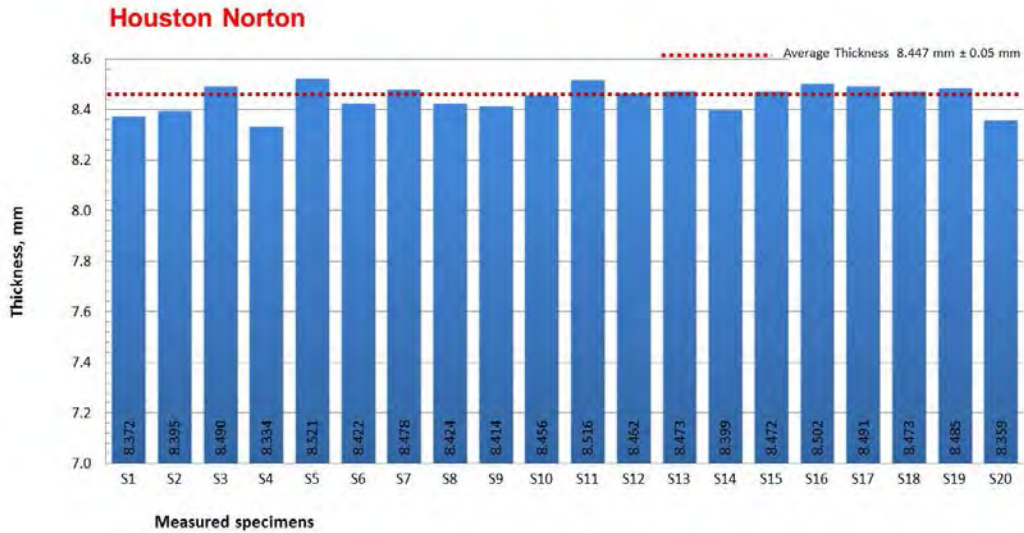
Figure C-52. Houston-Norton Dr.: Average Thickness of the Liner Sample

**C.3.2.5 Thickness.** A total of 120 readings were taken on 20 1 in. × 1 in. samples cut from different locations of the specimen. The thickness was measured randomly using a micrometer with a resolution of ±0.0025 mm. The average thickness of the liner was found to be 8.447 mm ± 0.05 mm as shown in Figure C-52. The design thickness was unavailable; therefore, no comparison was made.

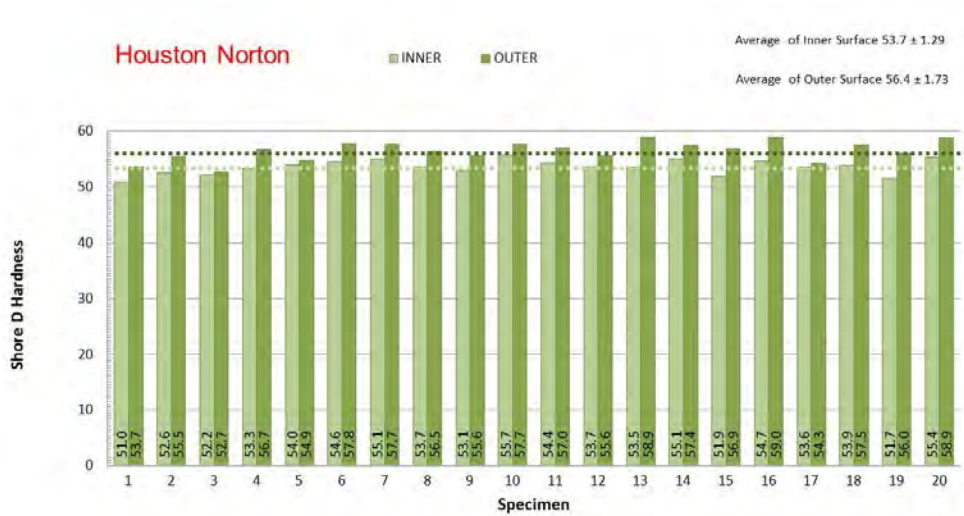
**Figure C-56. Houston Norton Dr.: Shore D Hardness Readings for the Liner’s Inner and Outer Surfaces**

**C.3.2.9 Surface Hardness.** A Shore Type D durometer (ASTM D2240) was used to determine the hardness of the liner samples. Samples (1 in. × 1 in.) were cut from the retrieved polyethylene slipliner with a band saw. A total of 400 readings were taken on the inner and outer surfaces of the liner

specimens. The average recorded hardness values are shown in Figure C-56. The hardness of the surface exposed to the flow (inner surface) was found to be slightly lower than that of the protected (outer) surface.
