# **Arsenic Removal from Drinking Water by Adsorptive Media**

## **EPA Demonstration Project at Rimrock, AZ Six-Month Evaluation Report**

Lili Wang  
Julia Valigore  
Abraham S.C. Chen

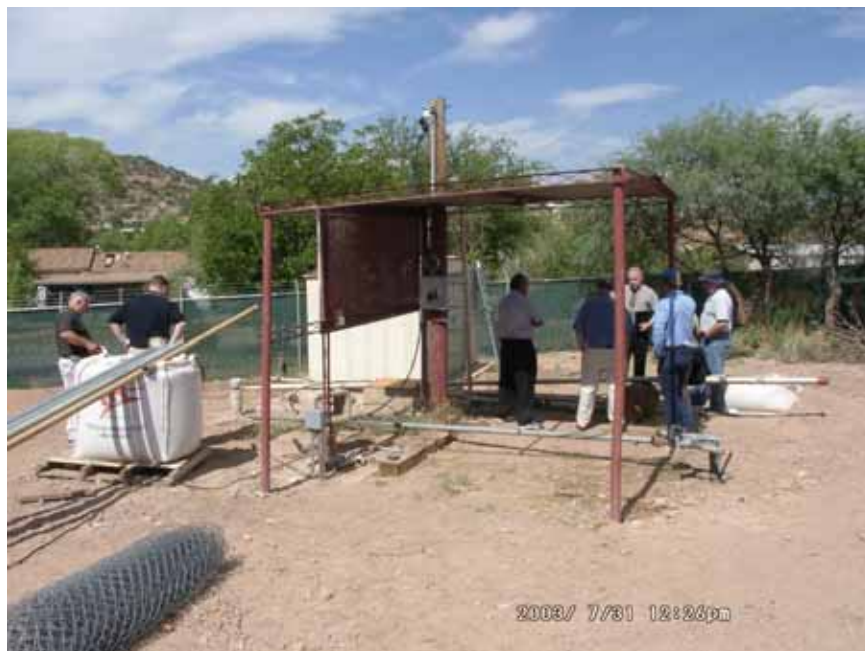
**Figure 4-1. Pre-Demonstration Site Conditions**

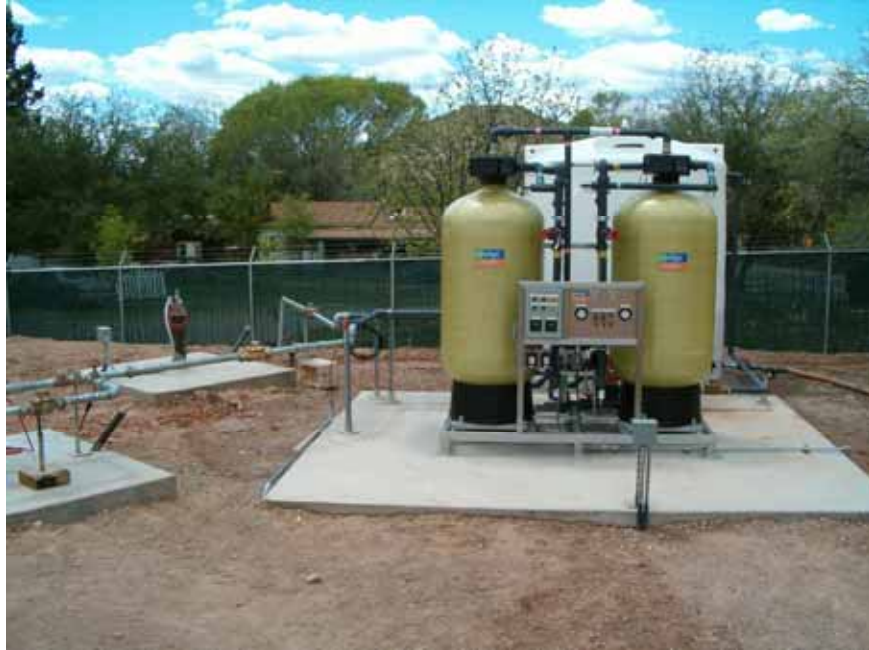
**Figure 4-4. Photograph of the APU-100 System**

underbed. Although originally proposed to contain 27 ft<sup>3</sup> of media in each vessel, less media was loaded to provide additional freeboard for backwash. The vessels are of fiberglass-reinforced-plastic (FRP) construction, rated for 150 psi working pressure, skid mounted, and piped to a valve rack mounted on a polyurethane coated, welded steel frame. Based on the actual flowrate of 31 gpm, the empty bed contact time (EBCT) and hydraulic loading for each vessel are approximately 5.3 minutes and 4.4 gpm/ft<sup>2</sup>, respectively. Figure 4-4 is a photograph of the APU-100 system.

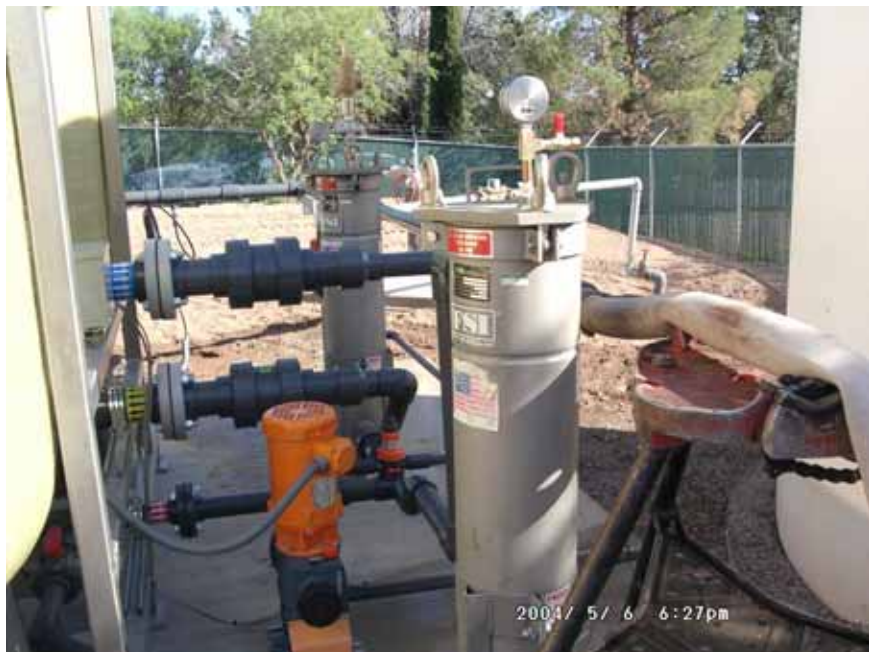
**Figure 4-5. Photograph of the Backwash Recycle System**

- **Backwash.** Based upon a set time or a set pressure differential ( $\Delta p$ ), the adsorption vessels are taken off line for backwash one at a time using raw water from the well. The purpose of the backwash is to remove particulates and/or media fines accumulating in the beds. Backwash may be initiated either manually or automatically. Each backwash event produces 8 to 10 BV of wastewater.
- **Backwash Water Recycling.** Due to the lack of sewer or other wastewater discharge facilities on site, a backwash recycle loop was added to the system to reclaim the wastewater. The recycle system consists of a 25- $\mu$ m bag filter, a 3,000-gallon polyethylene tank, and a reclaim pump. Wastewater from the storage tank is metered into the system intake between the NaOCl injection point and the bag filter at a rate of 0.5 gpm. Figure 4-5 is a photograph of the recycle system.

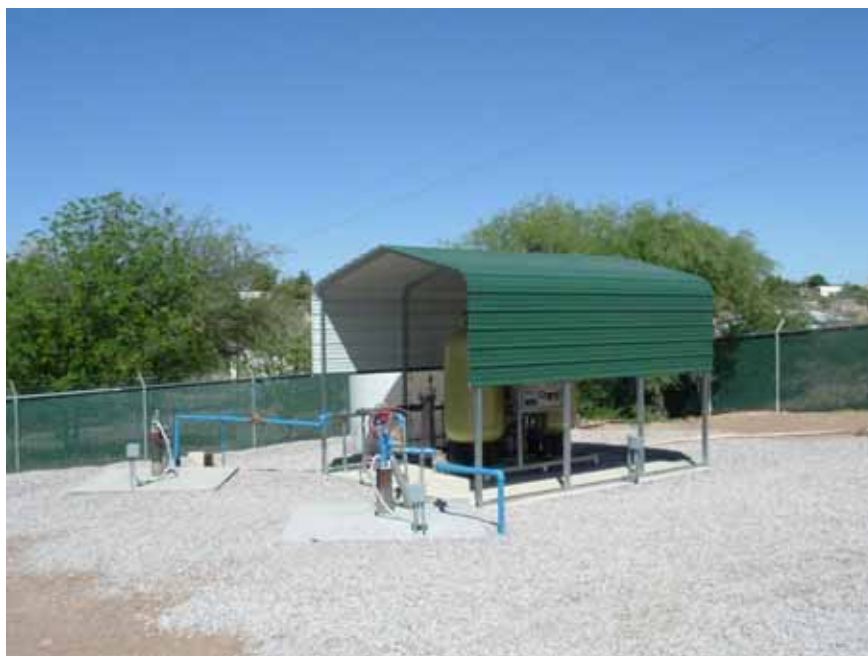
**Figure 4-6. Sun Shed Structure over the Treatment System**

**4.3.3 Shed Construction.** After the APU-100 system was installed, a sun shed structure was built by AWC over the treatment system in mid-May (Figure 4-6). The dimensions of the shed structure, manufactured by Versa-Tube, were 12 ft × 15 ft with a height of 9.5 ft. The shed was constructed with a galvanized steel frame anchored to the concrete pad and sheeted with 29-gauge steel that had a specially coated surface. The shed was pre-engineered with a 90-mph wind load and a 30-lb/ft<sup>2</sup> snow loading capacity. From late-November to mid-December 2004, the sides and ends of the shed structure were enclosed with metal covering for the winter.

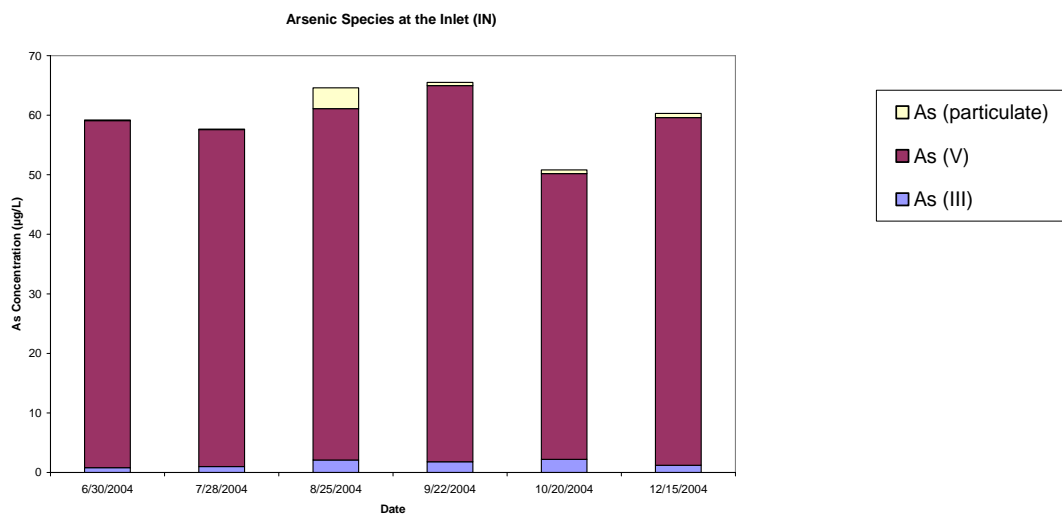
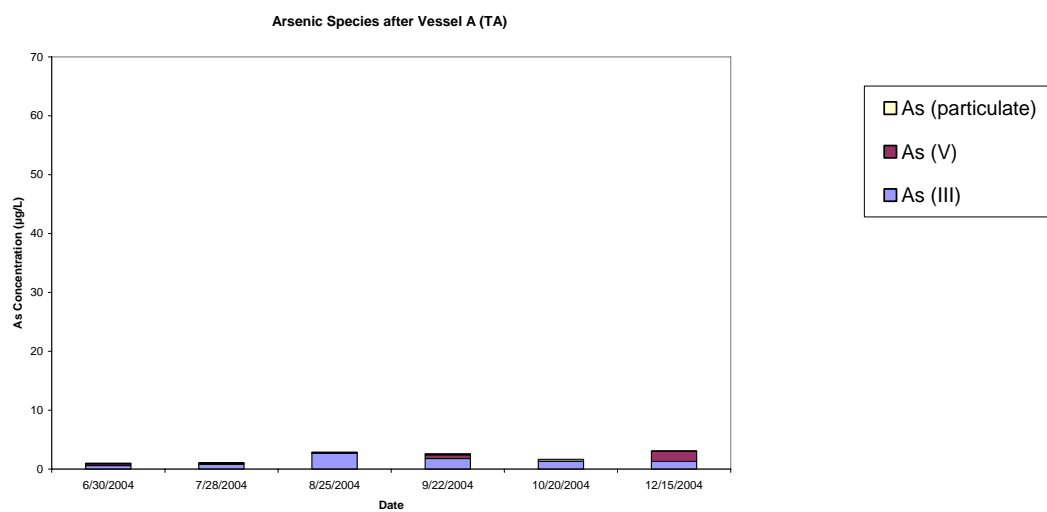
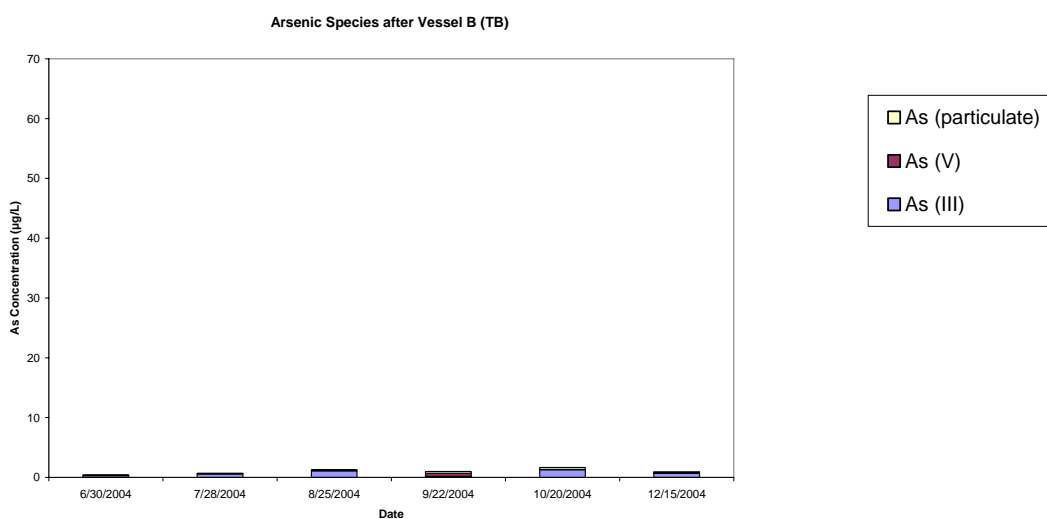
**Figure 4-7. Concentration of Arsenic Species at the Inlet, after Vessel A, and after Vessel B**

to 3.0 µg/L to be further polished by the lag vessel. The treated water from the lag vessel contained only 0.2 to 1.3 µg/L of total arsenic. By the end of the first six months of system operation, the APU-100 system treated approximately 25,000 BV of water (equivalent to 4,109,000 gallons of water), which was about 38% of the vendor-estimated working capacity (66,000 BV as shown in Table 4-4). It must be noted, however, that the treatment system was operating with a reduced flowrate and a longer EBCT than was originally designed, which might increase the removal capacity of the media.
