**WEB-BASED DATABASE ON RENEWAL TECHNOLOGIES**

**Wendy Condit, P.E., John C. Matthews, Ph.D., and Ryan Stowe**  
**Battelle Memorial Institute**

**EPA Contract No. EP-C-11-038**  
**Task Order No. 01**

**May 2016**

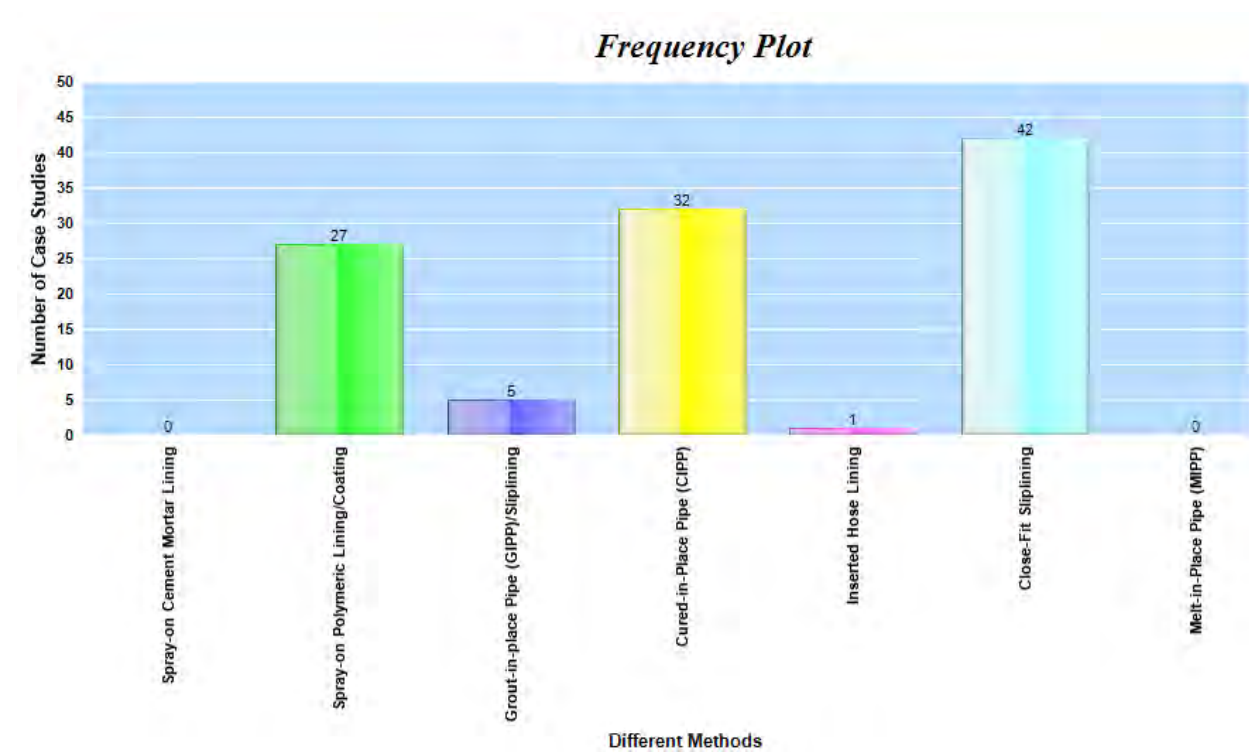
**Figure 2-5. RehabAnalytics Total Count Summary for Water Main Case Studies**

*RehabAnalytics* displays case study frequency counts and cost data plots for wastewater and water main renewal technologies. For example, the *Frequency Plot* subtab under the *Water* tab runs a query to display the total number of case studies by water main renewal method (see Figure 2-5). A similar plot is available online for the wastewater main renewal case studies. This plot is actively generated from the database, so it has the ability to automatically update as new case studies are added.

The *RehabAnalytics* page contains summary information on case studies for water main renewal including total case study counts (see Section 2, Figure 2-5) and an automated plotting of normalized cost data. The largest number of case studies collected was for close-fit lining (42), followed by CIPP (32), and spray-on polymeric lining (27). Bid cost data were also collected for water main renewal by CML to benchmark the innovative technology costs. Although it is not a structural repair, CML is a widely-used renewal method and utilities will be familiar with typical costs for their region for this conventional technology. The trenchless technology cost data collected were normalized to the host pipe footage and diameter for the project as shown in Figures 3-3 to 3-5 for spray-on polymeric lining, CIPP, and close-fit lining, respectively, for water mains. The spray-on polymeric lining normalized costs for water mains ranged from \$3 to \$35 per linear foot per inch diameter (Figure 3-3). Ellison et al. (2010) has suggested that detailed pipe wall inspections could save costs for spray-on lining applications by lining only where it is needed at the appropriate thickness (e.g., for non-, semi-, full-structural applications). However, this is an area of future research. The CIPP normalized costs for water mains ranged from approximately \$10 to \$45 per linear foot per inch diameter (Figure 3-4). The close-fit lining normalized costs for water mains ranged from \$3 to \$21 per linear foot per inch diameter (Figure 3-5). In the future, the use of trenchless water main renewal techniques could grow as they become more cost competitive with open trench replacement and as the capabilities to internally re-connect service lines improves.

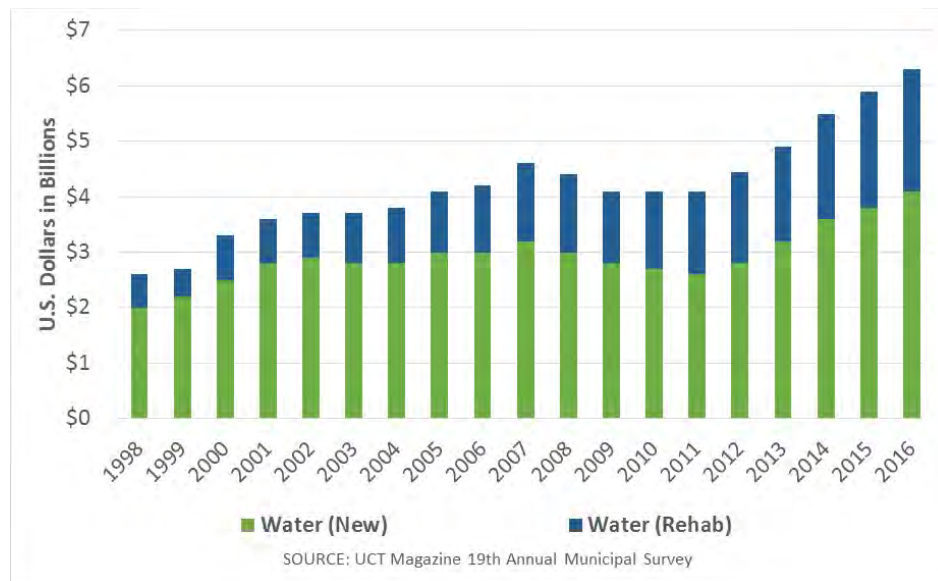
Figure 3-1. Expenditures on Water Pipeline Infrastructure (UC, 1998 to UC, 2016)

The adoption of trenchless technologies for potable water applications has been slower than wastewater applications, but it is becoming more prevalent over time. Over the past 18 years, total U.S. municipal spending on drinking water distribution systems has more than doubled from \$2.6 to \$6.3 billion (see Figure 3-1). In that same timeframe, the expenditures on water main renewal has more than tripled from \$0.6 billion in 1998 to \$2.2 billion in 2016. Water main renewal is also a growing proportion of the total expenditures compared to new construction, reaching 35% in 2016 (UC, 2016). This section reviews the overall status of the water main renewal market based on the collected case studies and relevant industry information. Available water main renewal technologies are presented, along with a summary of the case studies identified including total case study counts, pipe sizes, pipe material types, regional distribution, and any findings on lessons learned. The technologies are categorized as shown in Figure 3-2 with a focus on spray-on linings, CIPP, and close-fit lining, which were identified as the most prevalent methods used for water main renewal from the case study review.

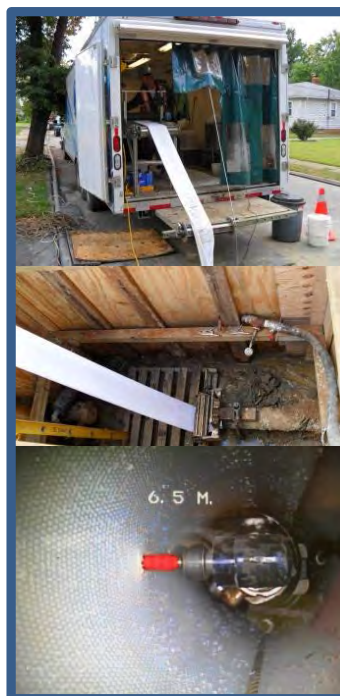
Under a related research effort, EPA performed an evaluation of an innovative CIPP lining product for water main rehabilitation in Cleveland, Ohio. The project evaluated the technology maturity, feasibility, complexity, performance, cost, and environmental impact. This case study is included in the Web-based renewal database (see Table 2-1). The full results are reported in EPA (2012b) for more information.

The field demonstration of the Sanexen Aqua-Pipe® CIPP liner in Cleveland provided valuable information on the design, installation, and QA/QC of CIPP used to rehabilitate water mains. The field demonstration involved the CIPP lining of approximately 2,000 ft of a 6-inch cast iron water main pipeline that had been installed in 1914 and 1949. The testing results showed that the CIPP as installed exceeded the applicable requirements of ASTM F-1216 to provide for a Class IV fully-structural liner. Findings from the study included the need to improve the cleaning process in order to avoid damaging or deforming corporation stops and to address other issues contributing to the need to excavate and externally reinstate 17 of the 63 service connections (27%). A more typical external reinstatement rate was reported to be 5% to 10% by the vendor (EPA, 2012b). Case study results from the water main renewal database suggest that fully internal reinstatement of service lines can be a challenge for several water main CIPP technologies depending on site conditions.

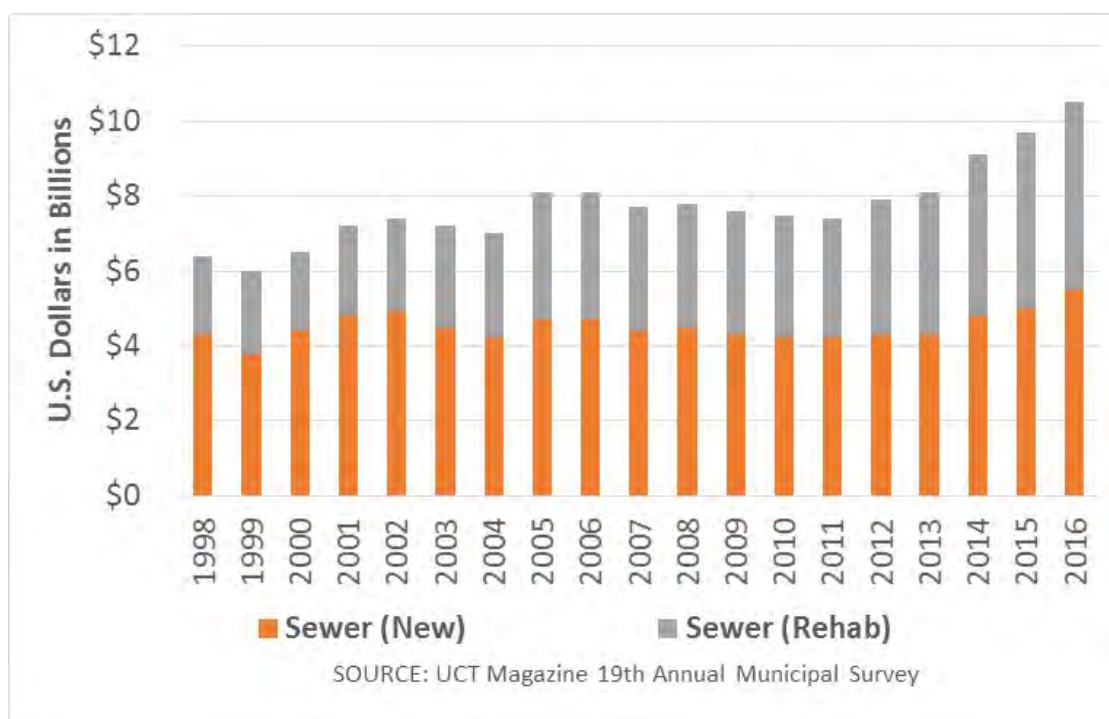
**Figure 4-1. Expenditures on Wastewater Pipeline Infrastructure (UC, 1998 to UC, 2016)**

A survey recently released by EPA indicates that over \$271 billion in total funding is required to address aging infrastructure needs at publically-owned wastewater utilities (EPA, 2016b). Approximately 53% of this funding is needed to correct issues with wastewater collection systems including \$51.2 billion for sewer main renewal, \$44.5 billion for new sewer main installation, and \$48 billion to correct combined sewer overflow conditions (EPA, 2016b). As shown in Figure 4-1, the annual municipal expenditures on wastewater main renewal is more than double that for water mains (e.g., at \$5 billion versus \$2.2 billion as of 2016). Sewer main renewal is also approximately on par with new sewer main construction at 48% of the total expenditures with an increasing trend over time (UC, 2016).

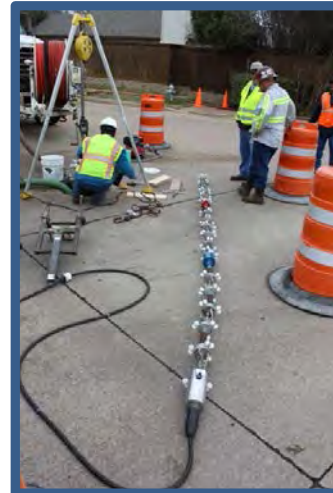
EPA funded a field demonstration conducted by WERF of the rehabilitation of 888 ft of 10-inch VCP using Reline America's Blue-Tek™ product. This case study is also included in the Web-based renewal database to share lessons learned on the use of new wastewater main renewal technologies. This ultra-violet cured CIPP demonstration provided valuable information on the design, installation, and QA/QC of this innovative technology. The project documented site preparation activities including temporary bypass, pre-lining inspection with CCTV, and the cleaning process. The installation steps were then observed including winching in of the liner, inflation via compressed air, and completion of the ultraviolet curing process. The installation for 888 ft of ultraviolet-cured CIPP took place over 3 days. The liner insertion was completed at a rate of approximately 18 ft/min, while inflation took 35 minutes per run. The ultraviolet curing was completed in approximately 3.8 ft/min per run. The QA/QC process was observed and samples taken for laboratory testing. The main challenges noted at the site were the varied inner diameter of the host pipe. In addition, certain sections of the liner were reported to be wrinkled due to a tear on the inner film. However, the minor defects noted did not compromise the overall strength. The mechanical testing showed that the liner's flexural strength and modulus exceeded the design requirements. As a result of the demonstration, the vendor later modified the technology design for use of a more tear resistant inner film (Matthews, 2014).

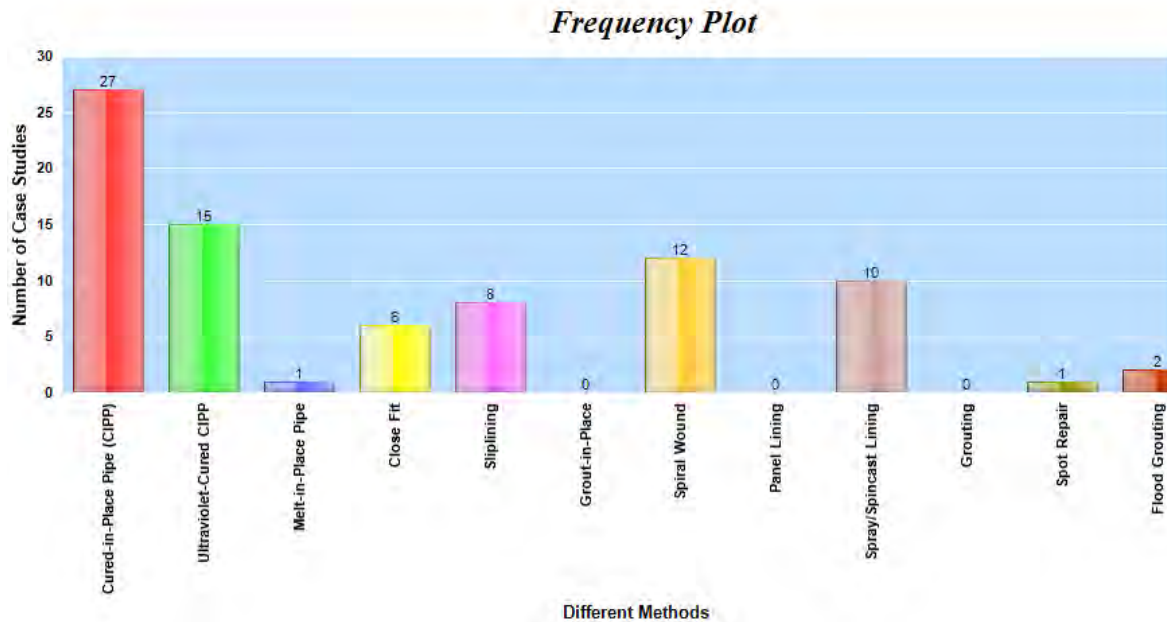
**Figure 4-3. RehabAnalytics Total Count Summary for Wastewater Case Studies**

The *RehabAnalytics* page contains summary information on case studies for wastewater main renewal including total case study counts and an automated plotting of normalized cost data. As shown in Figure 4-3, the largest number of case studies collected was for CIPP (27), followed by ultraviolet-cured CIPP (15), spiral wound lining (12), and spray-on lining (10).

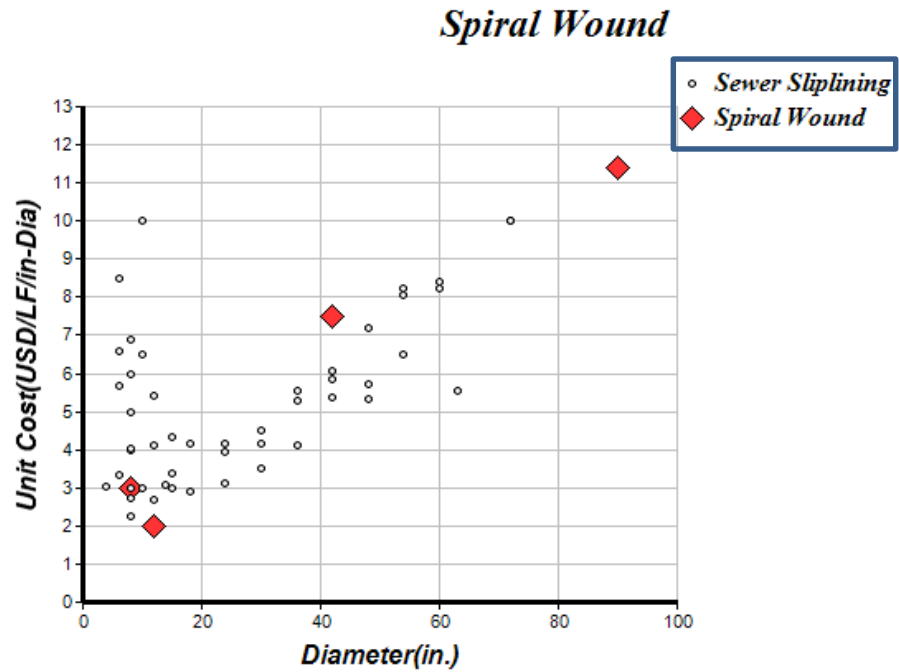
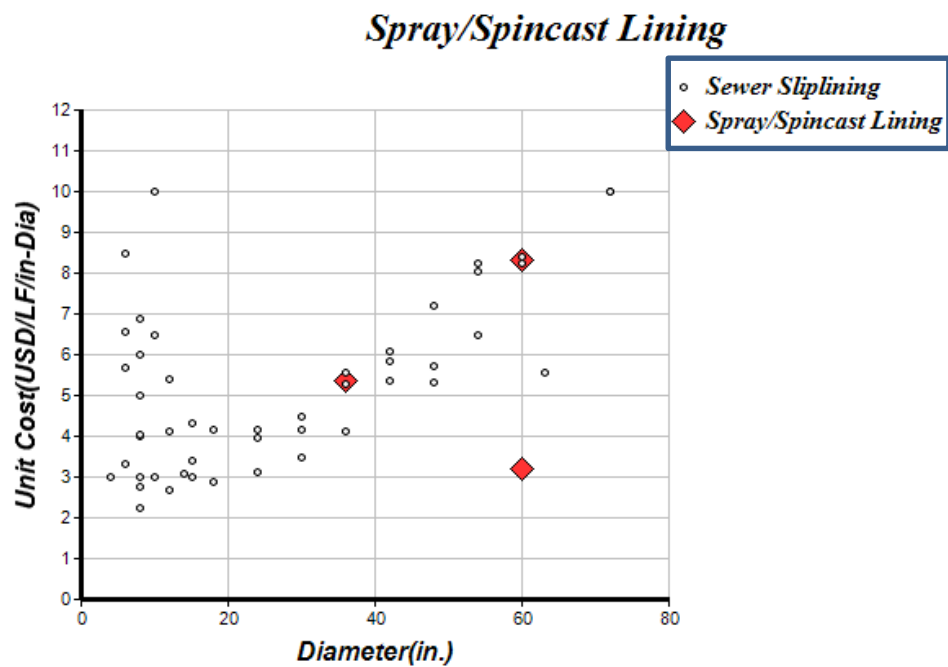
Bid cost data were also collected for wastewater main renewal by sliplining to benchmark the innovative technology costs. The trenchless technology cost data collected were normalized to the host pipe footage and diameter for the project as shown in the examples in Figures 4-4 and 4-5. Cost plots for additional trenchless technologies can be viewed on the *RehabAnalytics* page. Cost was obtained for only one sewer main project for the ultraviolet-cured CIPP at \$7 per linear foot per inch diameter. The spiral wound lining normalized costs for sewer mains ranged from \$2 to \$12 per linear foot per inch diameter (Figure 4-4). The spray-on lining normalized costs for sewer mains ranged from \$3 to \$9 per linear foot per inch diameter (Figure 4-5).
