# **EPA/OSHA JOINT CHEMICAL ACCIDENT INVESTIGATION REPORT**

**BPS, Inc.  
West Helena, Arkansas**

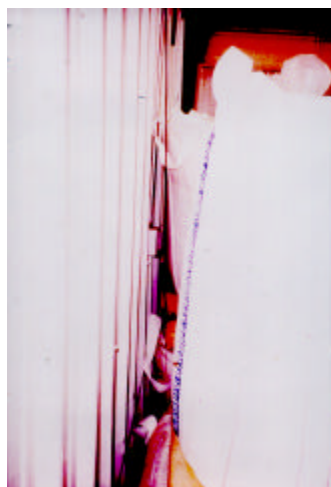
Figure 5. Supersack set-up at BPS Unit One

Shortly after the incident, BPS employees and management identified the decomposing material as an AZM supersack placed against or close to the hot compressor discharge pipe. The JCAIT confirmed that supersacks of materials were being spotted in close proximity or against walls at BPS. After the incident, JCAIT observed supersacks spotted along the wall in the Unit One warehouse. In this case, the supersacks were stacked two-high. The edge of the bottom supersack was within inches of the wall. The top supersack was listing so that it was in contact with the wall (Figure 5).

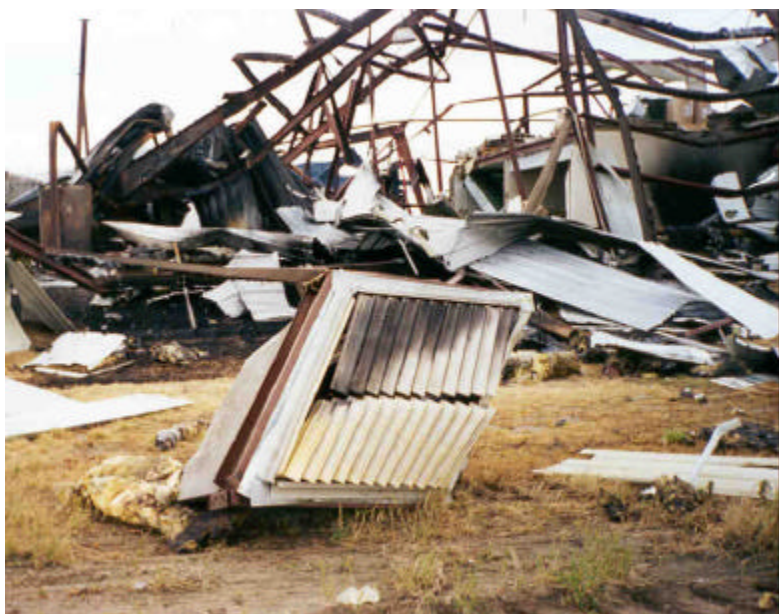
Figure 8. Ventilation Fan with Yellow Residue

Based on witness interviews, the JCAIT identified the approximate location of the chemicals in the warehouse area (Figure 7). Even though witness accounts are somewhat conflicting regarding the quantity and approximate location of the stored chemicals, most statements agree that AZM supersacks had just been placed next to the compressor piping. Witnesses also agree that the yellow smoke or powder was coming from this location. Forklift operators recollect placing Maneb pallets by the compressor pipe in an attempt to make room for the incoming AZM. In addition to the witness statements the JCAIT:
